71-231-2022

Pedestrian struck by vehicle

## Site Superintendent Run Over by Backing Dump Truck

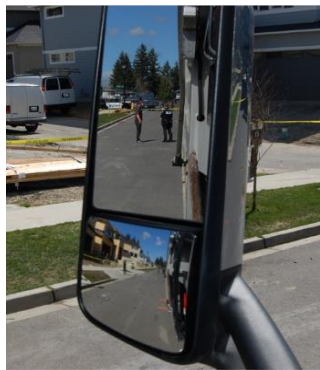
Truck side mirror shows workers are difficult to see if not wearing high-visibility vests.

- Continuously assess the hazards of vehicles to workers on foot and ensure hazards are corrected.
- Require workers to wear ANSI Class 2 high-visibility garments, such as vests, when exposed to vehicular traffic.

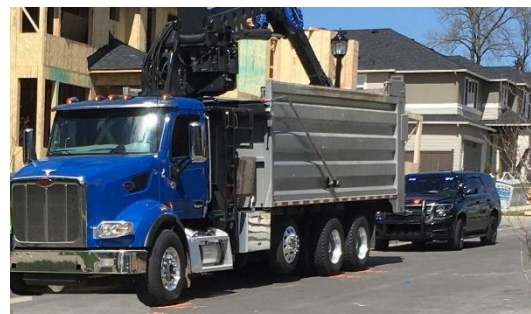
- The truck did not have a backup camera, nor was an observer signaling that it was safe to back up.
- The truck's backup alarm was working as it backed up.
- The truck drivers were not trained on procedures for backing up at construction sites.

Dump truck that backed over the superintendent.

- Consider installing pedestrian proximity detection systems on trucks to alert drivers of workers on foot.
- Train drivers that they must use a signaler or back up camera when backing near workers on foot.
- Create and enforce policies that:
  - Drivers maintain visual contact with workers on foot. When visual contact is lost, drivers should stop and not resume movement until visual contact is re-established.
  - Workers on foot stay out of backing zones unless trained and acting as an observer signaling the driver.
