RI 8682

Bureau of Mines Report of Investigations/1982

Failure Analysis of Diesel Exhaust-Gas Water Scrubbers

**By Robert W. Waytulonis, Sean D. Smith,
and Lito C. Mejia**

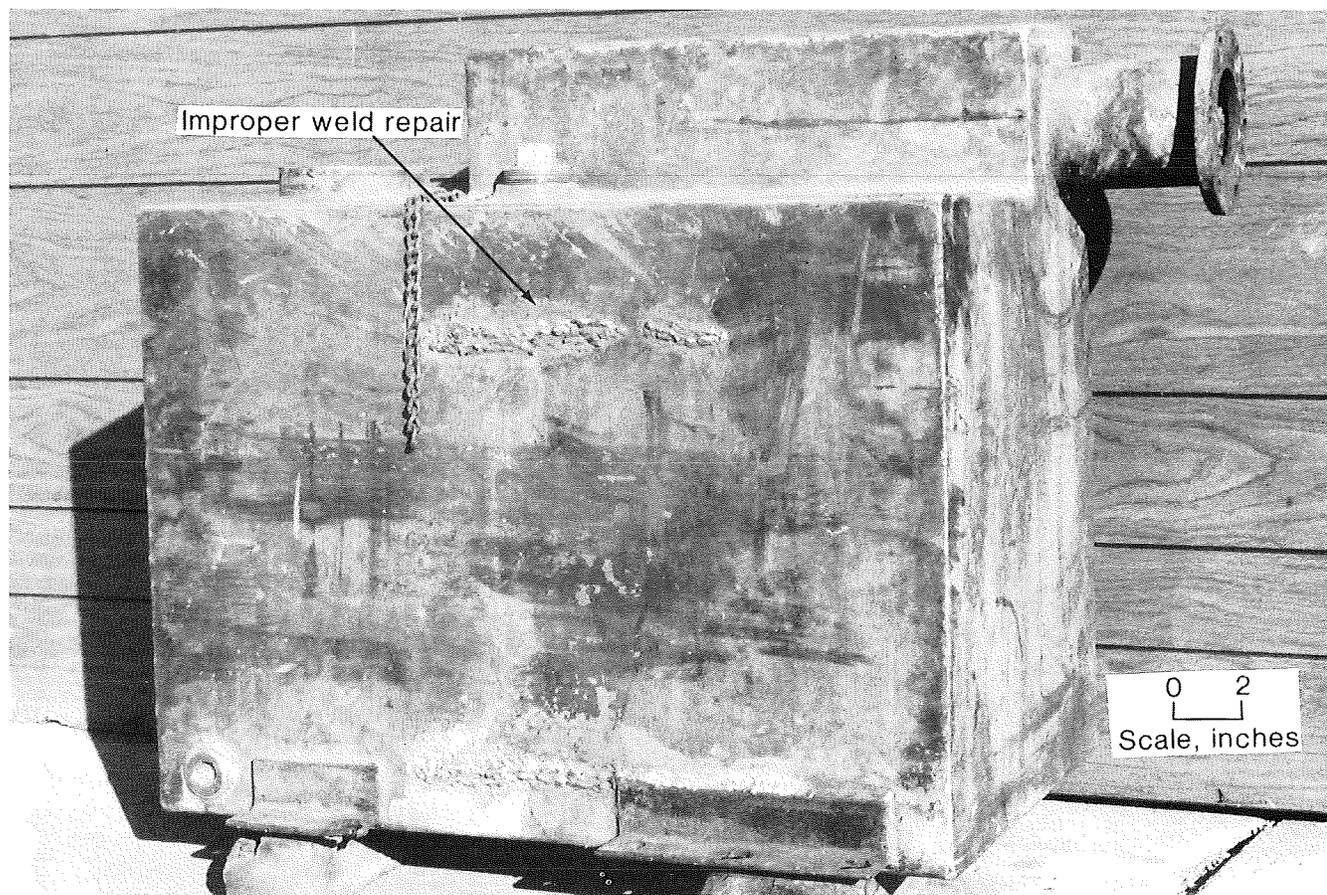
FIGURE 1. - Exhaust water scrubber 3—batch-type—formed of type 304 stainless steel. Arrow indicates improper weld repair where mild steel filler material was used.

can cause failure at welds or at mounting points. Dents and holes from inadvertent collisions with surrounding objects have been observed. All such damages must be repaired with welding materials suited to the scrubber material. Figures 1 and 2 show a stainless steel scrubber improperly repaired with welding materials designed for mild carbon steel.

Scrubber 3 (fig. 1) was fabricated of type 304 stainless steel and was in service for approximately 6 months in an eastern coal mine. Upon inspection, signs of pitting corrosion on interior surfaces were evident (fig. 7). Since the scrubber was in service for this relatively short time, the pitting corrosion was identified, in addition to that previously improperly repaired. It is believed that the corrosion resistance of stainless steels, as in the case of mild steels, is due to the formation of a thin hydrous oxide film on the metal surface. But, unlike mild steel, this film is further stabilized by the presence of chromium and nickel in 300 series stainless steels. The film is continuous, nonporous, insoluble, and self-healing (that is, under the proper conditions it can regenerate itself if it is destroyed); it "passivates" the metal, reducing its electrochemical potential to about the same low levels as gold, silver, platinum, and other noble metals (4-5).

7. Do not use mild steel welding rods for repairs on stainless steel.

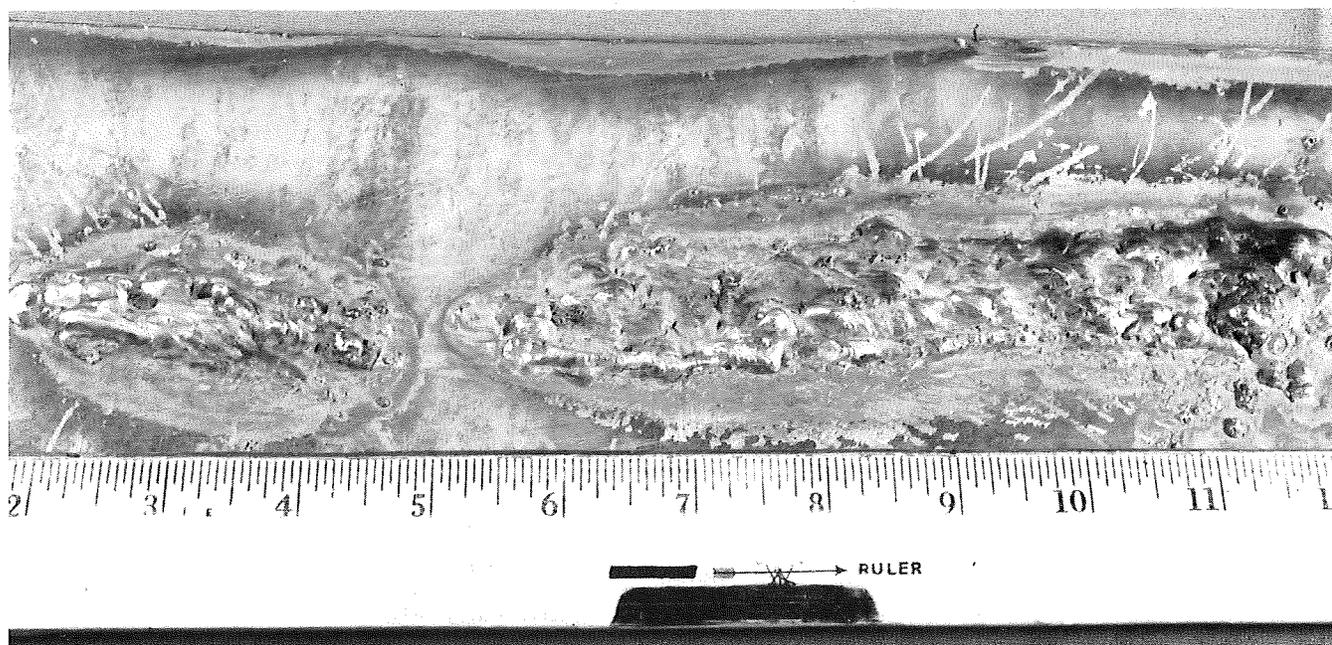
FIGURE 2. - Repair site of internal baffle weld failure on scrubber 3.

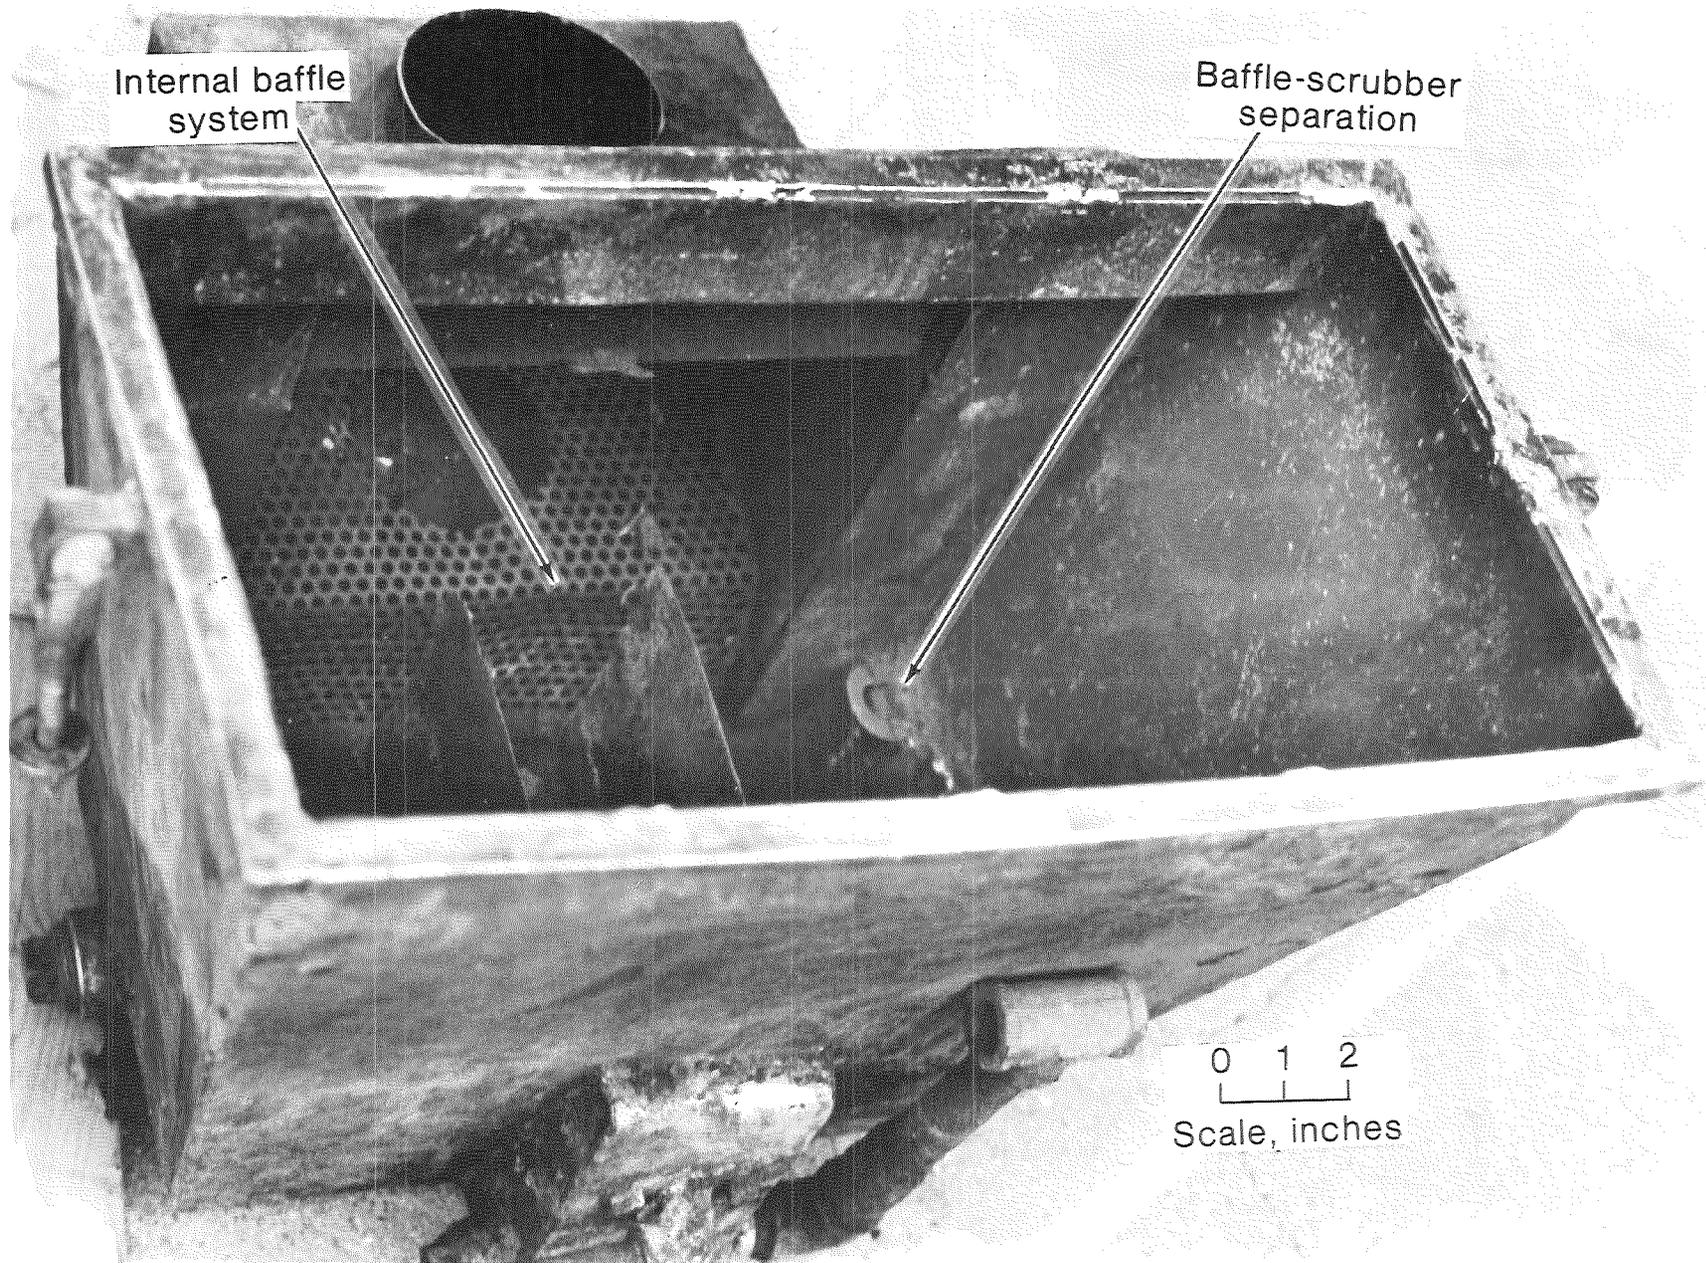
FIGURE 3. - Exhaust water scrubber 1—water-makeup type. Arrows indicate areas represented in figures 4 and 5.

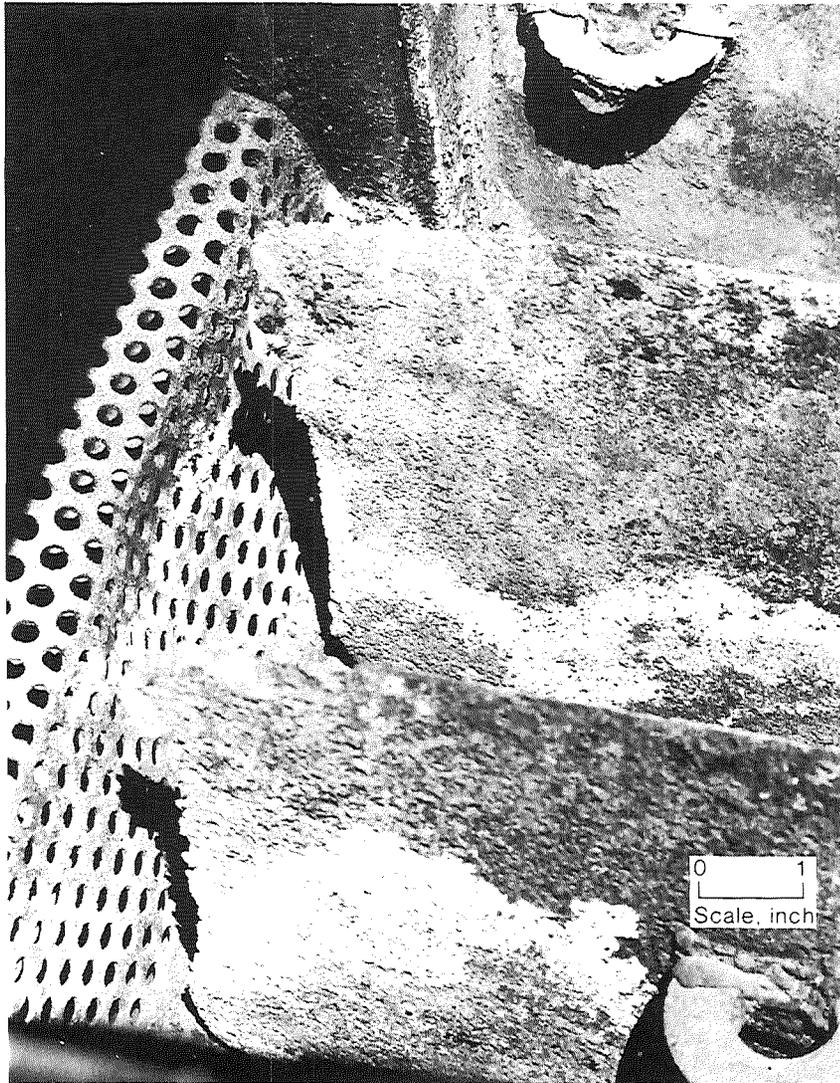
FIGURE 4. - Internal baffle system of exhaust water scrubber. Severe corrosion of mild steel baffles is evident.

The corrosion within scrubbers 1 and 2 was most likely a result of the susceptibility of the metal to ordinary corrosive effects, since the scrubber environment appears to be ideal for such corrosion. It would seem that oxygen-rich diesel exhaust gases could introduce sufficient quantities of dissolved oxygen to the solution (1, 6, 13). However, this cannot be verified because chemical analyses of sample solutions were conducted several weeks after the solutions were exposed to the exhaust gases. High concentrations of dissolved solids provided an electrolyte to react with the metal surfaces. With solution pH less than 4, scrubber solution temperatures as high as 65° C (150° F), and chlorine and other known depolarizing agents present, mild steel is subject to corrosion. Molybdenum austenitic stainless steels (316, 316L) are more resistant

4. Scrubbers should be totally fabricated from materials with no less corrosion resistance than that of type 304 stainless steel. Mild steel does not possess adequate corrosion resistance against typical scrubber solutions.

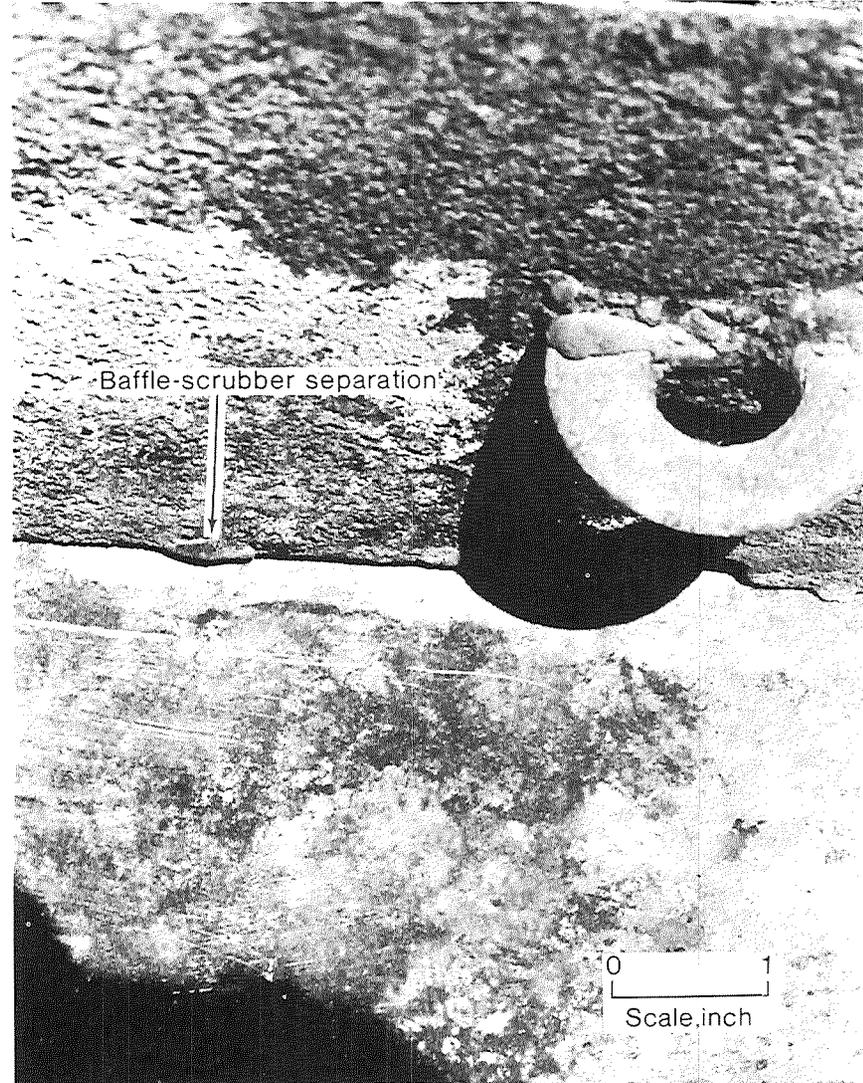
FIGURE 5. - Separation of baffle from scrubber at the weld. This is a typical phenomenon when dissimilar metals are welded.

The severe decay of many welds between mild steel and stainless steel parts indicates possible galvanic reactions (7). Typically, galvanic corrosion is directly related to the areas of the cathode and the anode. Severe localized corrosion will occur if the anode is much smaller than the cathode. This may be the case where the welds were the anode and the stainless steel walls were the cathode. Accordingly, dissimilar metal welds should not be used for scrubber applications.

5. In fabricating scrubbers, materials that will induce galvanic corrosion should be avoided. All metal parts within the scrubber should have equal electrochemical potential, that is, be constructed of stainless steel throughout.

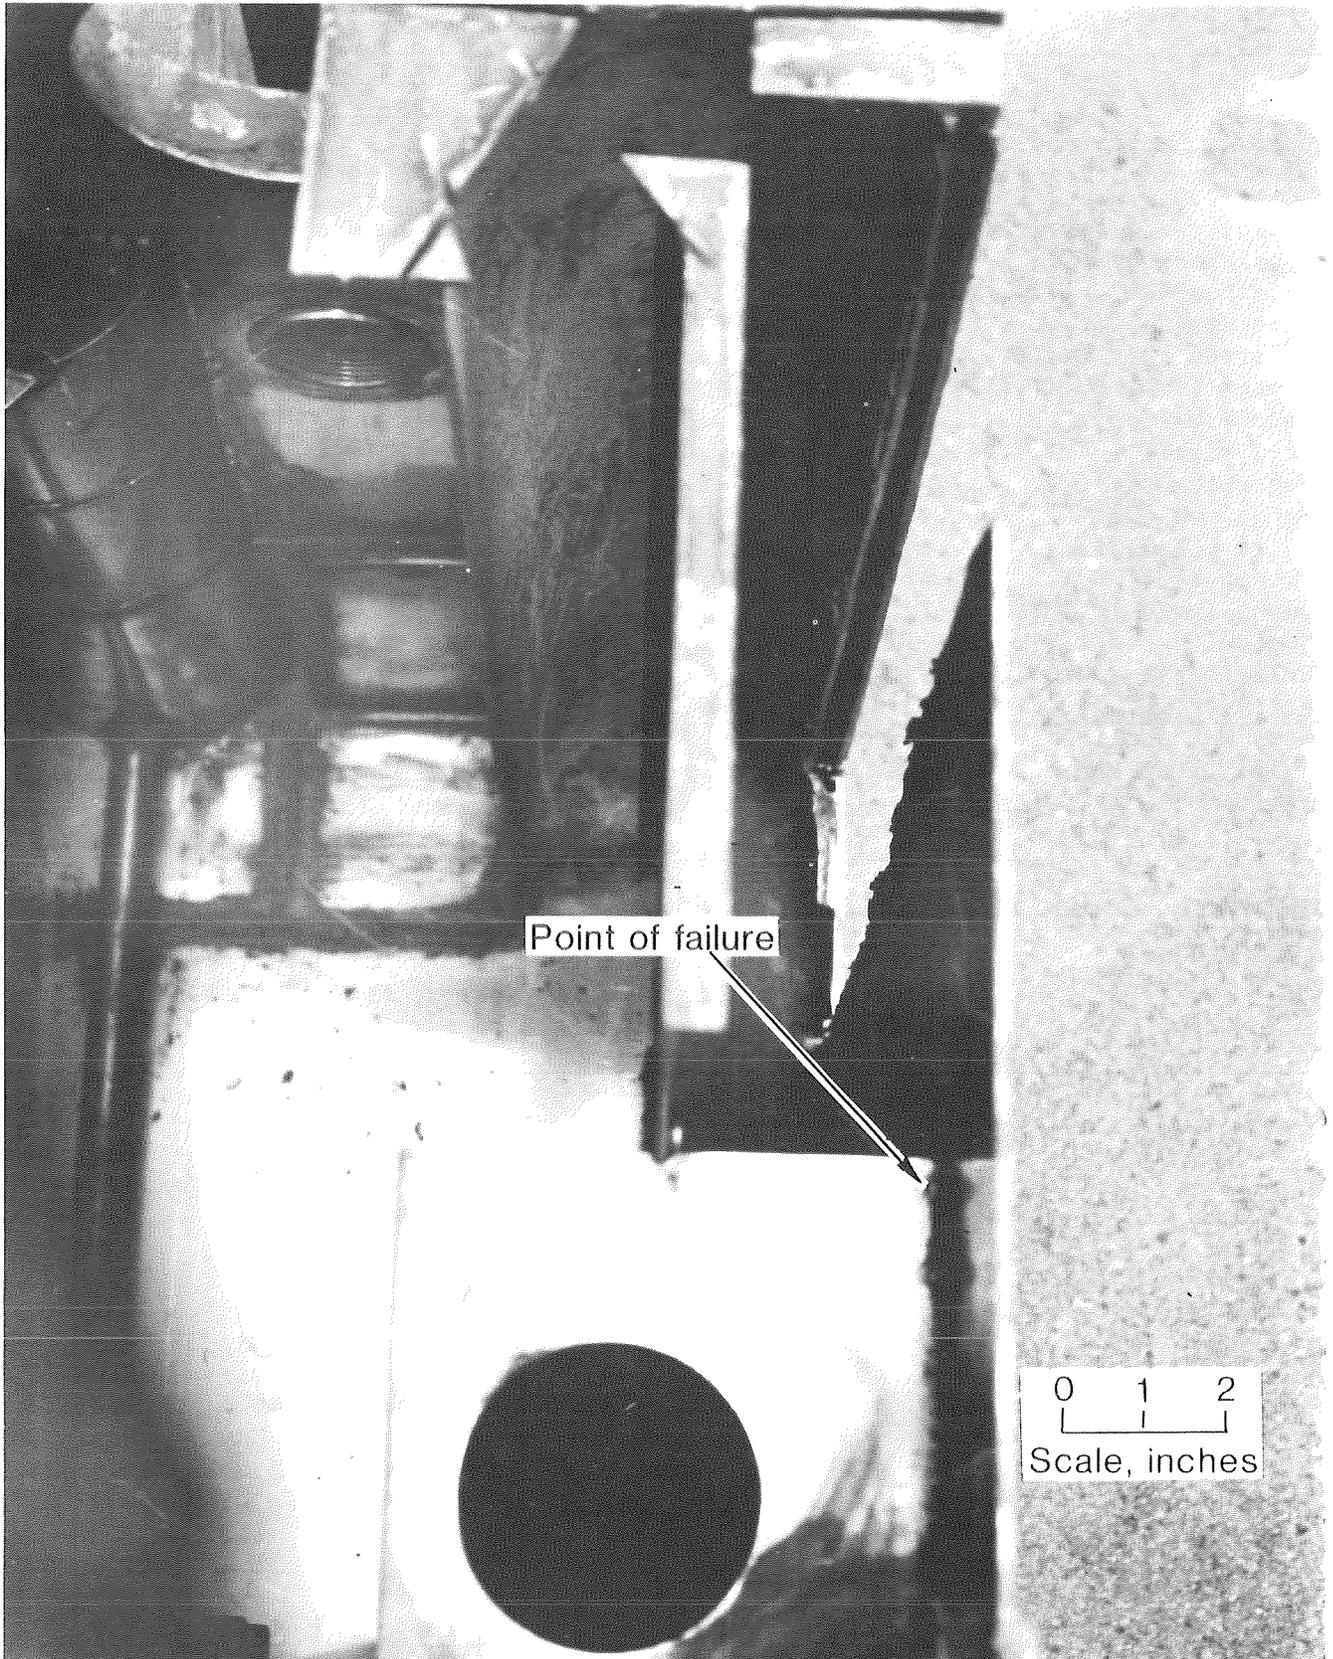
FIGURE 6. - Internal baffle system of scrubber 3. Failure occurred where scrubber and circular baffle were welded.

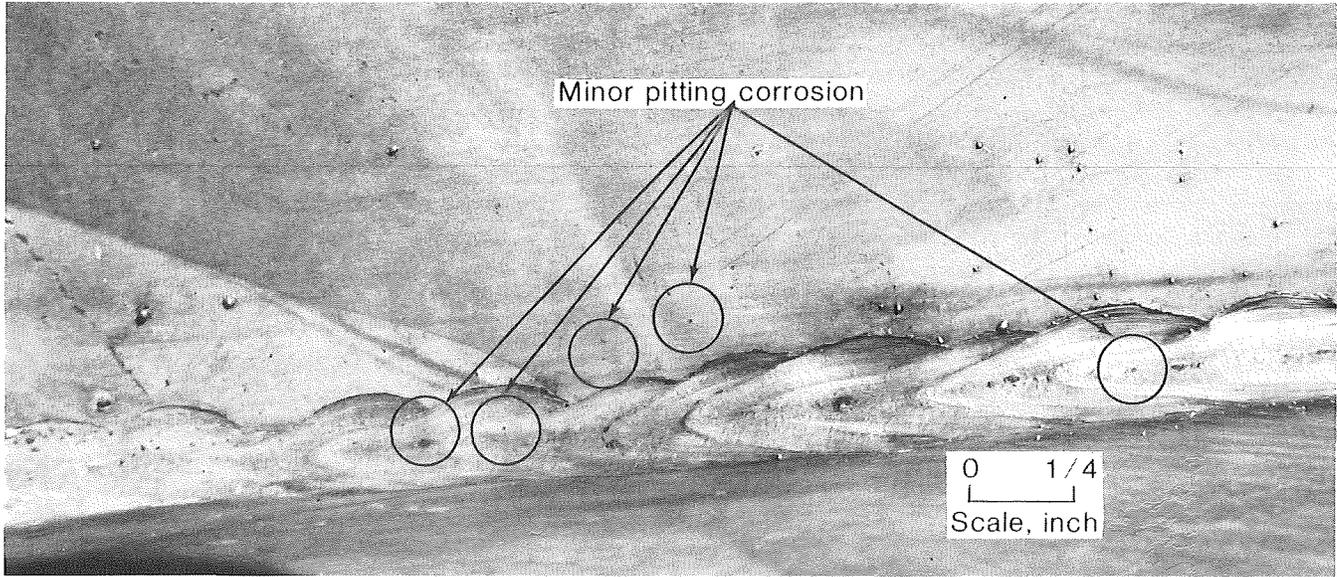
FIGURE 7. - Minor pitting corrosion on and adjacent to welds.

In the presence of a chloride-rich solution, a three-phase corrosion (15) of the exhaust tube shown in figure 8 occurred at the water level. There, agitation, high temperature, and the dissolved depolarizing agent plus oxygen in the exhaust stream contribute to the breakdown of the stainless steel. The mine water tested was characteristically basic (high pH) and contained about 1,000 ppm of chloride (table 2). At temperatures greater than 65° C (150° F) the high concentration of chloride ions provide the probable cause of the pitting that is observed near the welds and at the water level of the exhaust tube (2, 15). (See figs. 7 and 8.)

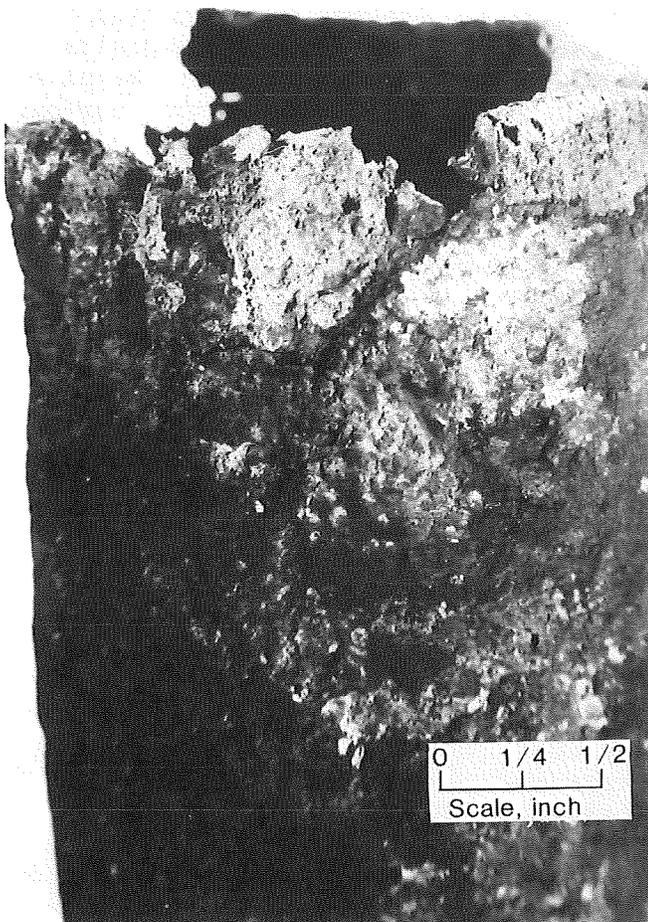
FIGURE 8. - Diesel exhaust tube at water scrubber entry point. Tube shows severe pitting and three-phase corrosion.

3. Mine operators should not fill scrubbers with water containing high concentrations of chlorides, since chloride is highly corrosive even to stainless steel. Filler water should be conditioned to neutralize chlorides, or mine operators should specify special materials for exhaust-gas water scrubbers when ordering equipment from manufacturers.

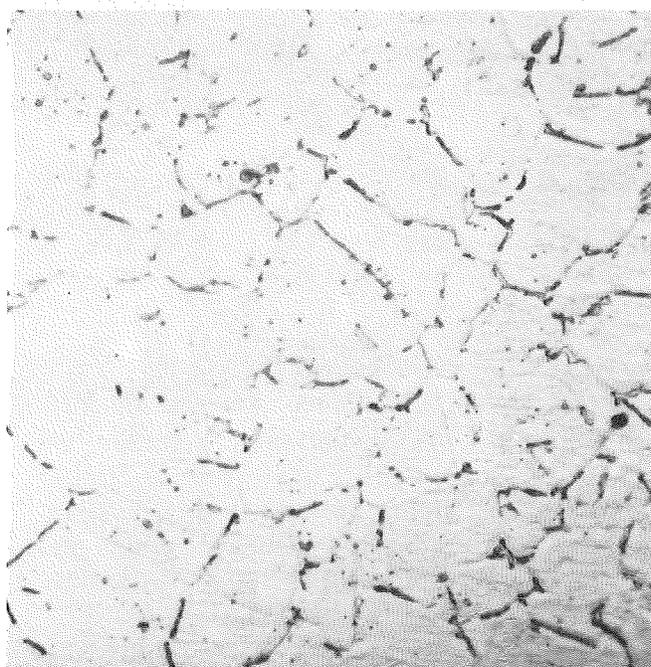
Also, the sensitization of stainless steels by the intense heat generated during welding fabrication further promotes corrosion, particularly on the internal surfaces adjacent to the welds. During the welding process, an area adjacent to the weld undergoes intergranular carbide precipitation. Except for the extra-low-carbon grades of type 300 series stainless steels, or those containing a stabilizing element such as titanium, particles of chromium-containing carbides precipitate at grain boundaries during sensitization which lowers the corrosion resistance at the grain boundaries

(7, 10). The corrosion resistance of stainless steels is due to the presence of chromium in the material. The localized nature of corrosion near the welds indicates reduced resistance from intergranular carbide precipitation (fig. 9). Although the range varies with time and alloy content, sensitization occurs between 650° and 870° C (1,200° and 1,600° F) (16). The decreased corrosion resistance is attributed to the presence of chromium-rich carbides at the grain boundaries and the depletion of chromium in the adjacent matrix (9). Extra-low-carbon stainless steels (304L, 316L) have increased immunity to this problem, but are not without their problems. When welding extra-low-carbon steels, care must be taken to use the proper weld filler (extra-low-carbon welding rods), and surfaces to be welded must be cleaned of grease, oil, and other carboniferous materials. Use of general purpose welding rods is not recommended. When possible, all joints should be welded internally and externally to guarantee adequate penetration. The weld area must

FIGURE 9. - Carbide precipitation at grain boundaries. Precipitation is generated by the high heat of welding (sensitization) which enhances pitting corrosion (X 100).

be properly cleaned to obtain a sound weld. It is noted that many mines do not have the equipment, material, or expertise to weld stainless steel.

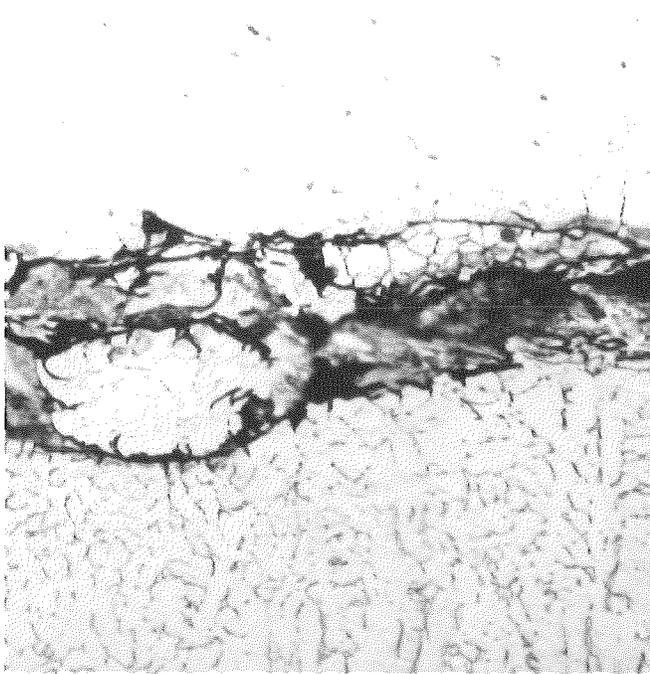
A section of a typical corner weld from stainless steel scrubber 3 was removed and the microstructure is shown in figure 10. The grain structure in the upper half of the photograph is the parent material, while the lower half shows the weld metal with typical dendritic structure. The discontinuity in between is the result of inadequate weld fusion. As a result, a fatigue crack initiated from this discontinuity and propagated from the inside root of the weld. While

FIGURE 10. - Inadequate weld penetration in a typical corner weld. Smaller grains are the welding material (note the presence of carbide precipitation) (X 100).

other factors led this scrubber to fail, this fatigue crack may have led to eventual failure as well. Cracked corner welds was a problem often heard in conversations with mine maintenance personnel. To eliminate this problem, it may be necessary to weld these joints on both sides of the corner.

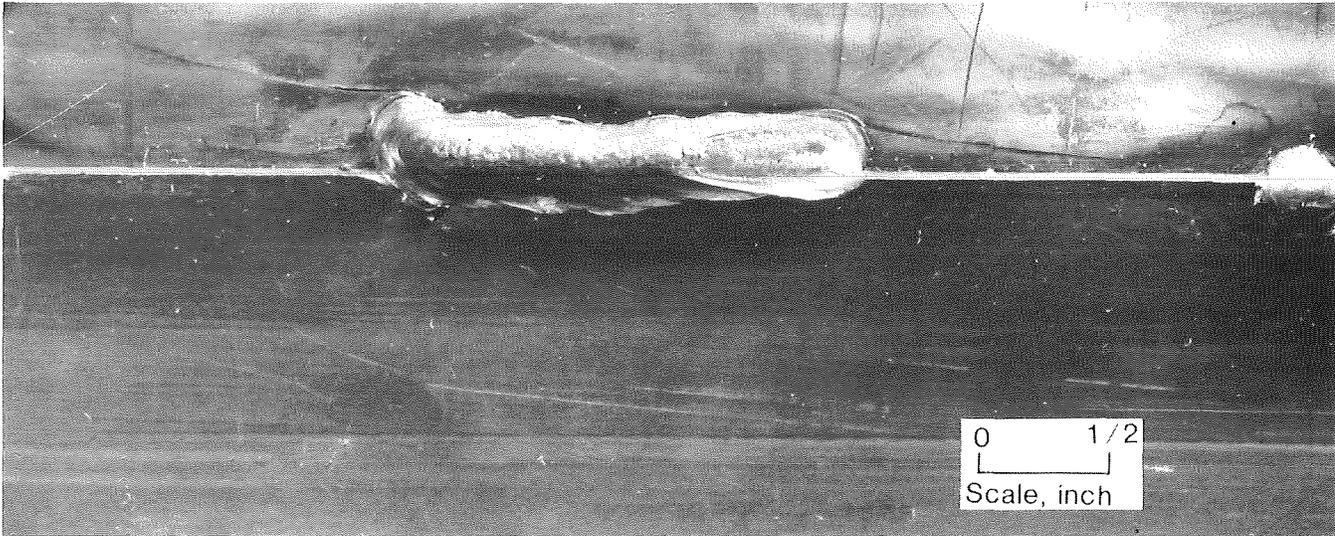
The cracks in figures 11, 12, and 13 occurred near welds which joined the circulatory section of a stainless steel scrubber to the scrubber wall. The cracks resulted from fatigue stresses concentrated at intermittent welds and occurred entirely within the base metal of the wall, adjacent to the weld. Beginning at the inside surface of the scrubber, the cracks then propagated through the metal thickness until the remaining cross section was insufficient to support the applied stresses. The ratchet marks on the crack surface (fig. 12) are characteristic of high stress and originate from numerous fatigue cracks. Several small fatigue cracks combined to form the single crack which eventually led to failure.

The applied stresses were likely caused by equipment vibration and exhaust pulses acting on the baffle section of the walls. The lack of rigidity along the entire weld joint allowed the sections to vibrate and resulted in fatigue cracks. It is suggested that by replacing intermittent welds with a continuous weld, the system's vibration could be reduced. In figure 13, a crack is shown to have formed at the sharp 90° angle in the baffle plate. It is not advisable to use such abrupt cuts, since stress will concentrate there and the amount of load required for crack propagation is greatly reduced. Accordingly, such cuts should be rounded.

FIGURE 11. - Fatigue crack at an intermittent weld. This is the externally repaired crack shown in figure 1.

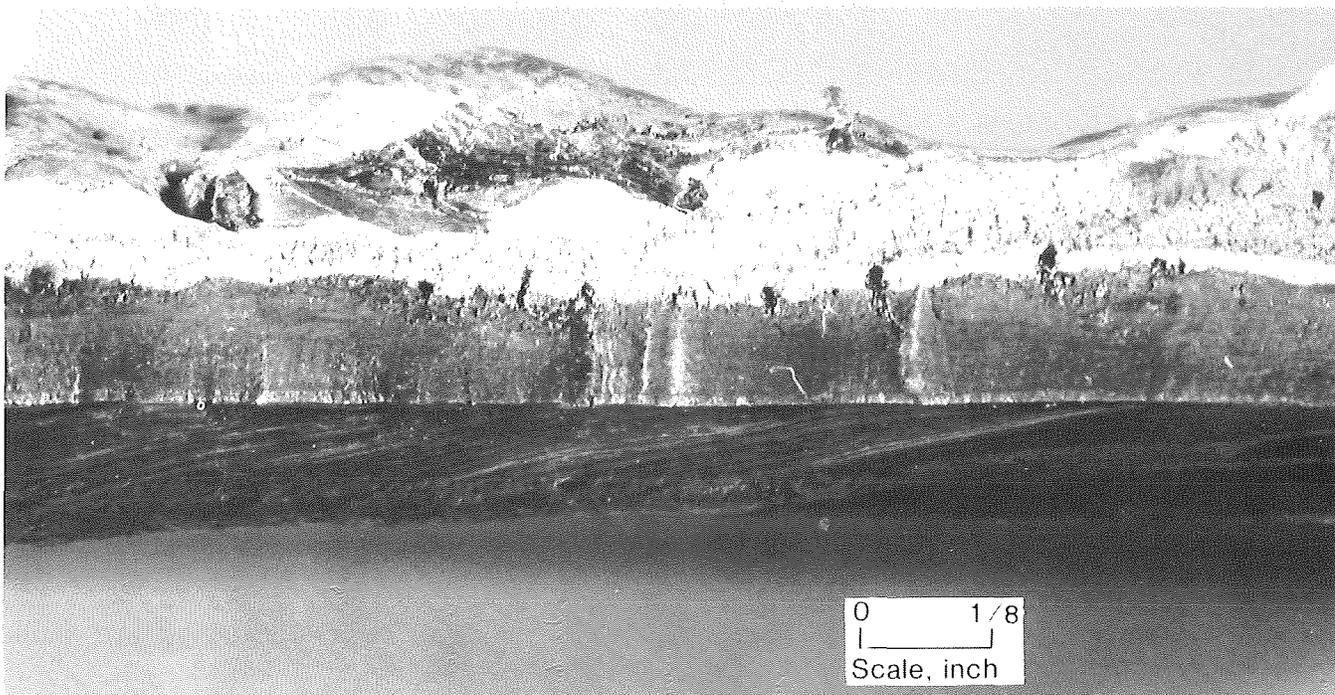
FIGURE 12. - Surface of fatigue crack. The darker portions of the crack contain several ratchet marks or ridges characteristic of high stress and numerous fatigue crack origins.

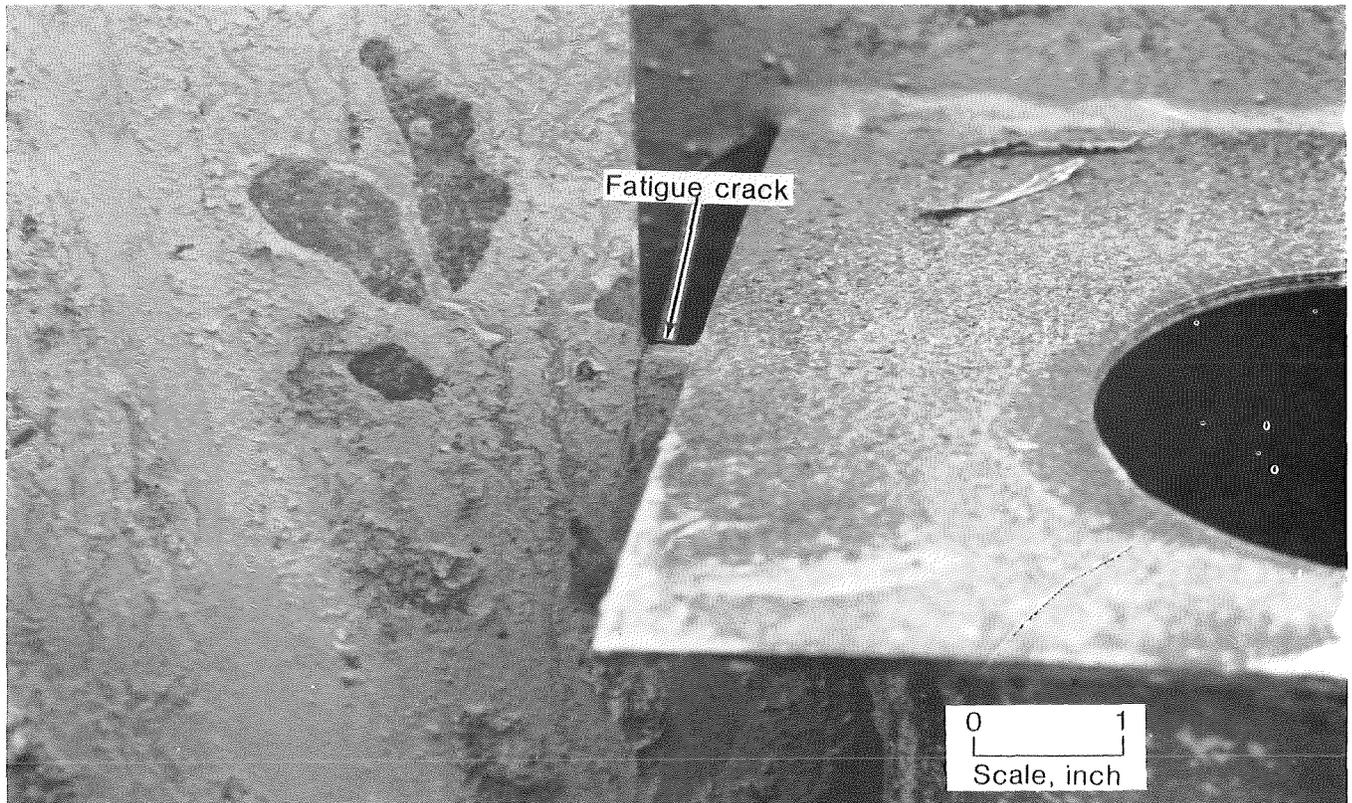
FIGURE 13. - Fatigue crack propagating from a stress concentration.
