# AN EVALUATION OF THE FIRE AND EXPLOSION HAZARDS OF OIL SHALE MINING AND PROCESSING

**VOLUME 2: DATA SUMMARY OF ANVIL POINTS  
RAW SHALE WASTE PILE COMBUSTION**

Contract J0275001  
Tosco Corporation

BUREAU OF MINES  
UNITED STATES DEPARTMENT OF THE INTERIOR

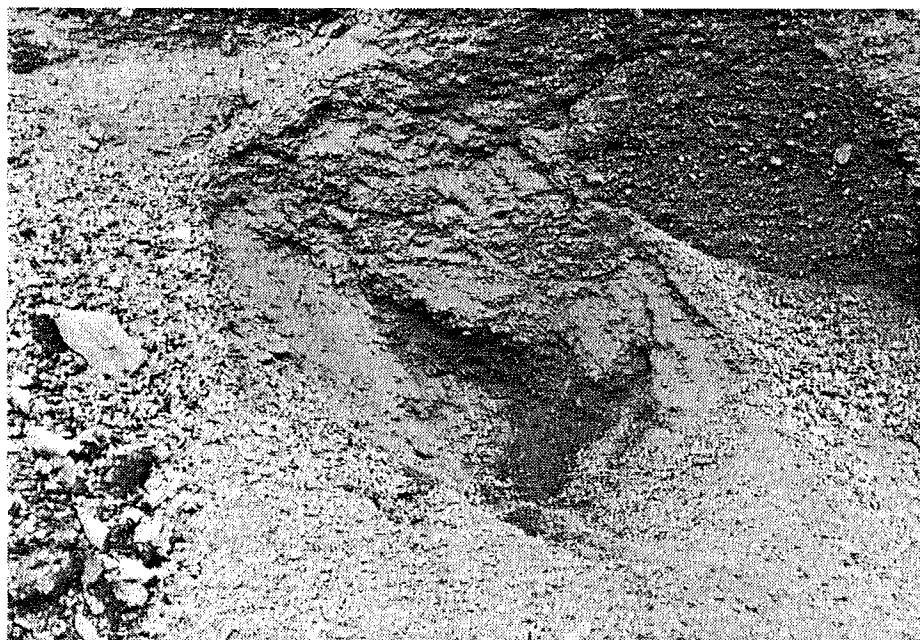
Fig C.11

Burned and unburned shale

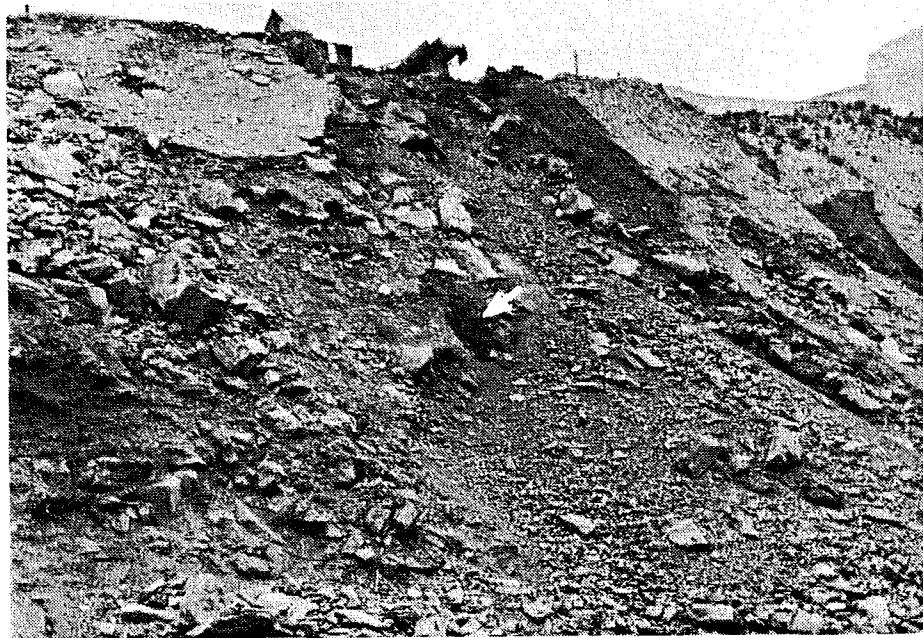
Vapor chimney below crusher at station 3 + 50-3 (arrow).

Analyses of gas sample taken over vapor chimney
