# COAL WASTE DISPOSAL SURVEY. COAL REFUSE—AN INCREASINGLY SERIOUS PROBLEM FOR COLORADO PLATEAU PRODUCTION

Contract J0333931  
Plant Resources Institute

BUREAU OF MINES  
UNITED STATES DEPARTMENT OF THE INTERIOR

OFR  
84-97

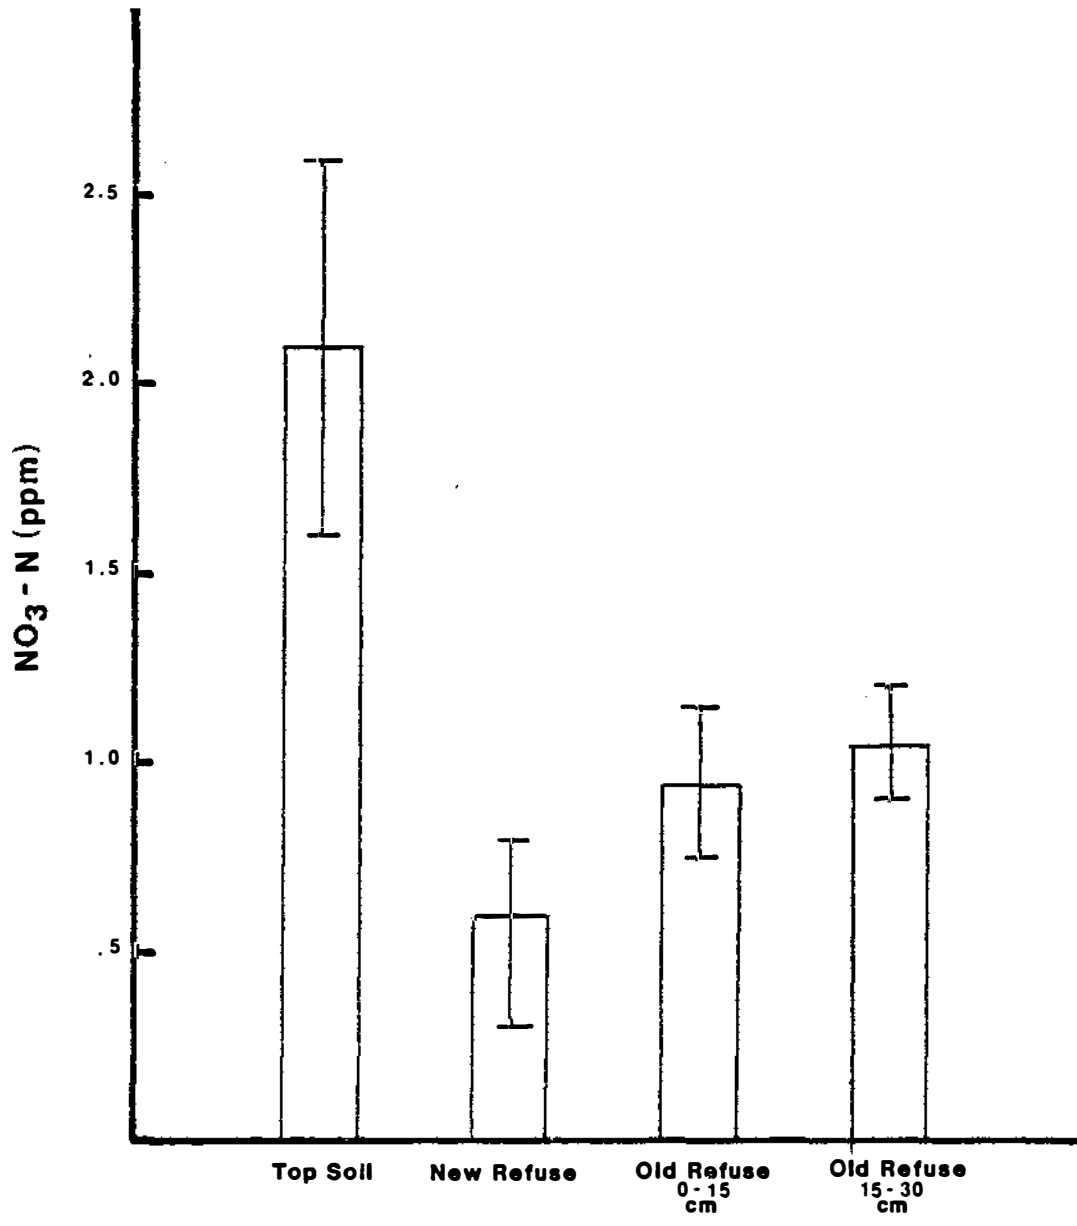
Figure 2. Means and standard error of nitrate-nitrogen content. Values represent 5 samples.

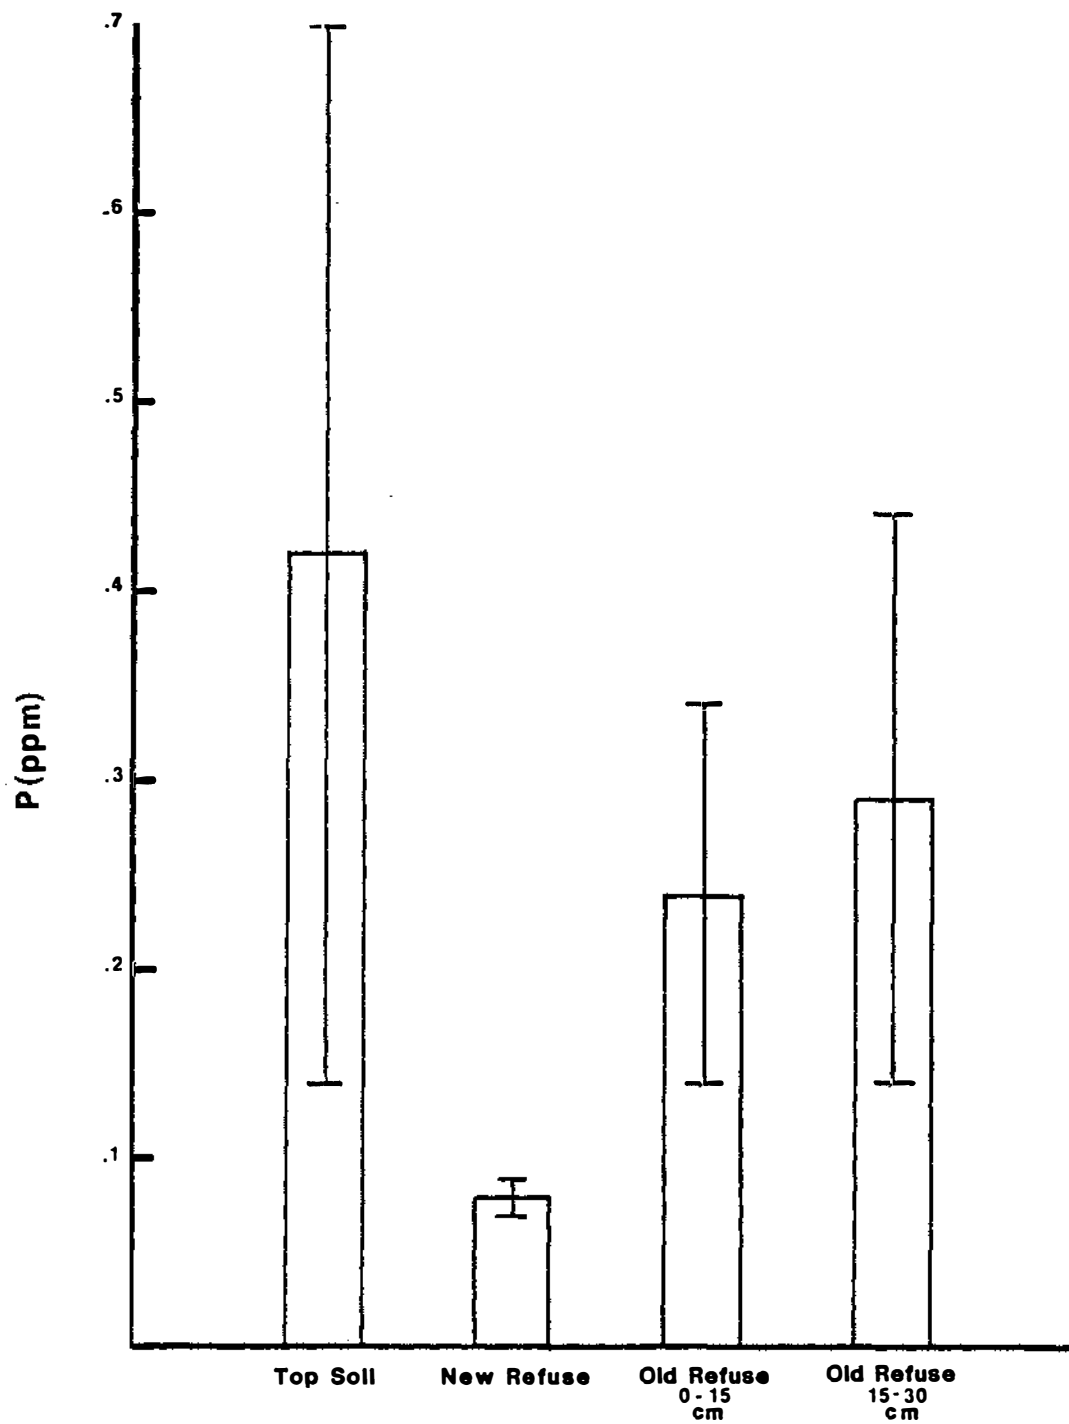
As expected, phosphorus content of the refuse material tended to be lower than levels in topsoil, although paired t-tests and ANOVA showed no significant differences (Figure 3). The lack of statistical significance was probably due to small sample size. New refuse material contained less water soluble phosphorus than the older refuse material. Again, this appears to be a function of pH. Phosphorus is more available at a pH between 6.50 and 7.50. At higher pH's typical in the new refuse, phosphorus is less available. Agricultural soils which contain less than 5 ppm soluble phosphorus are considered deficient and are generally fertilized to improve yields (Bingham, 1966). Both the topsoil and refuse materials of the study sites are below 5 ppm ( $\bar{X} = .25$  ppm) and may benefit from the addition of phosphorus fertilizer to aid plant growth.

Figure 3. Means and standard error of phosphorus content. Values represent 5 samples.

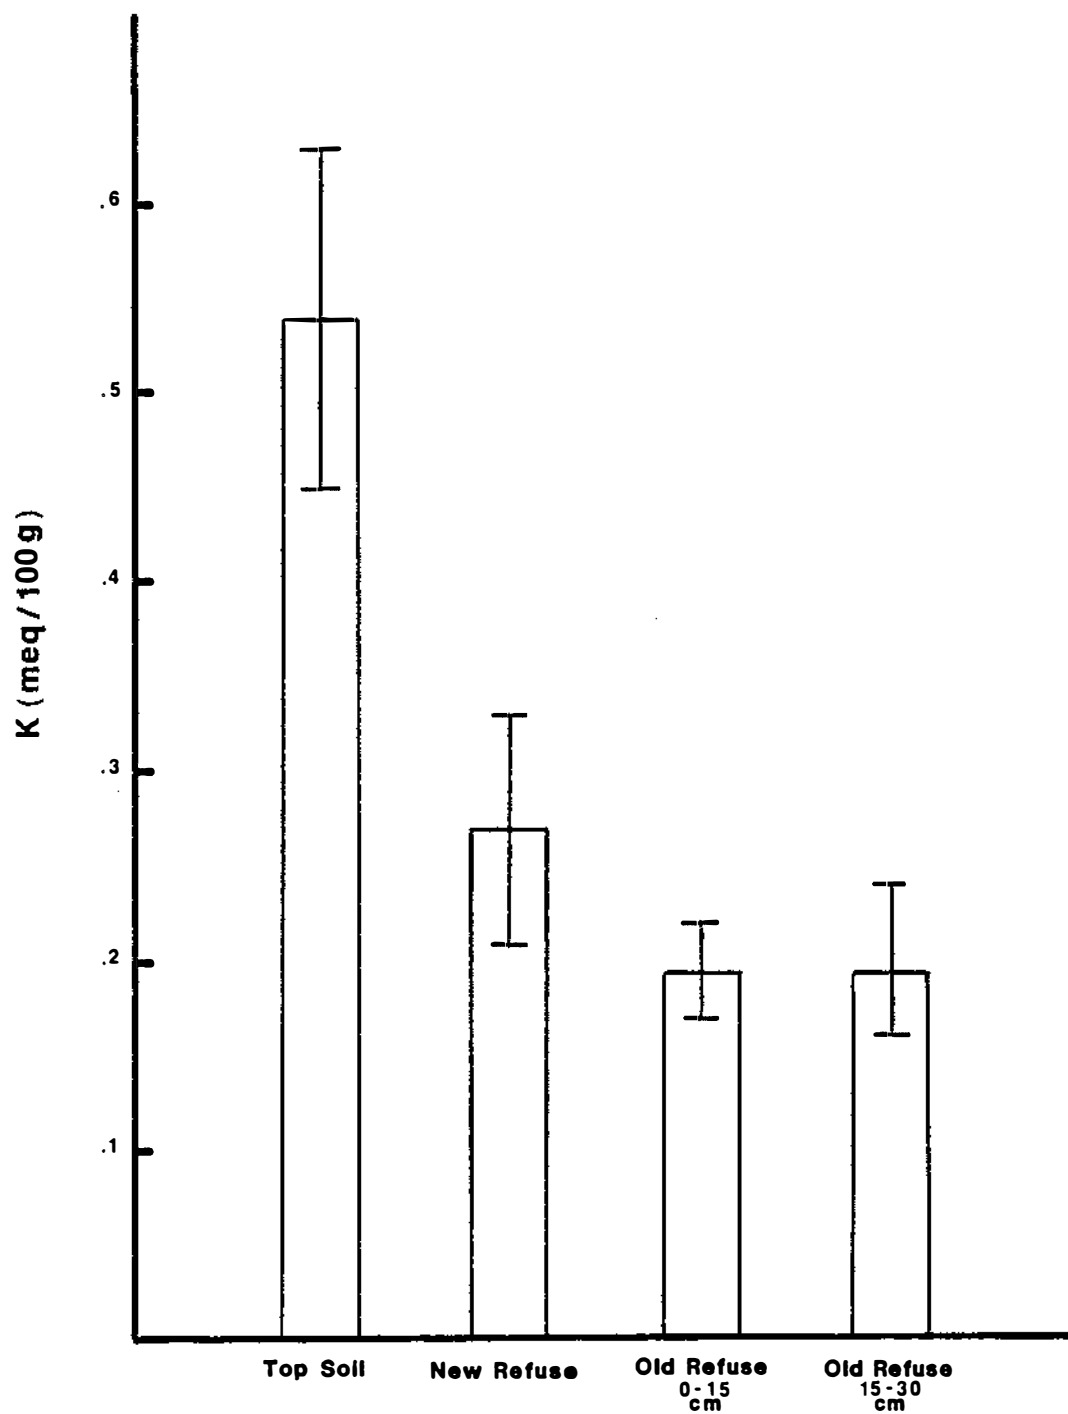
100g or 34 ppm). Old refuse material contained significantly less potassium than the topsoil ( $T = 3.37$ ,  $\alpha < .05$ ). New refuse material also contained less potassium than the topsoil but more than the older refuse material (Figure 4). Although potassium levels are less in the refuse materials, there still appears to be a sufficient amount to meet the requirements for native species. pH is not a factor in K availability in the range of pH's that were common to the samples.

Figure 4. Means and standard error of potassium content. Values represent 5 samples.

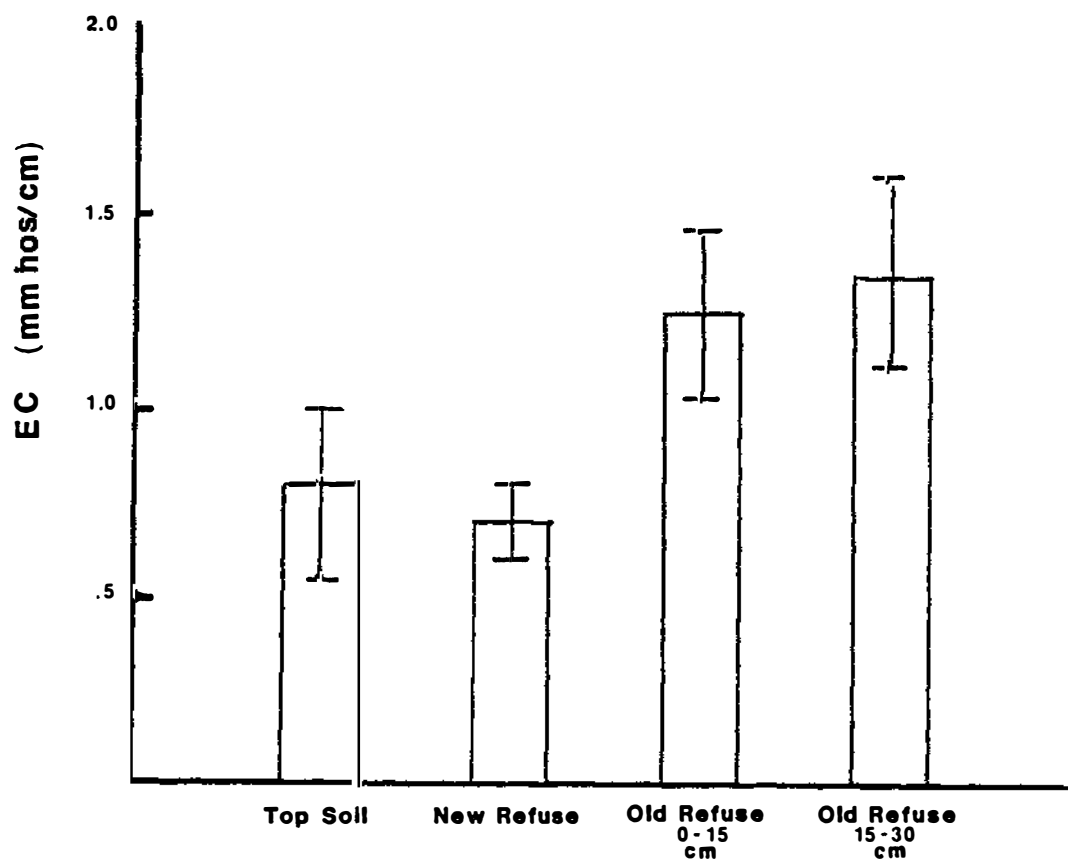
Figure 5. Means and standard error of electrical conductivity  
Values represent 15 samples.

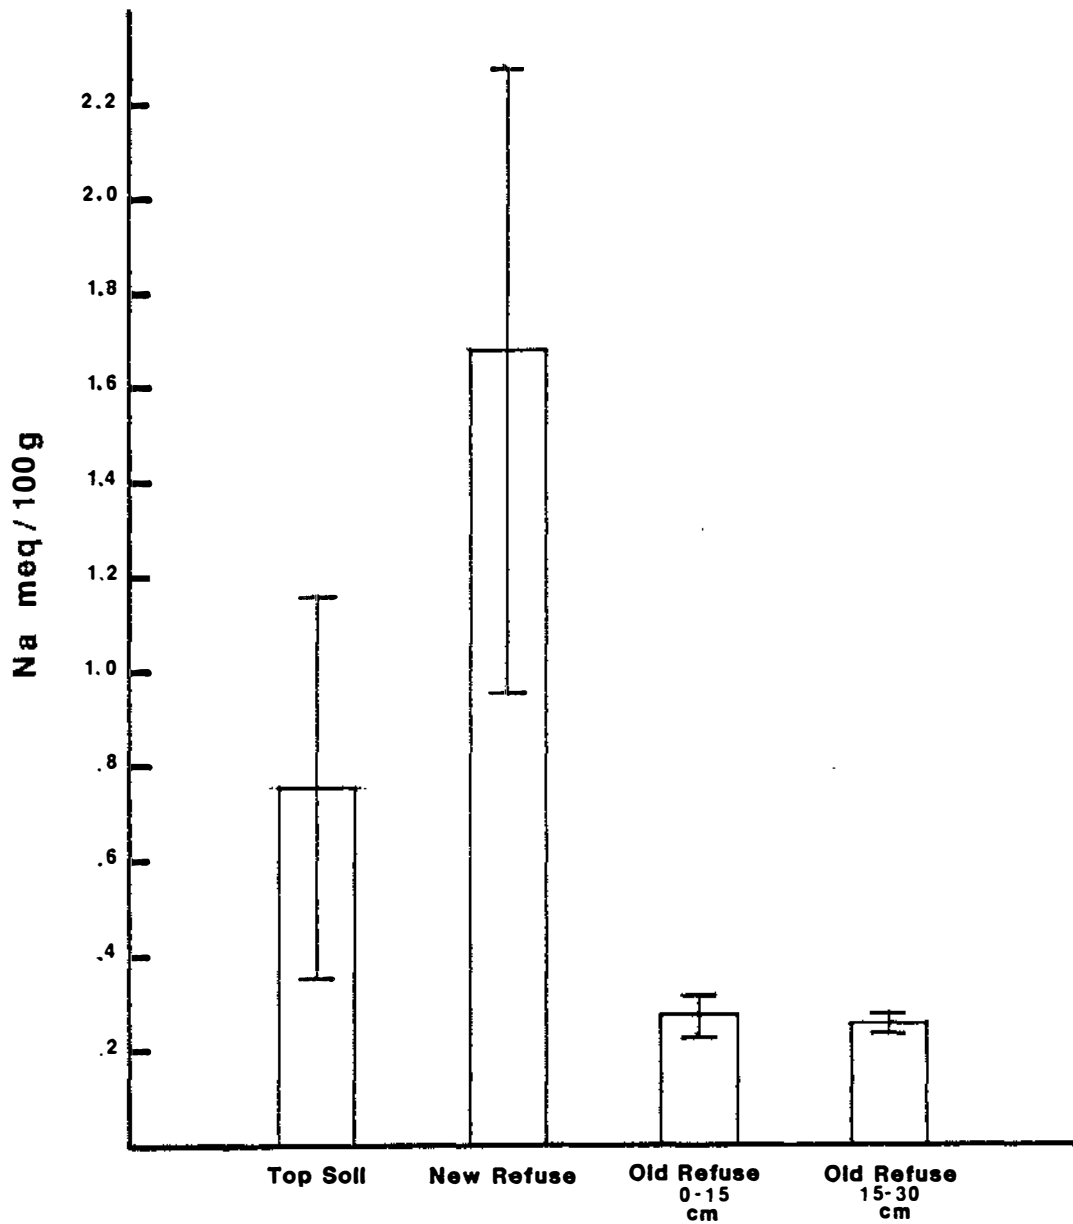
Sodium content of the topsoil and new refuse material showed a high amount of variation between the different mines (Figure 6). New refuse contained the greatest amount of sodium ( $\bar{X} = 1.68$  meq/100g) and the older refuse material contained the least ( $\bar{X} = .28$  meq/100g). Plant tolerance for sodium is indicated by the sodium absorption ratio (SAR) values. Determination of sodicity in soils of refuse is arbitrarily based on SAR. Soils are generally considered non-sodic if SAR values are below 13. The SAR equation determines the ratio of sodium to calcium and magnesium.

Figure 6. Means and standard error of sodium content. Values represent 5 samples.

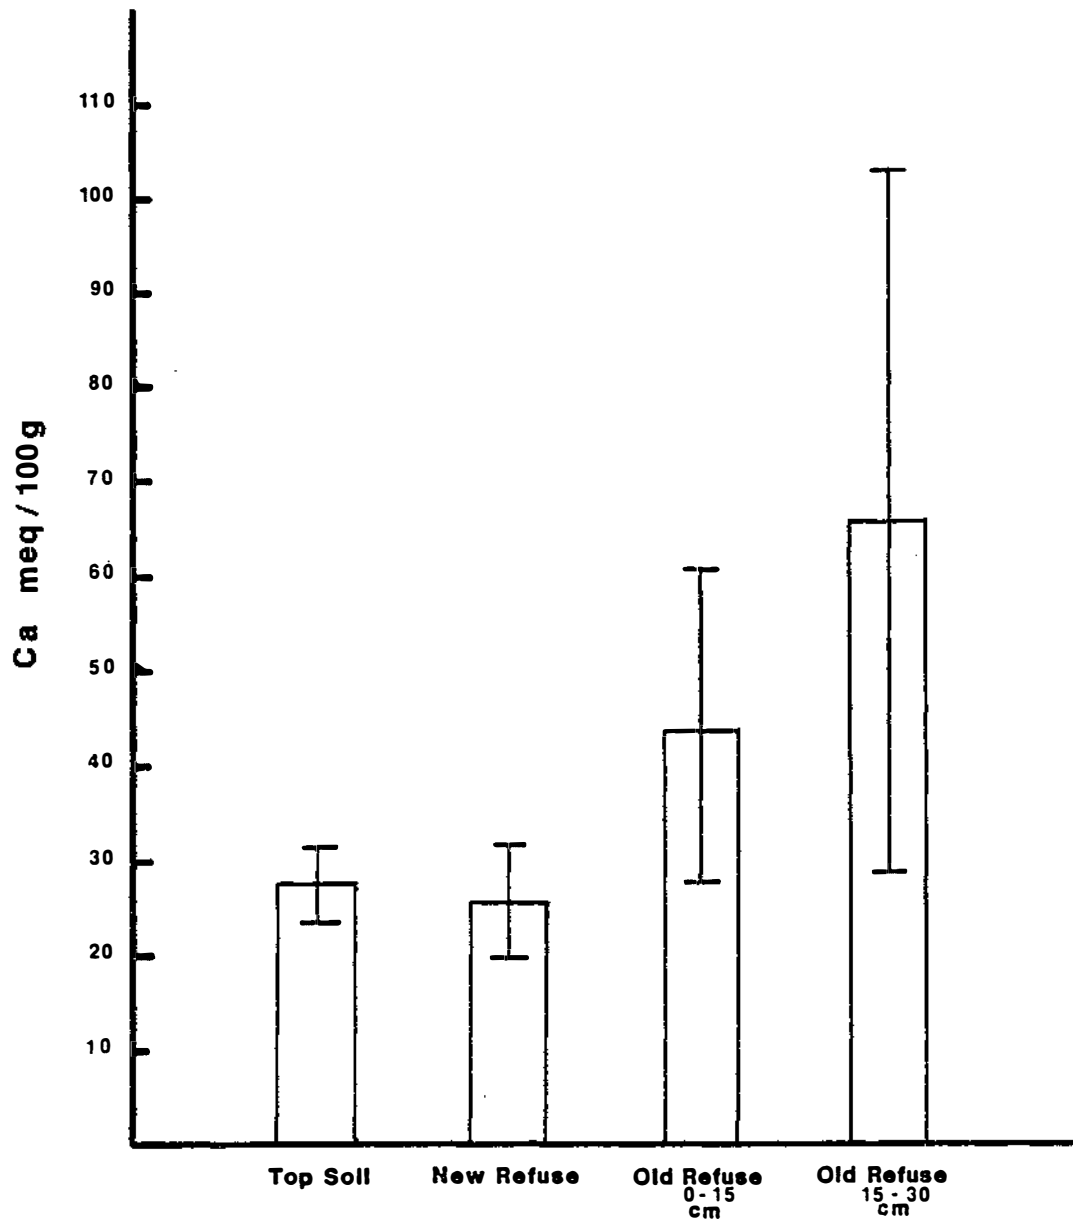
Calcium content also showed wide sample variation from 13.0 to 175.0 meq/100g (Figure 7). The old refuse material contained the highest average amount of calcium. However, the average is influenced by one mine which contained 94.8 and 175.0 meq/100g of calcium. Otherwise, calcium content of refuse material was within general ranges found in topsoil.

Figure 7. Means and standard error of calcium content. Values represent 5 samples.

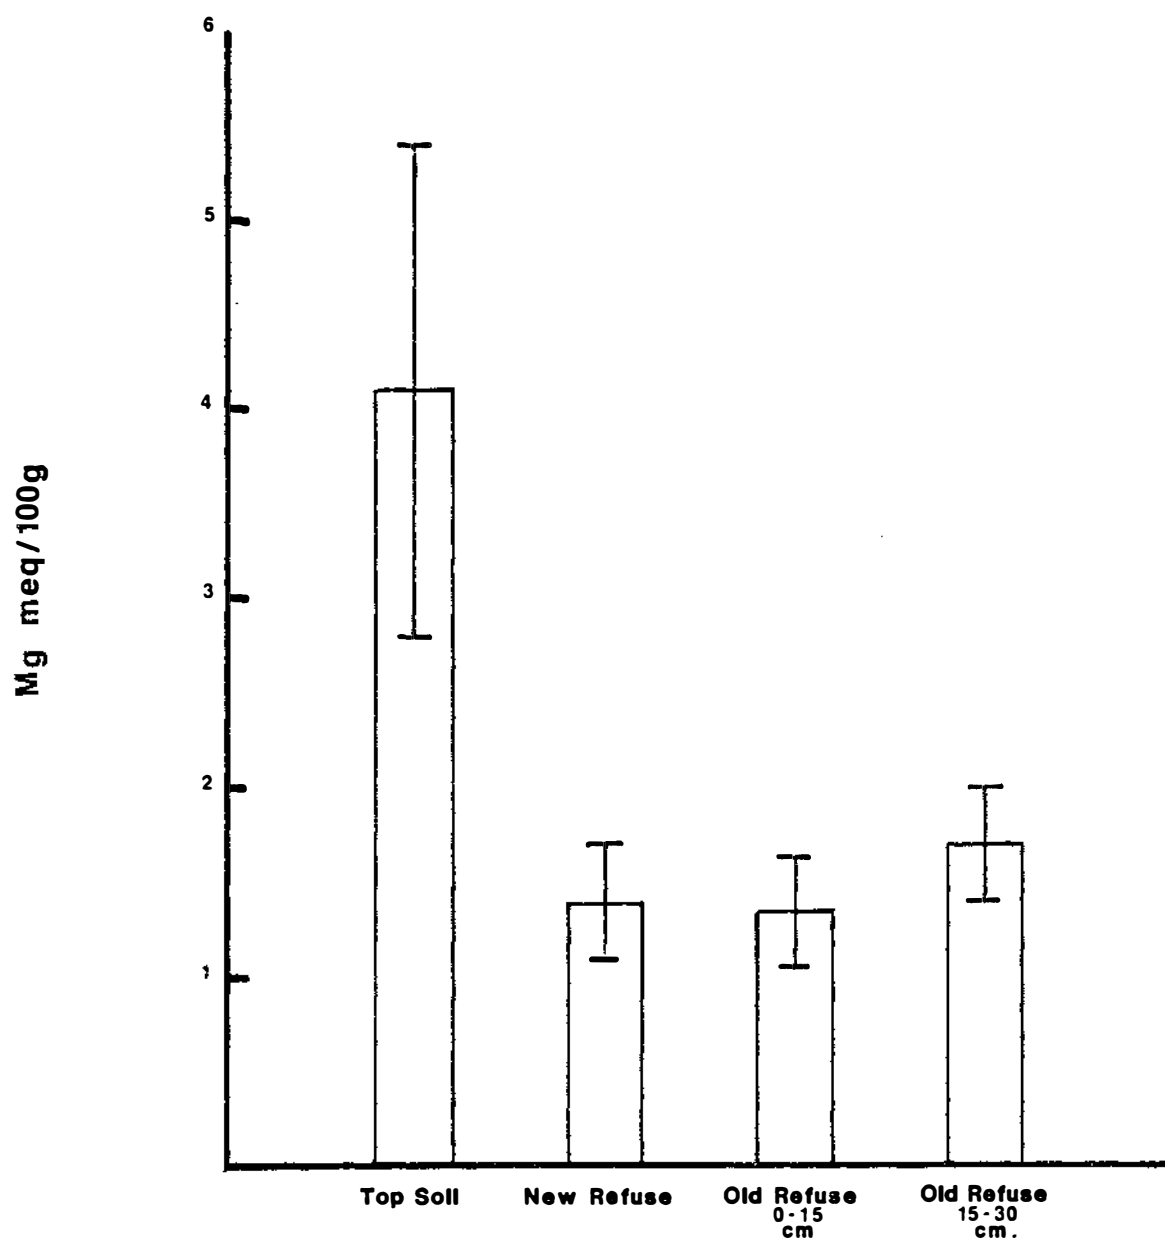
Magnesium content of the topsoil was significantly higher than the new refuse ( $T = 2.45, \alpha < .05$ ) and also higher than the old refuse (Figure 8). Empleton (1966) indicates that soils which contain less than 50 ppm magnesium are probably deficient. Our values for both topsoil and refuse ranged from 69.3 ppm (.57 meq/100g) to 970 ppm (7.98 meq/100g) and are in sufficient quantities for plant growth.

Figure 8. Means and standard error of magnesium content. Values represent 5 samples.

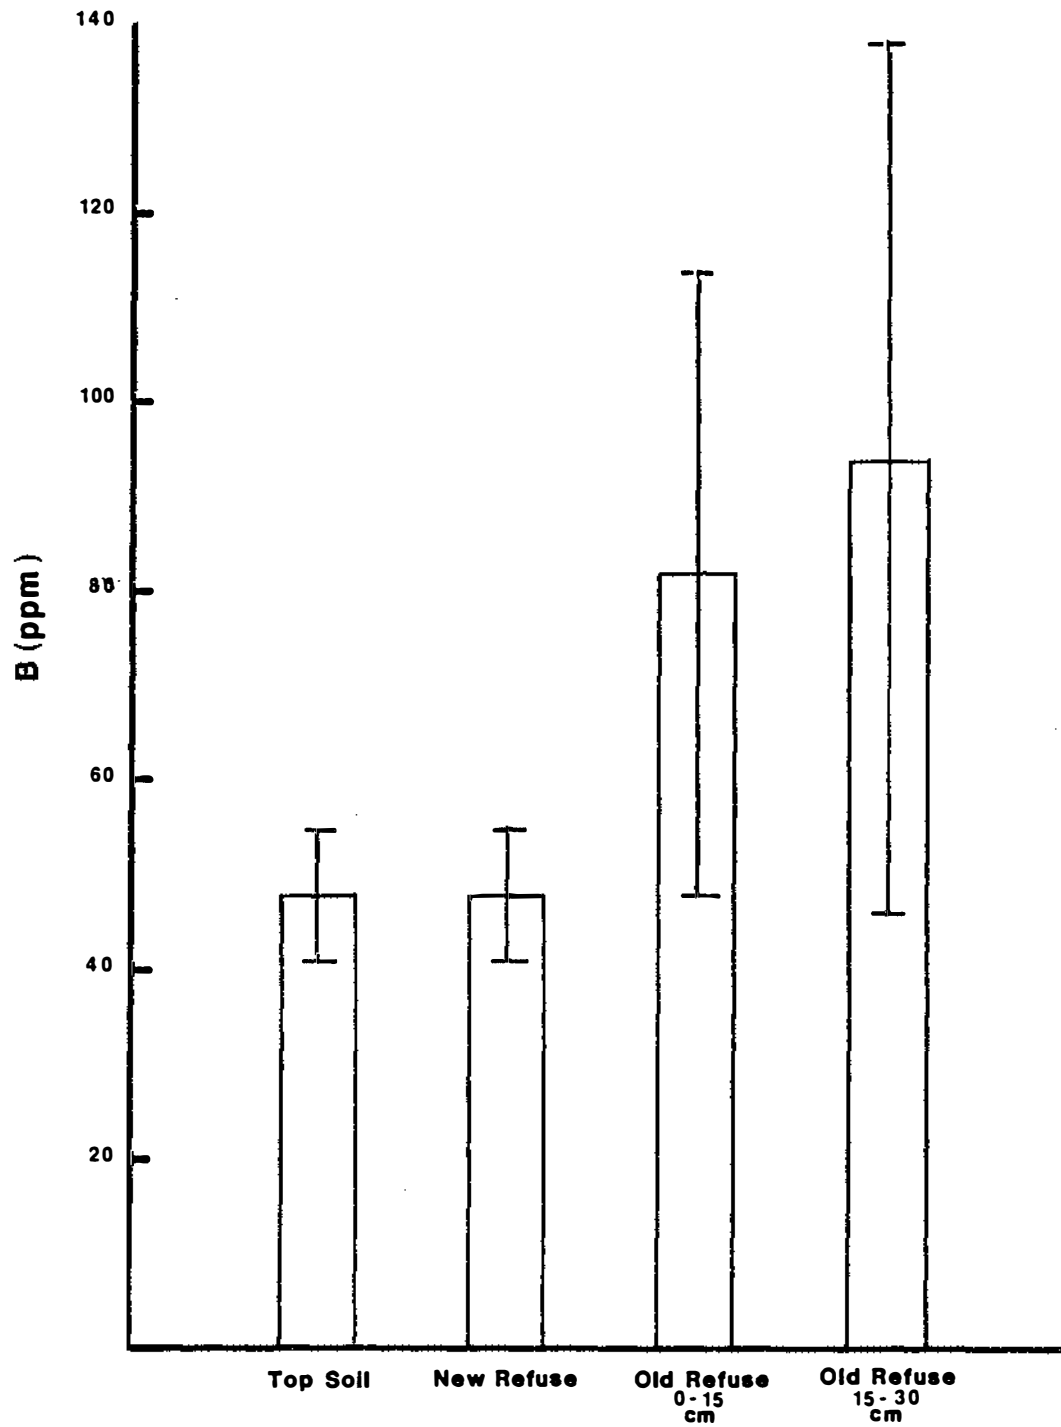
Boron toxicity is commonly associated with coarse soil texture and increasing pH from 7 to 9 (Peterson and Newman, 1976). Samples showed a wide range of variation in both topsoil and refuse content of boron (18.4 to 224.4 ppm). Old refuse material had a greater mean boron content than topsoil or new refuse. However, this was again due to one mine which had high boron concentration (176.4 and 224.4 ppm) (Figure 9). This high boron content in the old refuse from one mine does approach toxic levels for some plants; however, its relative insolubility at these higher pH's may prevent it from being absorbed at hazardous concentrations (pH values were 8.53 and 8.05 and texture of the refuse was a sandy loam). Bradford (1966) indicated that normal soils ranged from 2 to 100 ppm boron. Except for the old refuse material from the one mine which had a high boron content, the refuse materials from other mines were within normal range.

Figure 9. Means and standard error of boron content. Values represent 5 samples.

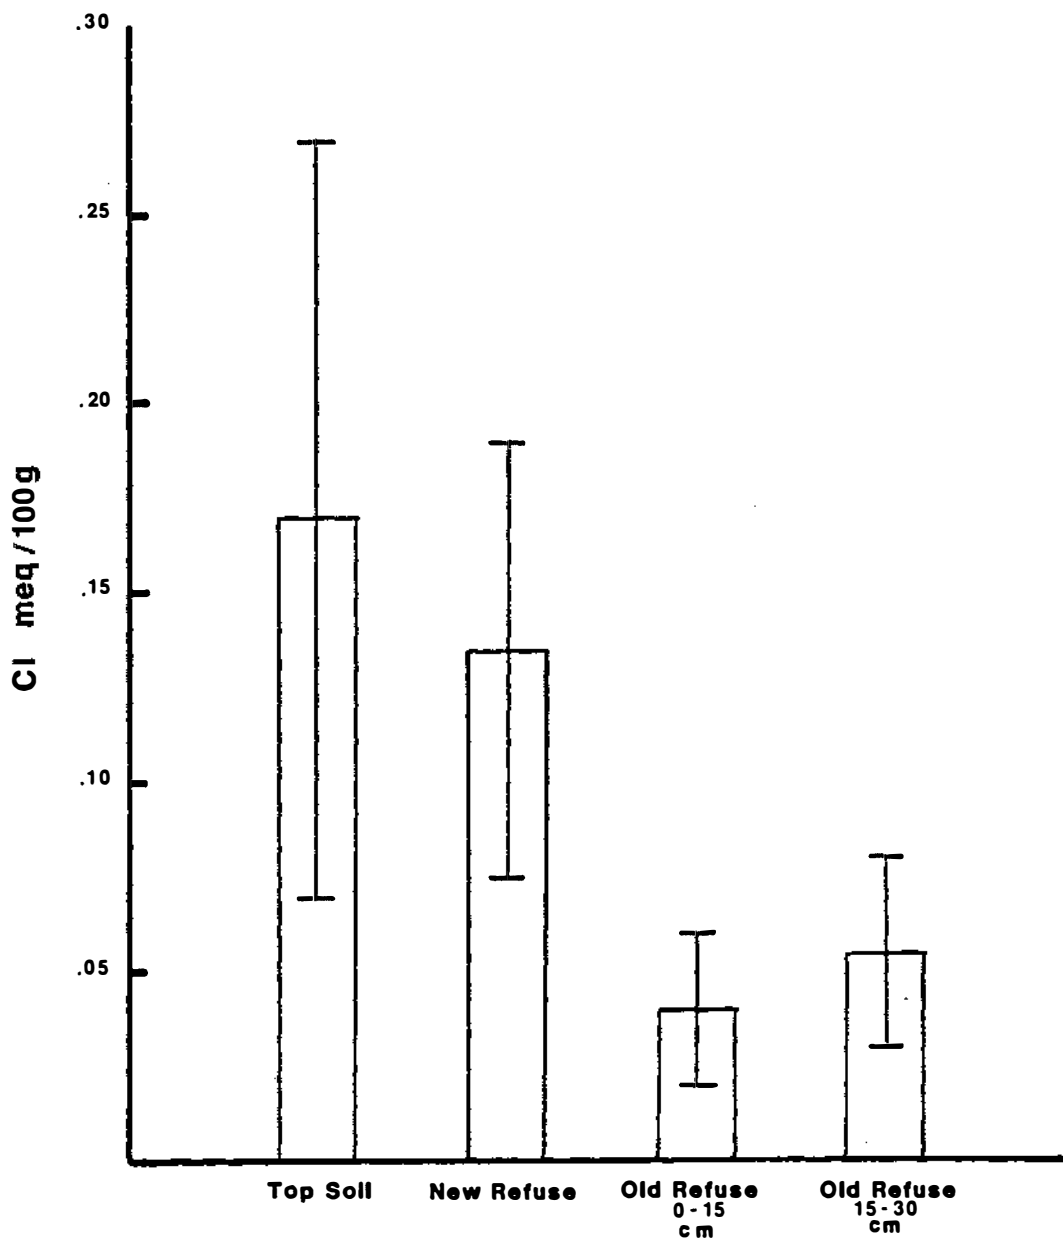
The range in chloride content of the topsoil (0.001 to 0.01 meq/100g), new refuse (.001 to .313 meq/100g), and old refuse (.001 to .120 meq/100g) shows high variability among sampling sites. A trend towards decreasing chloride content as a function of refuse material age appears to occur (Figure 10). However, small sample size and large sample variation prohibit any positive conclusions.

Figure 10. Means and standard error of chloride content. Values represent 5 samples.

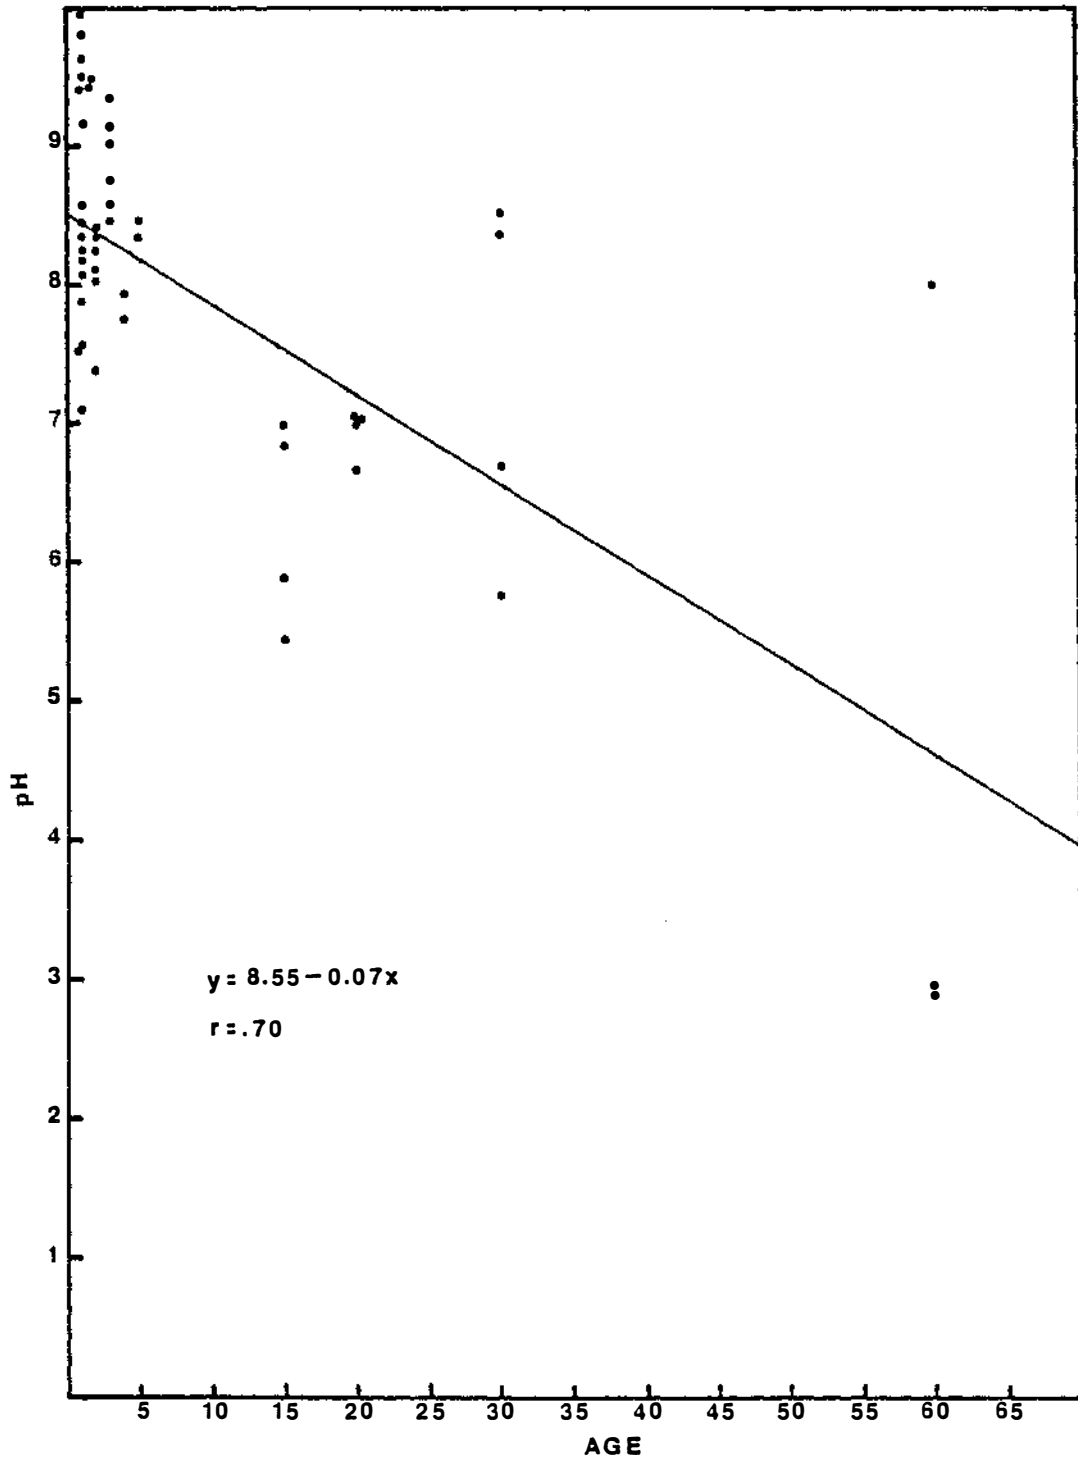
Figure 11. Regression line showing the relationship of refuse pile age and pH.

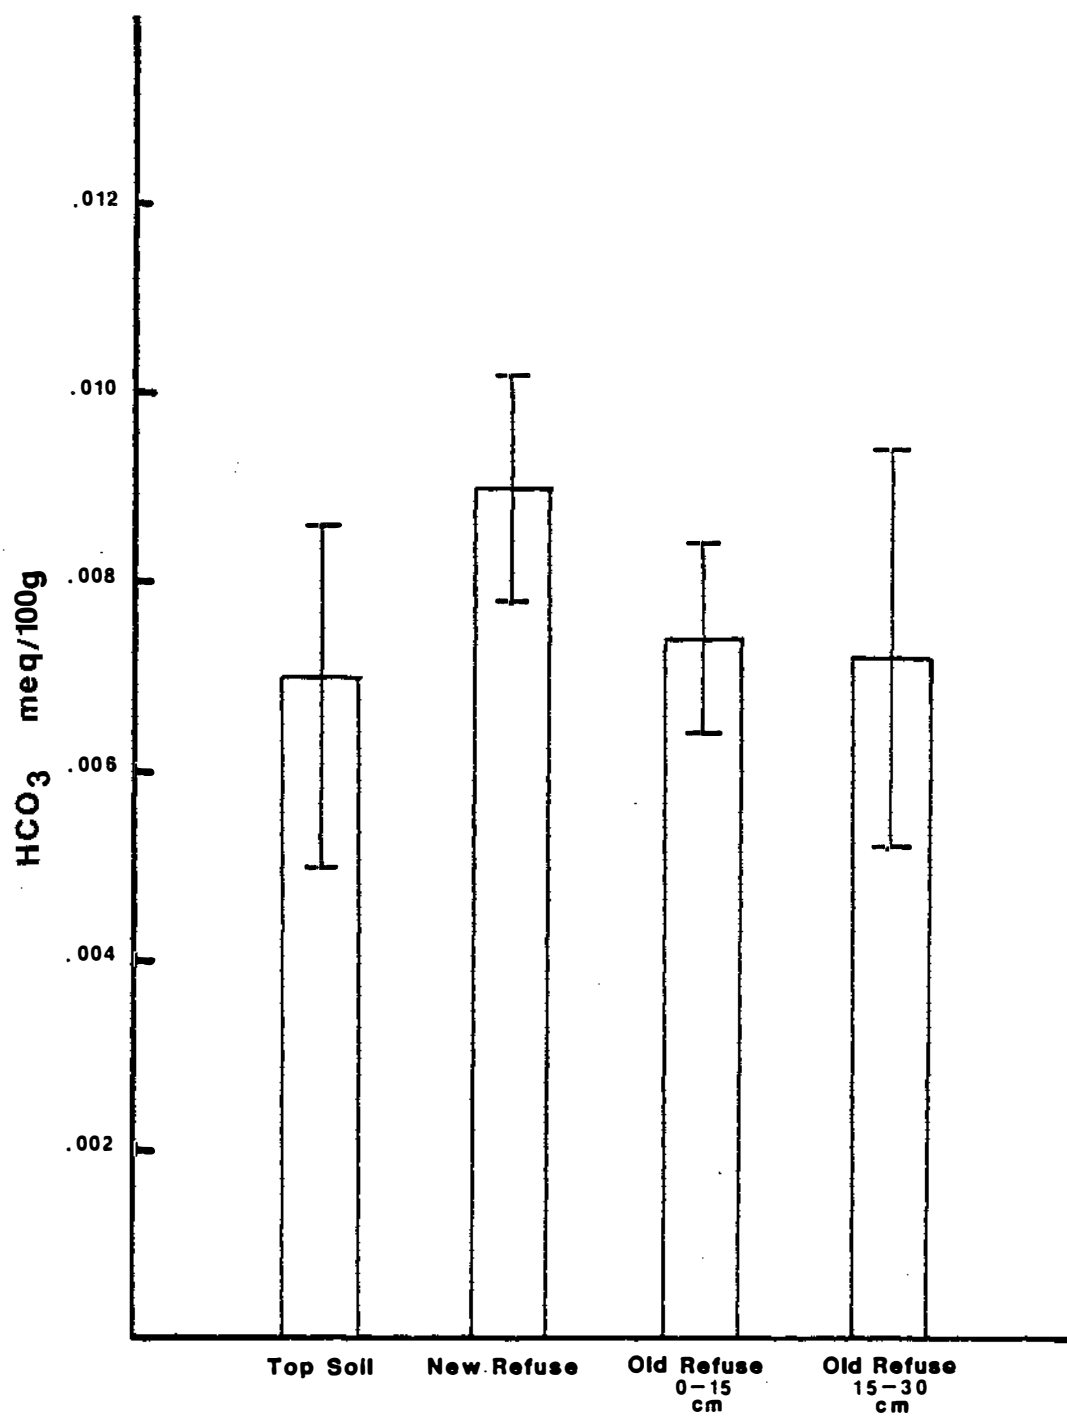
Figure 12. Means and standard error of bicarbonate content. Values represent 5 samples.

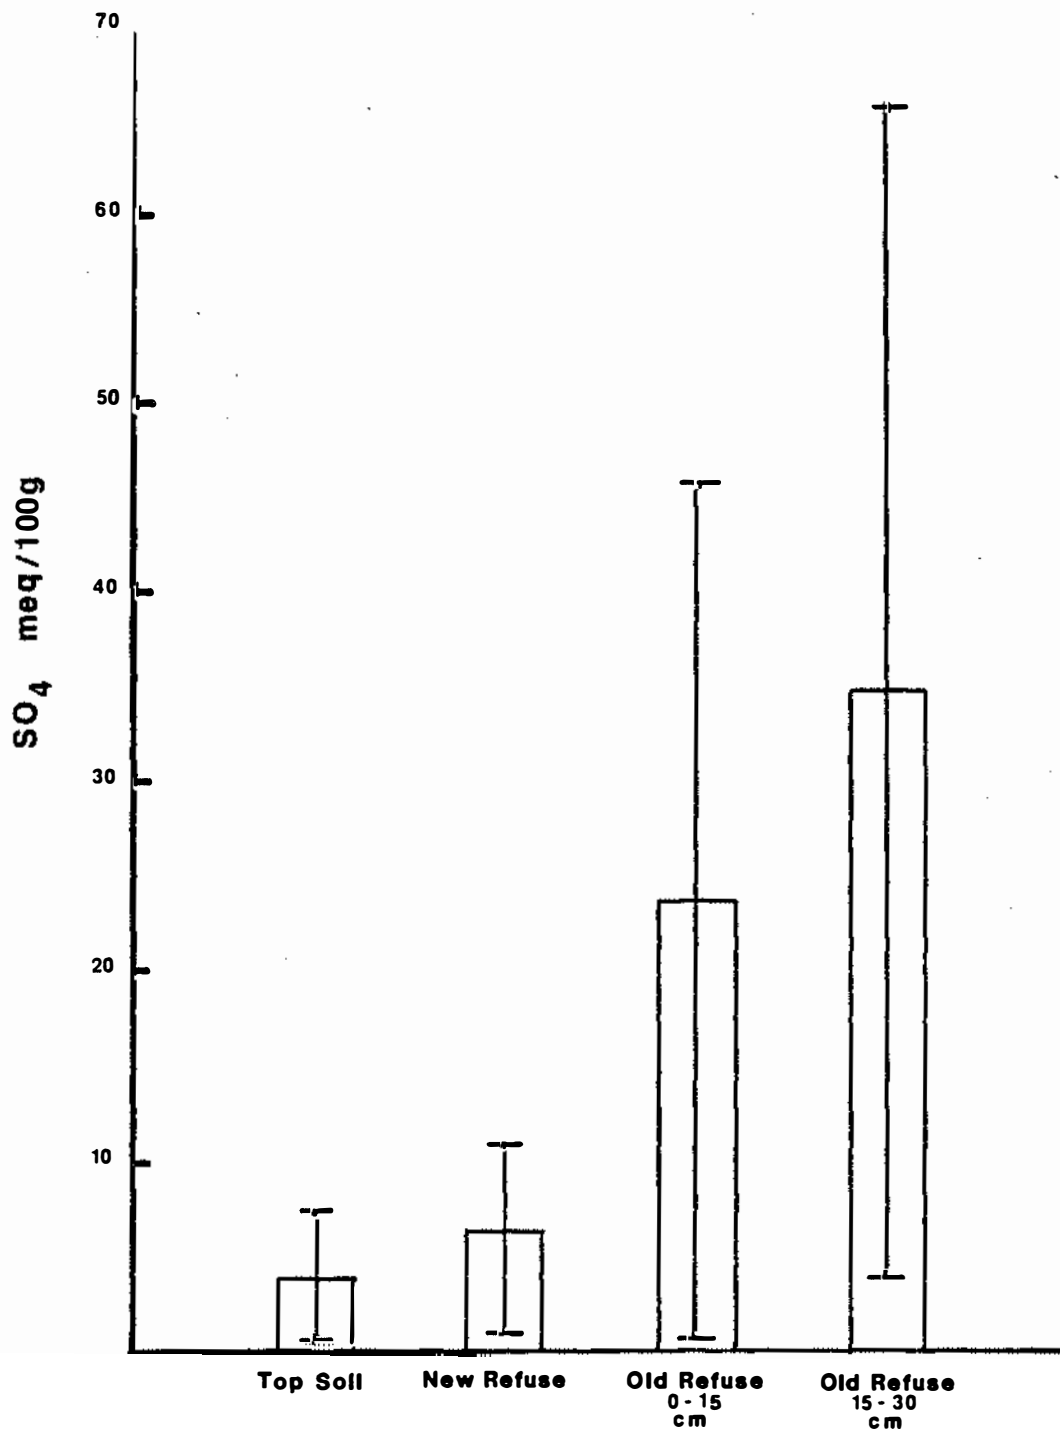
Sulfate was negatively correlated to pH and positively correlated with age of the refuse material (Figure 13). This again strengthens the observations that pyrite oxidation and/or some other oxidative processes are occurring in the refuse material which cause a lowering of the pH.

Figure 13. Means and standard error of sulfate content. Values represent 5 samples.

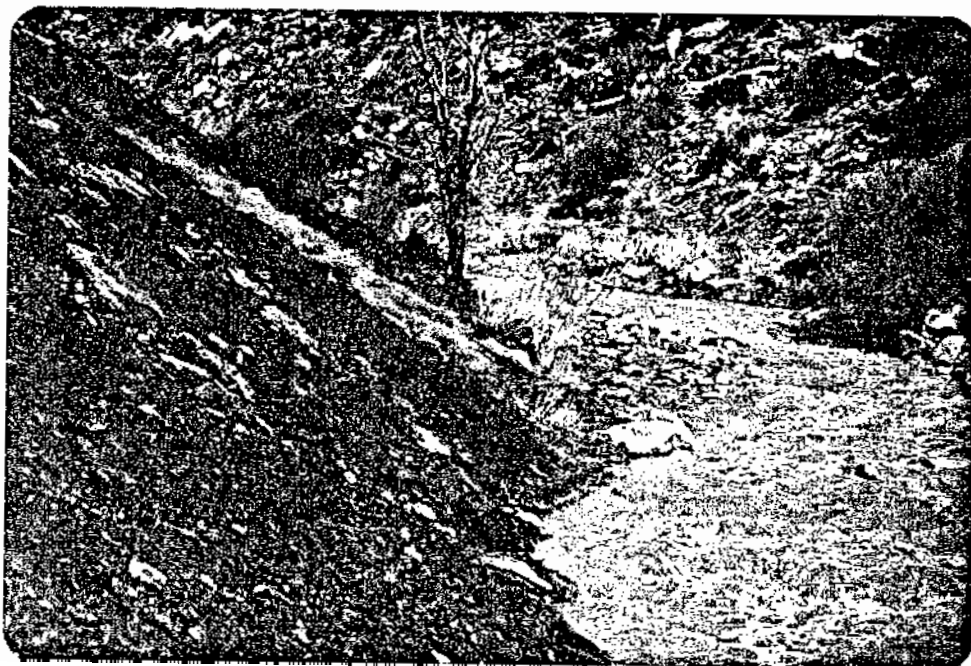
Several old abandoned refuse dumps were observed to be unprotected near streams (Figure 14); however, water samples were not collected due to the unusually high runoff during the sampling time. Total suspended solids in these areas appear to be naturally high and any additional sediment contributed from these refuse piles would be expected to be negligible to the total amount. However, one mine did report that an abandoned refuse pile was causing a blackening of the water in a major river after rainstorms.

Figure 14. A stream is eroding the banks of this old abandoned refuse pile. Photo taken April 21, 1982.

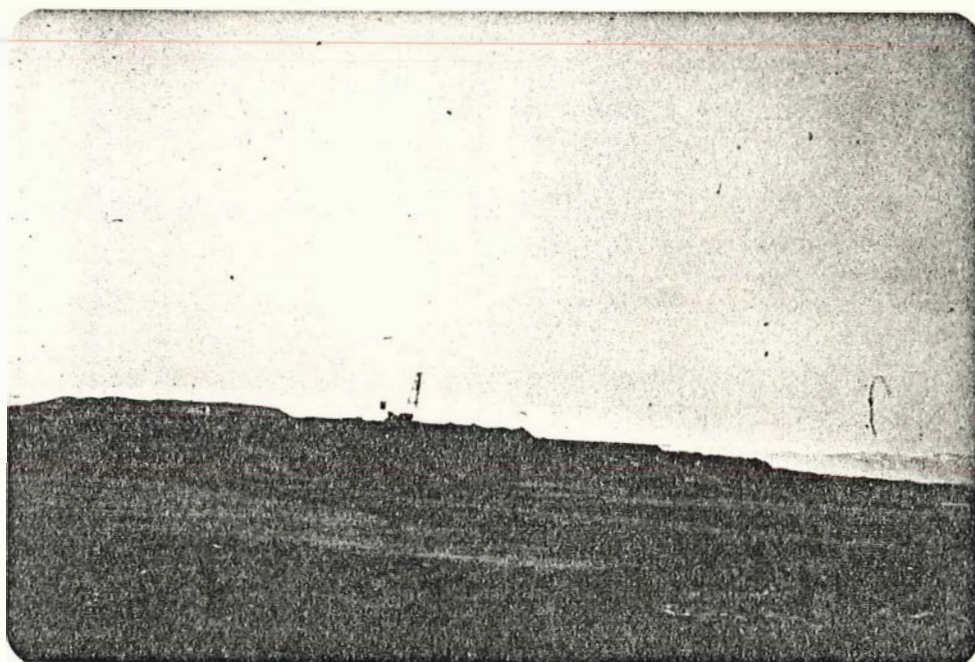
Figure 16. Refuse pile for Beaver Creek Coal Co. at C.V. Spur Processing Plant. Photo taken April 22, 1982.

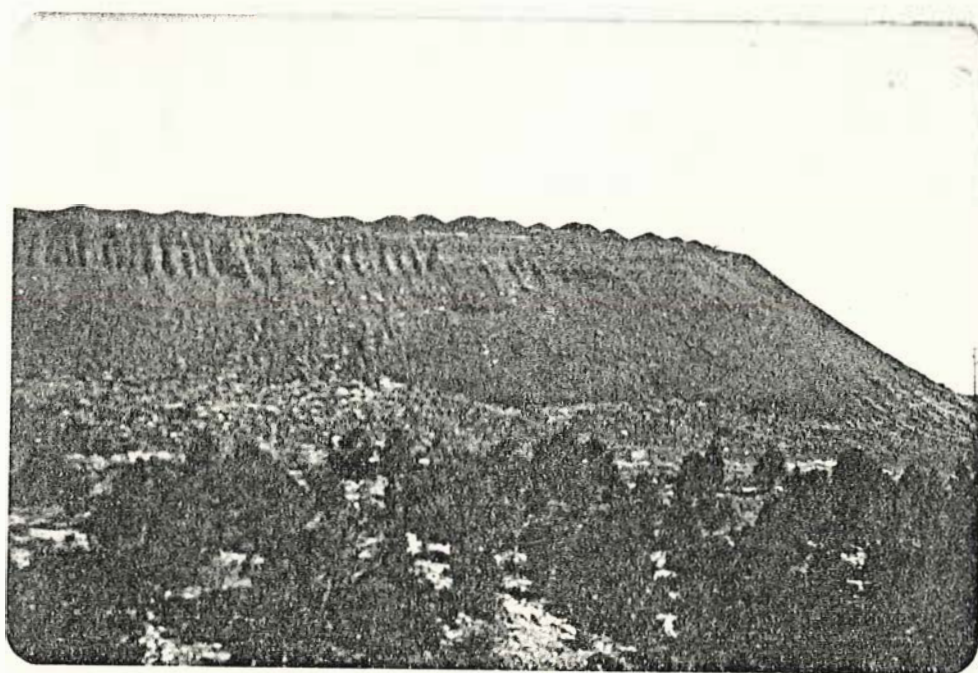
Refuse is extensive in the area with most being deposited prior to the passage of mine reclamation regulations (Figure 17). Construction of

Figure 17. Refuse pile at the King Mine. Photo taken April 22, 1982.

the refuse pile began in the early 1940's and has been added to intermittently up to the present date. In addition, there are four slurry ponds with coal refuse lining the perimeter of the ponds. Slurry is currently being sold after drying.

No revegetation efforts have begun and are not expected to begin for 30 years. Material to cover the refuse site will be taken from deeper soil material nearby.

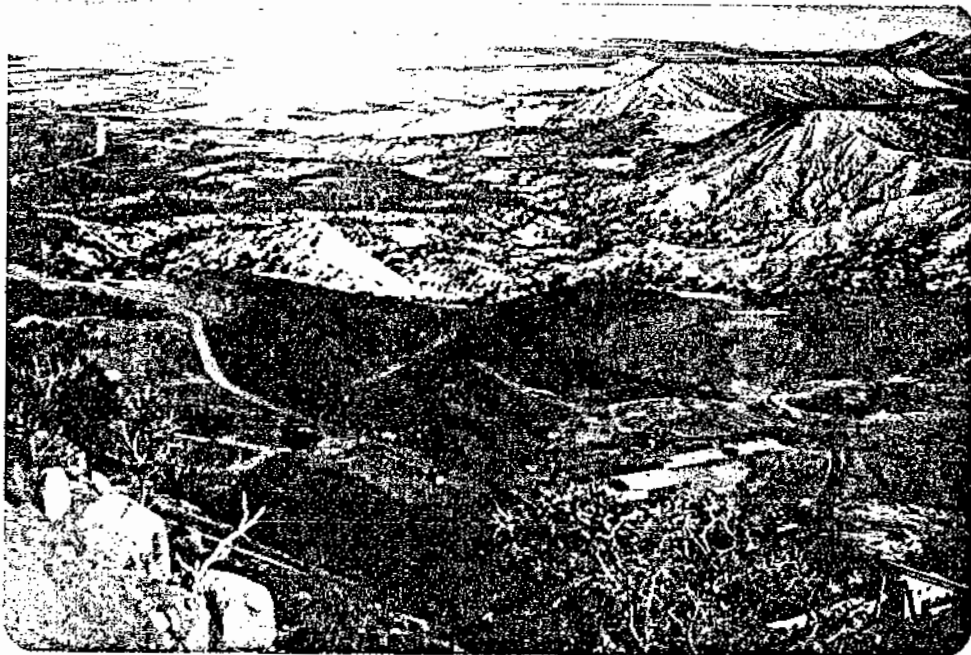
Mine A has two refuse pile locations, one for rock and one for coarse and fine refuse. The first is approximately 122 m x 61 m x 4 m (400 ft. x 200 ft. x 12 ft.) in height and is composed of rock 3.5 cm (1½ in) and greater in diameter. The second refuse pile covers several acres and is 183 m x 610 m x 37 m (600 ft. x 200 ft. x 120 ft.) in height and contains the coarse refuse (less than 3.5 cm or 1½ in.) and the dredged sediment. The refuse pile is oriented in a northeast direction with 20% slopes into the sedimentation ponds while the other side meets a hill. The refuse pile is expanding northward. Sparse vegetation, such as

Figure 18. Mine and refuse pile at Plateau Mine.  
Photo taken April 22, 1982

Princess plume (Stanleyia sp.) and mat saltbush (Atriplex sp.) was observed growing on the exposed refuse. Since mining operations were initiated prior to the 1977 regulations, no topsoil has been stockpiled for reclamation.

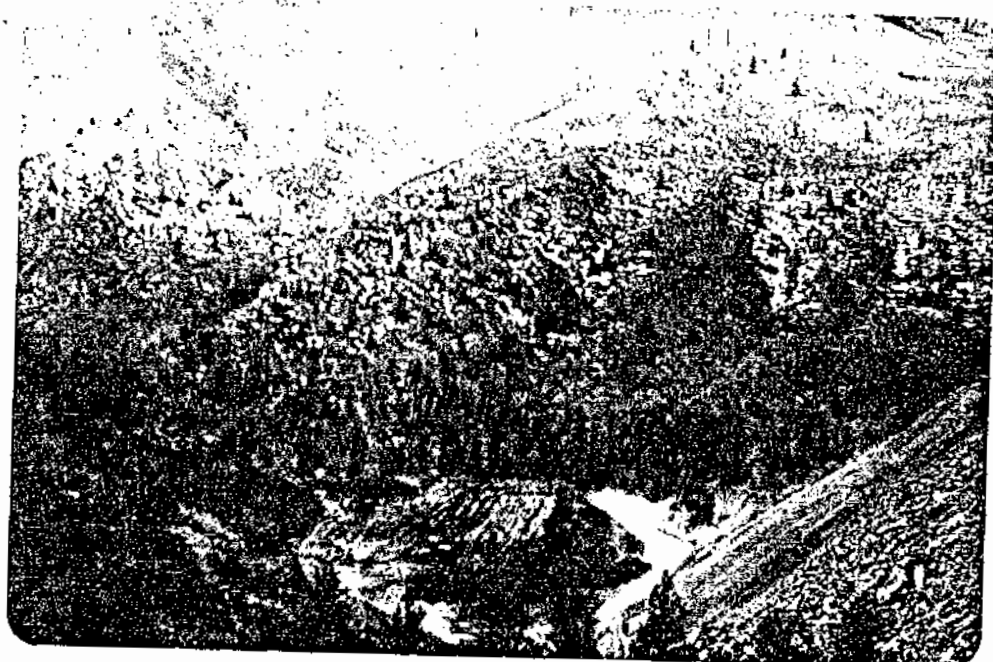
Figure 24. Refuse pile at Snowmass Coal Co. will eventually fill the canyon. Photo taken April 30, 1982.

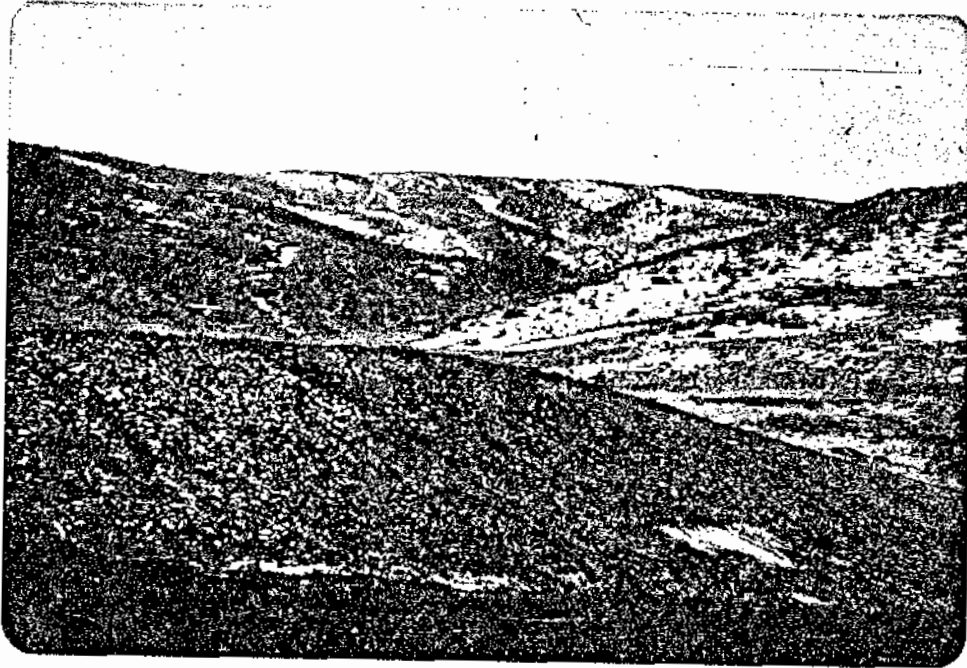
Figure 25. Refuse pile at Meeker Area Mine. Photo Taken April 30, 1982.
