# COAL WASTE DISPOSAL SURVEY. COAL REFUSE—AN INCREASINGLY SERIOUS PROBLEM FOR COLORADO PLATEAU PRODUCTION

Contract J0333931  
Plant Resources Institute

BUREAU OF MINES  
UNITED STATES DEPARTMENT OF THE INTERIOR

OFR  
84-97

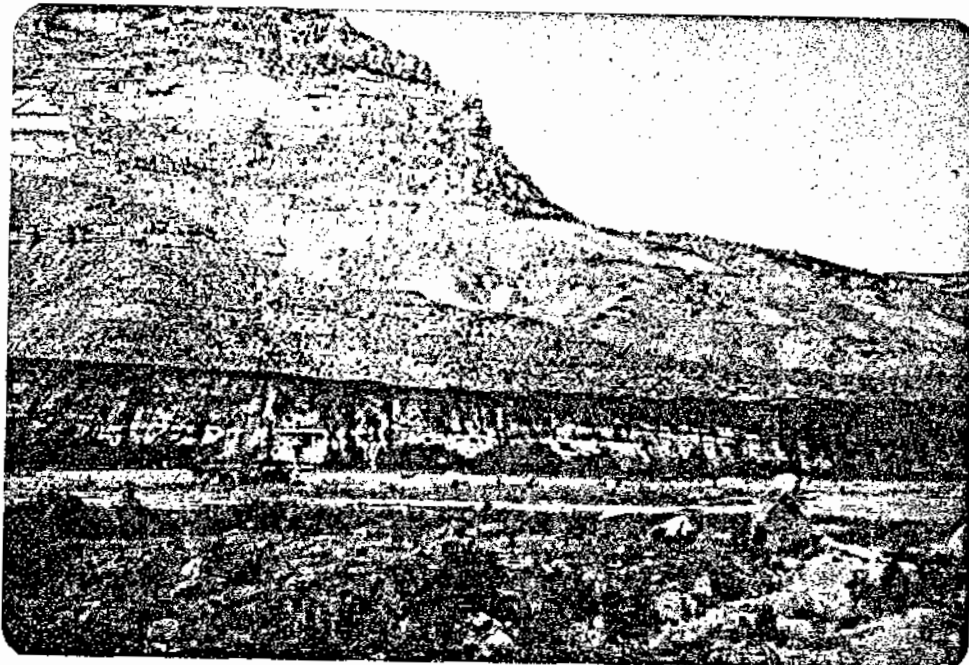
Figure 26. New refuse pile at Powderhorn Coal Co. Photo taken May 6, 1982.
