Final Report

February 1983

DEMONSTRATION OF FRESNEL LENS BLIND AREA VIEWERS ON LARGE UNDERGROUND MINE VEHICLES

Contract No. J0215029
Tracor MBA

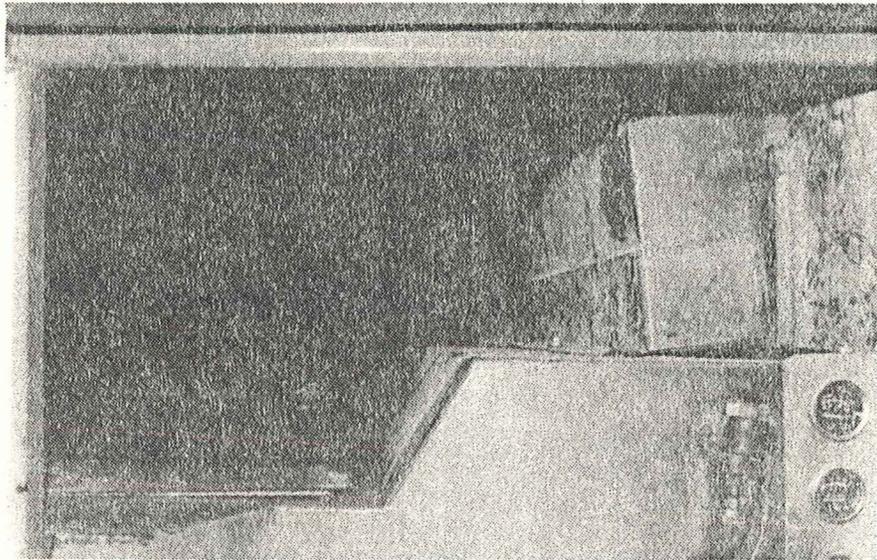
FIGURE 2.2.1-1
DRIVER'S VIEW DIRECTLY TO RIGHT SIDE

It was found that the Wagner Teletram, in use at the Cleveland mine of International Salt Company, was especially designed for this particular mine. Its superstructure did not conform with the Wagner vehicles inspected at the Wagner manufacturing facilities or with the specification sheets. The driver's view to the right side vehicle was blocked except for a small area approximately 2 ft. square directly to the right of his vehicle. The rearward view (on the right side) was also obstructed by several items that would make it very difficult to utilize a blind area viewer without blocking the driver's only view in that direction also. Photographs showing the driver's view directly to the right side and the right rearward directions are shown in Figures 2.2.1-1 and -2 respectively.

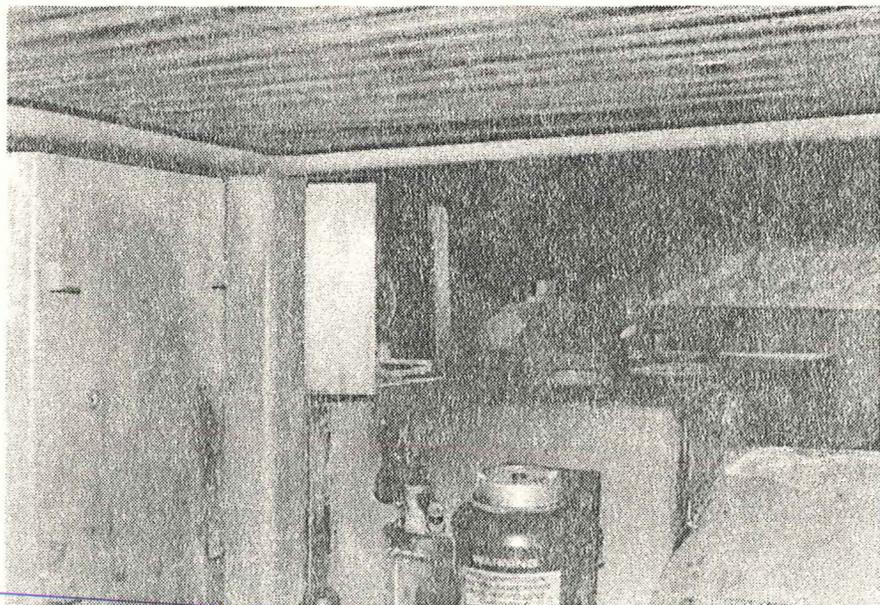
FIGURE 2.2.1-2
DRIVER'S VIEW TOWARDS RIGHT REAR

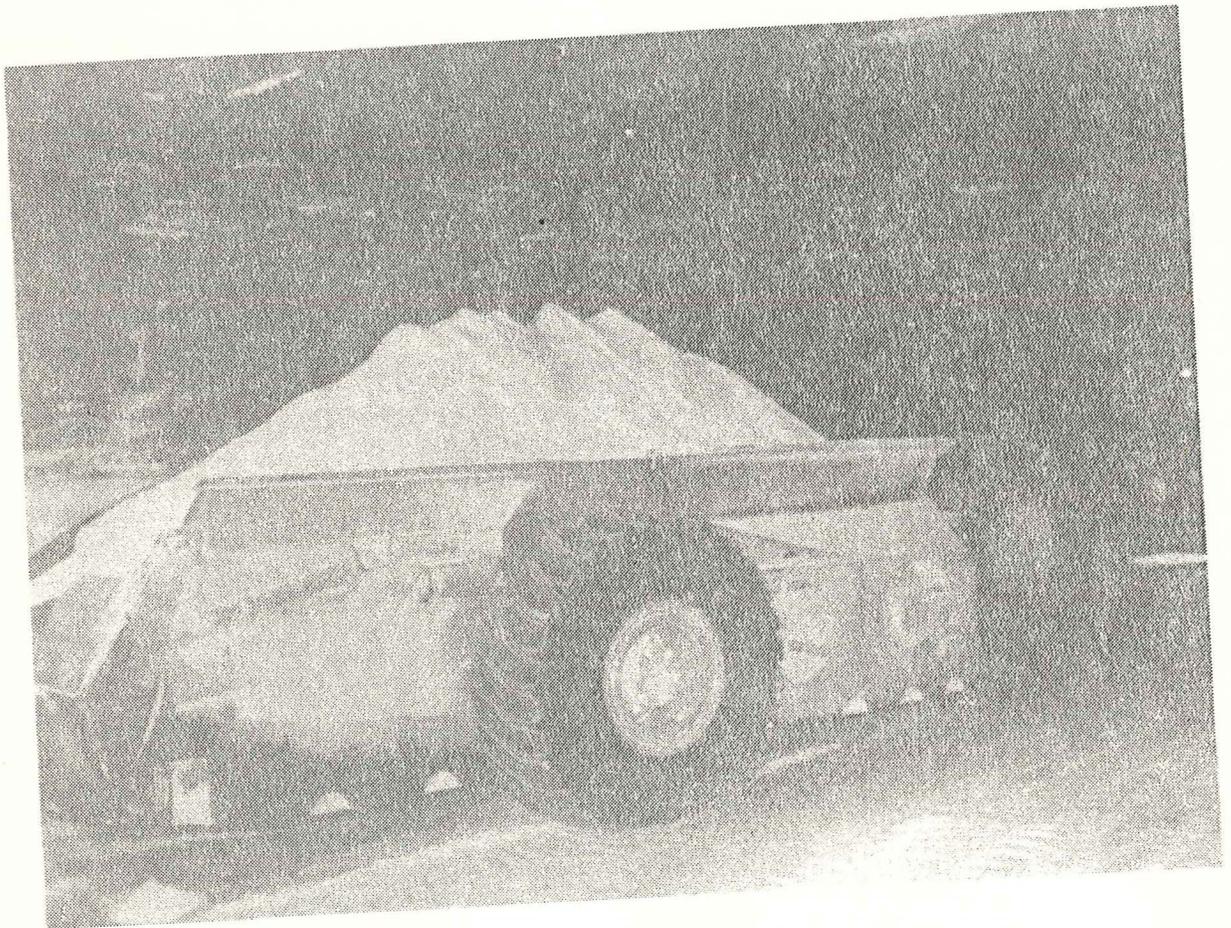
FIGURE 2.2.1-3
RIGHT REAR WHEEL AREA WAGNER TELETRAM VEHICLE

The driver's blind area, with which he was most concerned was that in the vicinity of the right rear wheel. This area is shown in Figure 2.2.1-3. To utilize the blind area viewer to see objects in this particular area would require that the BAV be mounted in back of the right front wheel, however, this was not practical with this vehicle's configuration. See Figures 2.2.1-4 and -5. The other possibility was to mount the blind area viewer directly opposite the driver positioning the blind area viewer on its side so the 70° angle of viewing was pointed towards the rear right side. Figure 2.2.1-6 shows the blind area viewer temporarily in this experimental position. However, this position was not deemed feasible for an installation of the BAV as it would block the driver's view which he was accustomed to using in positioning the vehicle under the loading hopper. Thus the Wagner teletram being used at the International Salt Company's mine in Cleveland Ohio was not used for the testing of the BAV. Figure 2.2.1-7 shows previously calculated visibility improvements with BAV.

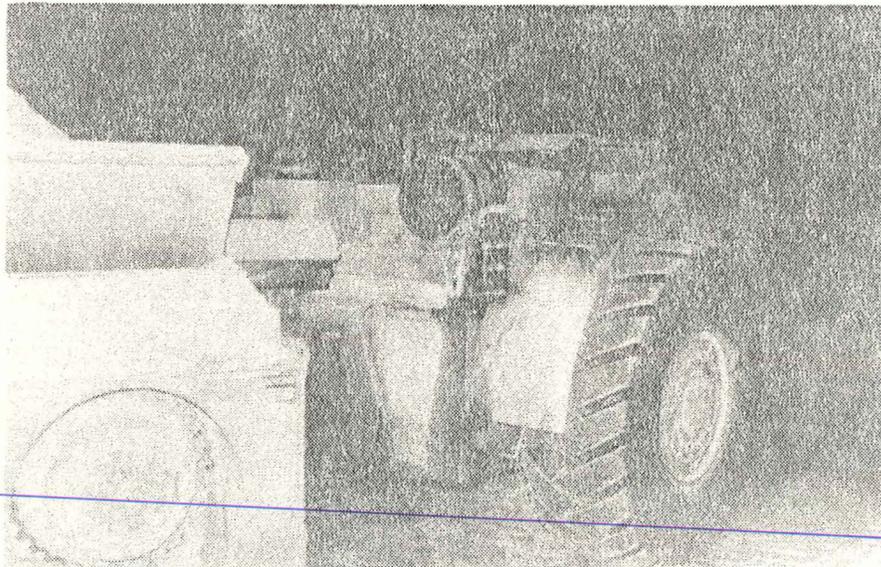
FIGURE 2.2.1-5
RIGHT FRONT WHEEL AREA WAGNER TELETRAM

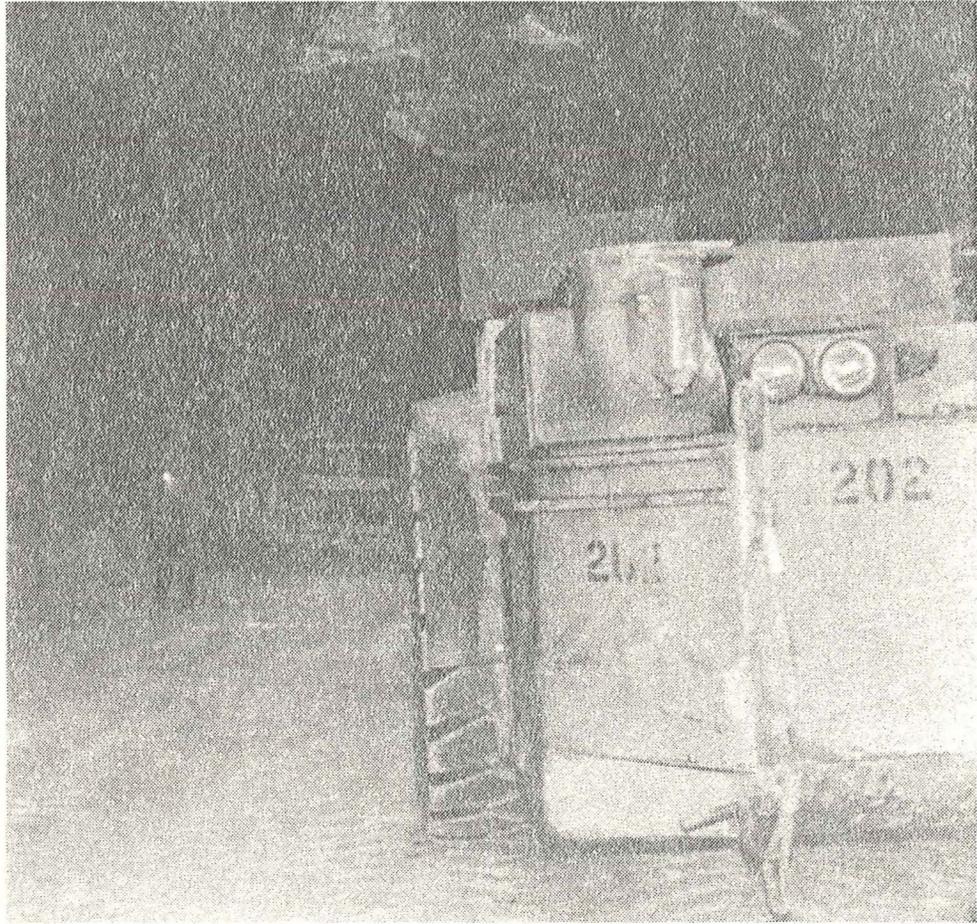
FIGURE 2.2.1-6
RIGHT SIDE OF WAGNER TELETRAM WITH BAV IN
EXPERIMENTAL POSITION

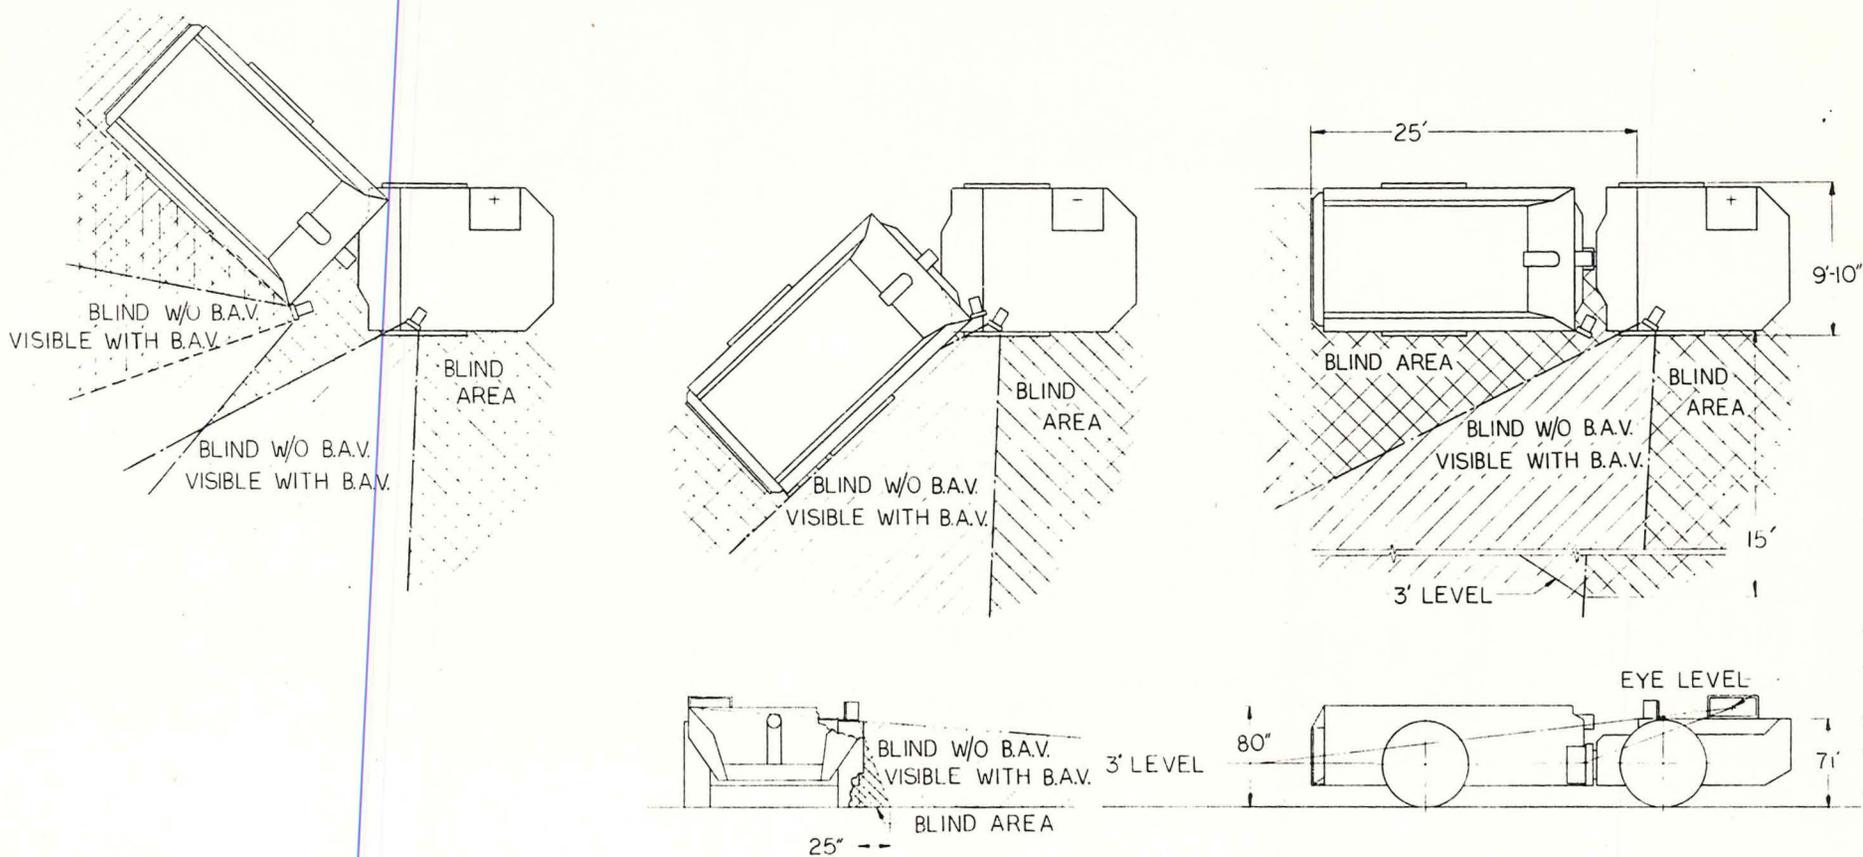
WAGNER MODEL
MTT-426-23

FIGURE 2.2.1-7
BLIND AREAS PLOTTED FOR WAGNER TELETRAM
SHOWING POSSIBLE VISIBILITY IMPROVEMENTS WITH BAV

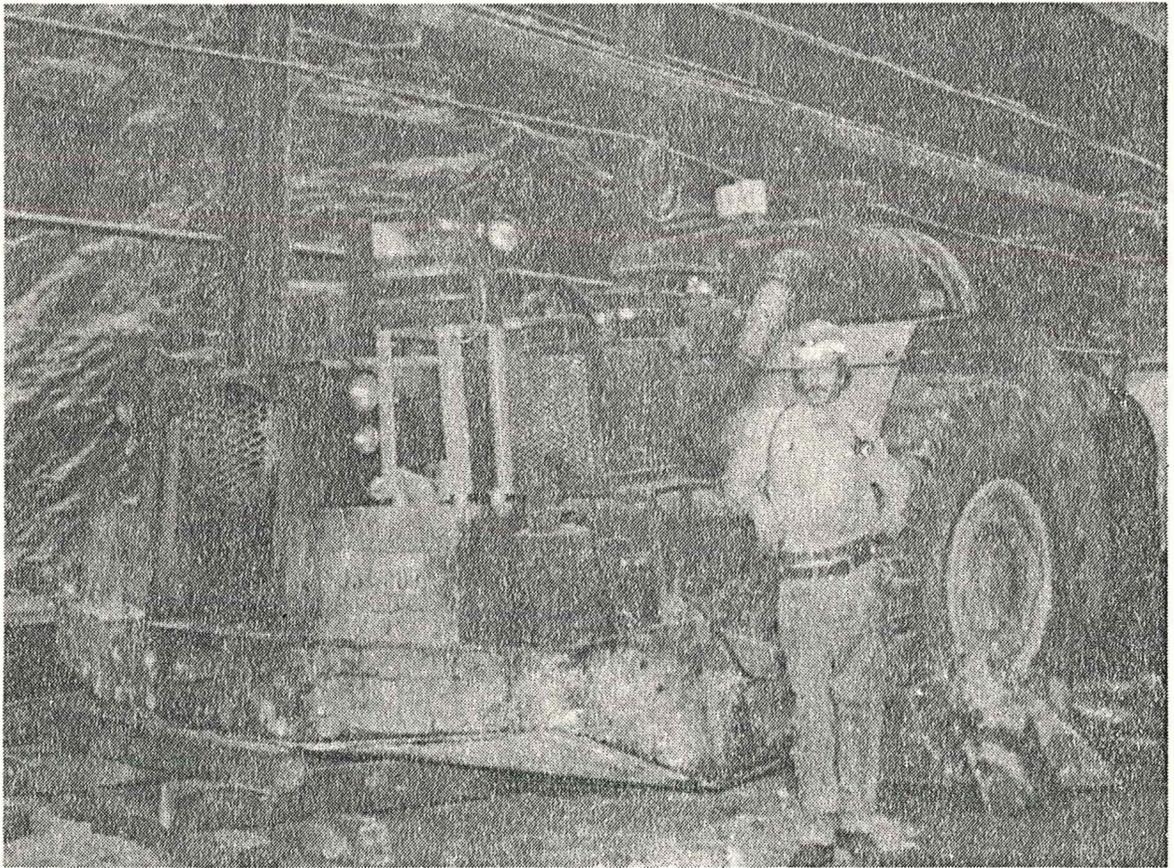
FIGURE 2.2.1-8
EIMCO 920 LHD

The EIMCO 920 LHD is not a very large vehicle as shown in Figure 2.2.1-8. However, a small vehicle approximately 3 feet high could be blocked from the operator's view up to as much as 16 feet away from the vehicle, Figure 2.2.1-9. Vehicles this size (converted golf carts) are used in this mine for personnel transportation.

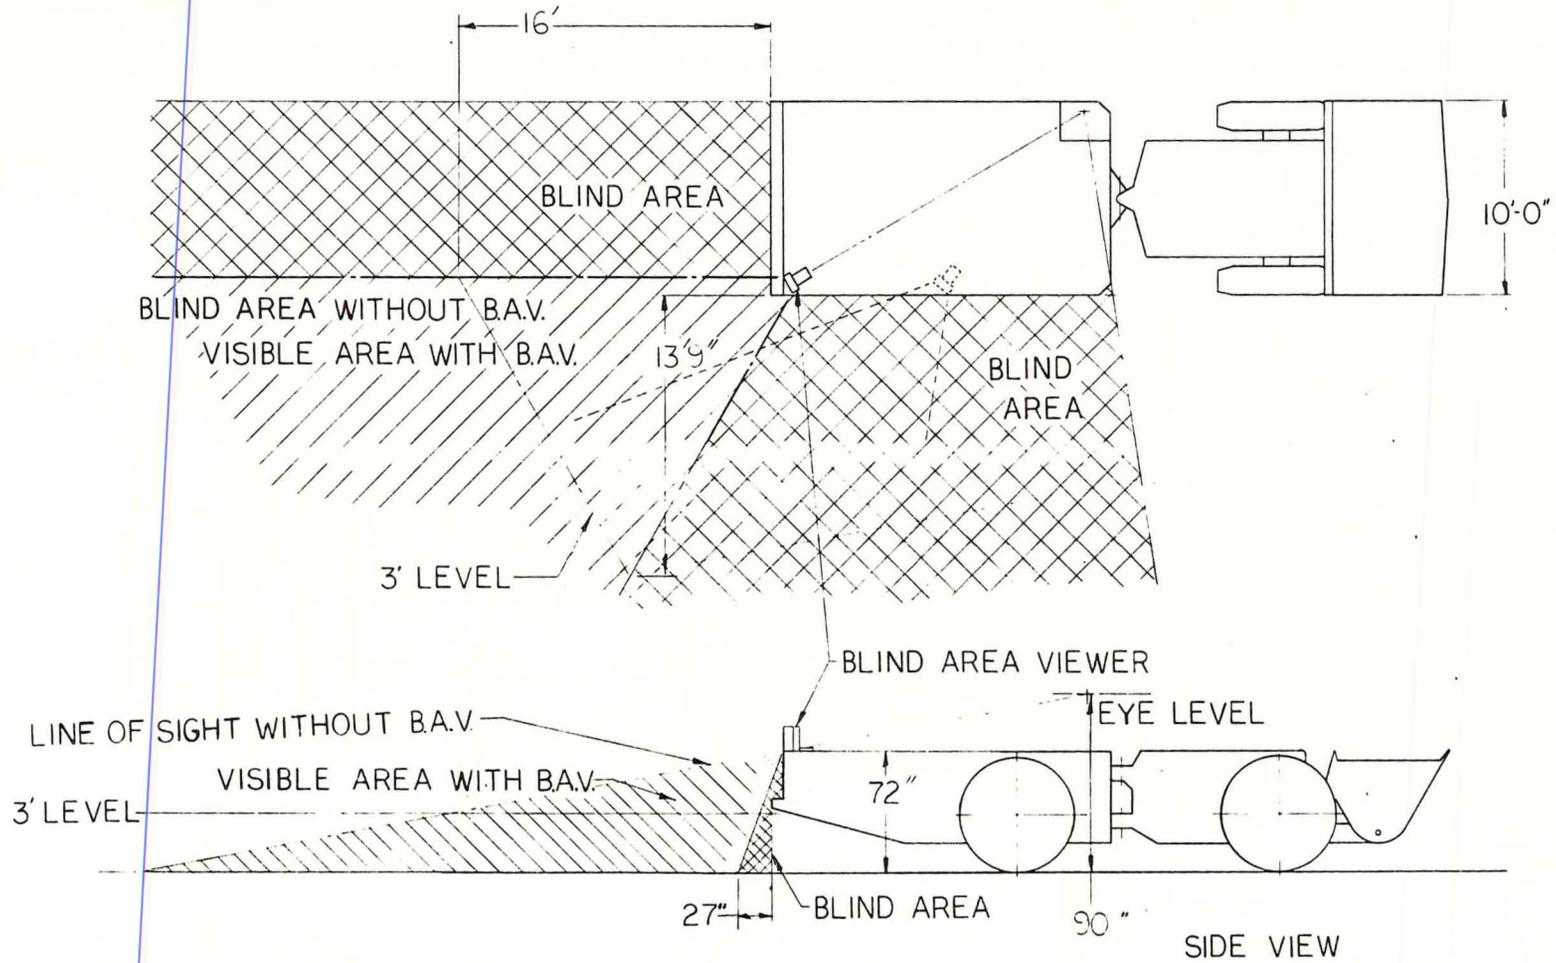
EIMCO MODEL
920C LHD

FIGURE 2.2.1-9
PLOTTED BLIND AREAS FOR EIMCO 920 LHD AND IMPROVEMENTS
IN VISIBILITY POSSIBLE WITH BAV

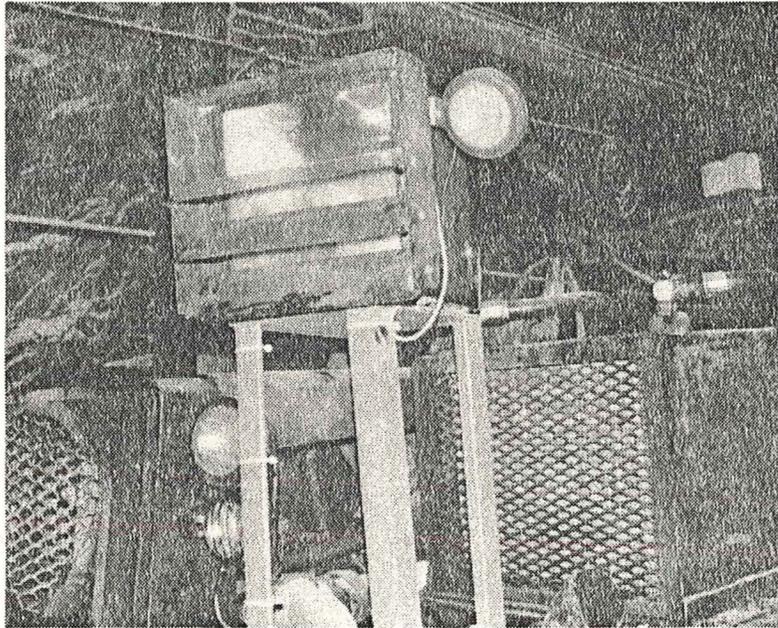
FIGURE 2.2.1-10
BAV INSTALLATION ON EIMCO LHD

In order not to interfere with normal maintenance procedures, it was necessary to build a three-leg bracket on which to mount the BAV. See Figures 2.2.1-10 and -11. This bracket was designed so that it could be installed or removed readily. It was attached to the vehicle by three bolts with the nuts welded to the vehicle frame. The BAV was mounted on top of the bracket using its normal mounting hardware and rubber vibration dampers.

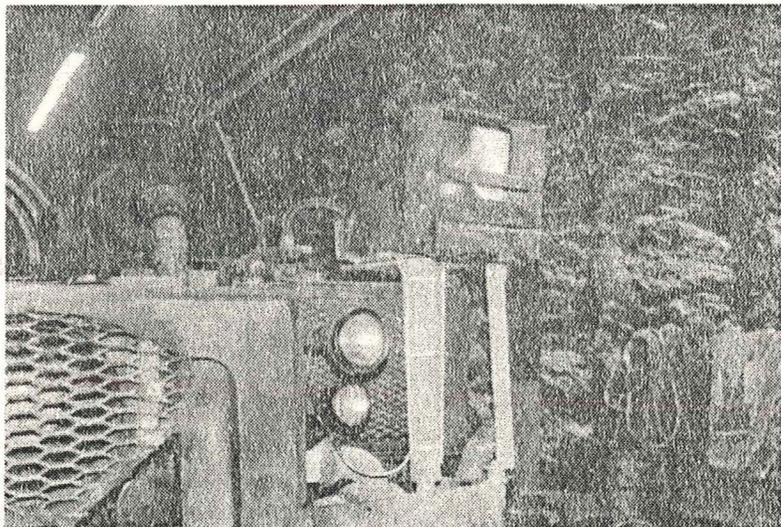
FIGURE 2.2.1-11
BAV INSTALLATION ON EIMCO LHD

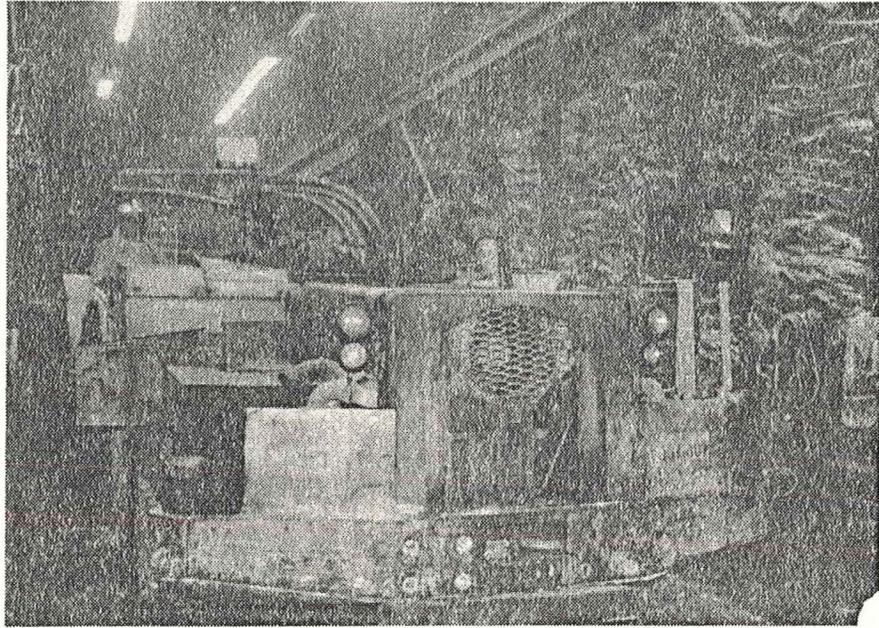
FIGURE 2.2.1-12
DRIVER'S POSITION RELATIVE TO BAV

Figure 2.2.1-12 is an overall view showing the driver's position relative to the BAV. Figure 2.2.1-13 is a photograph showing the driver's view of the BAV. These photographs were taken in the underground shop maintenance area.

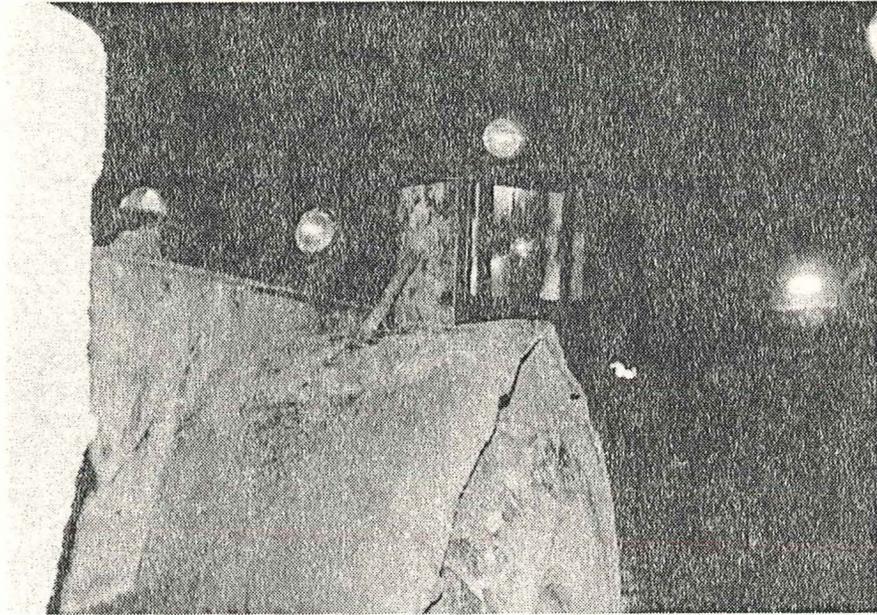
FIGURE 2.2.2-1
BAV MOUNTED ON WAGNER 21 TON TRUCK

Figure 2.2.2-1 is a photograph showing the mounting of the BAV on a Wagner 21-ton truck (No.476). This truck had a solid fender to which was welded a bracket to enable the BAV to be mounted in a horizontal position with the louvers vertical. This directed the 70° angle of vision towards the right rear wheel where the driver had expressed the desire to be able to see.

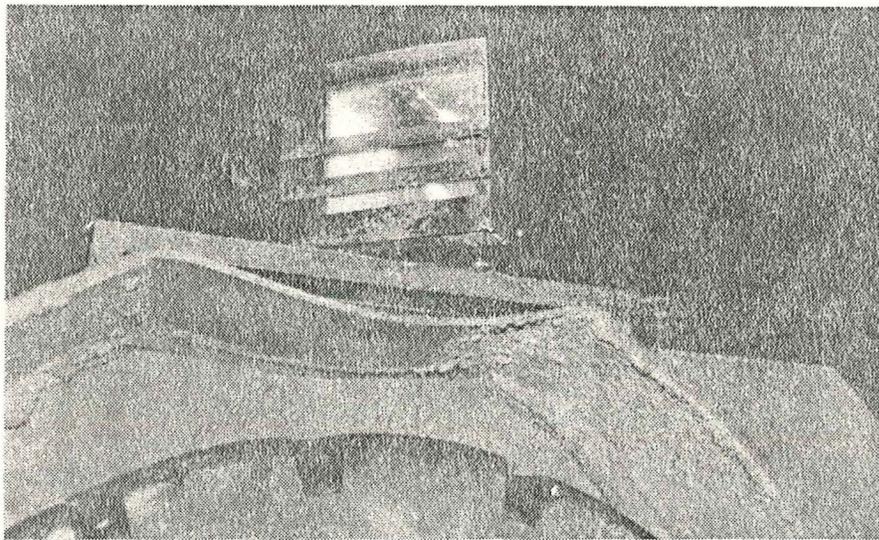
FIGURE 2.2.2-2
BAV MOUNTED ON WAGNER 35 TON TRUCK

Figure 2.2.2-2 is a photograph showing the BAV mounted on a Wagner 35-ton truck (No. 479). This truck had a three section fender with a flexible rubber section at the top. This necessitated building a bridge over the flexible section for mounting of the BAV. Figure 2.2.2-3 is a top view showing construction of this bracket arrangement. On this truck the BAV was mounted in its normal vertical upright position. For each of the installations at the Ozark Lead mine the vehicle decals were installed. These decals were designed to be used on vehicles that are equipped with blind area viewers. They descriptively illustrate the blind area viewer and its function. Figure 2.2.2-4 is a photograph showing the positioning of the decal on the Wagner trucks.

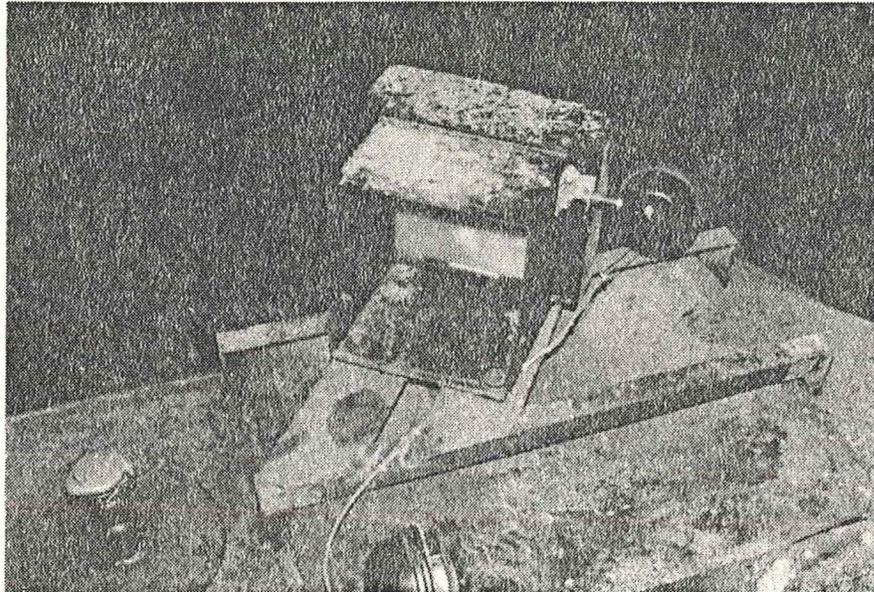
FIGURE 2.2.2-3
TOP VIEW OF BAV & MOUNTING BRACKET ON
WAGNER 35 TON TRUCK

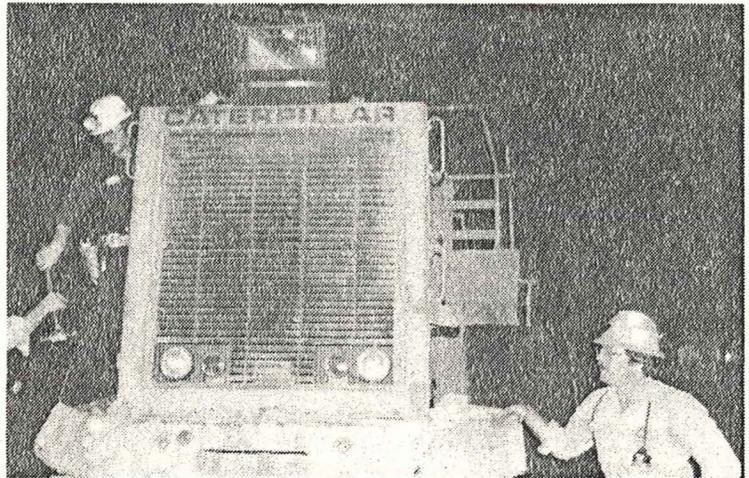
**FIGURE 2.2.2-7
BAV INSTALLATION ON
CAT 980C FRONT END LOADER**

The BAV installation on the Caterpillar 980C is shown in Figures 2.2.2-7, -8 and -9 illustrating the position of the BAV, the driver's view of the BAV and the positioning of the BAV decal respectively.

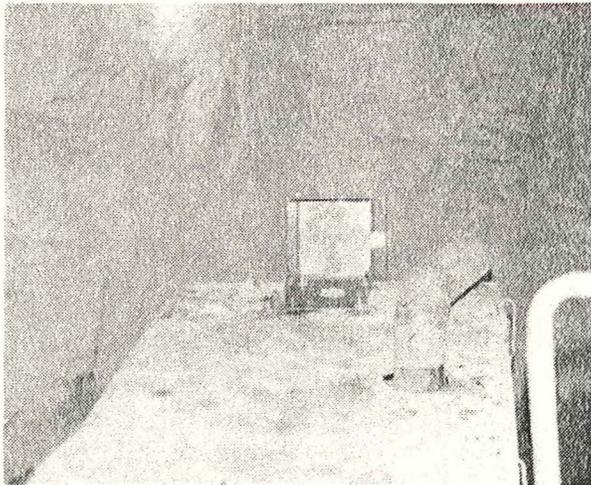
**FIGURE 2.2.2-8
DRIVER'S VIEW OF
BAV ON CAT 980C F.E.L.**

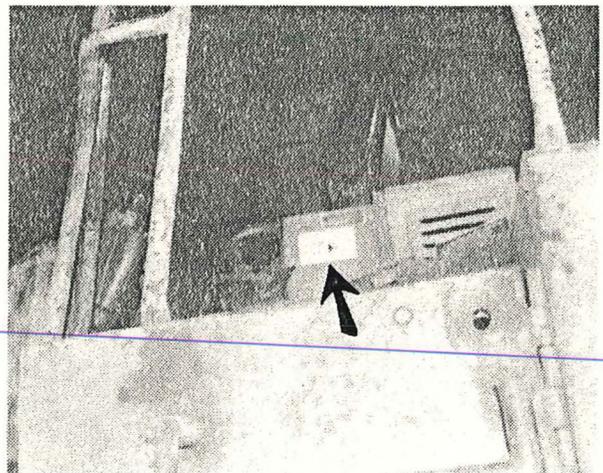
**FIGURE 2.2.2-9
BAV DECAL ON F.E.L.**

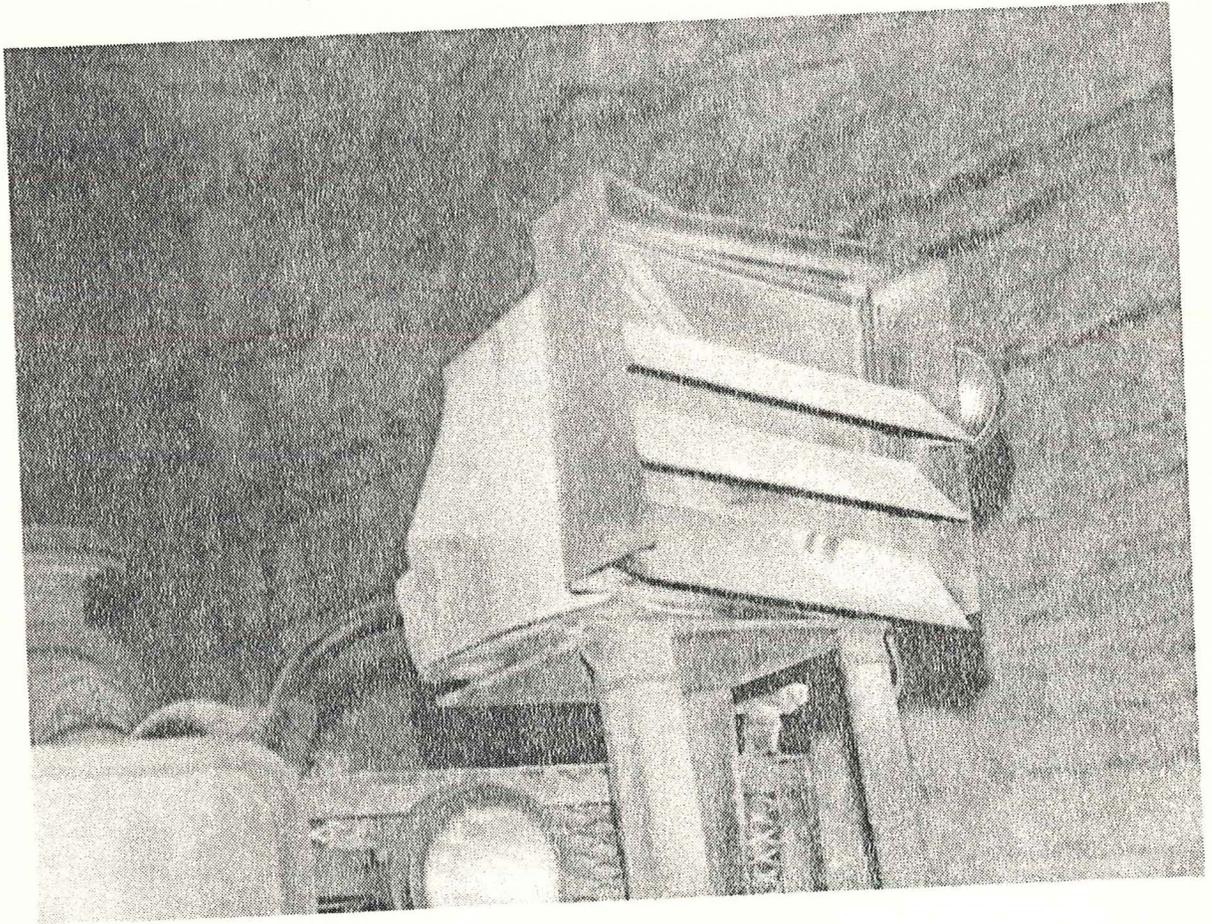
FIGURE 3.1.1-1
DAMAGED BAV ON EIMCO LHD

There were no normal mining conditions that could damage the BAV. However, one was destroyed in an accident between a vehicle and a large piece of equipment. The actual details of the accident could not be ascertained, but it was believed that in towing a drilling jumbo the boom had swung and hit the top of the BAV. This type of operation is not a normal procedure and most likely would never be repeated. The damaged BAV is shown in Figure 3.1.1-1. Its lens was badly cracked.

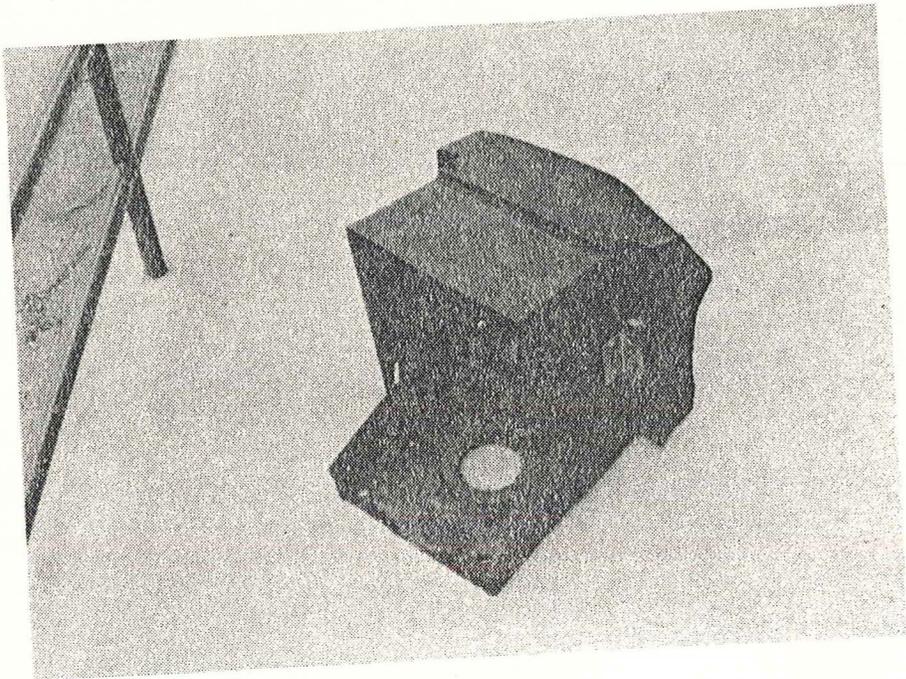
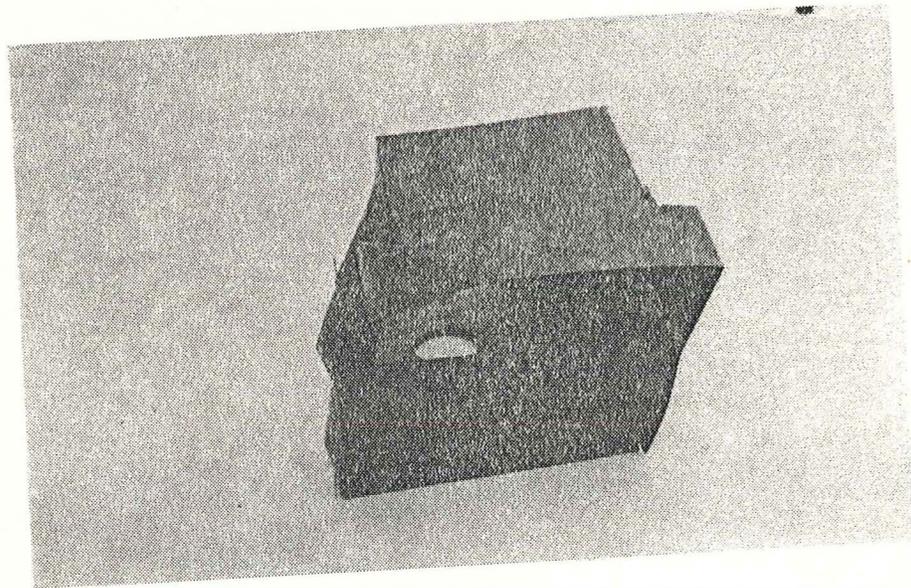
FIGURE 3.2.1-1
DAMAGED BAV REMOVED FROM CATERPILLAR FRONT END LOADER

The BAV mounted on the Caterpillar front end loader survived only four days of operation. The cause of the accident is not known. The louver hood was crushed, pushing the lens out the bottom. The operator reported he did not realize it had happened until sometime later and the lens could not be found. The damaged hood is shown in Figure 3.2.1-1.

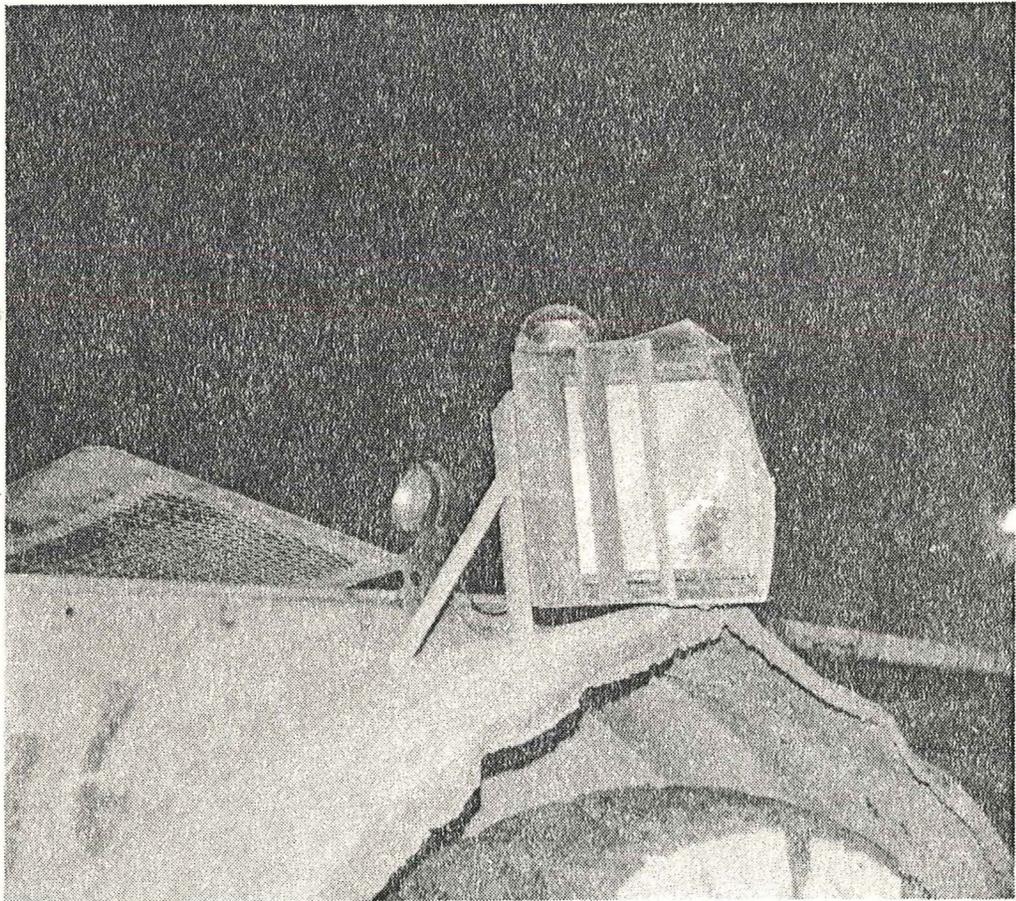
FIGURE 3.2.1-2
DAMAGED BAV ON WAGNER TRUCK

The BAV that was installed on truck No. 476 had a cracked but usable lens. This was one of the BAVs transferred from International Salt Company's mine. After approximately 4 weeks of operation it was struck by the bucket of a front end loader damaging the louver hood and fracturing the lens beyond use. The louver hood was re-straightened by the maintenance shop and a new replacement lens installed. This damaged BAV is shown in Figure 3.2.1-2. The replacement BAV survived another five weeks before it was knocked off by a low hanging vent bag Y in the south end of the mine.

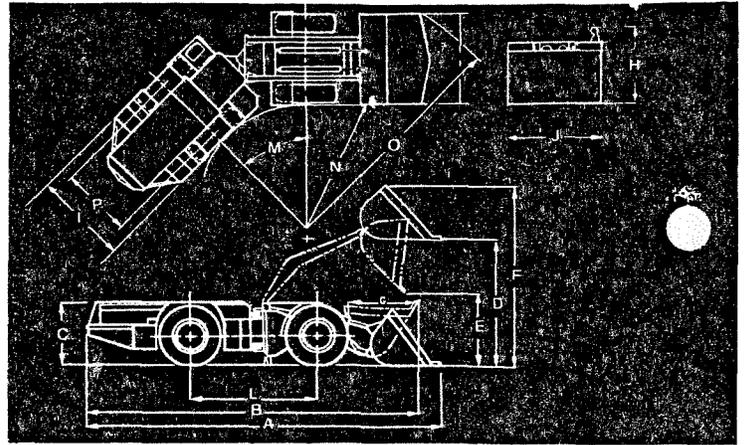
MACHINE DIMENSIONS: EIMCO 920C LHD		ENGLISH	METRIC
A.	Overall Length (Bucket down)	36 ft. 11 in.	11,252mm
B.	Overall Length (Bucket in carry position)	36 ft. 6 in.	11,125mm

C.	Overall Height (Bucket down)	6 ft. 10 in.	2083mm
D.	Dump Height (Ejector bucket)	10 ft. 6 in.	3200mm
E.	Dump Height (Rolling bucket)	6 ft. 6 in.	1981mm
