**A minerals research contract report  
March 1982**

# **DEVELOPMENT OF A SLURRY FILLING SYSTEM FOR MODIFIED IN SITU OIL SHALE MINING**

Contract JO295046  
Rio Blanco Oil Shale Co.  
2851 South Parker Road  
Aurora, Colorado, 80014

OFR  
83-114

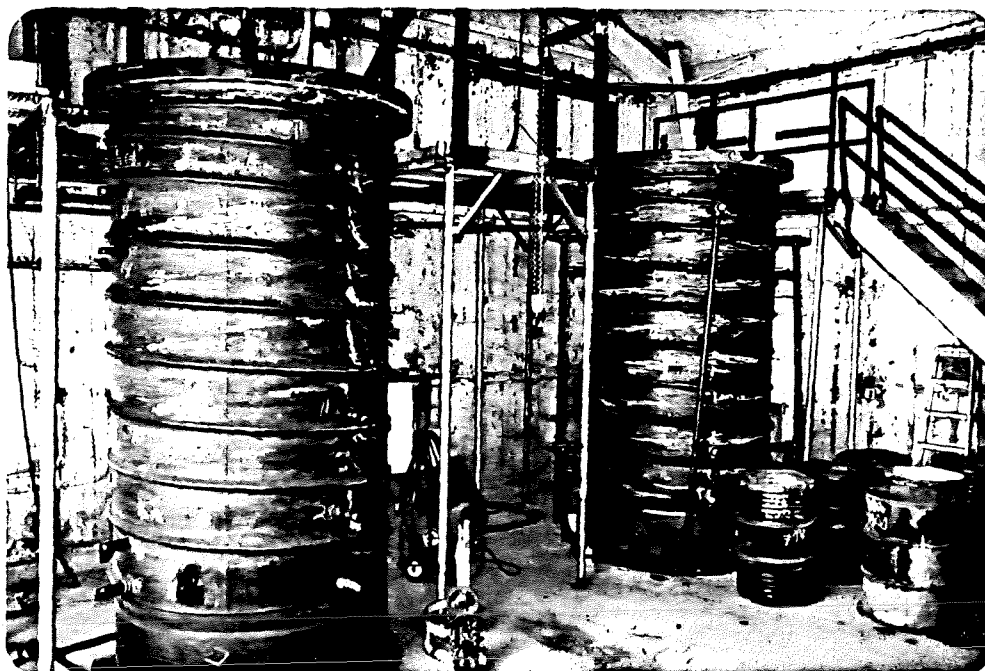
PHOTO 1. Test Vessels and Platform

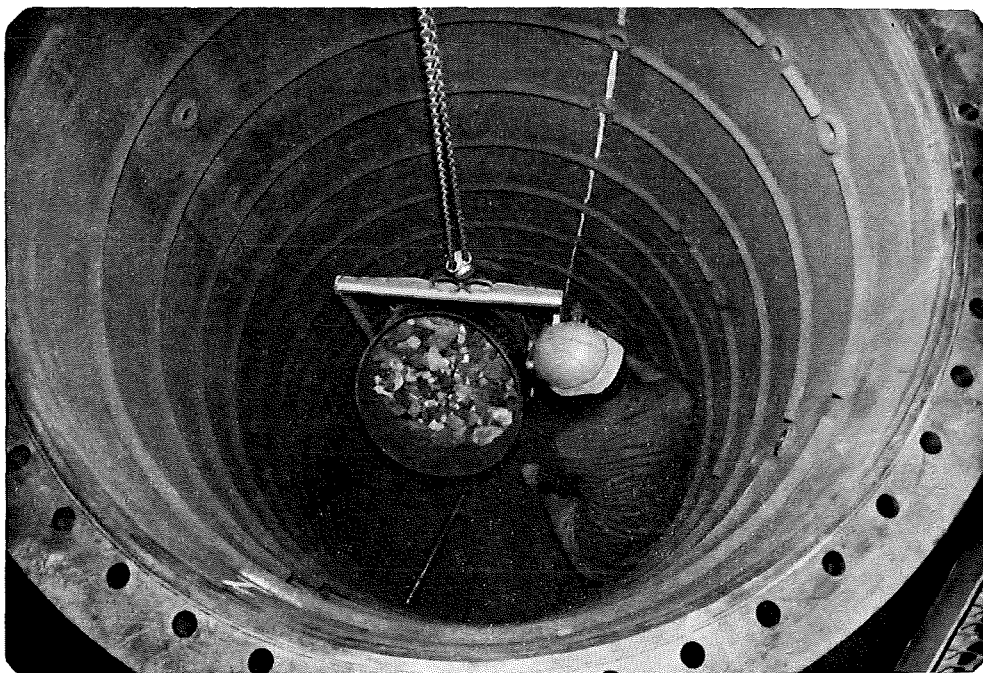
PHOTO 6. Shale Rubble Being Loaded in Vessel

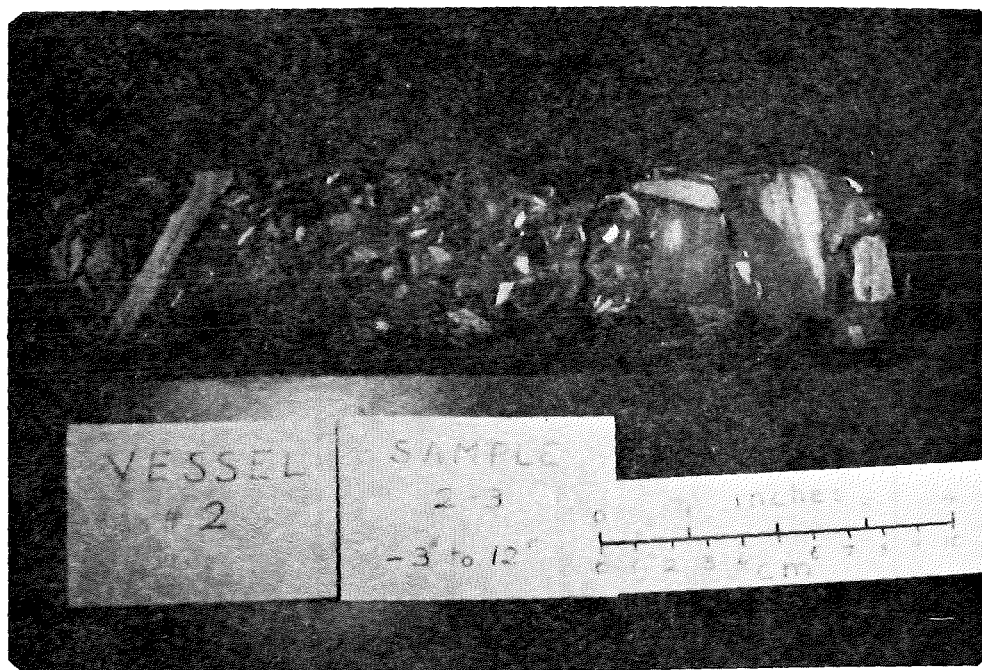
PHOTO 7. Core Sample

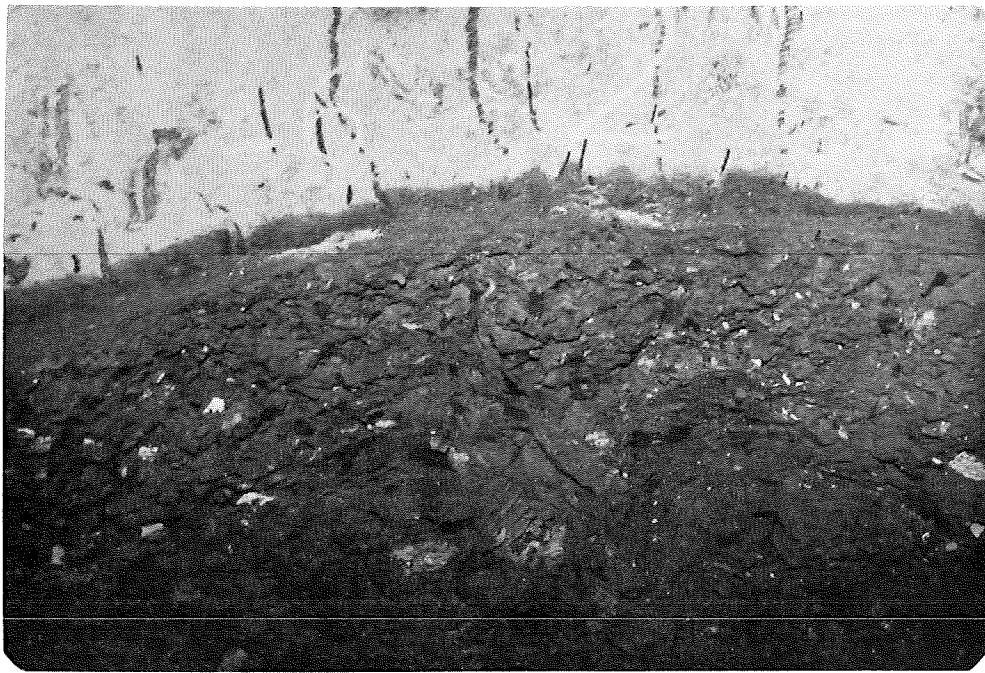
PHOTO 9. Visual Observation (Vessel #2)

3.5.7.2 Vessel #2. The distribution of the first stage grout, which was the only one injected, could be observed very clearly. No cracks were found, but some small pockets of ungrouted fine material were found. All these pockets were located where manual blending inadequately mixed the various rubble sizes. This resulted in pockets of fine rubble that were difficult to grout (Photo 9). Except for these small pockets, the overall rubble mass was well grouted.

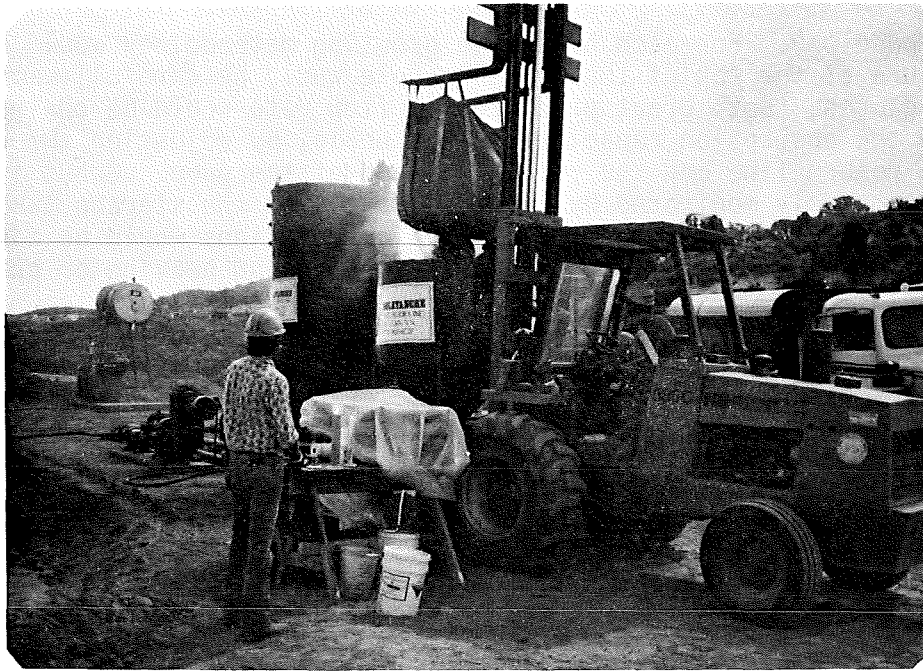
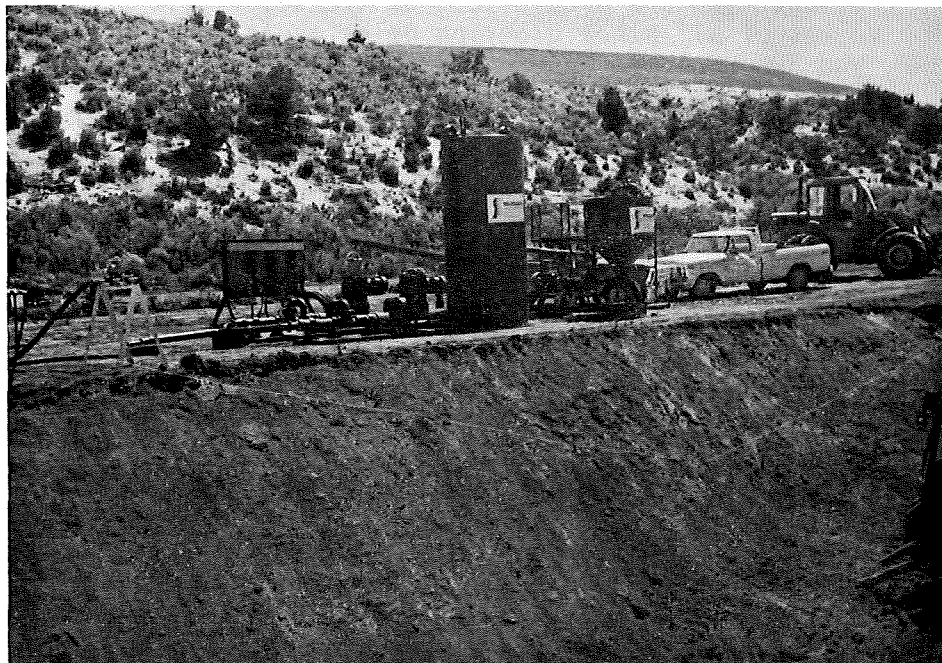
PHOTO 13. Grouting Plant

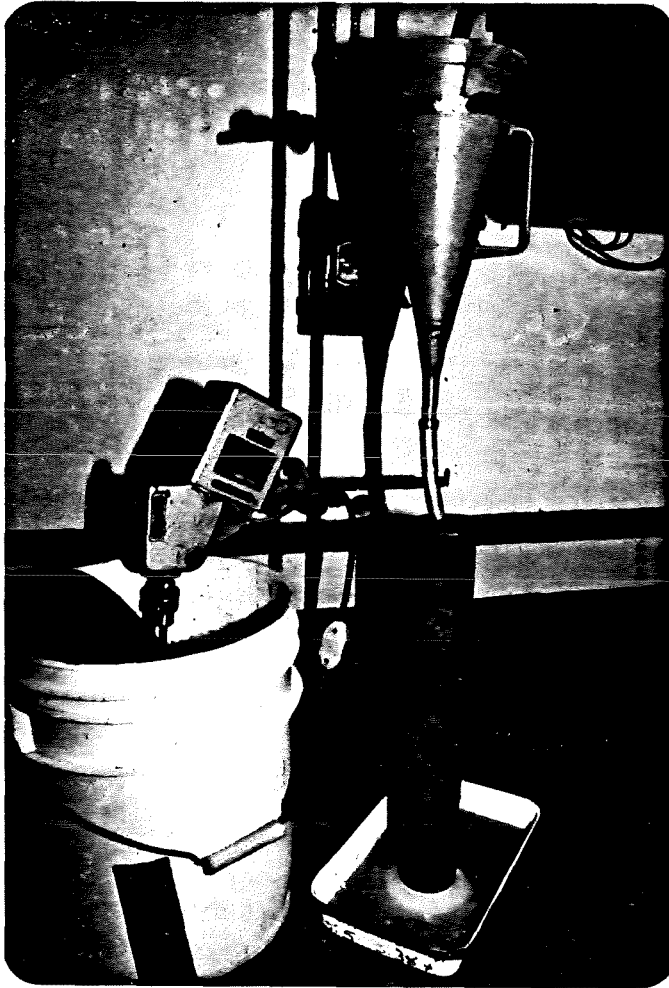
Figure A-1. Electric Stirrer

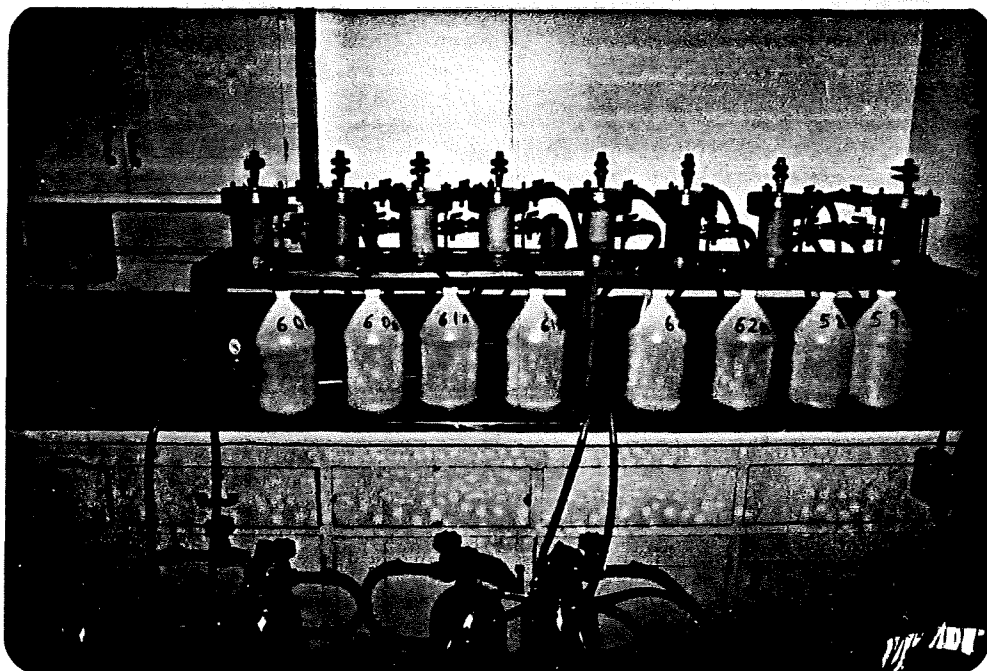
Figure A-4. Equipment for Permeability Test
