DEVELOPMENT OF HIGH-PRESSURE
WATER JET EQUIPMENT FOR UNDERGROUND
APPLICATION OF EXCAVATING ENERGY MINERALS

UNITED STATES DEPARTMENT OF THE INTERIOR
BUREAU OF MINES

Russell J. Miller and Fun-Den Wang
Excavation Engineering and Earth Mechanics Institute
Colorado School of Mines, Golden, Colorado 80401

FINAL REPORT

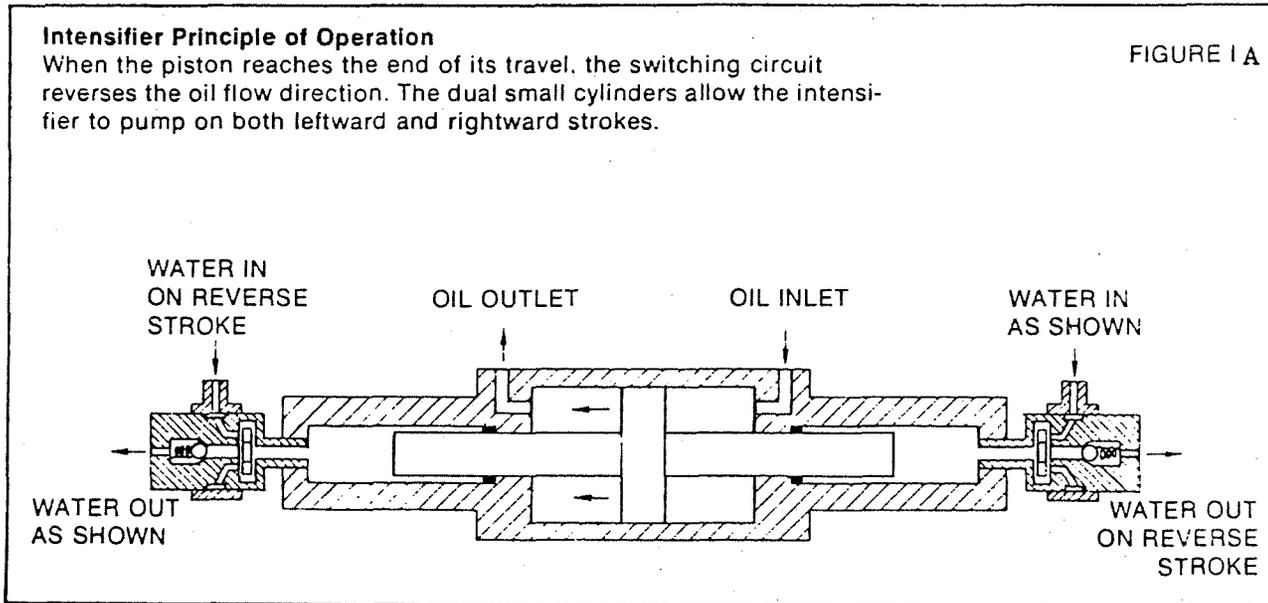
FIGURE 1 A

Intensifier Principle of Operation

When the piston reaches the end of its travel, the switching circuit reverses the oil flow direction. The dual small cylinders allow the intensifier to pump on both leftward and rightward strokes.

Figure 1 - Intensifier Principle of Operation

The pumping action requires an inlet and outlet check valve on each end of the intensifier. Usually, these check valves are joined by a tee-connection and fed into the cylinder. This construction results in high stress at the tee-joint. The high stress cycles with each stroke of the pump causing a fatigue failure. In the design shown in Figure 1a, this tee-connection is avoided through the use of coaxial check valves.

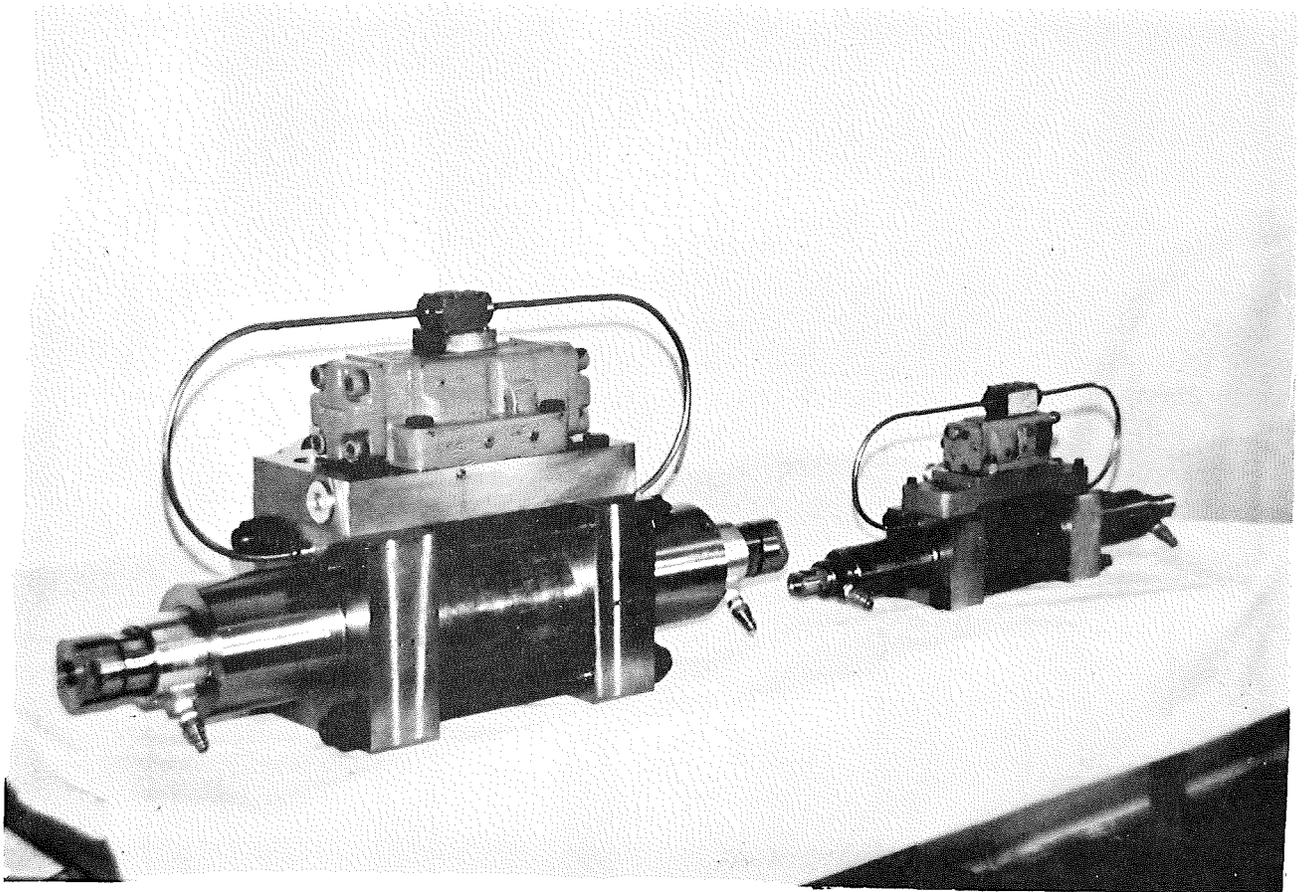
Figure 1b - The Large 250 HP Intensifier Designed and Built for This Investigation and the Smaller Original High-Pressure Intensifier

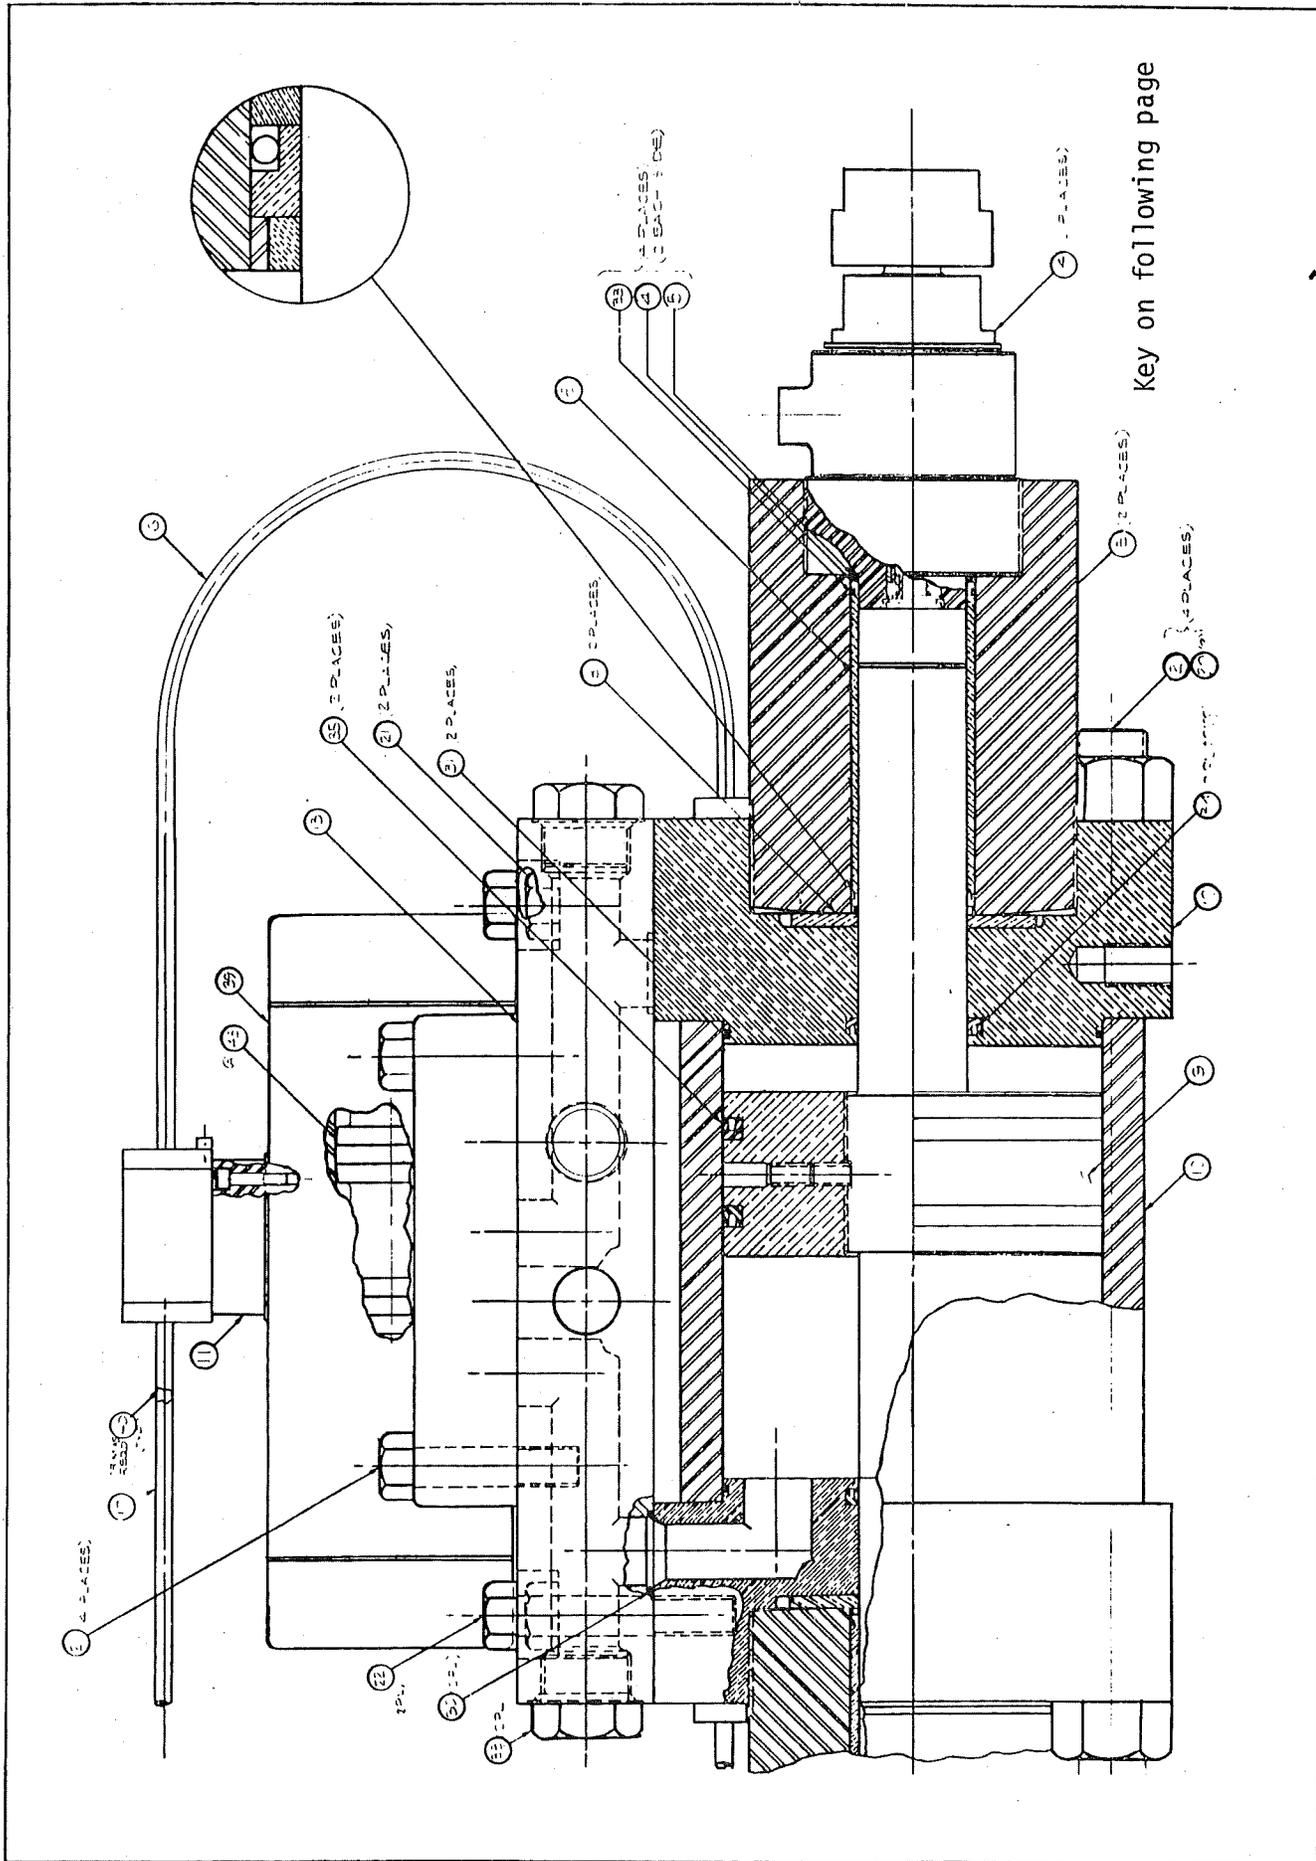
Figure 1c

Sealing of the plunger is accomplished with a four piece elastomer type seal for positive sealing. The main water seal is accomplished with an L-shaped filled teflon ring (see inset Figure 1c). This ring is energized to squeeze against the plunger with an O-ring. The O-ring and L-shaped teflon piece provide the seal against leakage of water. Behind this seal

Yet another problem that occurred early in the start-up was deterioration of the seal between the low-pressure cylinder and the endblock of the intensifier (see 31 on figure 1). This seal was an O-ring with a backup ring and tolerances as recommended in the manufacturers handbook. However, apparently the high-pressure combined with the cycling allowed the back-up ring to be continuously eaten away causing an eventual failure of the O-ring. This problem was stopped by replacing the hard rubber back-up rings with fabricated back-up rings made from Lexan sheet. These rings lasted well for the duration of the experiments but inspection afterward revealed slow erosion. This seal should be redesigned for long-life.

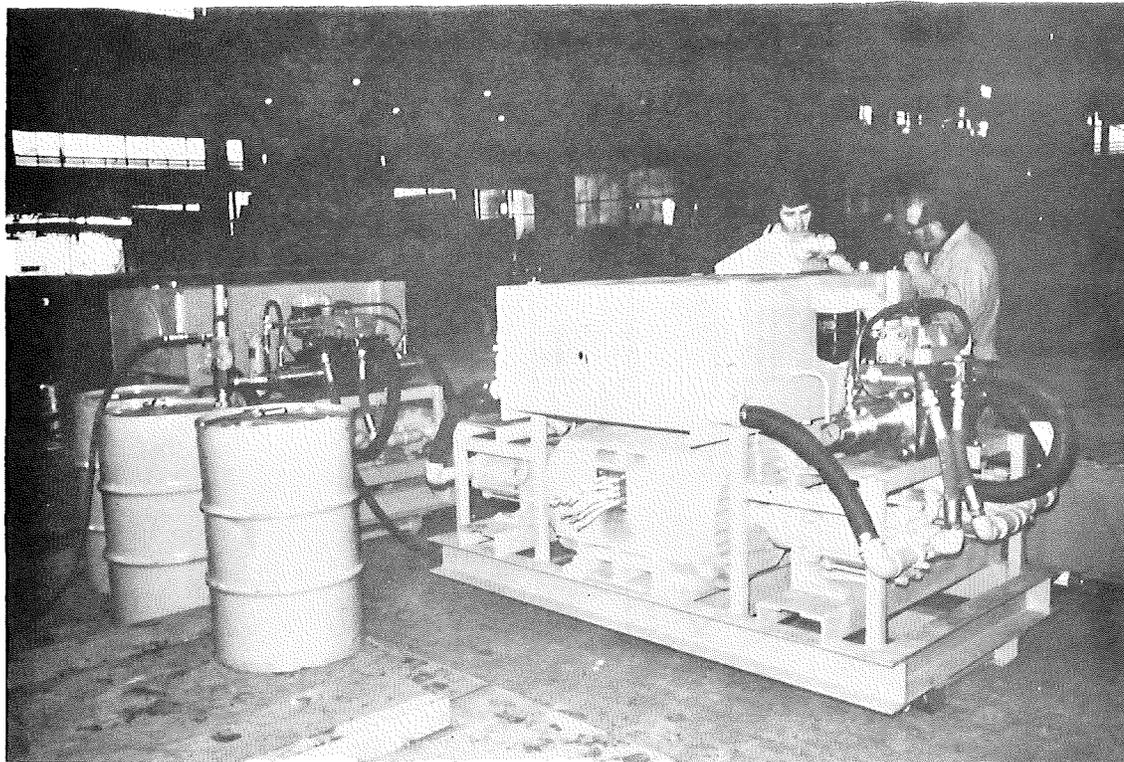
Figure 2 - Intensifier in the Shop

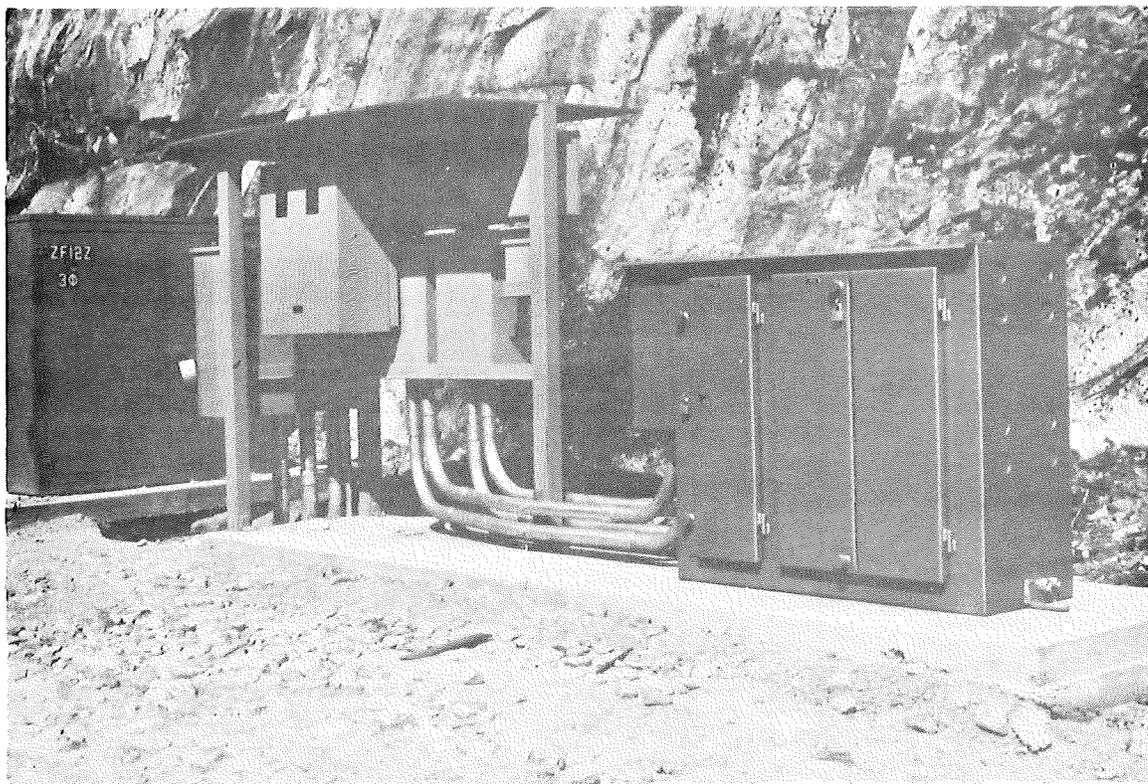
Figure 3 - Electrical Controls for Hydraulic Power Packs

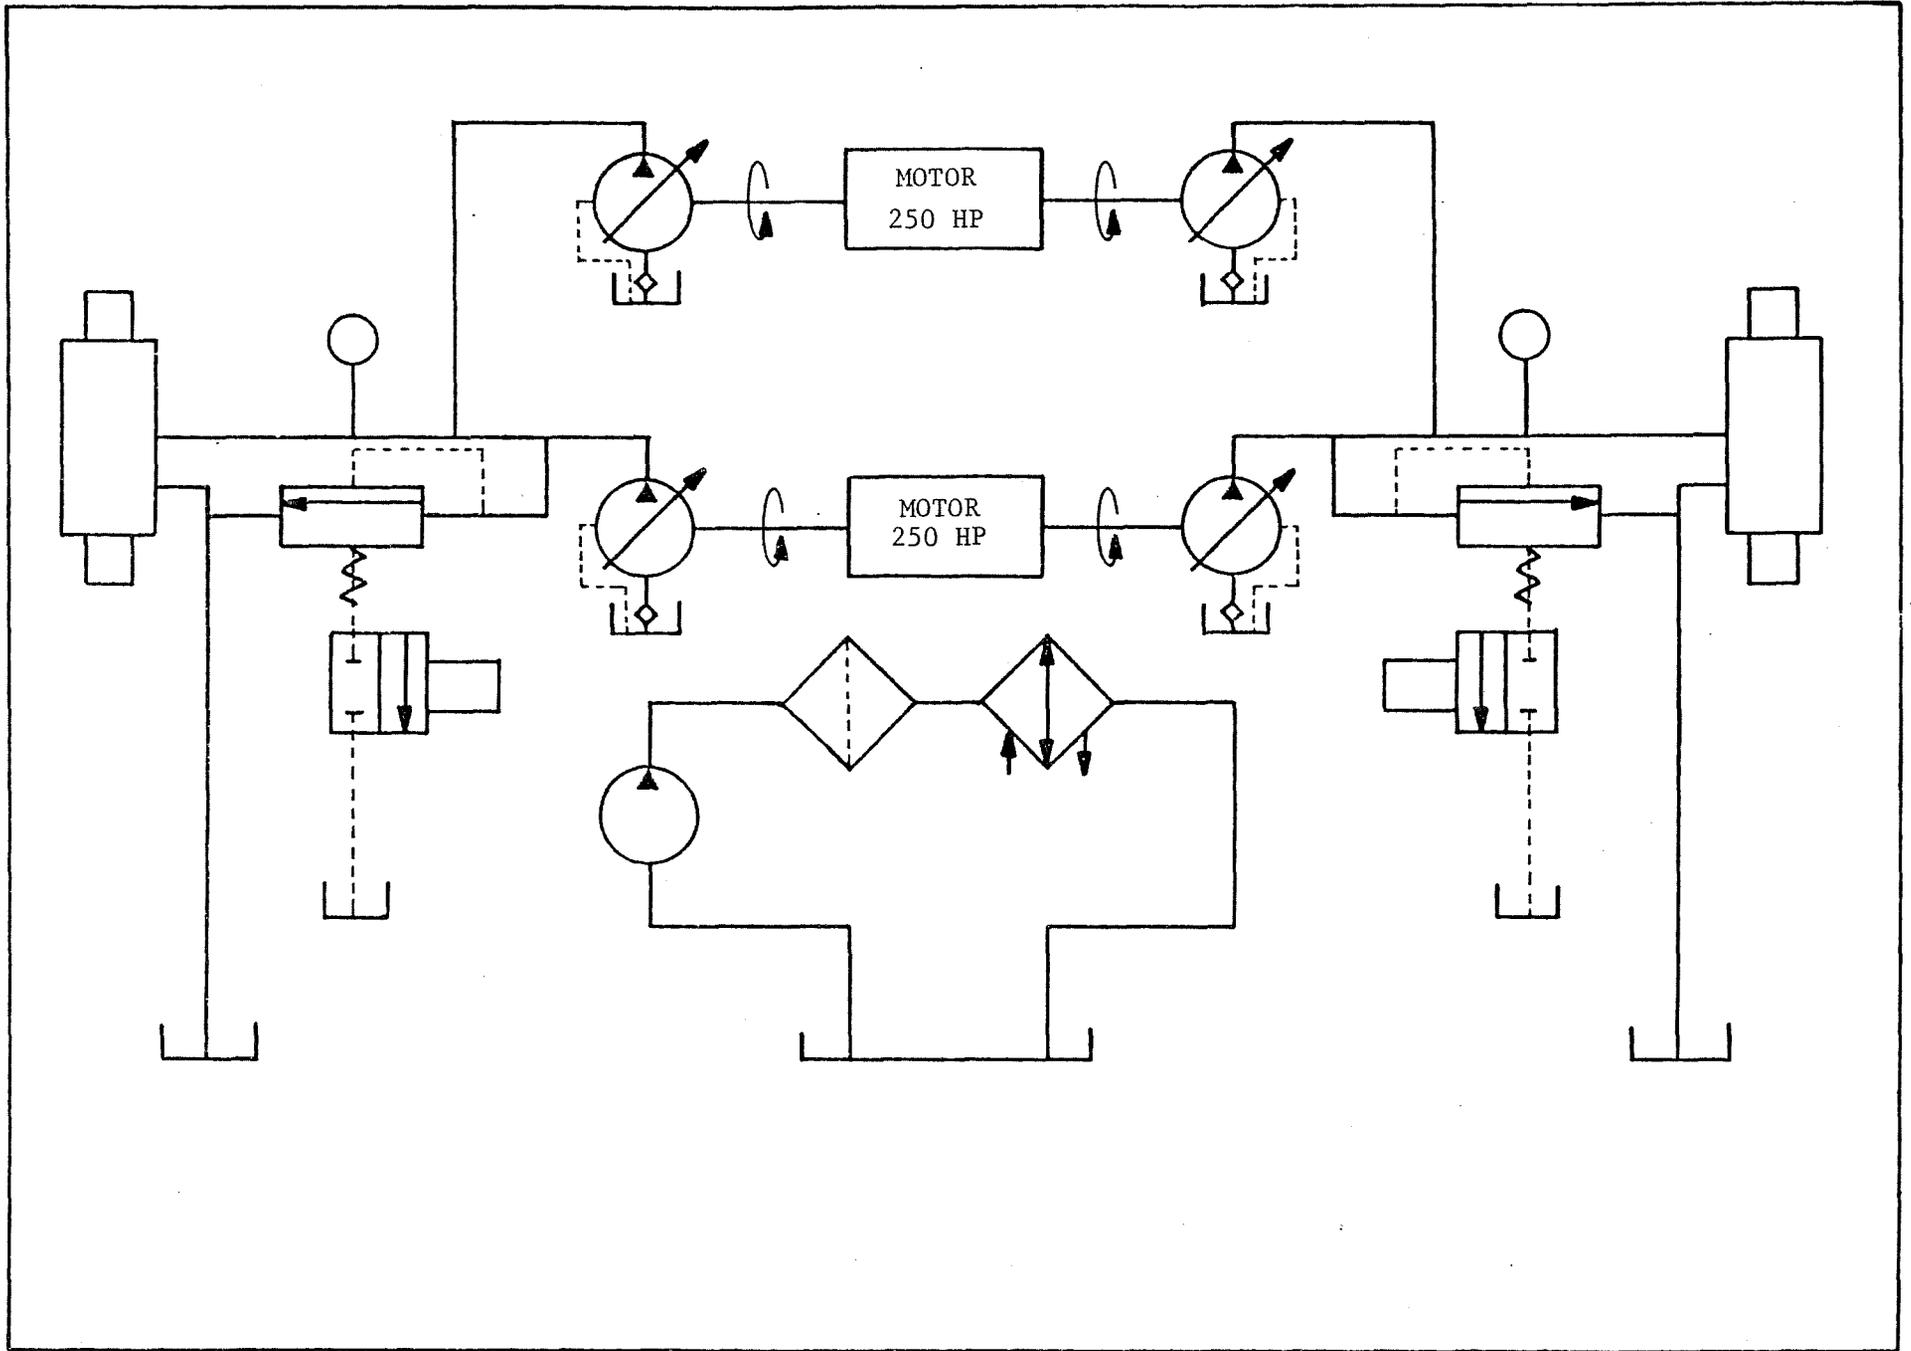
The second circuit, shown in figure 5, was essentially the same as the first except that the cooler and filters were removed from the return line and placed in a separate loop. A larger cooler was installed. A return line from the intensifier was plumbed with solid piping. This was perhaps a mistake, since it was later found that adding compliance to the return line by means of a stand pipe with air in it helped to reduce the water hammer shock upon shifting.

Figure 5 - Circuit 2

With these changes the operational problems were greatly reduced. One skid ran quite well, but the oil in the other skid still tended to overheat during long runs. It was suspected that the pulses in the return line circuit affected the performance of the relief valve so that oil was spilled over the relief causing excess heating. The only remaining problem was the continual leakage from the pipe thread joints.

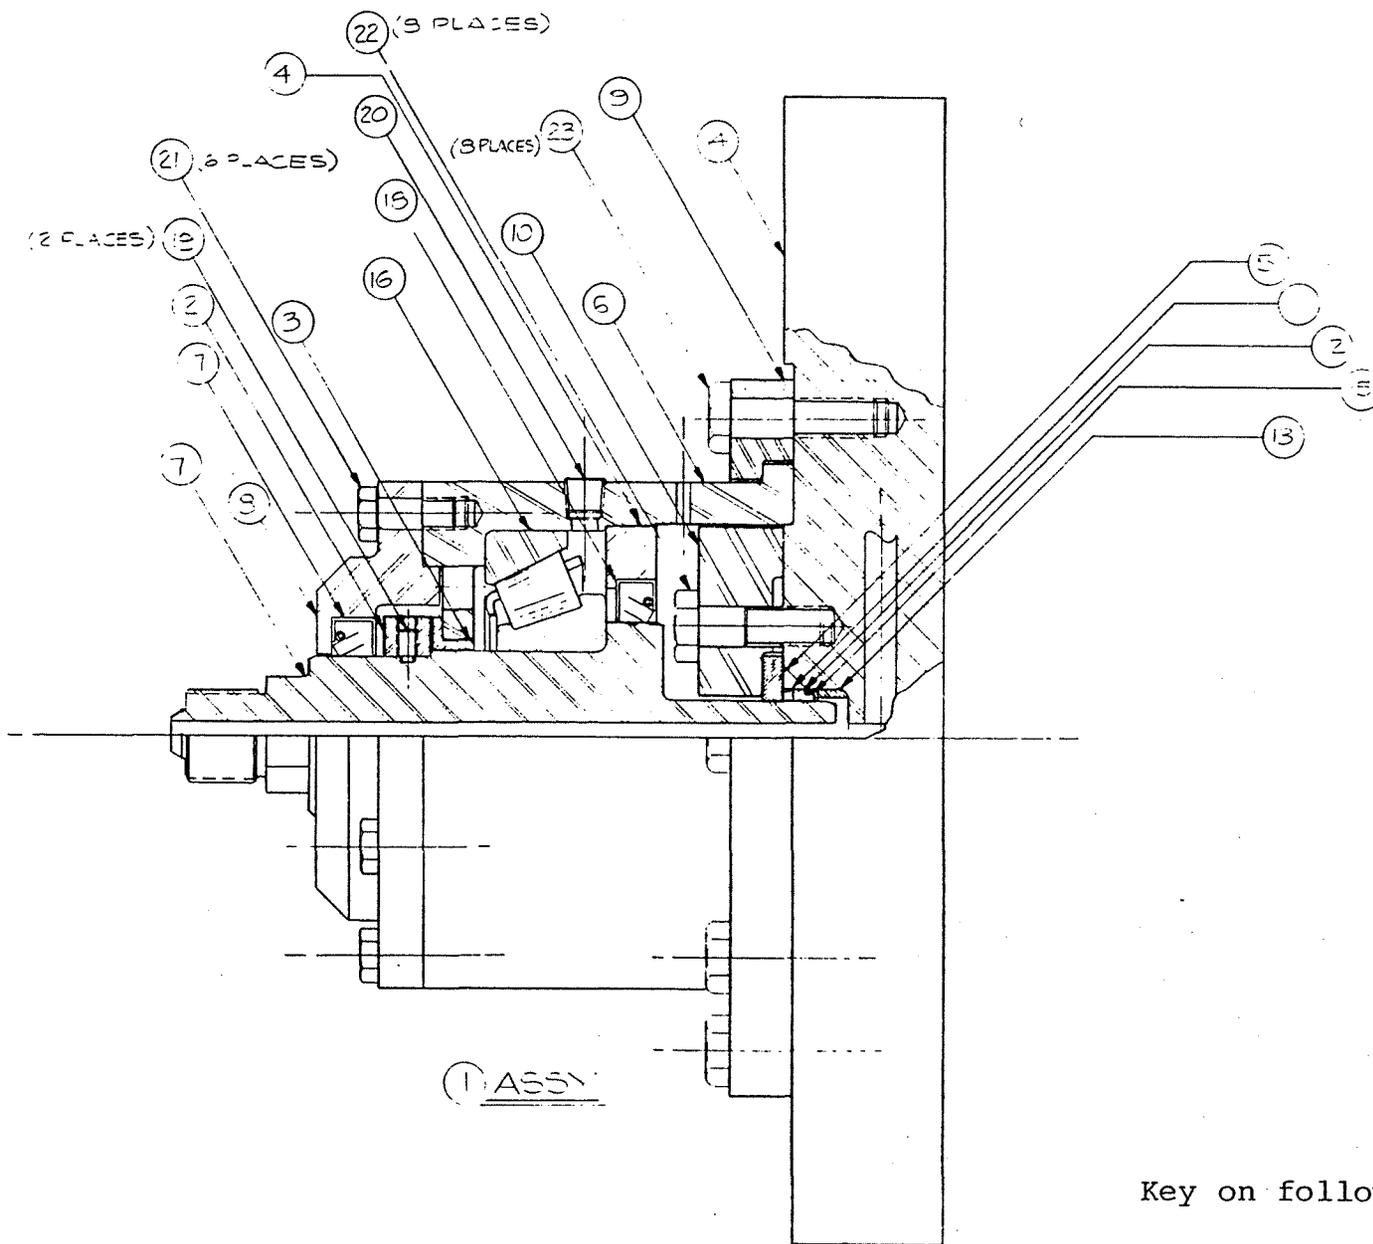
The water from the pumping system is carried by four tubes along the machine to the swivel. The function of the swivel is to carry the water from the stationary tubes to the rotating head. Figure 6 shows a cross section of the high pressure swivel. Part 7 is stationary and most other parts are rotating. The four input lines from the pumps are first manifolded together and then piped through the swivel. On the rotating side, the water again enters a manifold for distribution to the nozzles. The seal, as shown in parts 11, 12, and 15 is the same type of seal as the rod seal in the intensifier and is in fact the same seal used in the small 50 hp industrial intensifiers mentioned earlier.

Figure 6 - High-Pressure Swivel

The shaft that rotates within the seal is made from 15-5 PH heat treated to the H900 condition. In assembly, parts 5, 10, 11, 12, 15, are aligned with an alignment tool before bolts 22 are tightened. The remainder of the swivel is then bolted in place as an assembly. The 20 ton thrust load produced by the pressure acting on the end of shaft 7 is taken by a tapered roller bearing. This bearing is sealed in an oil bath for lubrication. A vent-hole is provided to prevent leakage from the high pressure water seal forcing its way past the oil seal into the oil chamber. No problems whatsoever were encountered with this swivel. In fact the seal was never changed during the whole experimental program. The swivel is shown mounted on the rear of the cutterhead in Figure 7.

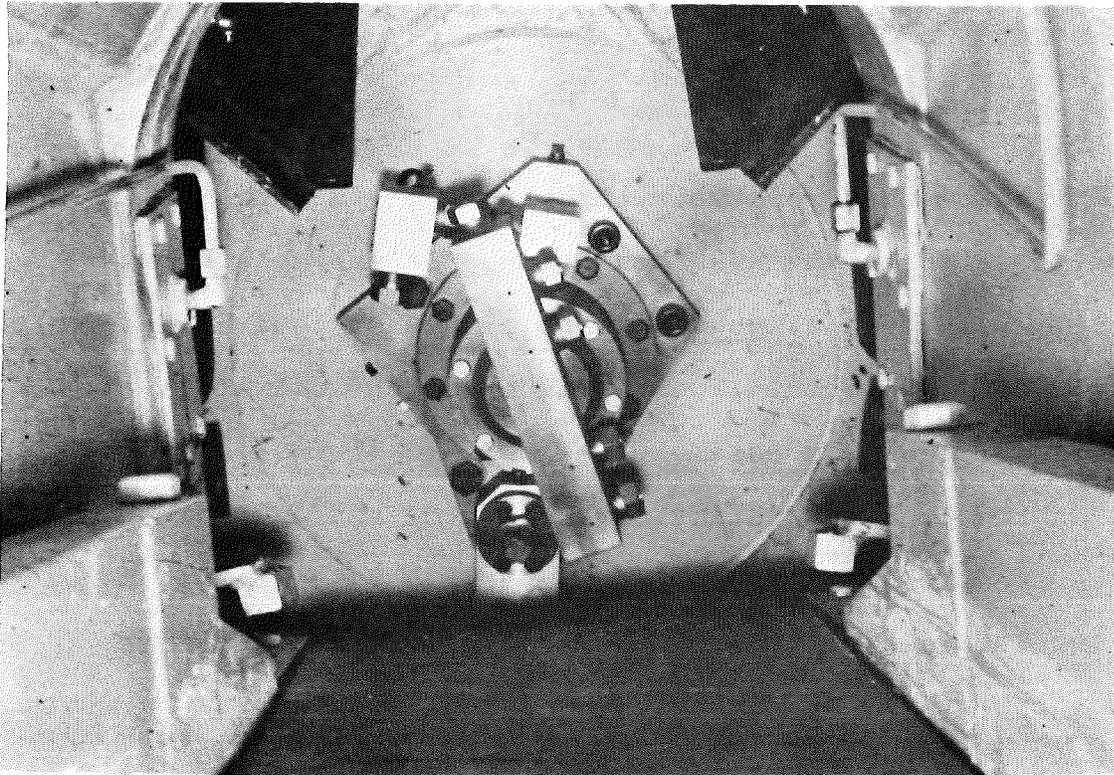
Figure 7 - High-Pressure Swivel Mounted
to the Back of the Cutterhead

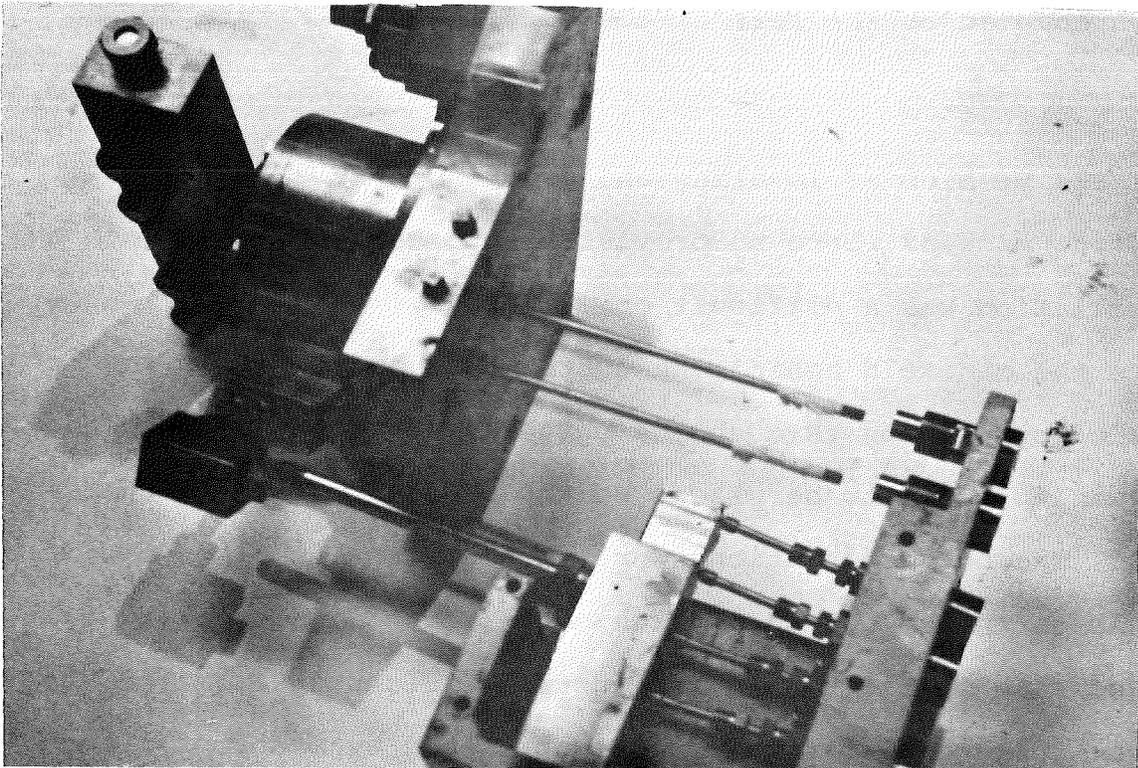
Figure 8 - Relationship of Swivel to Small Manifold

the swivel was mounted. The two center nozzles were plumbed through holes drilled in the cutter housings and tied directly to this main manifold. Going out along a radius the next five nozzles were plumbed in a separate manifold on the front face of the cutter head. This manifold was tied to the main swivel manifold with a standard high pressure tubing connection using 9/16 diameter tube. A view showing the matching of this small manifold with the swivel is given in Figure 8. The remaining nozzles were plumbed to a large manifold that ran along the radius for a distance of 34.5". The connection between this manifold and the main manifold at the swivel was made very difficult because of space restrictions. The flow rate required was too large to carry in a single 9/16 tube and no space was available for multiple tubes. No commercial fittings for this large size were available. In addition, there was some question as to the alignment accuracy required to connect the two manifolds using short lengths of large diameter tube. The connection was accomplished with the floating link arrangement shown in figure 9. Large pins were fabricated from 17-4 PH and sealed to the two manifolds with a cone and thread type of seal. The pins were then joined by a length which was sealed by O-rings backed up with chamfered metal rings. There was a leakage problem with these seals, and they had to be replaced several times during the course of the experiments. If this link design is required in another installation, it is recommended that the seals used

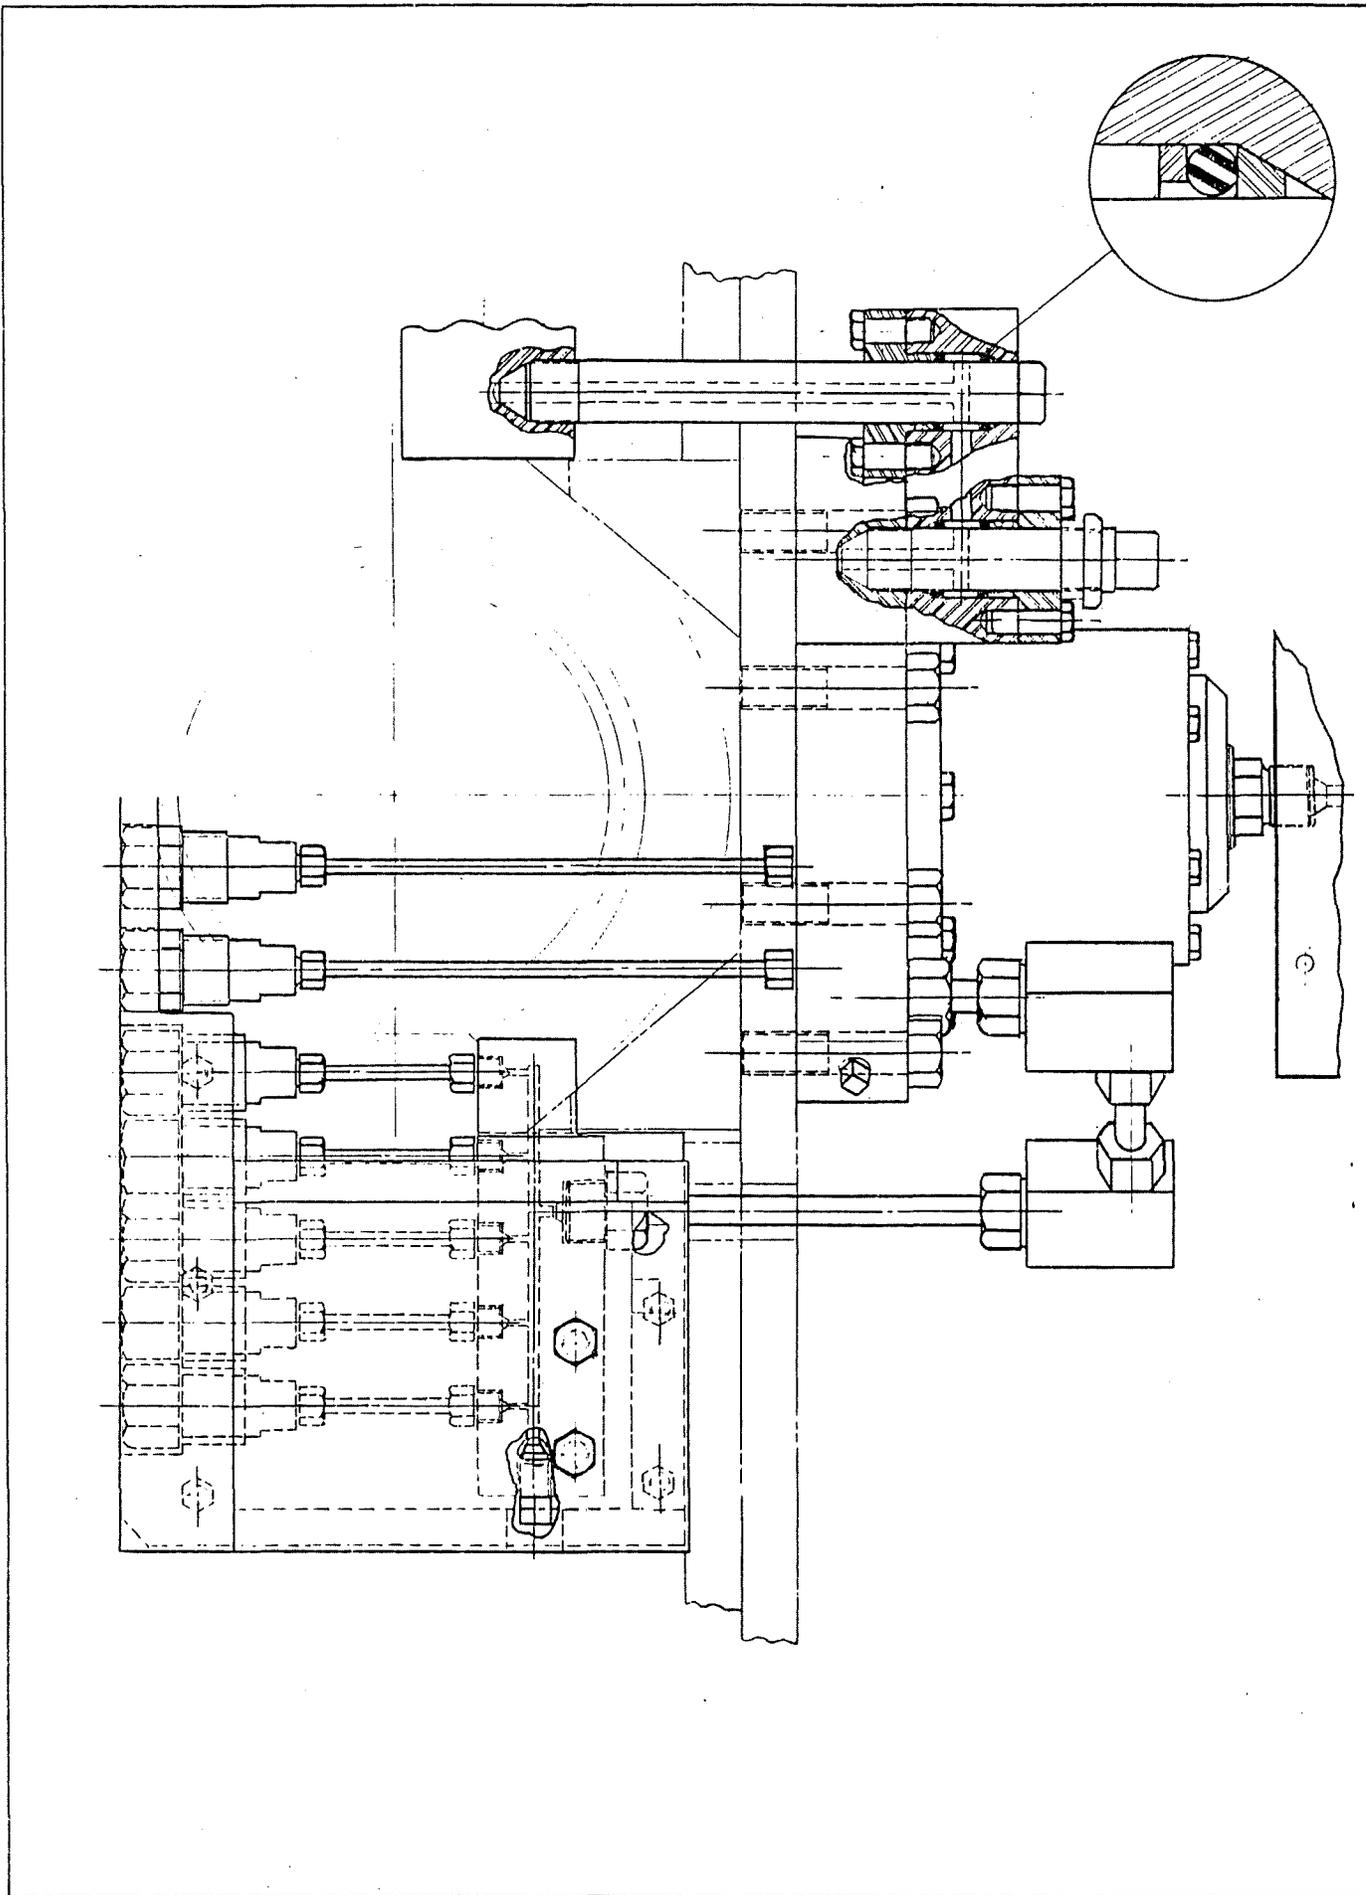
Scale 1:3.6

Figure 9 - Assembly of Swivel, Inner Manifold, and Link to Outer Manifold

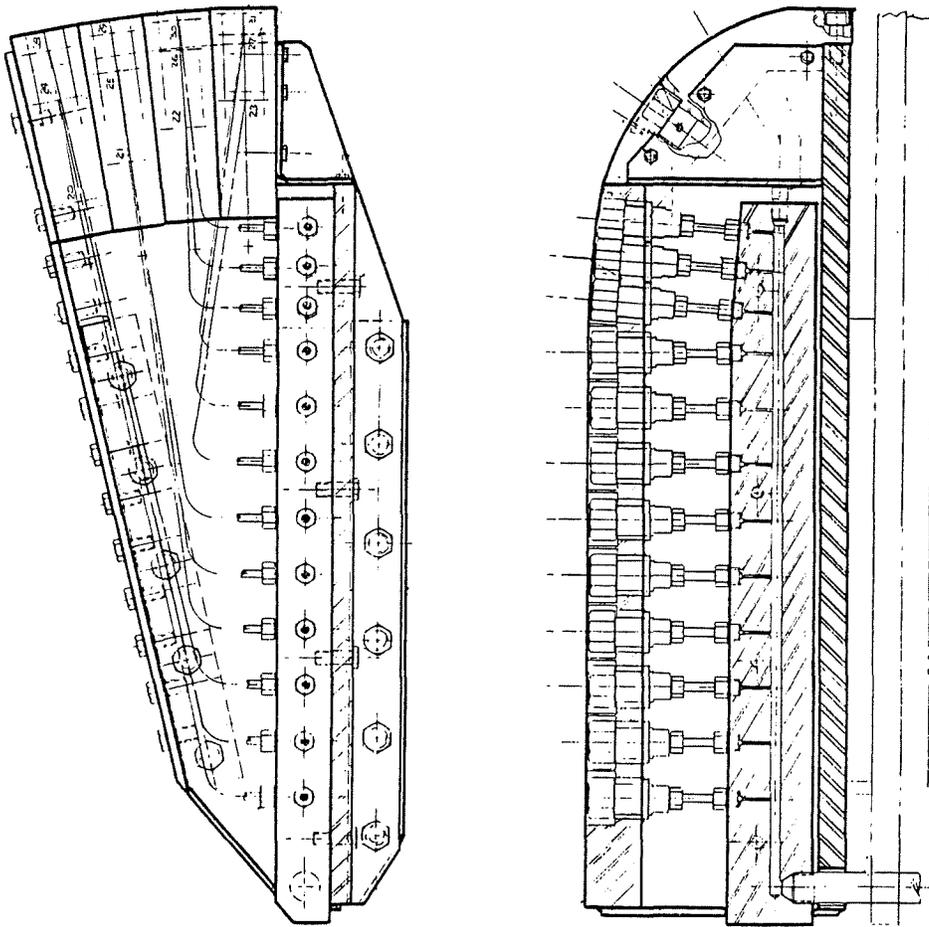
Scale 1:6.5

Figure 10 - Outer Manifold

The manifold on the outer radius is a rectangular block of 17-4 PH with a long through hole gun drilled into it. All the outer nozzles were then plumbed into this manifold using 1/4" tubing and standard cone and thread tube fittings. Figure 10 shows the connection between the nozzles and the manifold as well as the protective shield covering the manifold. The nozzles could be moved slightly by bending the quarter inch tube. In this manner, the nozzles were adjusted to their final exact position and locked in place with set screws and shims driven between the nozzles and the protective shield. Views of the assembled manifolds are provided in Figures 11 through 15.

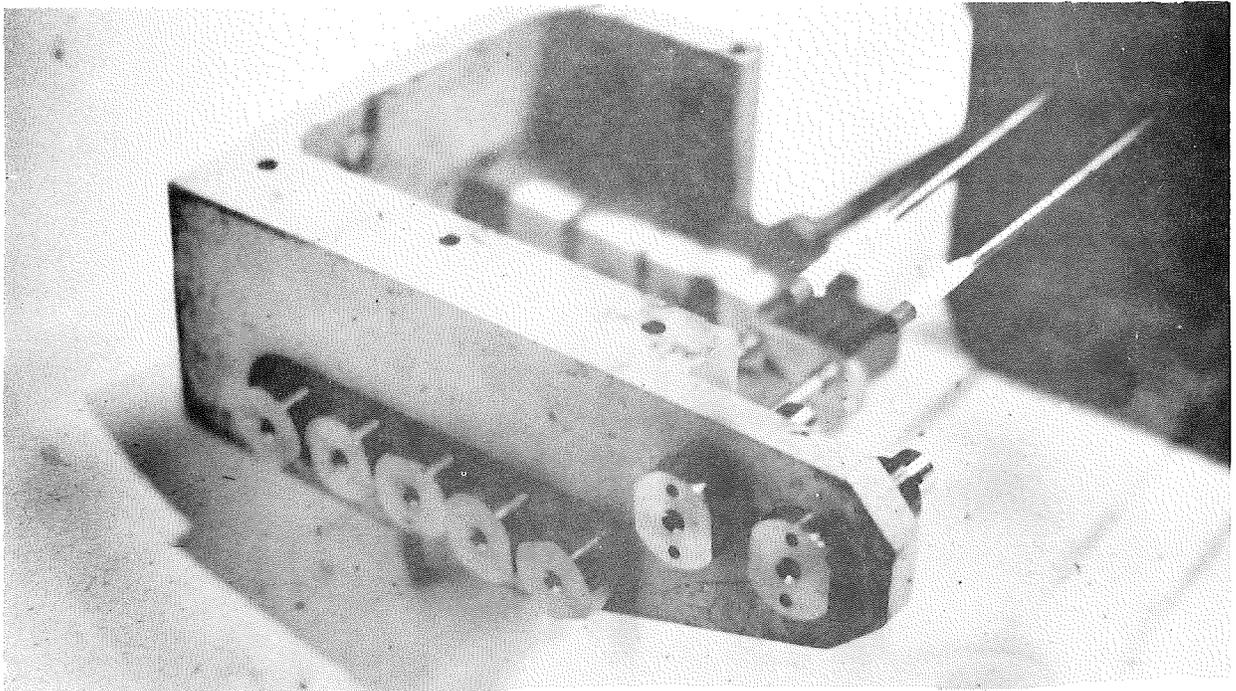
Figure 11 - Front View of Small Manifold approx. $\frac{1}{4}$ scale

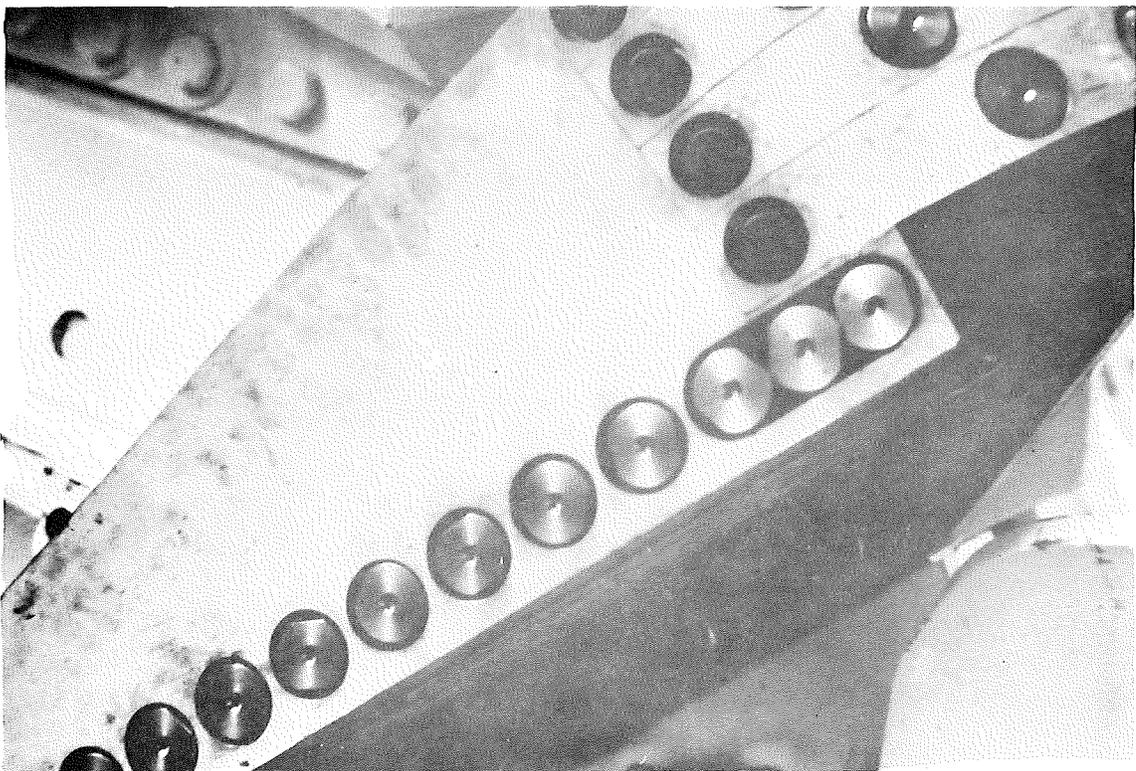
Figure 12 - View Showing Arrangement of Nozzles 8 through 19 on Large Manifold approx. $\frac{1}{4}$ scale

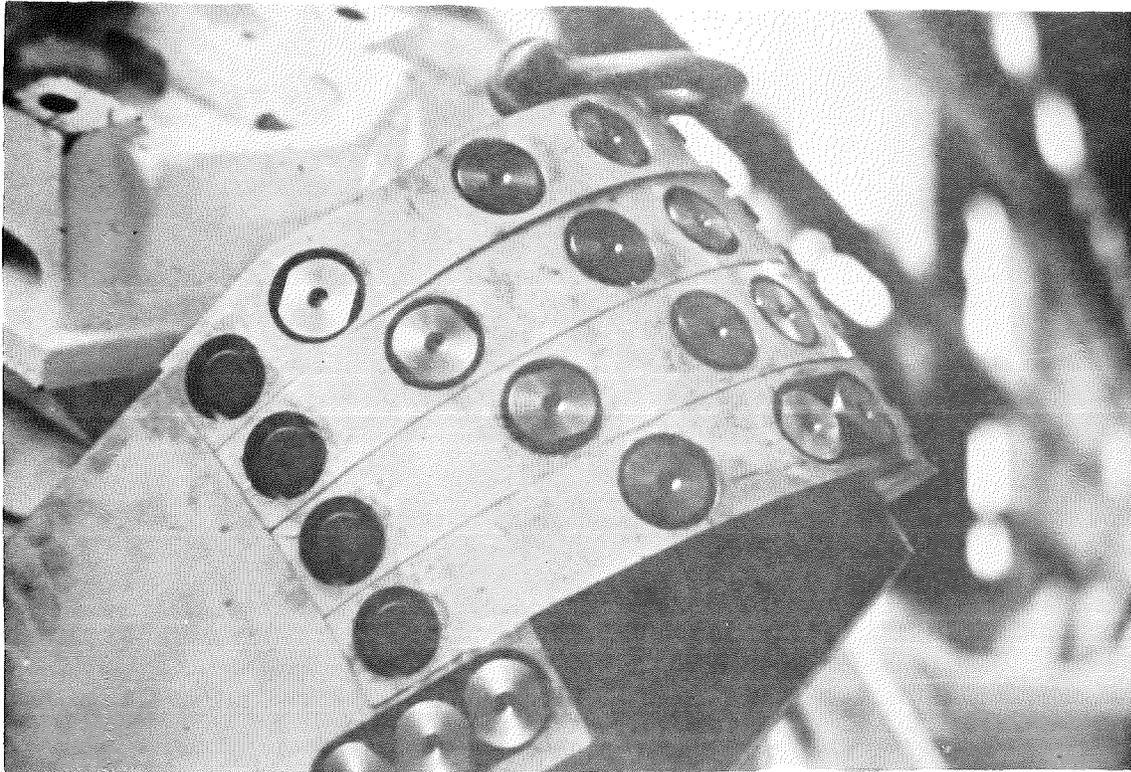
Figure 13 - View Showing Nozzles for the Curved Section of Tunnel Face at the Gauge approx. $\frac{1}{5}$ scale

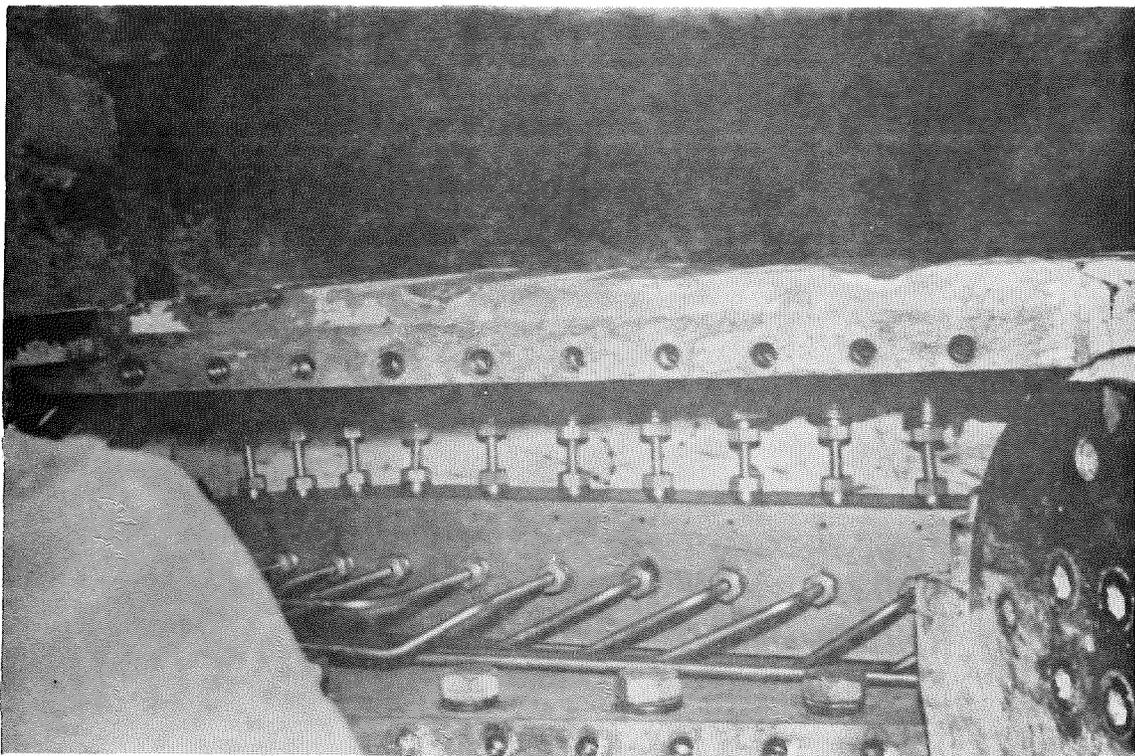
Figure 14 - View Inside Manifold Showing $\frac{1}{4}$ " Tubing Supplying Individual Nozzles approx. $\frac{1}{5}$ scale

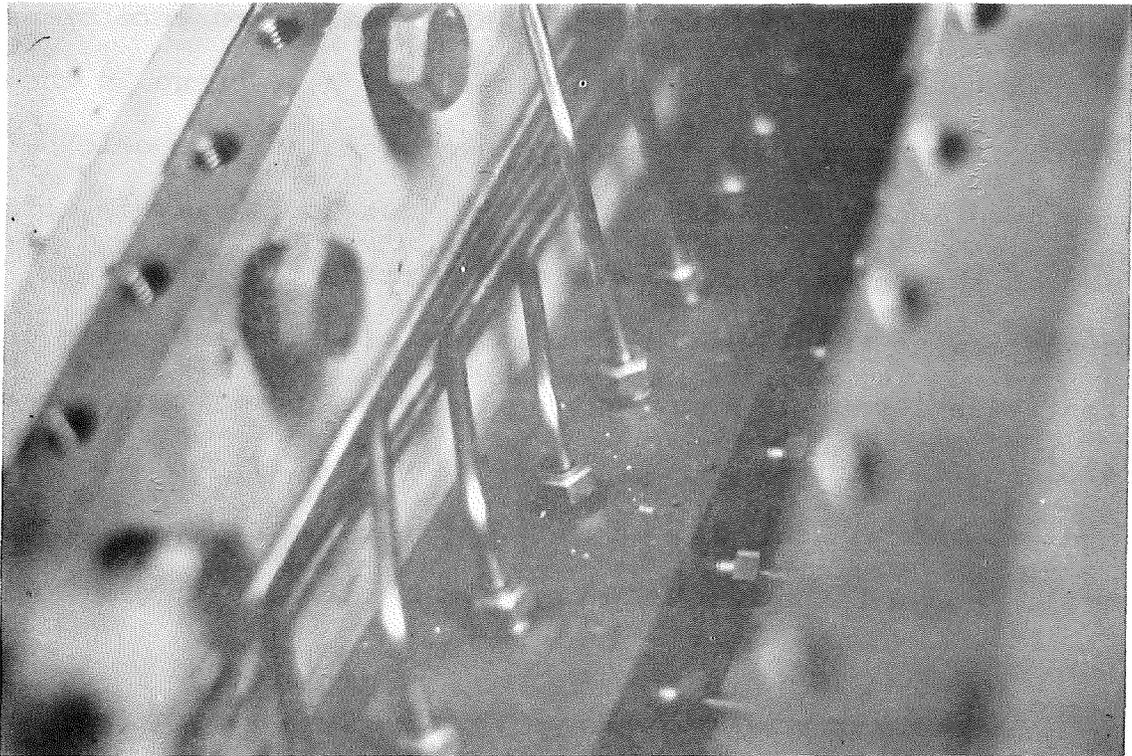
approx. $\frac{1}{2}$ scale

Figure 15 - Close-up of Connections to
Main Block Inside Manifold
