DEVELOPMENT OF HIGH-PRESSURE
WATER JET EQUIPMENT FOR UNDERGROUND
APPLICATION OF EXCAVATING ENERGY MINERALS

UNITED STATES DEPARTMENT OF THE INTERIOR
BUREAU OF MINES

Russell J. Miller and Fun-Den Wang
Excavation Engineering and Earth Mechanics Institute
Colorado School of Mines, Golden, Colorado 80401

FINAL REPORT

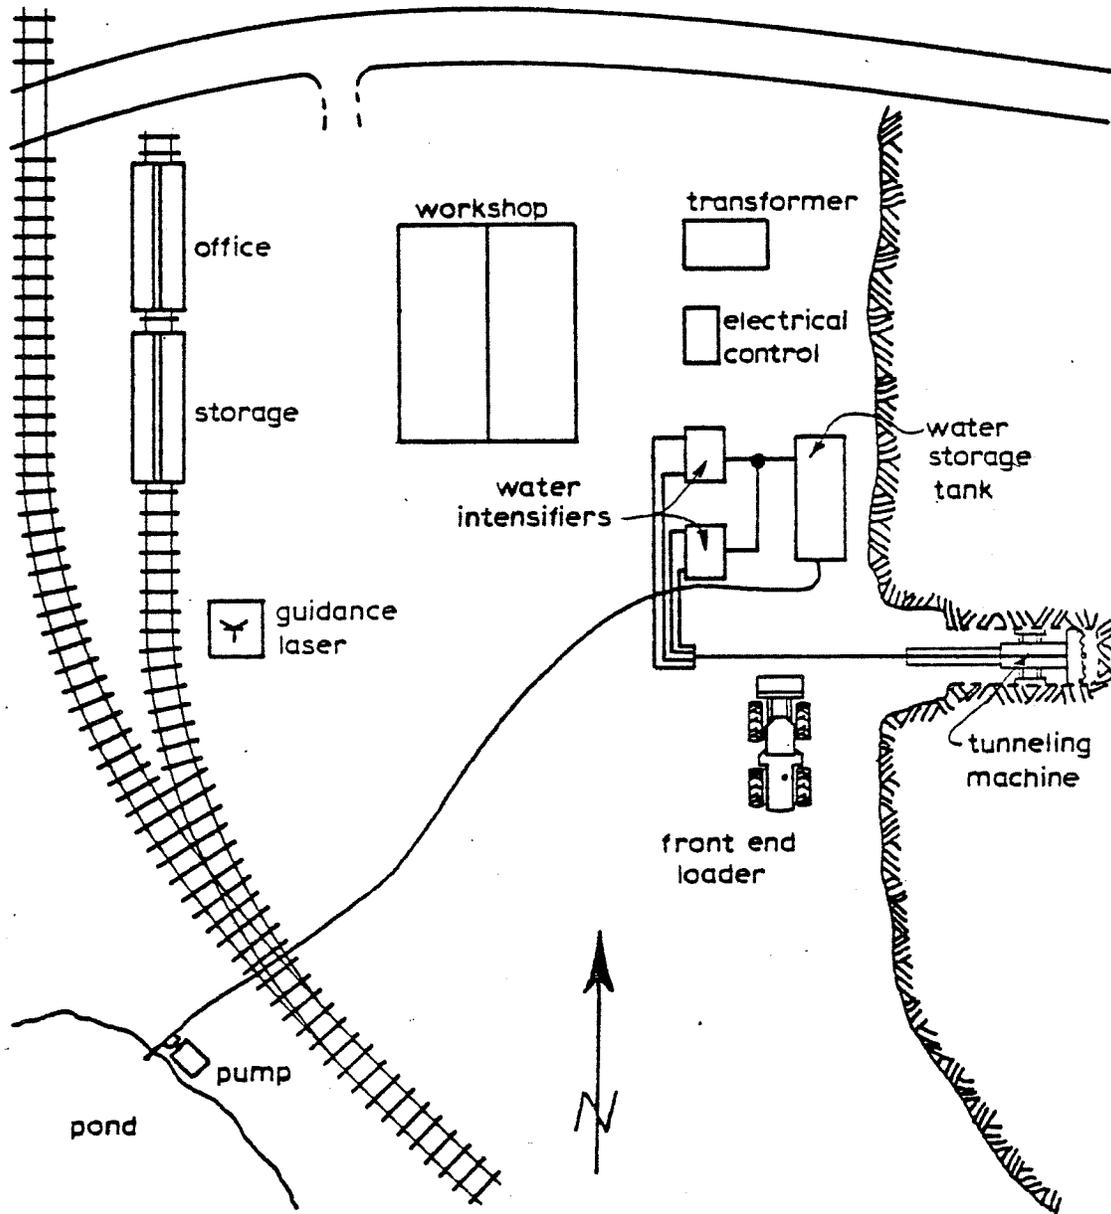
Figure 16 - Representation of Field Test Site Layout

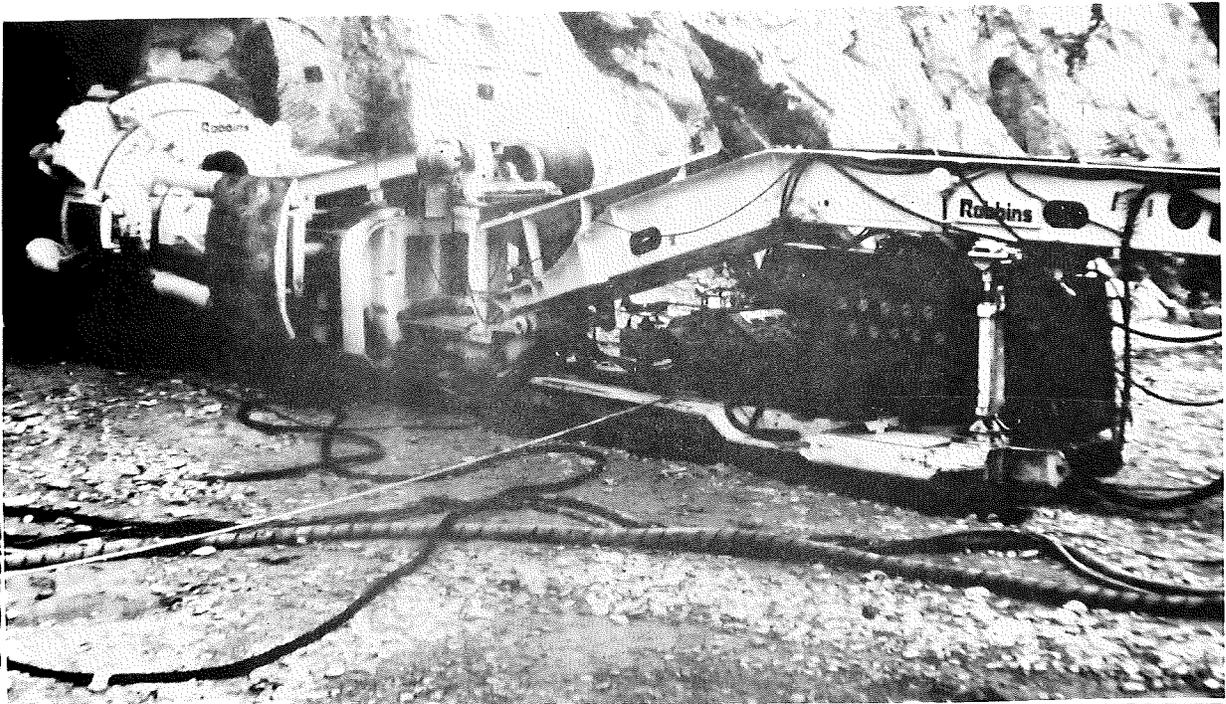
Figure 17 - The Tunnel Boring Machine Outside
the Portal at the Field Test Site

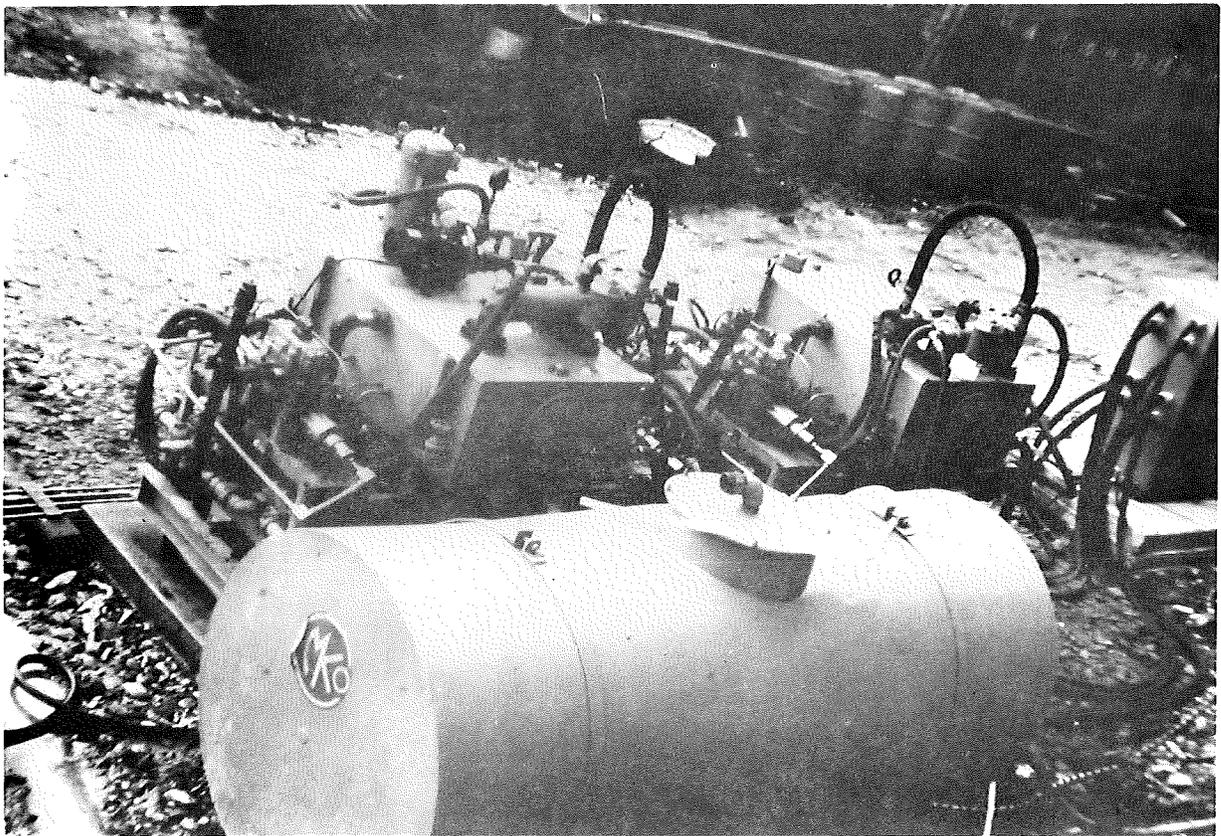
Figure 18 - View of the Intensifier Packages
and Water Storage Tank

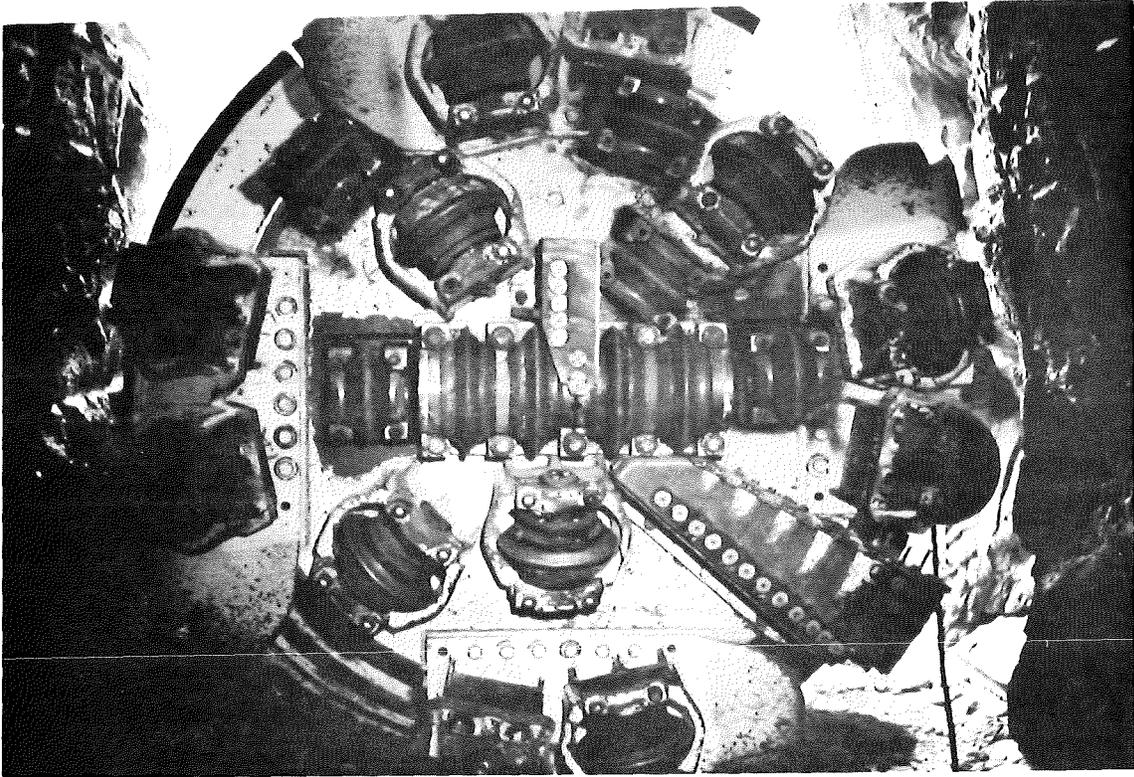
Figure 19 - The Cutterhead as Seen From Inside the Bore

The boring machine was placed inside the blasted section of tunnel and the grippers thrust against the sides of tunnel using timber spacers to distribute the load and improve the grip. The cutterhead was then advanced into the virgin tunnel face. There was some jumping of the machine as it started to cut the uneven face, and it was difficult to maintain an adequate grip. Some of the consequences of this early boring are evidenced in Figure 21. Finally, things quieted down as the cutterhead began cutting a full face. There were still problems gripping the uneven walls of the blasted section of tunnel. Therefore, boring was continued until the grippers were in machine bored tunnel. Figure 22 shows the boring machine in operation early in the bore. Note the muck coming off the trailing conveyor.

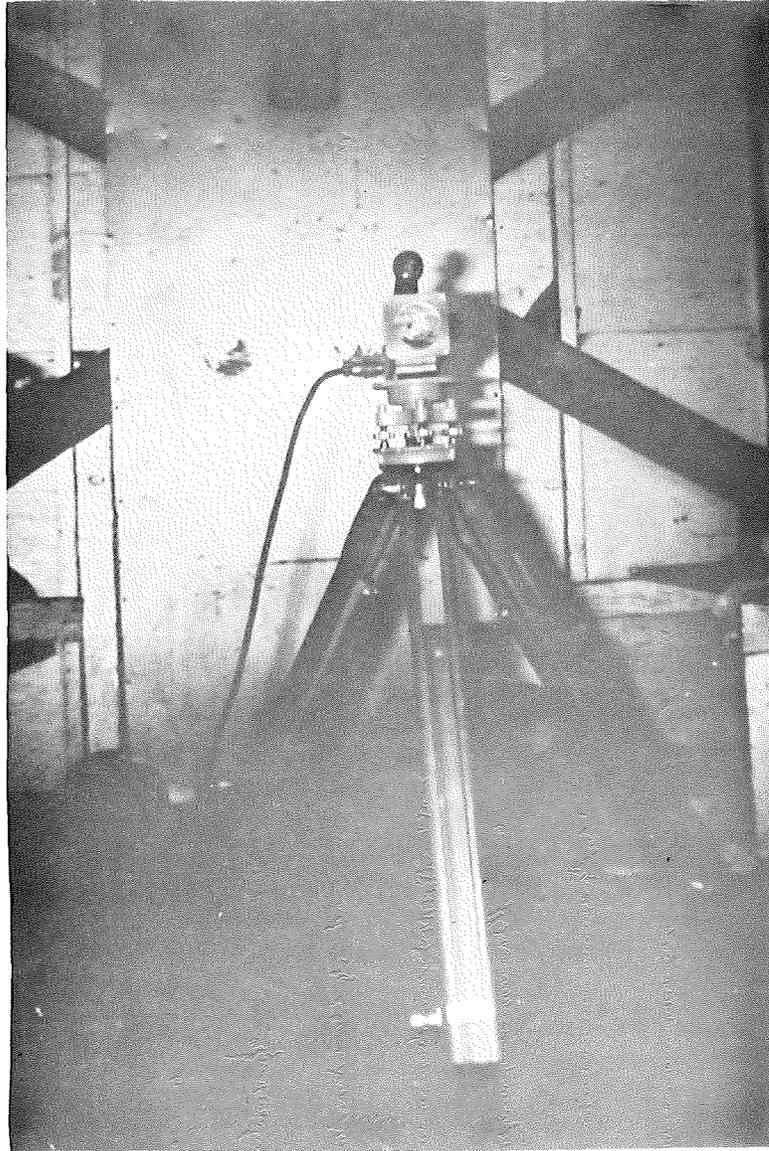
Figure 20 - The Tripod Mounted Laser Used
for Maintaining Line and Grade

from a holding pond and filling a 500 gallon tank near the intensifiers. The water was then run through a two-stage filtering process before supplying the intensifiers. Boring machine alignment was controlled by a tripod mounted laser approximately 150 feet behind the TBM.

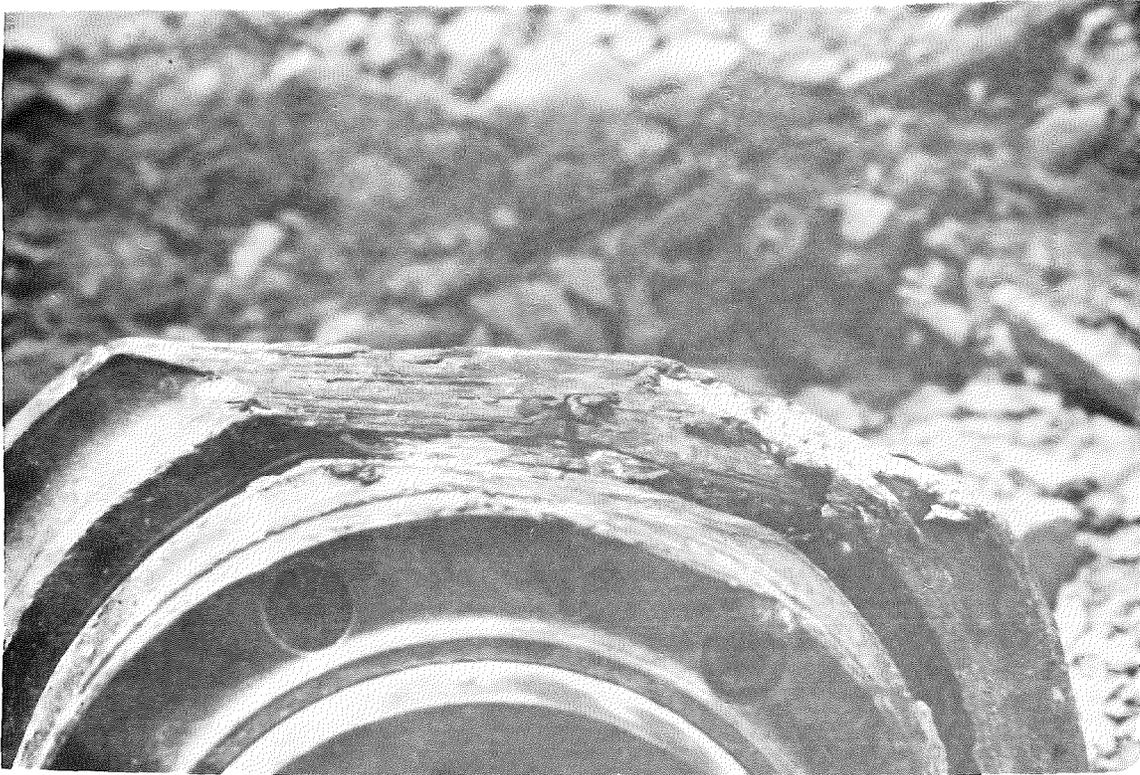
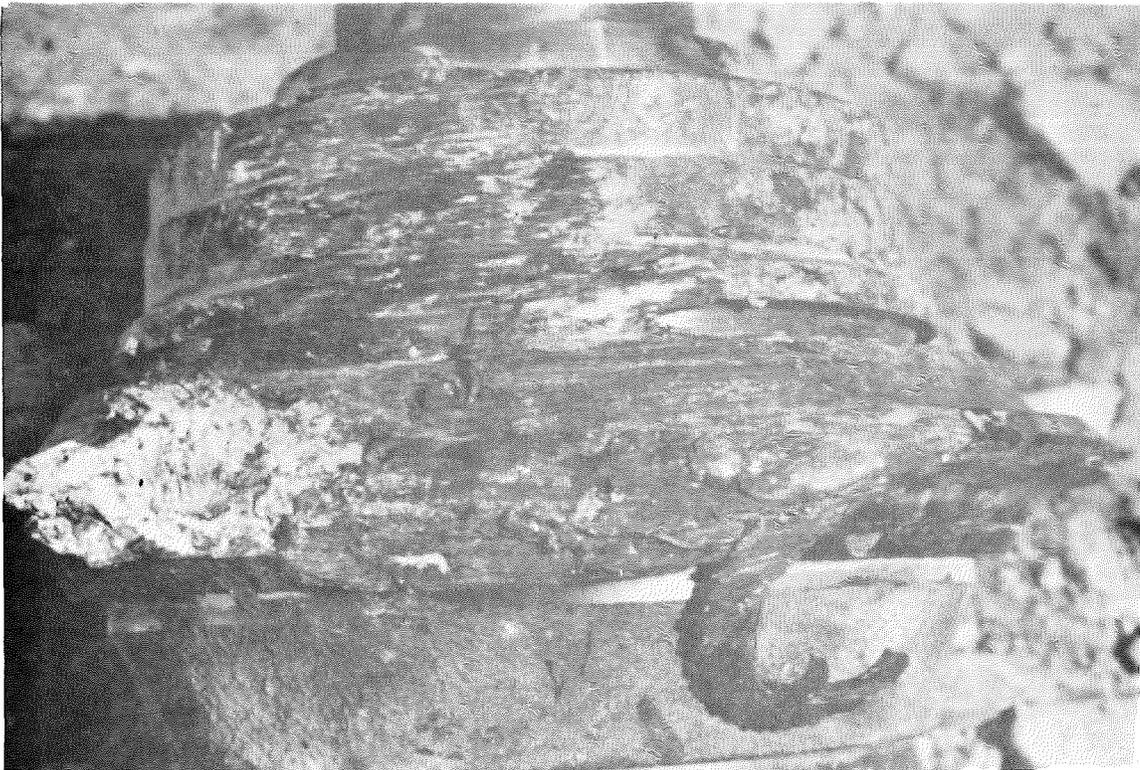
Figure 21 - Cutter Damaged in Early Boring

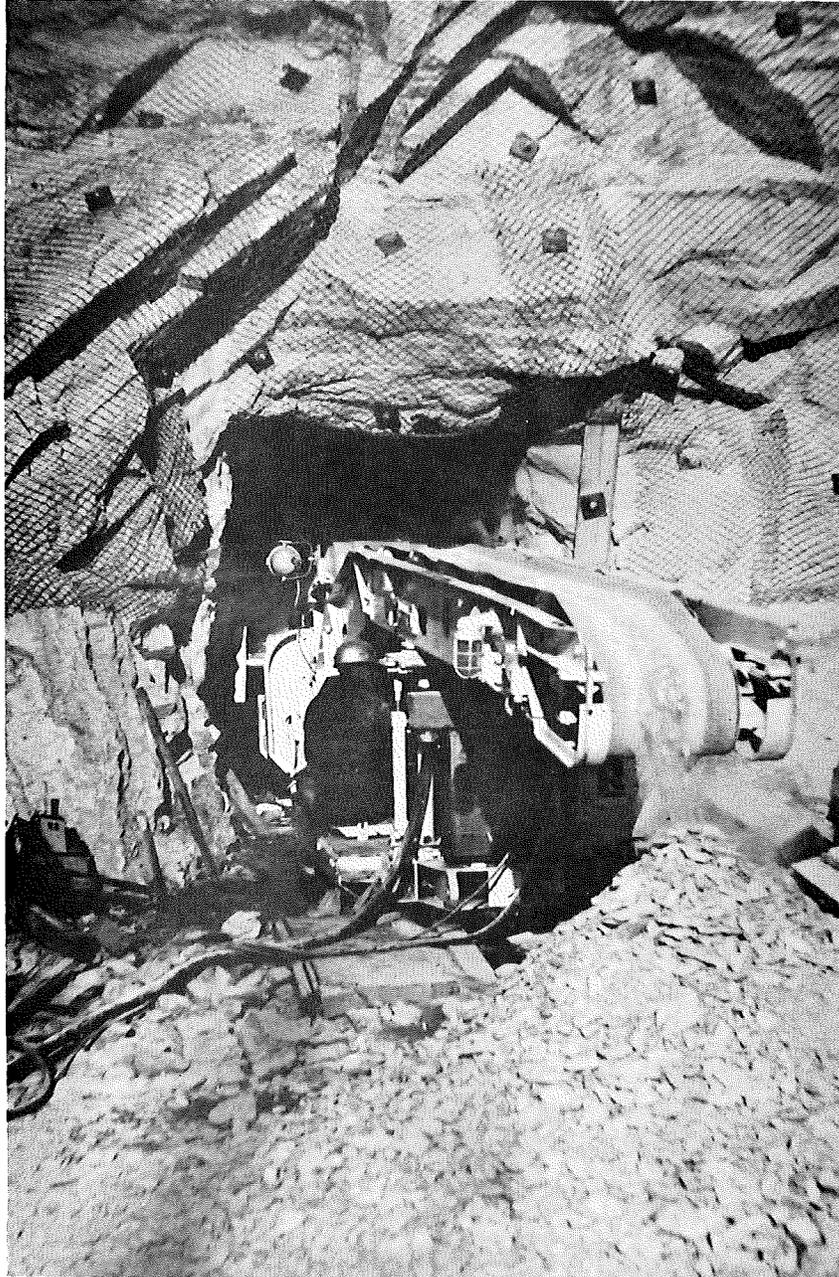
note operator for scale

Figure 22 - Starting the Machine Bored Tunnel

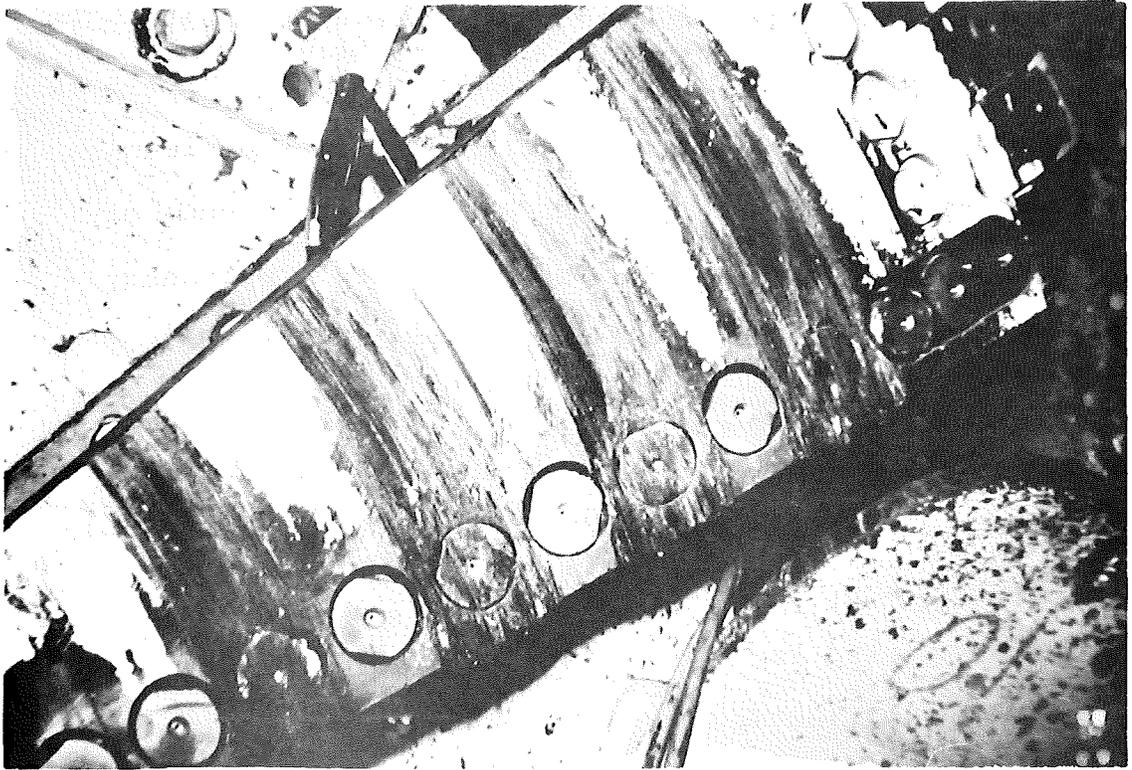
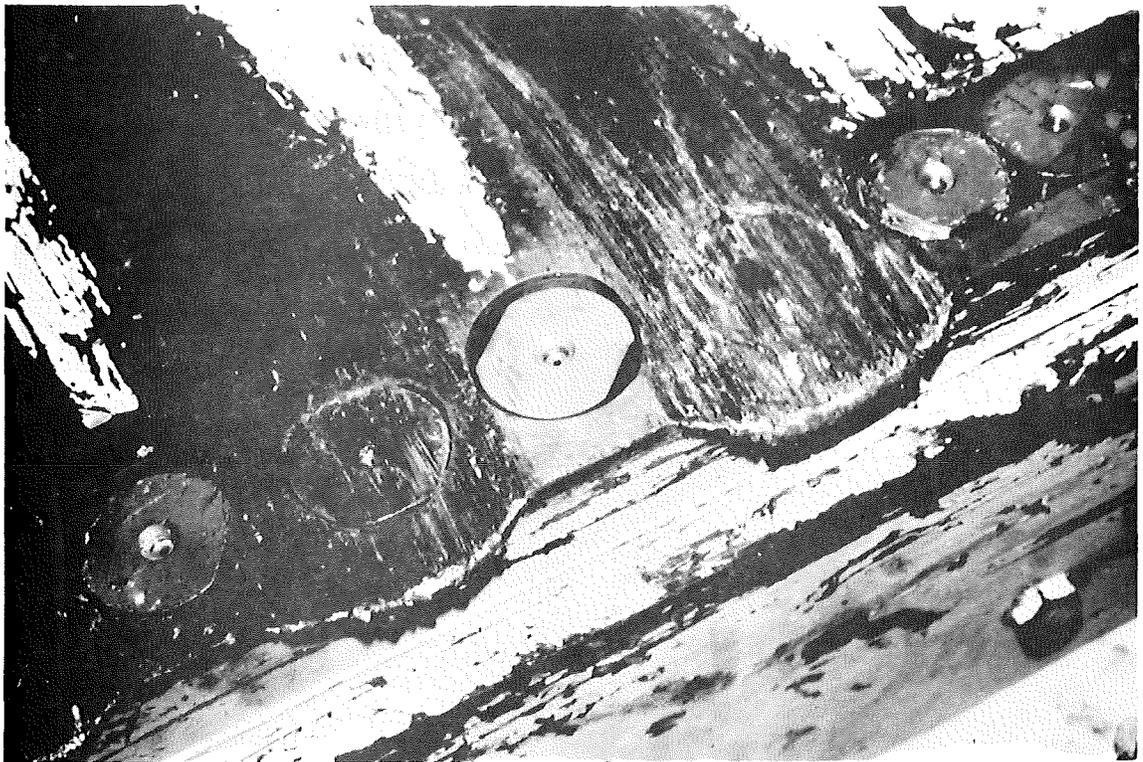
The manifolds survived remarkably well considering their exposed position on the cutterhead. One-inch standoff of the jets was found to be too close (see Figure 23) due to the high ridges between cutter paths resulting from the wide cutter spacing used. When smaller protective cutters were installed to operate in the area of wide spacings, the manifold was successfully returned to one-inch standoff.

Figure 23 - Damage Caused by High Ridges Between Cutters

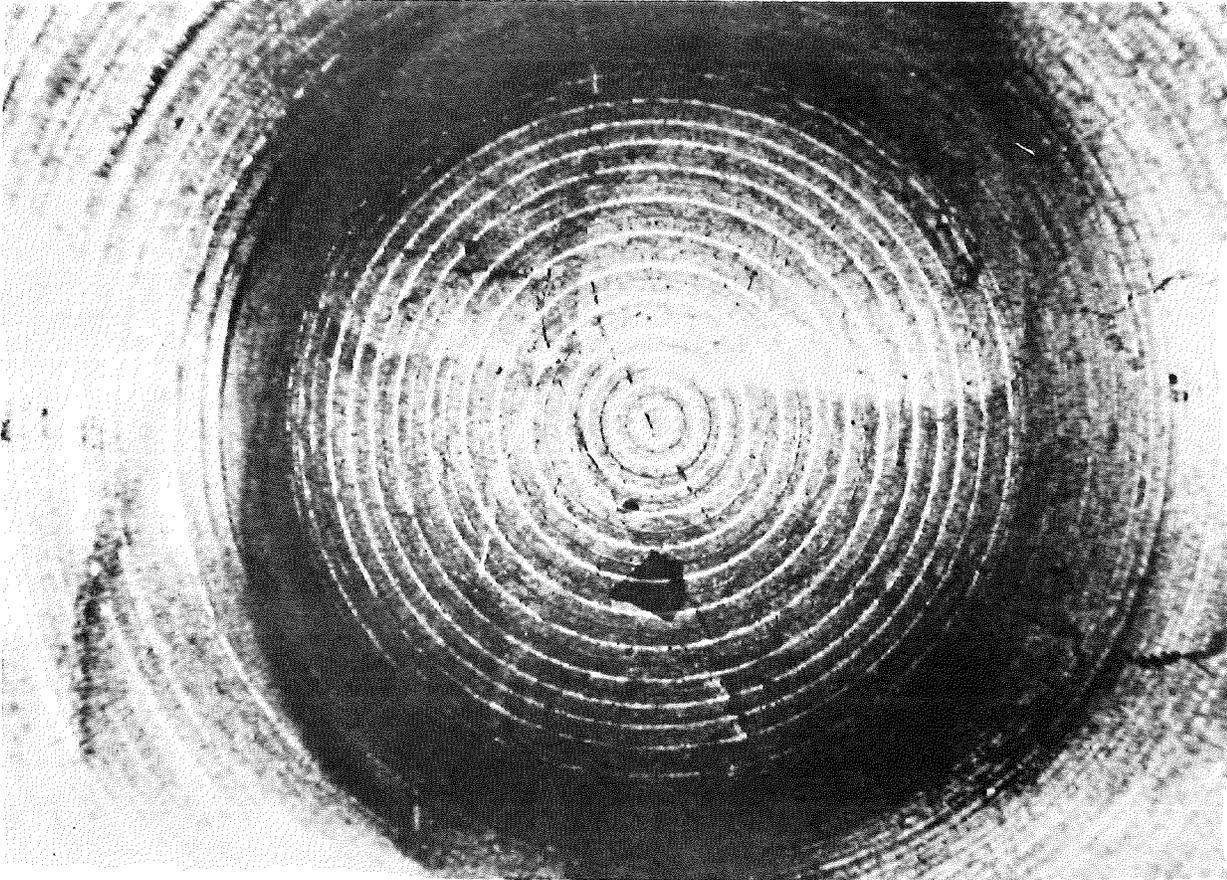
approx. 1:21 scale

Figure 24 - Tunnel Face Showing Planes of Weakness
and a Large Inclusion at Lower Center

Thrust was found to have a significant effect on penetration rate both for the mechanical and water jet assisted boring. Wide variations in boring performance were, however, observed at any given thrust. These variations are expected since such factors as rock strength, presence of planes of weakness, and variations in machine performance will affect the penetration rate for each test. Some of the changing rock conditions are illustrated in Figures 24 and 25.

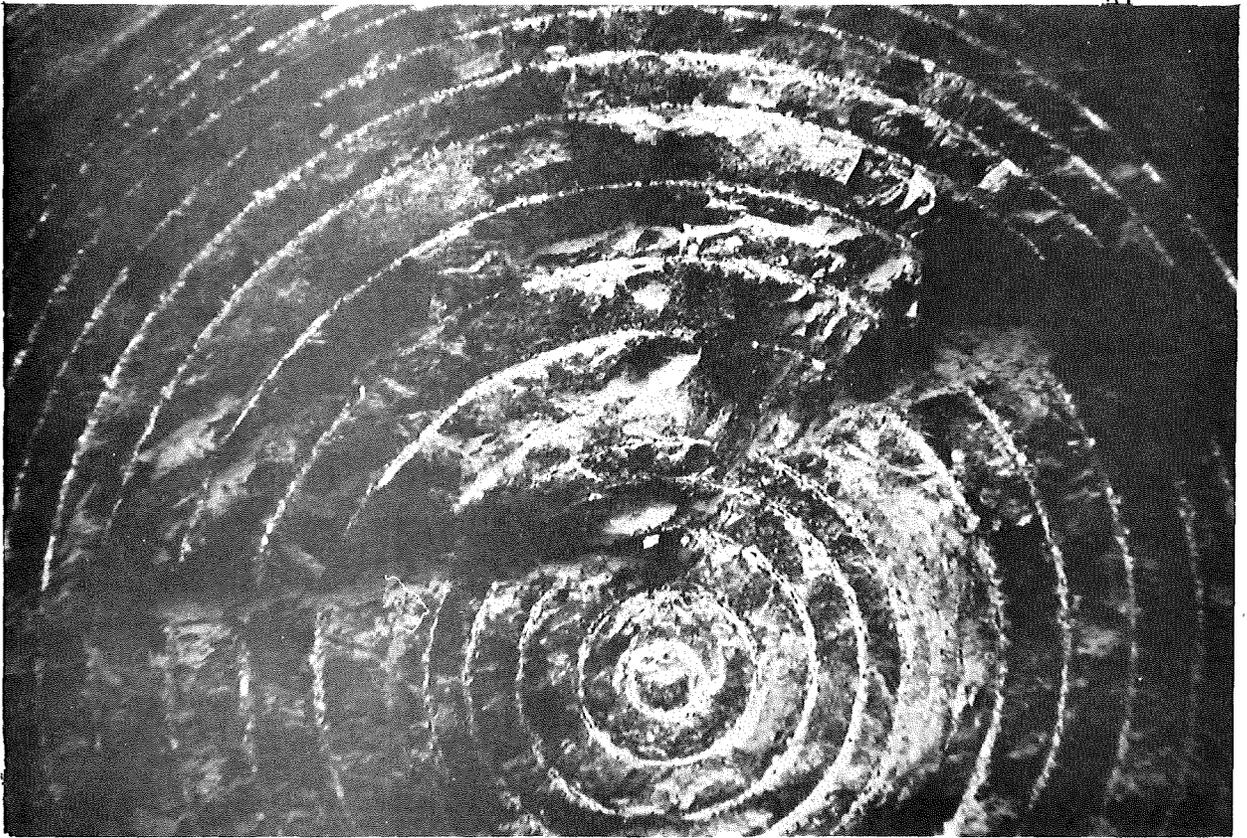
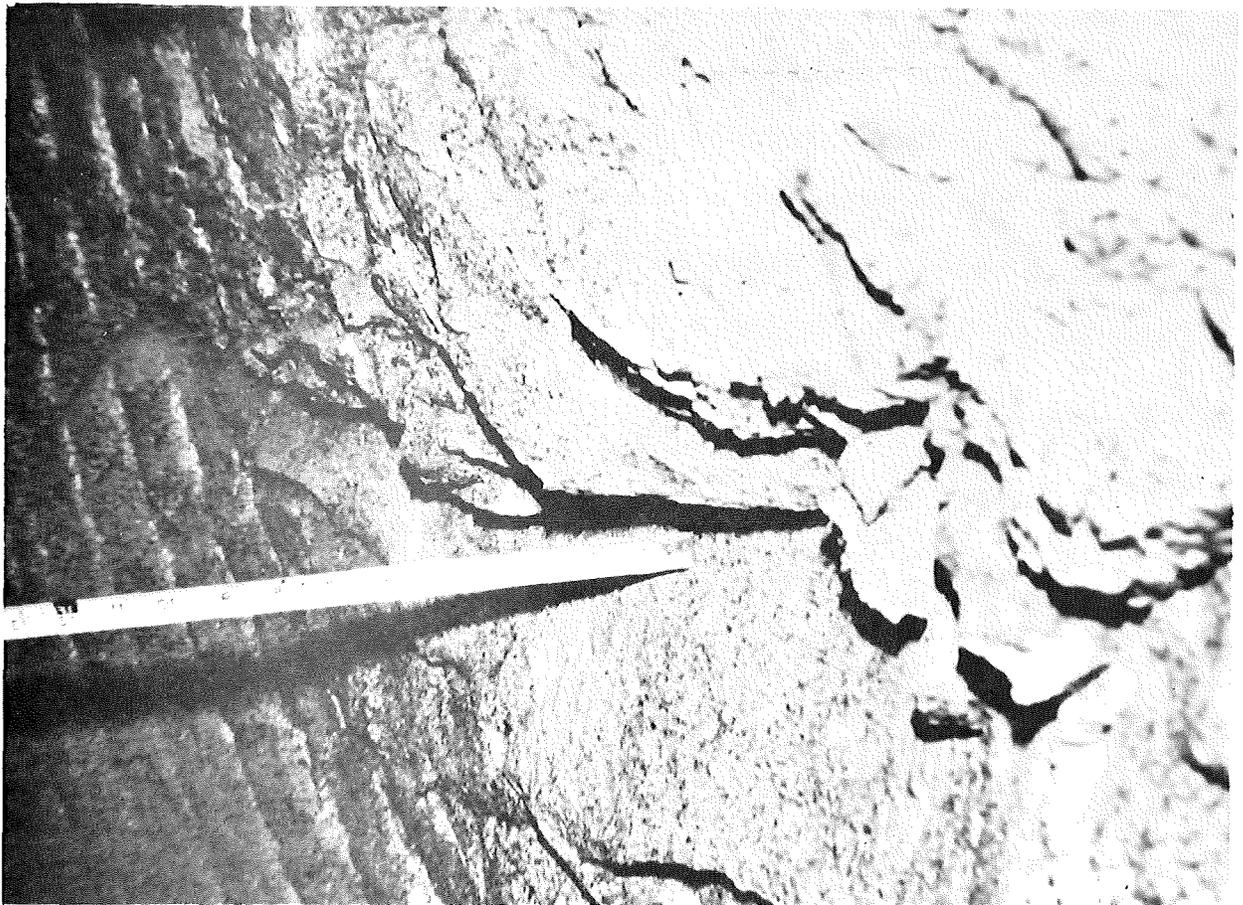
APPROX 1/2 SCALE

Figure 25 - One of the More Severe Zones of Fractured Rock Encountered

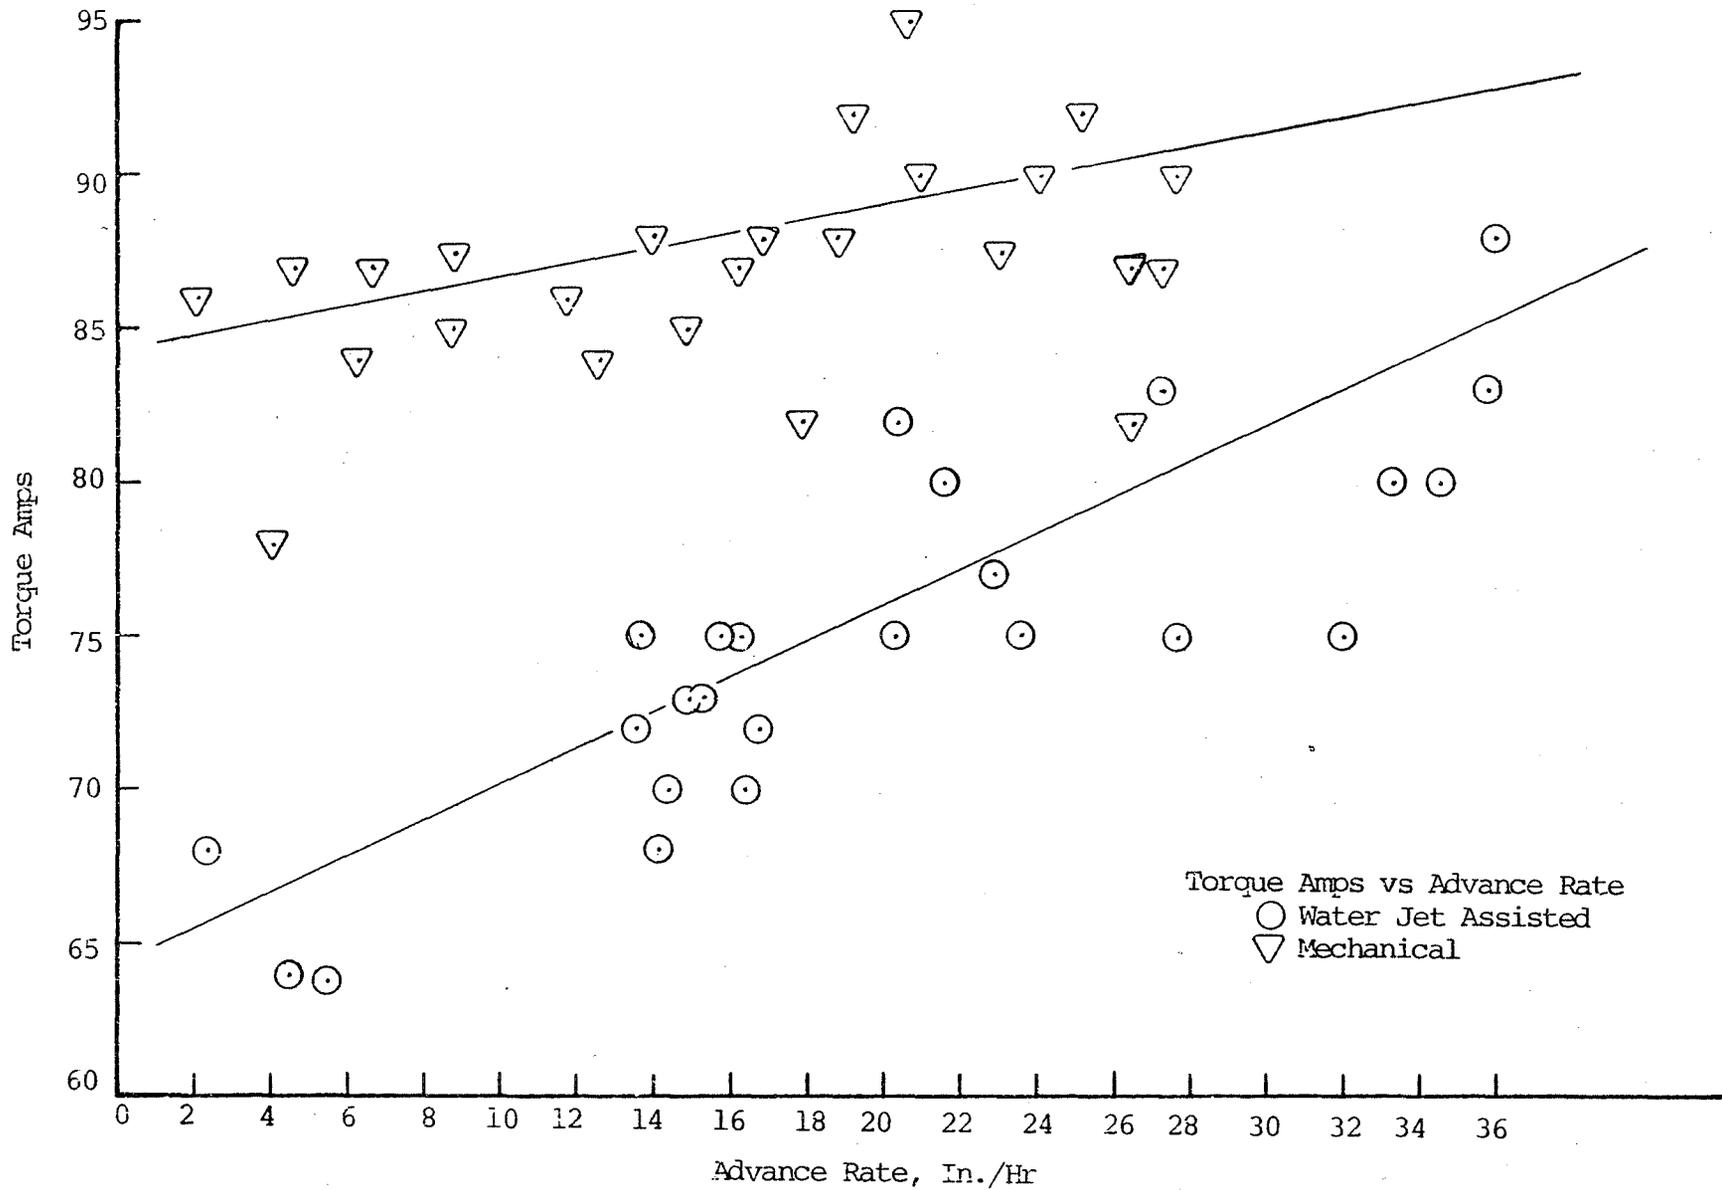
A surprising result of the water jet testing was a significant reduction in machine torque as can be seen in Figure 26. Since the torque required to actually cut the rock should not significantly change, the reduction in torque is believed due to reduced friction on the cutterhead.

Figure 26 - Torque Amps Vs. Advance Rate, Water Jet and Mechanical

Machine torque requirements were reduced approximately 25 percent when the water jets were used. It was suggested this was due to reduced cutterhead friction in the presence of the water jets.
