FIELD EVALUATION OF ZINC-BASED SOLDERS
FOR COPPER AND COPPER ALLOYS

Roy E. Beal

Prepared for the
U.S. Department of the Interior
Bureau of Mines
Washington, D.C. 20240

OFR
76-101

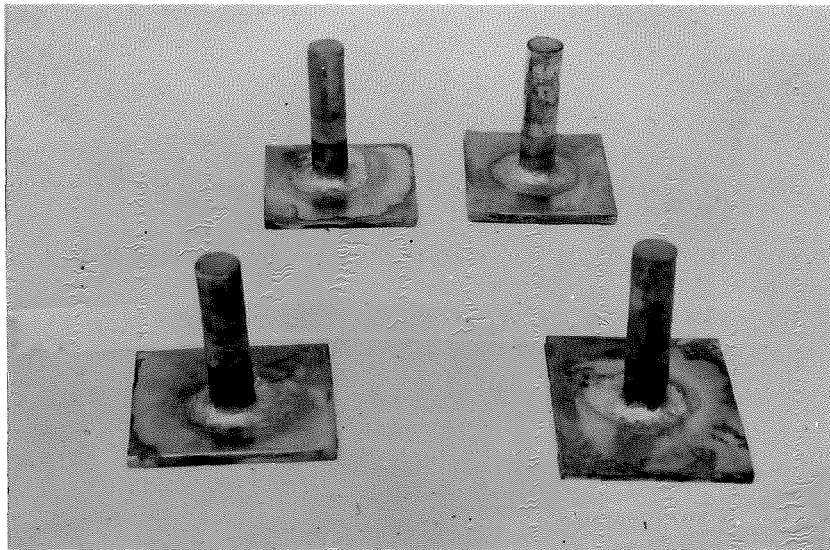
Figure 1

Copper and Brass Rods and Plates Soldered
with 95Zn-5Al

Many specimens of the plate and rod configuration now have been made, some of which are shown in Figs. 1 and 2. Three soldered with the 95Zn-5Al alloy and three soldered with the 89Zn-7Al-4Cu alloy have been submitted to Rolla.

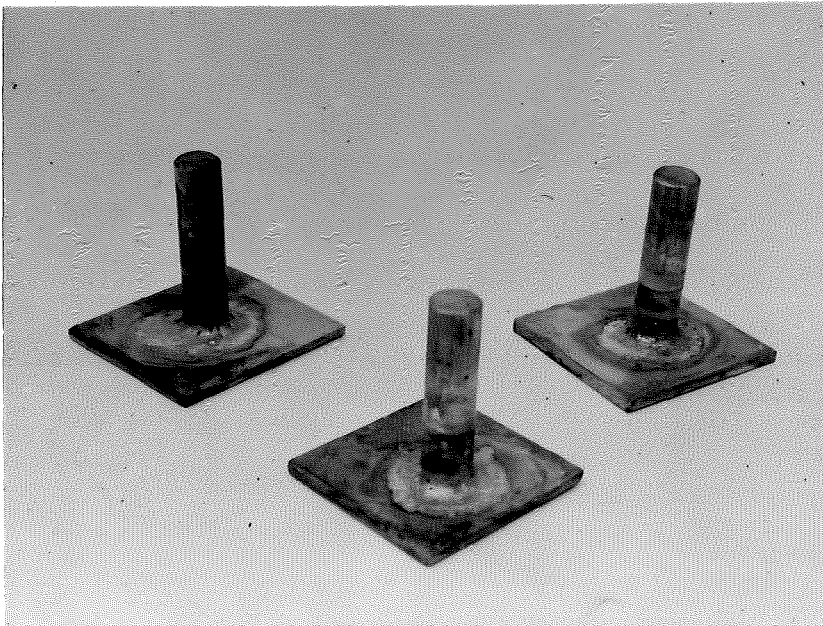
Figure 2

Copper Plates and Brass Rods Soldered
with 89Zn-7Al-4Cu

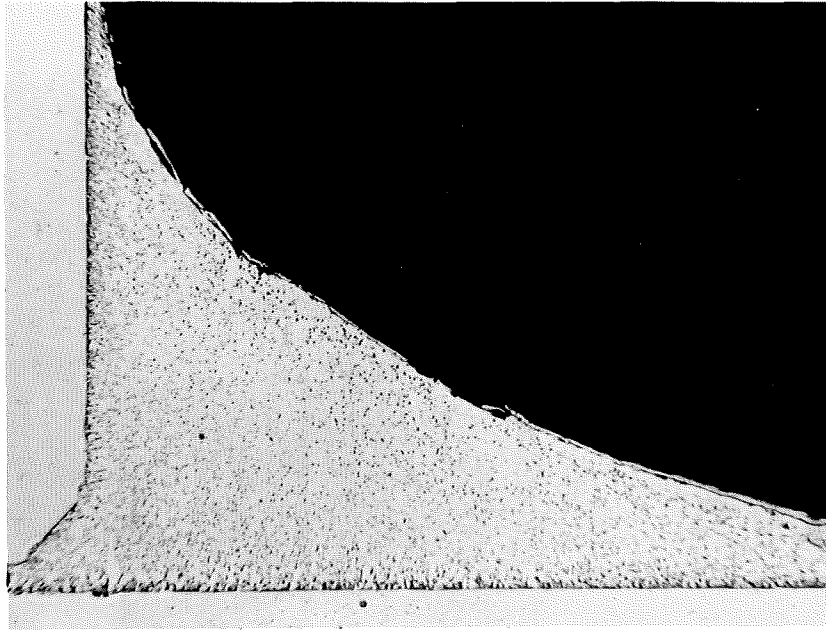
Figure 3

Brass Soldered with 95Zn-5Al. Unetched.

Good soldered profiles, equivalent to those of Schwaneke's earlier work for the Bureau of Mines, were achieved when heating conditions had been optimized as demonstrated in Fig. 3, which shows brass base metal joined with 95Zn-5Al in the unetched condition.

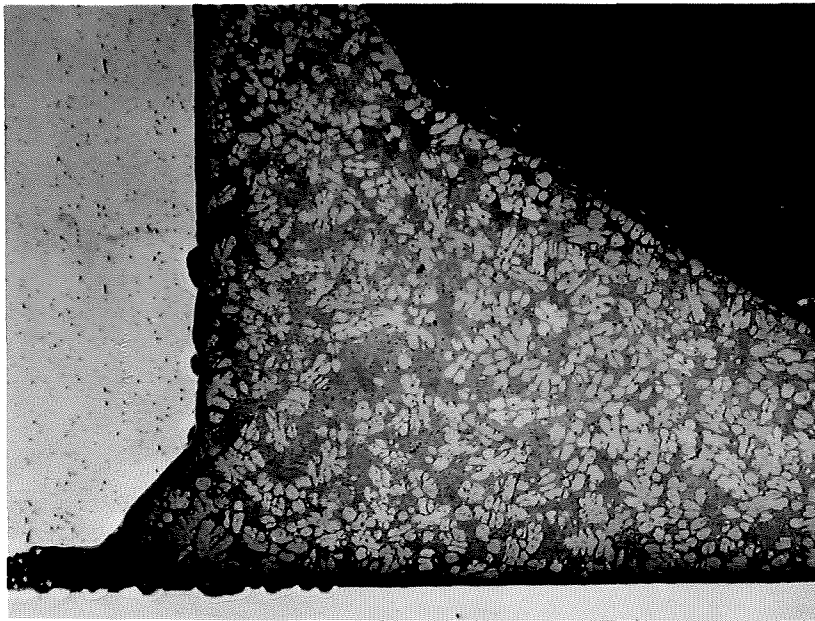
Figure 4

Brass Soldered with 95Zn-5Al. Note that most of plating appears dissolved.

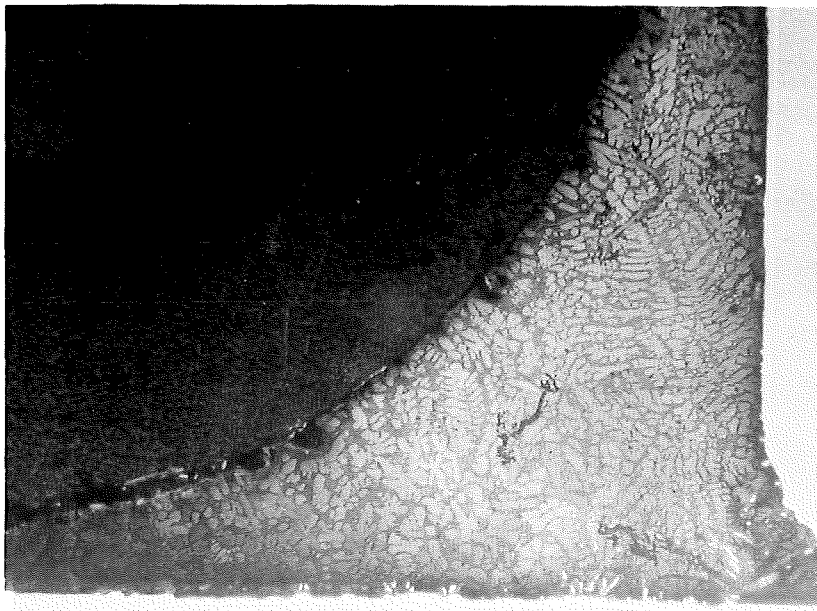
Figure 5

Brass Soldered with 95Zn-5Al with Plating
Present in Completed Joint.

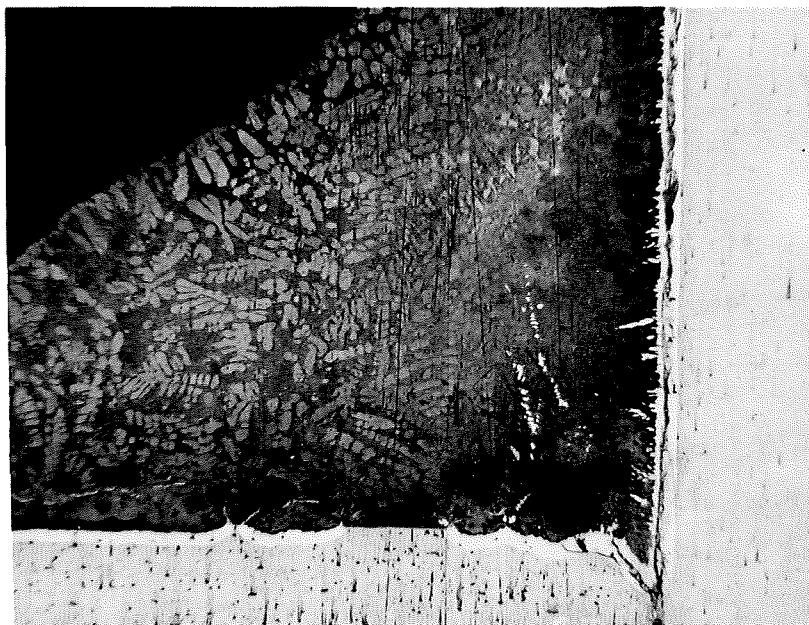
Figure 6

Brass Soldered with 95Zn-5Al. Plating
on plate partly penetrated, but still
intact on rod.

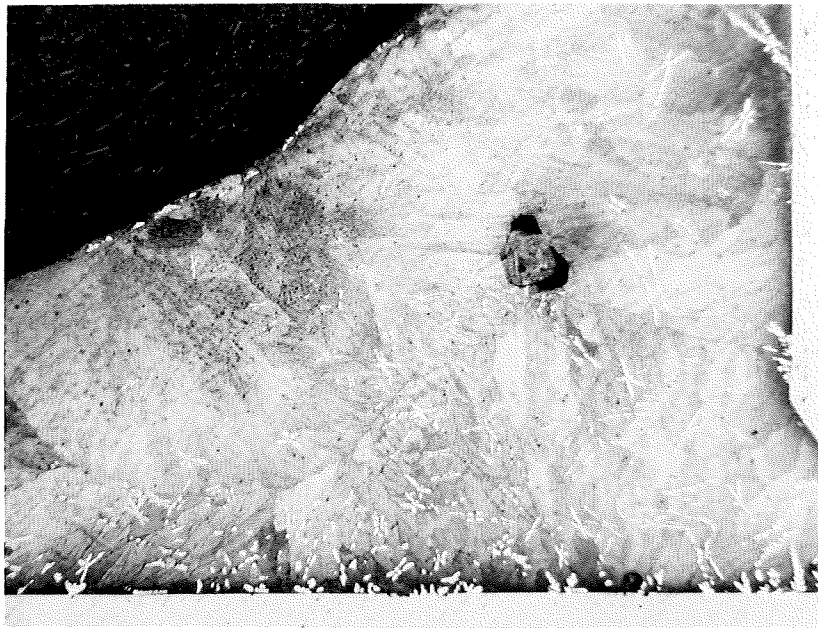
Figure 7

Brass Rod and Copper Plate Soldered with
89Zn-7Al-4Cu, Plating Dissolved or Dispersed.

Specimens manufactured with the 89Zn-7Al-4Cu material illustrated in Figs. 7 and 8 again show good wetting and joint appearance with low porosity and dispersion of the nickel-plated layer. In the joint between rod and plate, Fig. 8, large dendrites--probably nickel-rich--are seen principally on the plate.

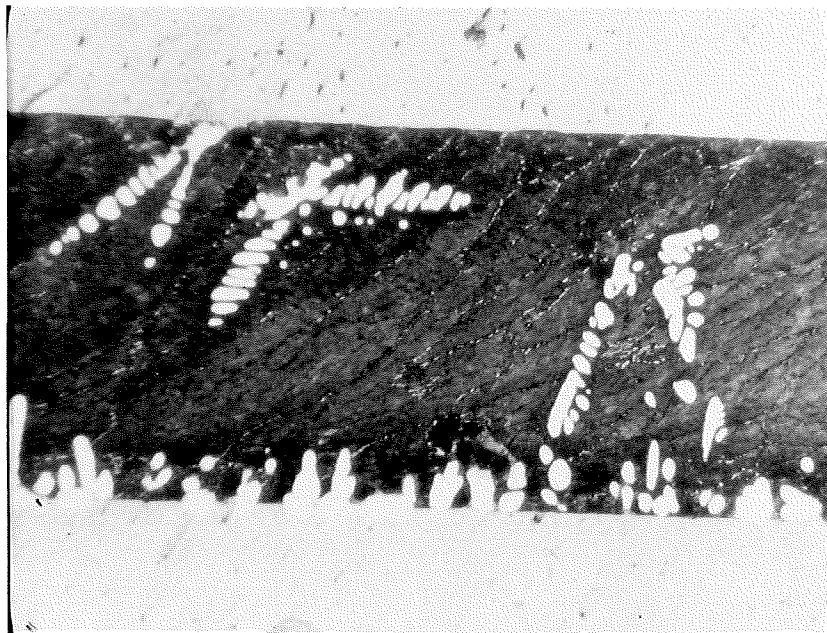
Figure 8

Large Dendrites Observed in 89Zn-7Al-4Cu
Soldered Joint Between Plate and Rod.

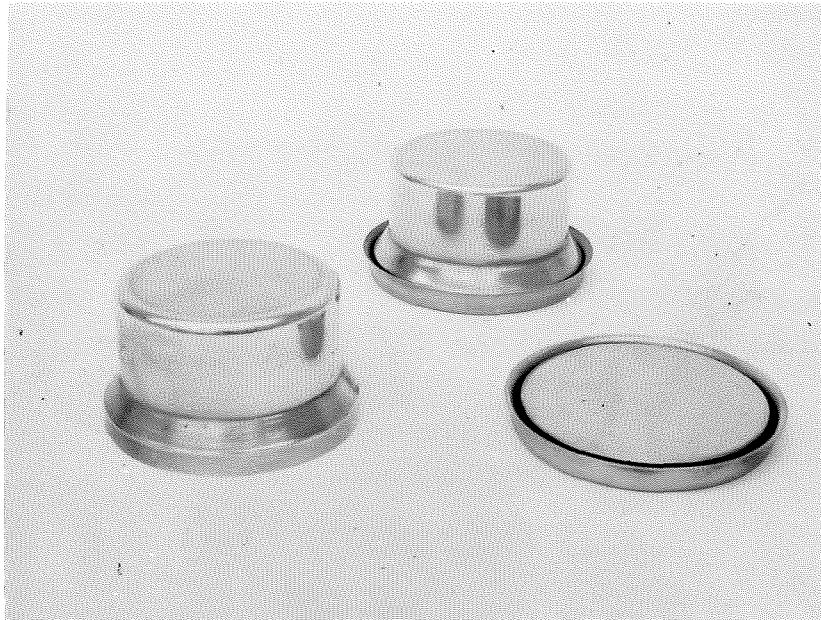
Figure 9

**Simulated Radiator Header Tank Capsules
Showing Both Parts and Assembly.**

A quantity of simulated radiator header tank capsules were manufactured from Alloy 260 radiator tank brass, as illustrated in Fig. 9. The radiator header plate joint was produced by spinning a groove into the tank brass, similar in dimensions to the actual radiator header plate joint, as shown on the right. On the left of Fig. 9 is the tank portion of the capsule, approximately 2 in. in diameter shaped to fit the header plate. The complete assembly ready for soldering is depicted in the rear of the same photograph.

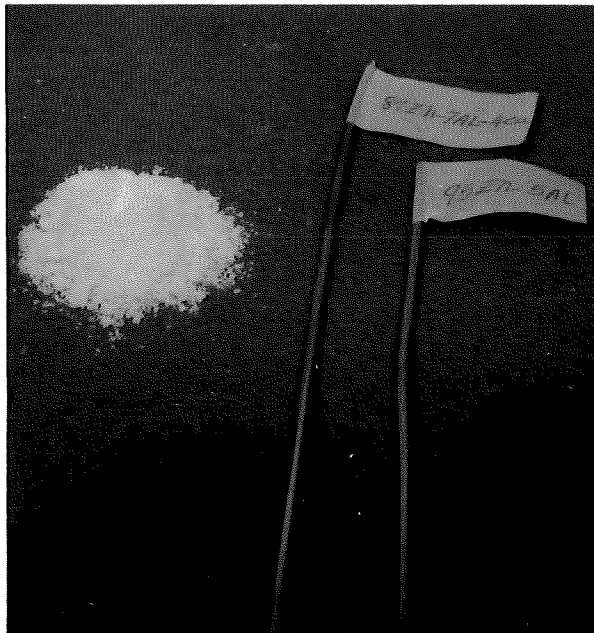
Figure 10
Solder Wire and Flux Powder Used

Materials for soldering are shown in Fig. 10. Rings were made of the solder wire of appropriate composition. Powdered flux is applied to the joint. The ring is placed in the joint area as shown in Fig. 11. After several trials with torch heating, furnace heating was tried and found to be more successful in producing a good soldered joint. An assembly ready for the furnace is presented also as Fig. 11. Heating of the

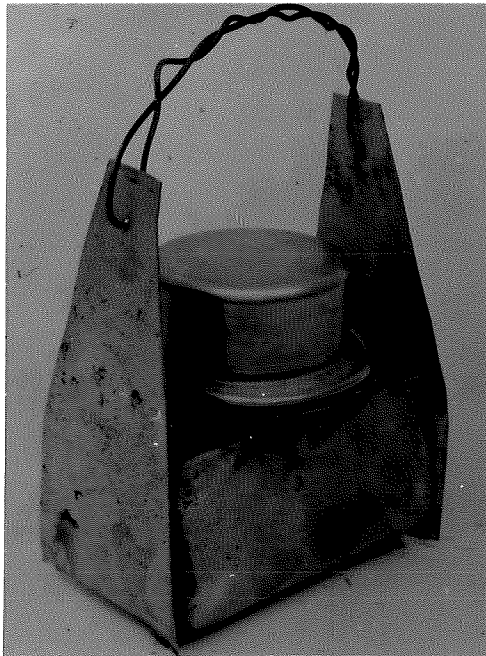
Figure 11
Radiator Capsule Assembled with Flux and Solder
Ready for Processing

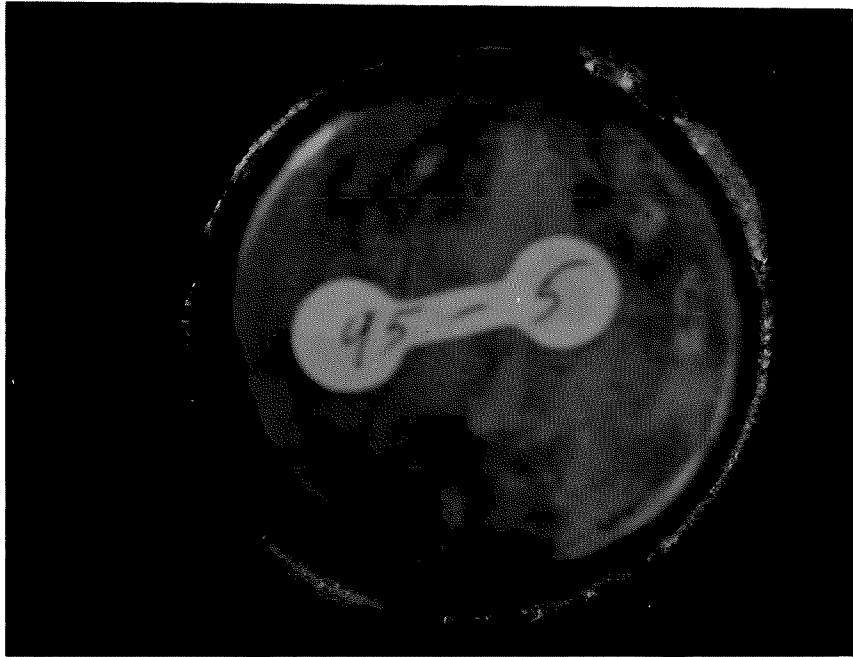
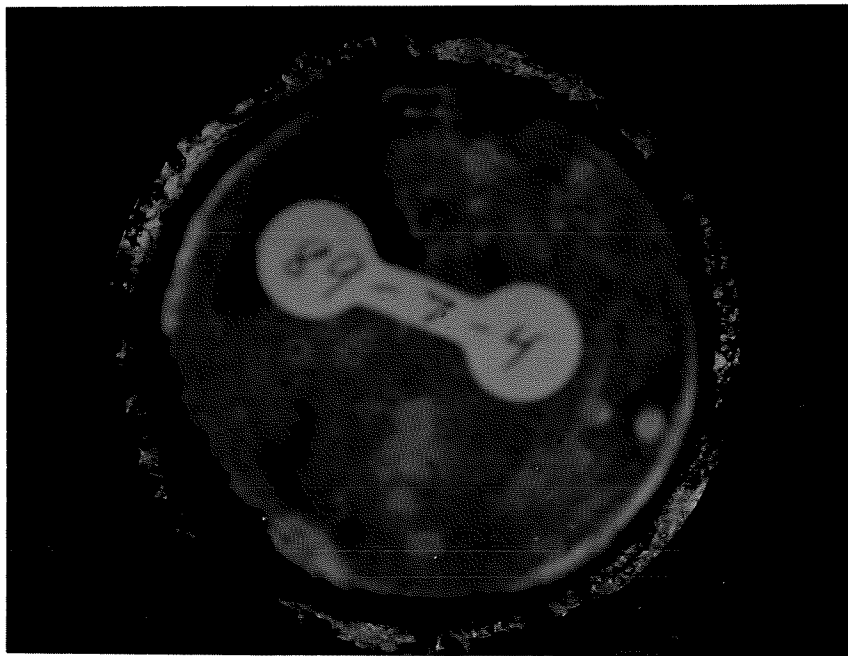
Figure 12

Typical Zinc Soldered Joints after Furnace Processing

assembly is performed in an electrically operated oven. Best processing conditions were established at a furnace setting of 1000°F. The basket is lowered into the furnace, and soldering takes place after approximately 15 sec. After solder flow has taken place, the capsules are removed and cooled. A number of the furnace soldered joints required additional manual soldering to produce a joint sound enough for testing. Typical soldered joints with the two zinc-based materials are shown in Fig. 12. The 95Zn-5Al joint in Fig. 12a shows good wetting for most of the joint with two small incompletely wet areas, partly due to insufficient solder alloy in the joint. The 89Zn-7Al-4Cu solder did not wet and flow so readily as the 95Zn-5Al solder as shown in Fig. 12b. Here several areas of unwet solder and base metal are seen.

The zinc-based solder joints that did not flow as well as those shown in Fig. 12a were improved somewhat by additional torch soldering. When reheating the joints by torch, it was found very difficult to melt and wet additional zinc solder to the originally furnace soldered joint. With liberal fluxing the solder metal simply did not want to flow. This was especially so in the region of the holes in the solder, which appeared to be flux-filled with residual material from the furnace operation. However, with persistence, the types of joint illustrated in Fig. 14 were produced.

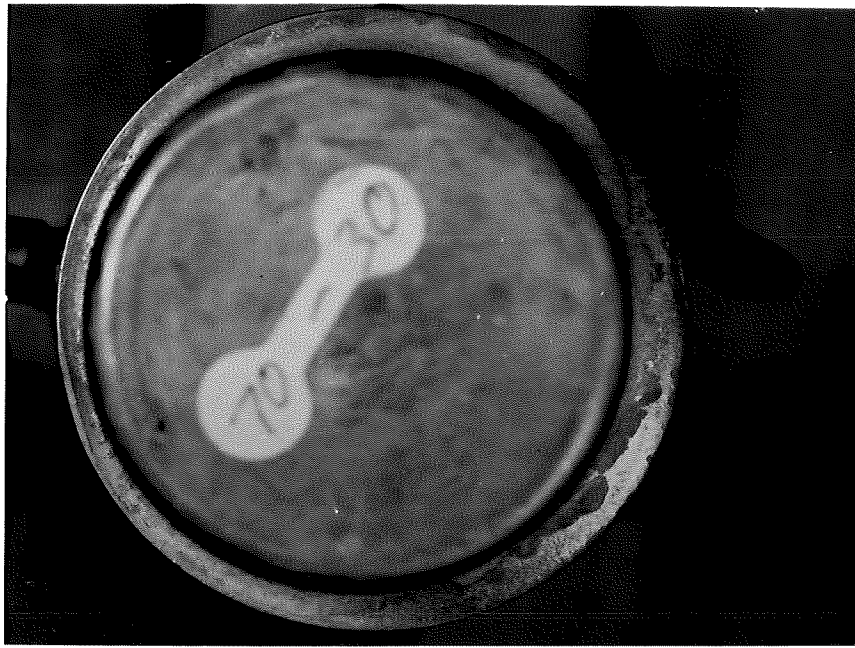
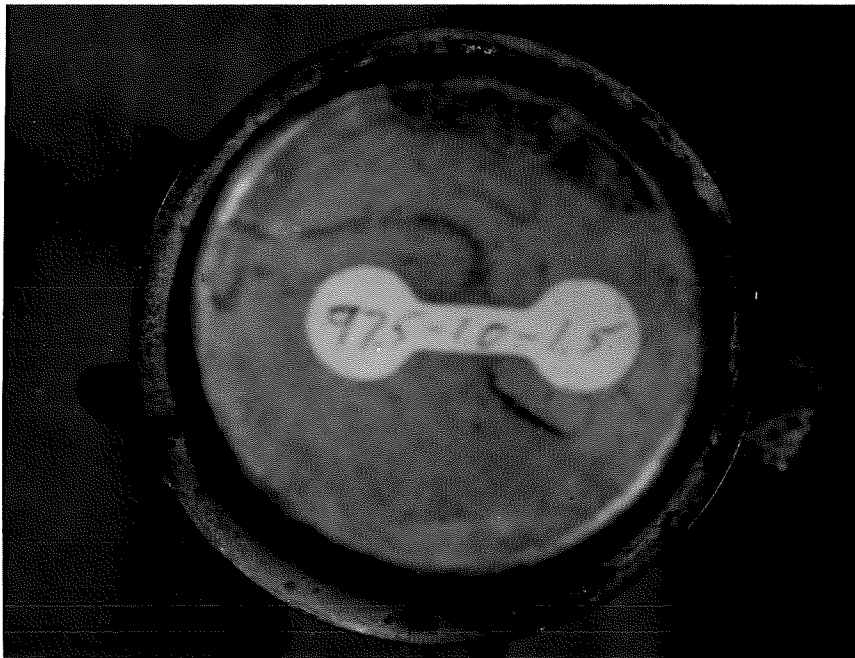
Figure 13

Typical Soldered Joints Produced by Furnace Processing Using Lead-Tin Solders and Zinc-Ammonium Chloride Flux.

The 70Pb-30Sn and 97.5Pb-1.0Sn-1.5Ag soldered joints being used for comparison purposes showed excellent wetting and spreading during the furnace soldering operation as clearly shown in Fig. 13.

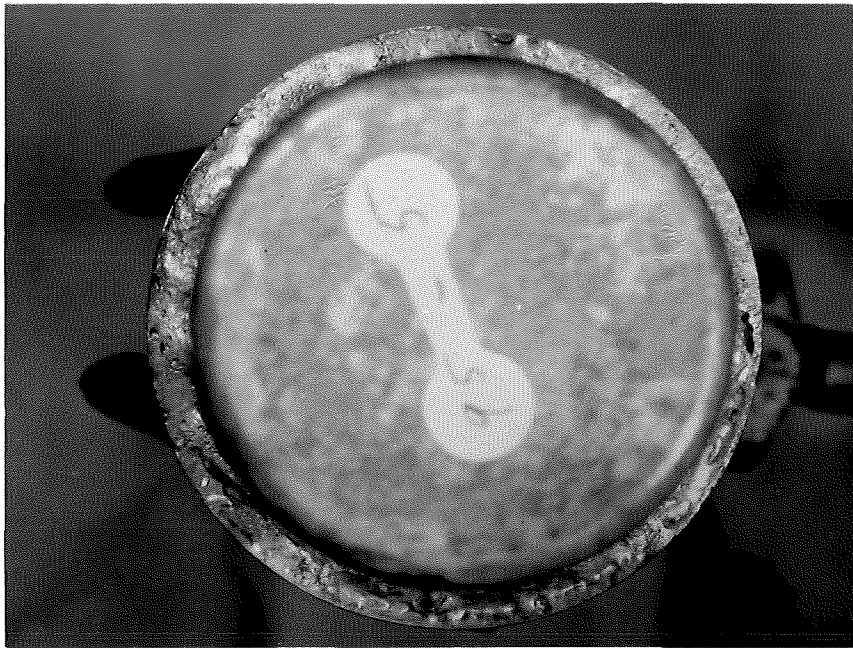
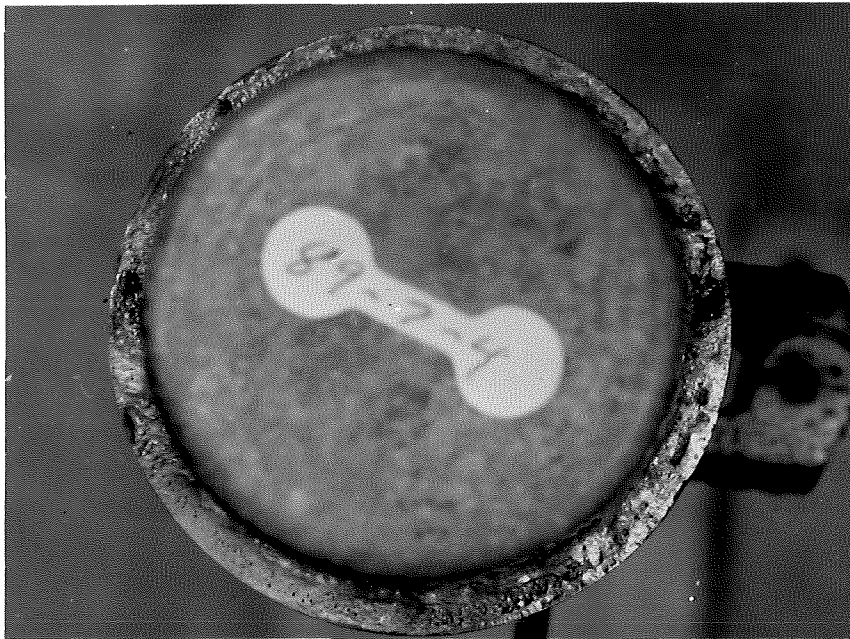
Figure 14

Zinc-based Soldered Joints after Furnace Processing
and Some Additional Torch Soldering

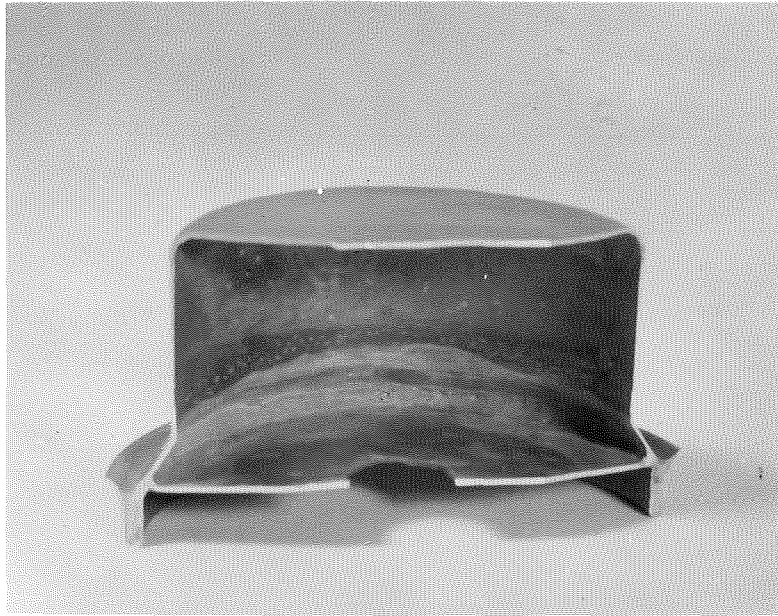
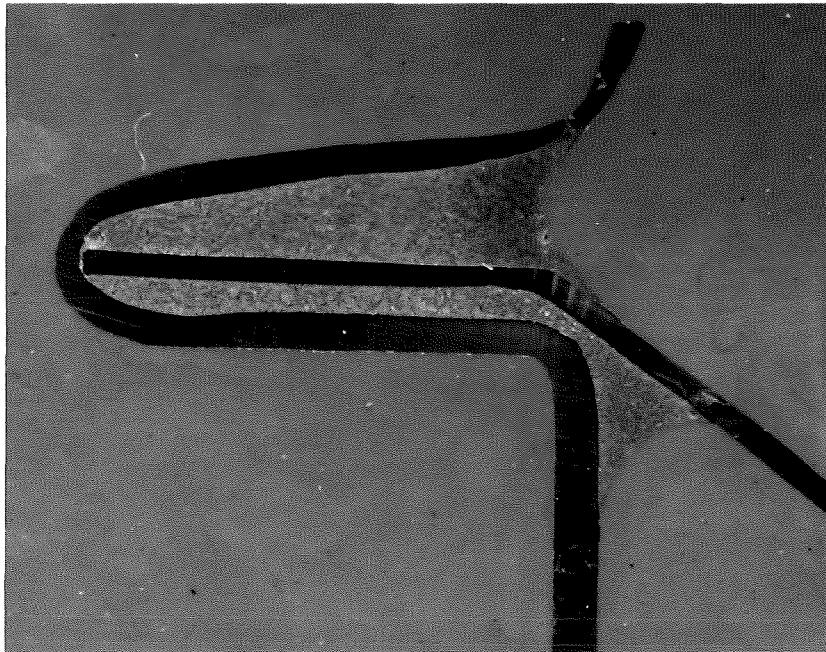
Figure 15

Half-section of Capsule and Macro-section of
the Completed Solder Joint with 95Zn-5Al Alloy

After soldering, several radiator header tank capsules were sectioned to examine the quality of the soldered joint. The 95Zn-5Al material is illustrated in Fig. 15. The inside fillet formed during soldering is very good and continuous with no visible defects, and is typical of furnace soldered joints with the 95Zn-5Al solder alloy. A macro cross-section, shown in Fig. 15b, shows the same material with excellent solder flow filling the joint cavity. A good capillary action is also illustrated by the inside fillet of Fig. 15b with a good final fillet shape. A similar examination of joint quality is illustrated in Fig. 16 for the 89Zn-7Al-4Cu solder alloy. In this case internal flow and wetting to form the inside fillet has not been as good as with 95Zn-5Al solders, although considering the dewetting and holes on the outside of the joint the inside fillet looks very good. A typical cross-section of the 89Zn-7Al-4Cu soldered joint is presented as Fig. 16b. Good solder flow with a good fillet shape is illustrated. A more comprehensive assessment of joint quality by sectioning will be made in the final report.

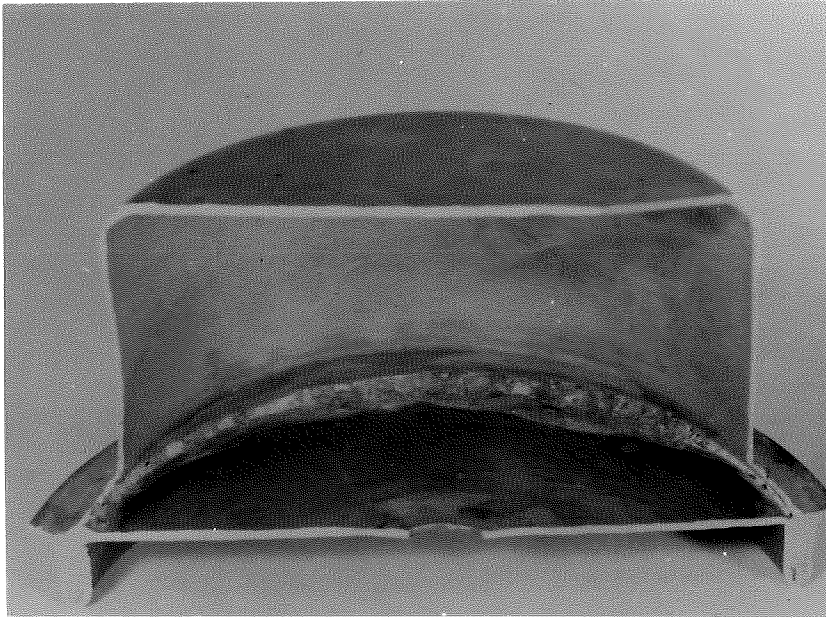
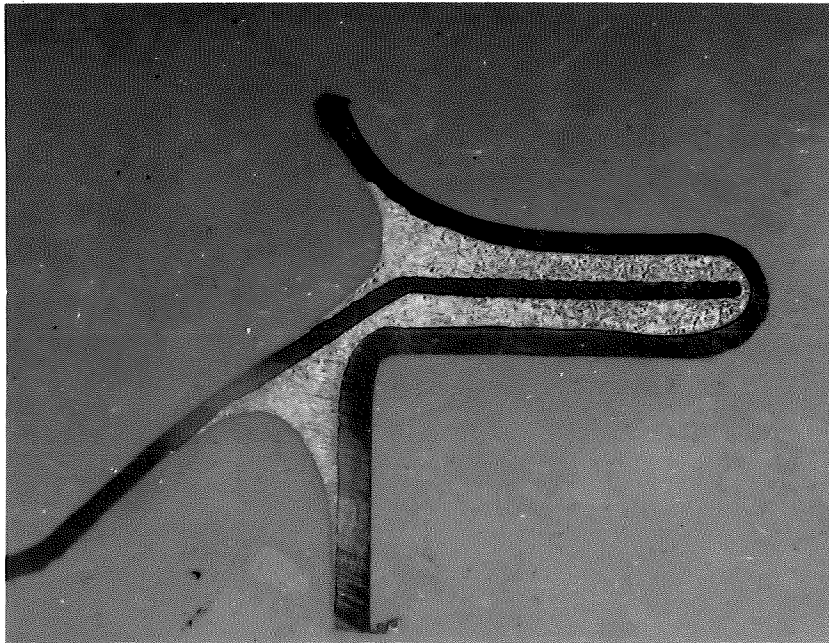
Figure 16

Half-section of Capsule and Macro-section of
Soldered Radiator Capsule Using 89Zn-7Al-4Cu
Solder

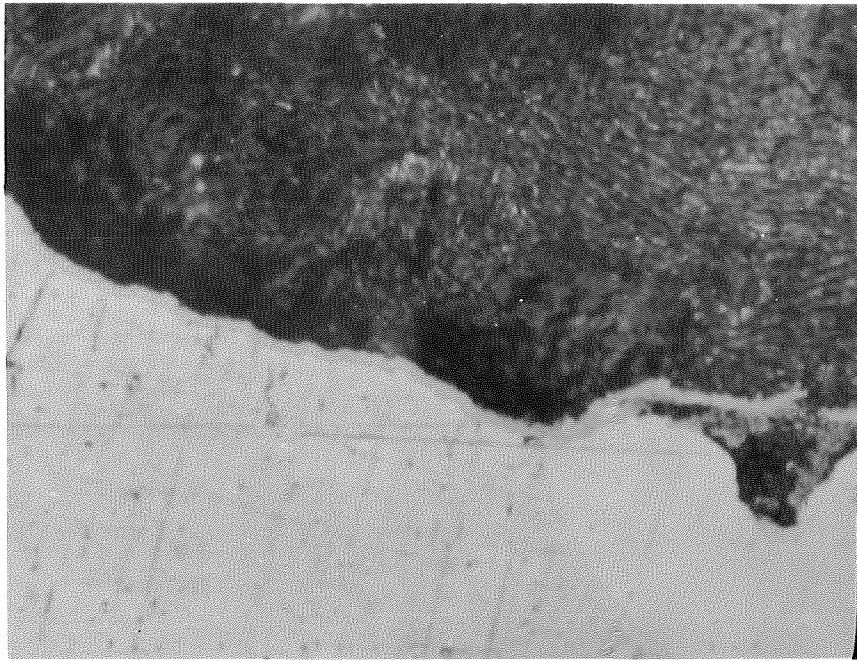
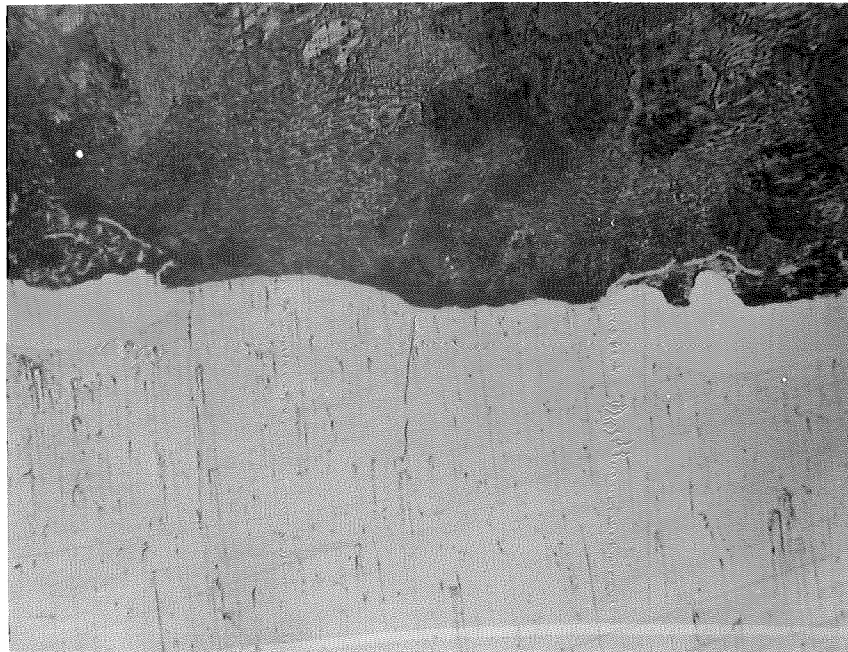
Figure 18

(a) Unwetted region in a soldered joint

Wetting Action of 95Zn-5Al Solder on Plated
Nickel Surface of Simulated Radiator Capsule

is observed with small dendrites growing from it on all the surfaces seen. The structure consists of fine dendrites in a fine-grained eutectic matrix. The 89Zn-7Al-4Cu solder has wet the header plate satisfactorily, but the tank section shows a variable-thickness reaction layer, denoting inferior wetting. Some of the original nickel plating can still be seen on the tank section areas not affected by the reaction zone. The microstructure reveals larger dendrites with less eutectic matrix present. The wetting action of the solders on the plated nickel surface of the simulated radiator capsule is illustrated by Fig. 18. Successful wetting of the joint appears to occur by stripping of the nickel plating off into the bulk solder with subsequent reaction between the zinc-based solder and the brass substrate. The reason for the small unwetted areas as in Fig. 18a remains unclear.

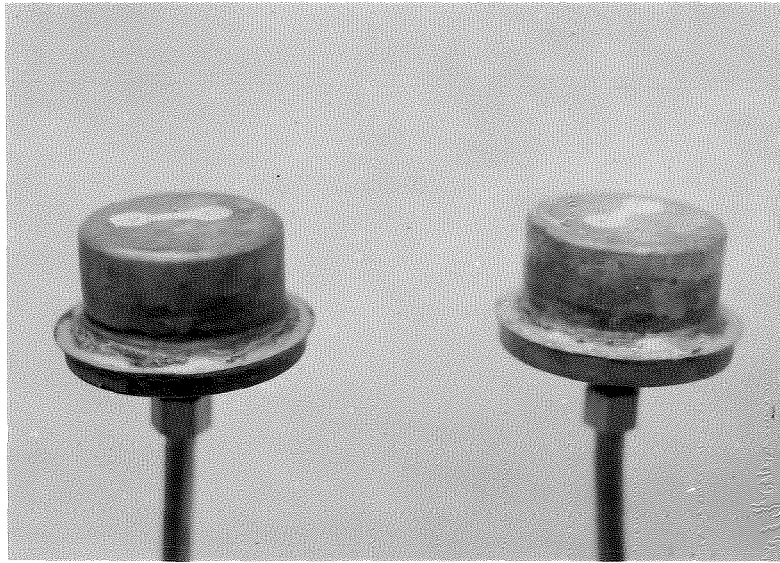
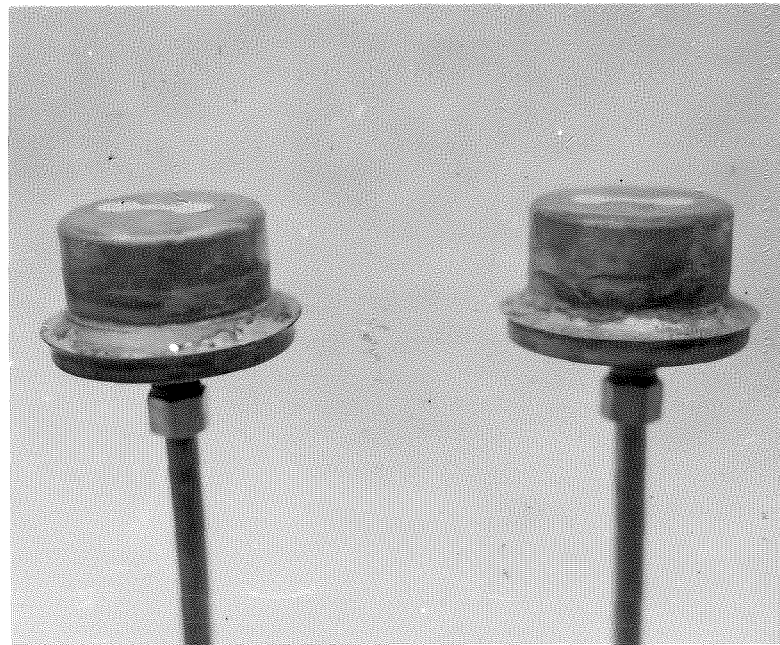
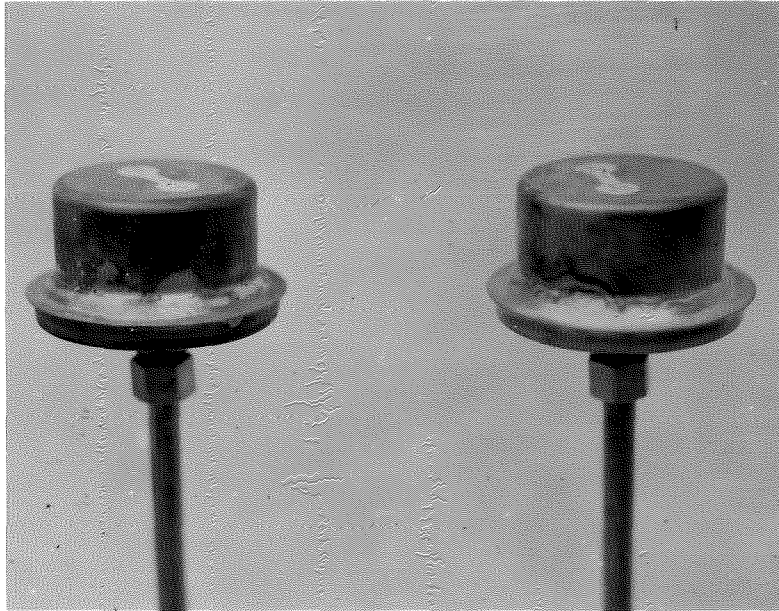
Figure 19

Simulated Radiator Header Tank Capsules
Assembled and Ready for Operation Test

Radiator header tank capsules soldered with each of the candidate zinc-based solders and two tin-lead solders are shown (Fig. 19) ready for test at 30 psig, cycled 5 min on and 5 min off, at 250°F in a 50/50 water/antifreeze mixture.

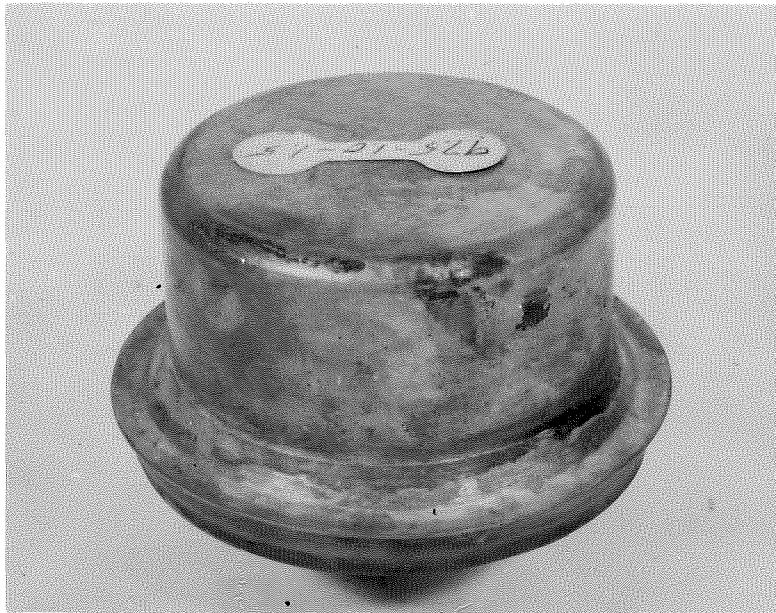
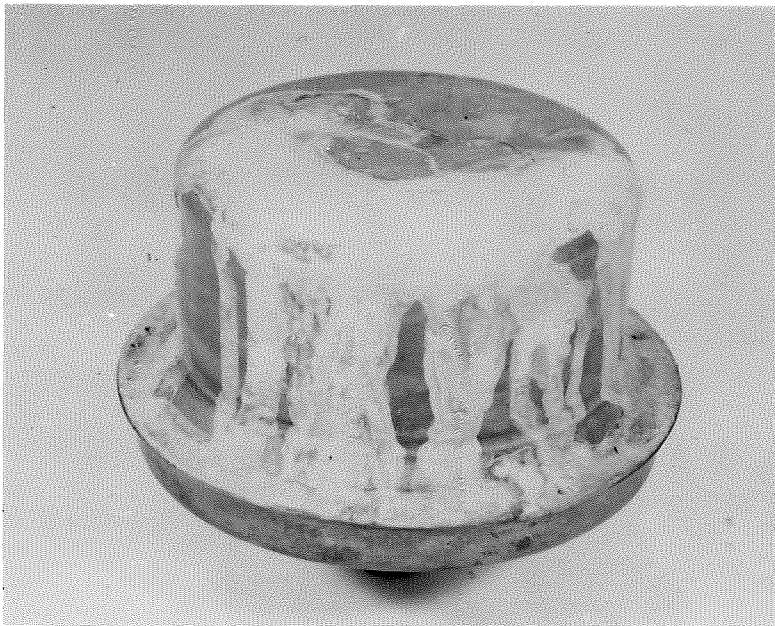
Capsules that Failed after 1000 hr at 30 psi
Pressure Cycled at 5 min On, 5 min Off at 250°F

The test was interrupted after 1000 hr with only two samples showing any signs of failure. Figure 22 shows a capsule that failed in the brass at the upper rim causing weeping of the coolant and, secondly, a 89Zn-7Al-4Cu capsule that was weeping through porosity and shrinkage paths in the solder joint. Half-sections of these two test samples are presented in Fig. 23. Some corrosion of the soldered joints was noted but no serious attack.

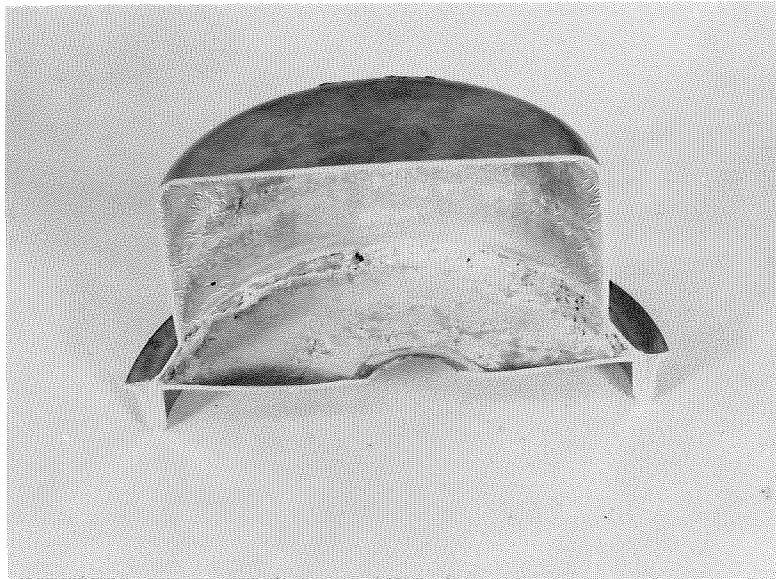
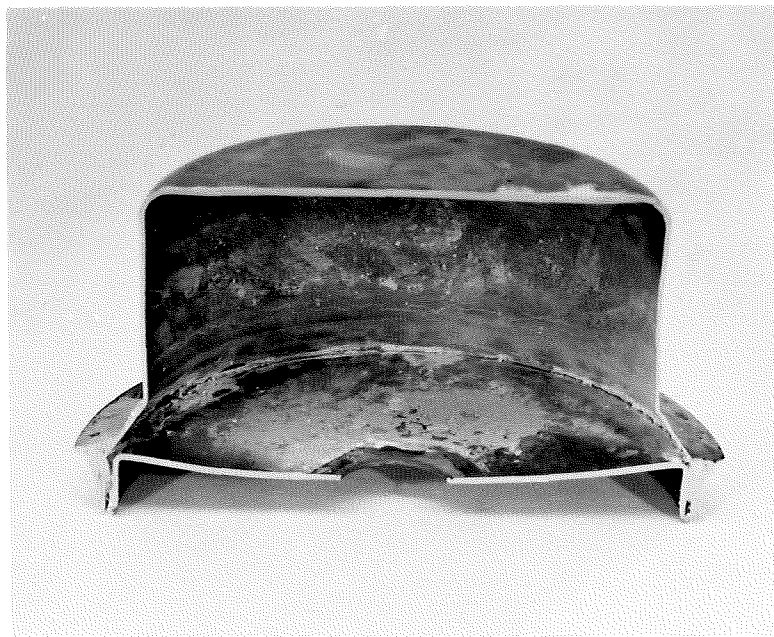
Figure 23

Half-Sections of Capsules after 1000 hr Test
at 30 psi. (a) Failed in brass and not at
soldered joint.

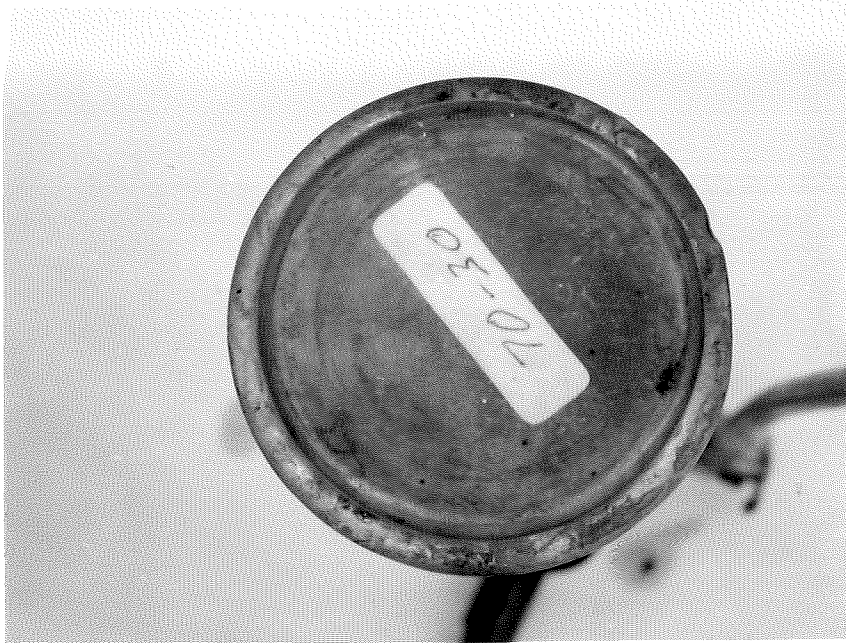
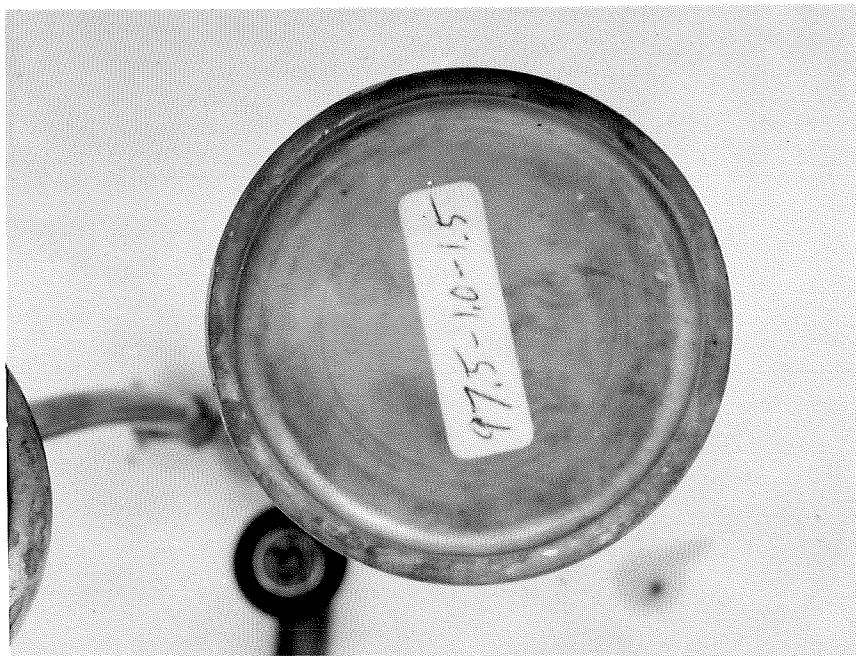
Figure 24

Capsules Soldered with Lead-Base Solders
Prepared for 90 psi Pressure Cycling.

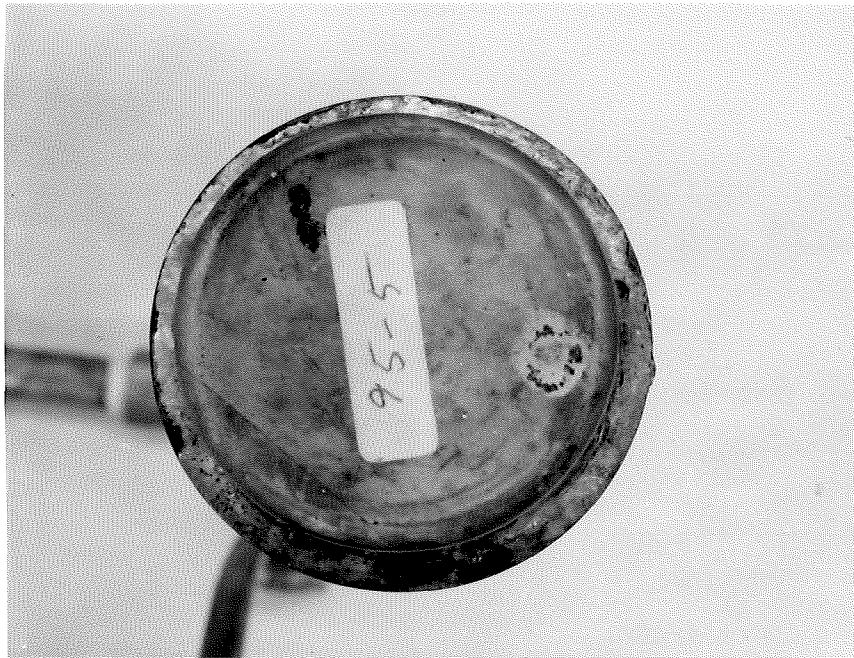
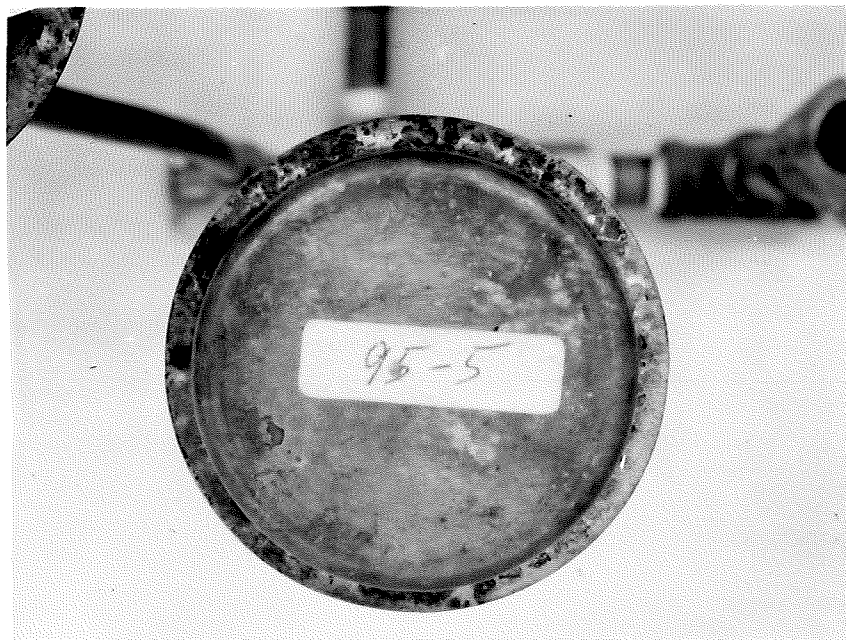
Figure 25

Capsules Soldered with 95Zn-5Al Ready
for Cycling at 90 psig.

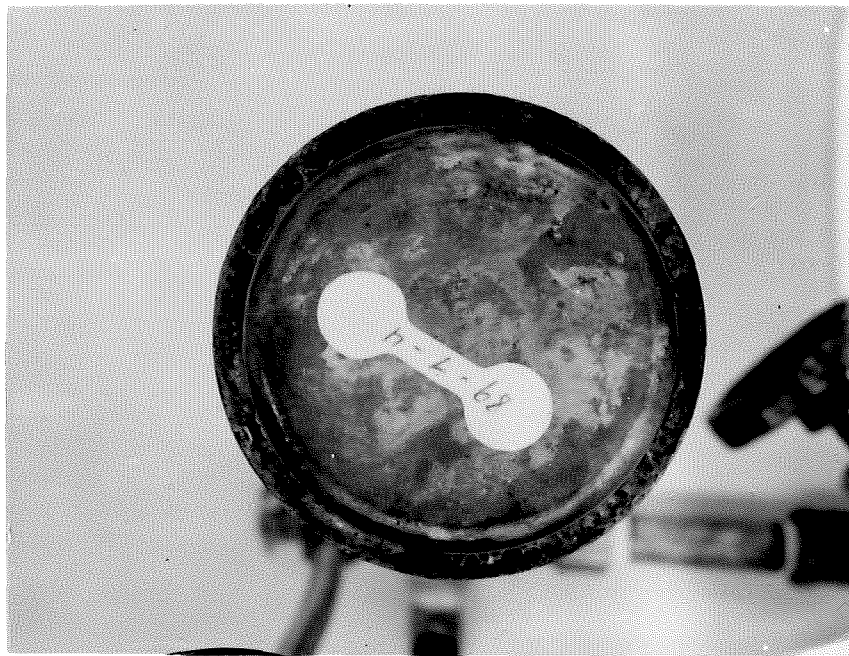
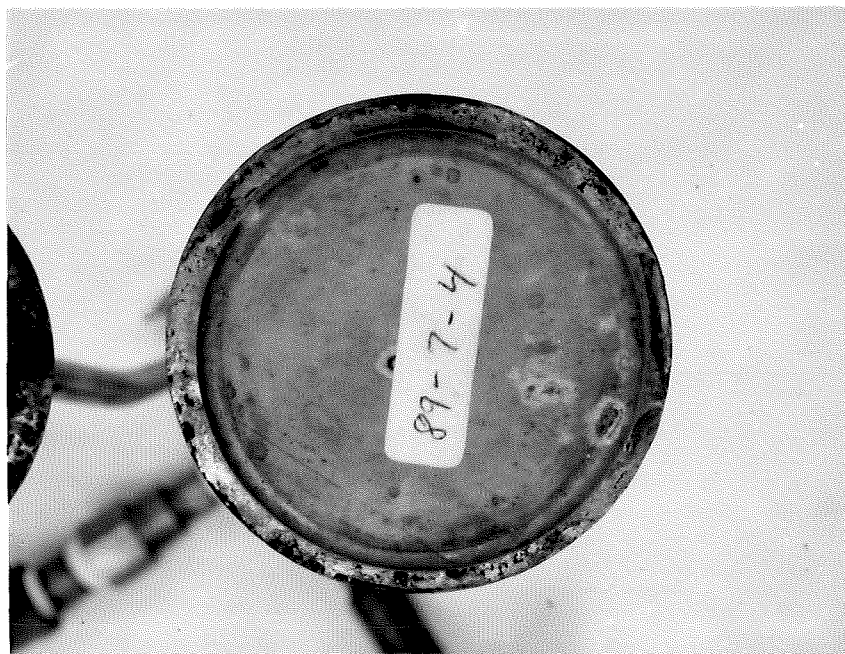
Figure 26

Capsules Soldered with 89Zn-7Al-4Cu Prepared
for 90 psig Cyclic Test.

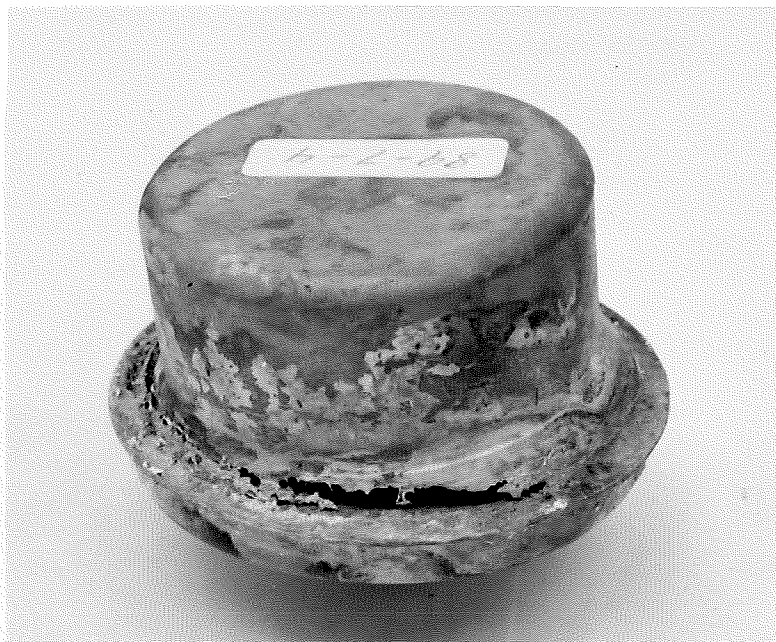
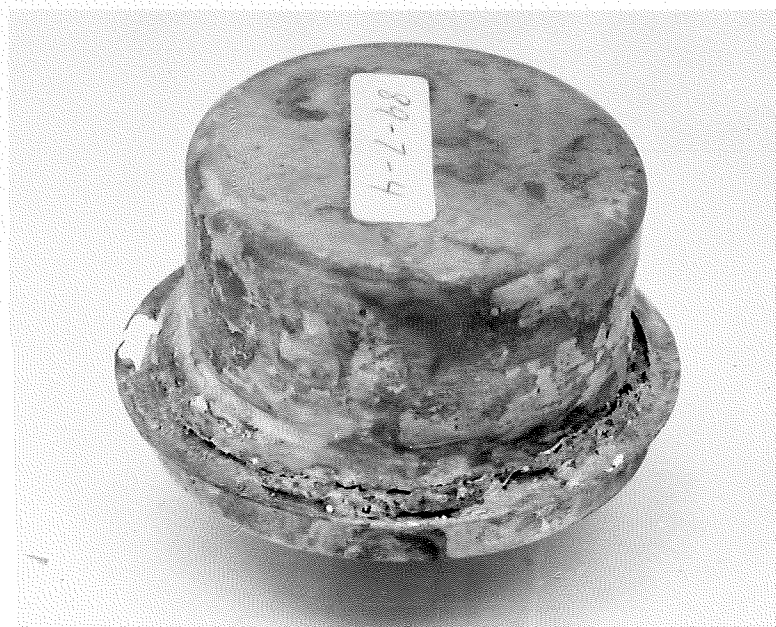
Figure 27

Dissolution of Brass by Aggressive Solder-Flux
Reaction Caused by Prolonged Heating to Make
the Joint (89Zn-7Al-4Cu solder).

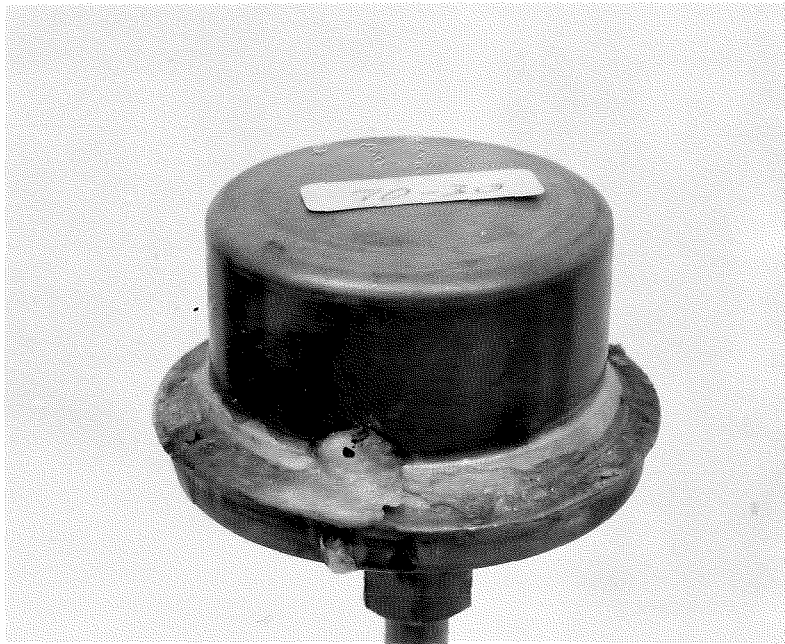
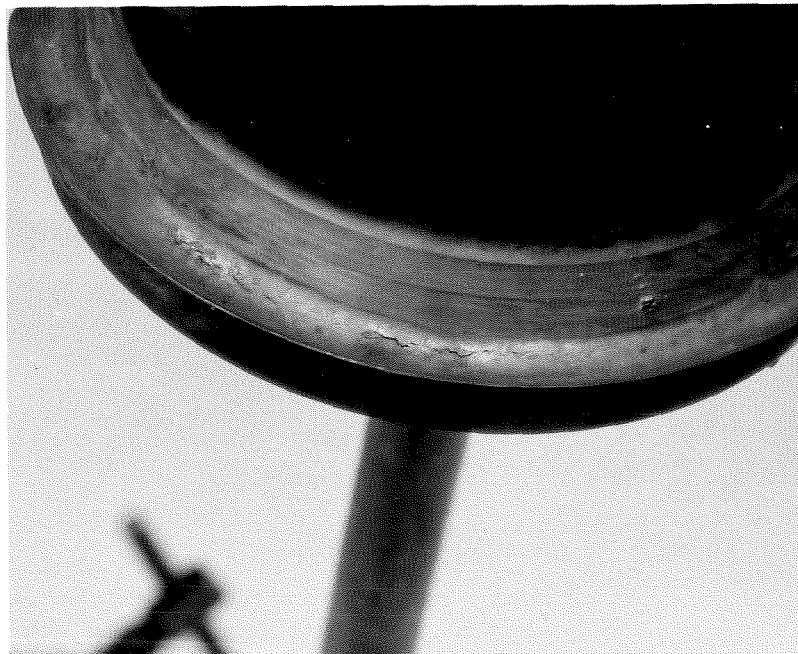
(a) Coolant leaking from capsule

(b) Crack in solder that failed

Weeping Fracture of Soldered Joint with 70Pb-30Sn
Solder after 250 hr at 90 psig and 250°F.

After 250 hr at 250°F and a 90 psig pressure, the 70Pb-30Sn solder joint failed as shown in Fig. 28. Coolant weeped from a crack that gradually became larger until the test was stopped for specimen removal. The test was continued up to 1000 hr before it was terminated to examine the test capsules
