FIELD EVALUATION OF ZINC-BASED SOLDERS
FOR COPPER AND COPPER ALLOYS

Roy E. Beal

Prepared for the
U.S. Department of the Interior
Bureau of Mines
Washington, D.C. 20240

OFR
76-101

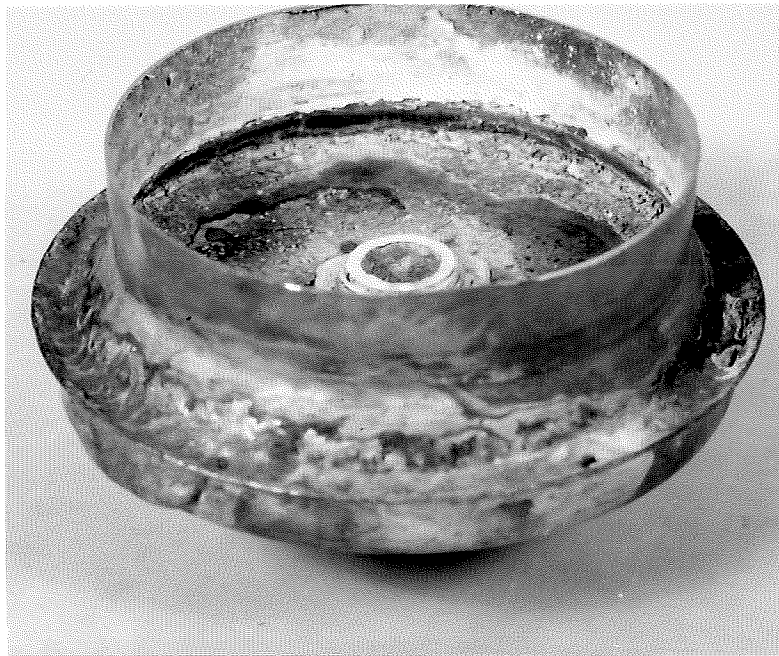
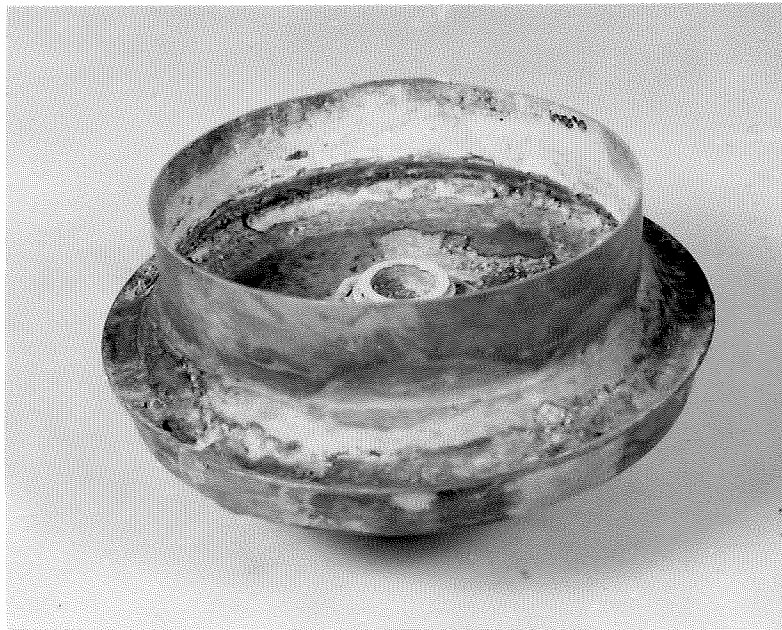
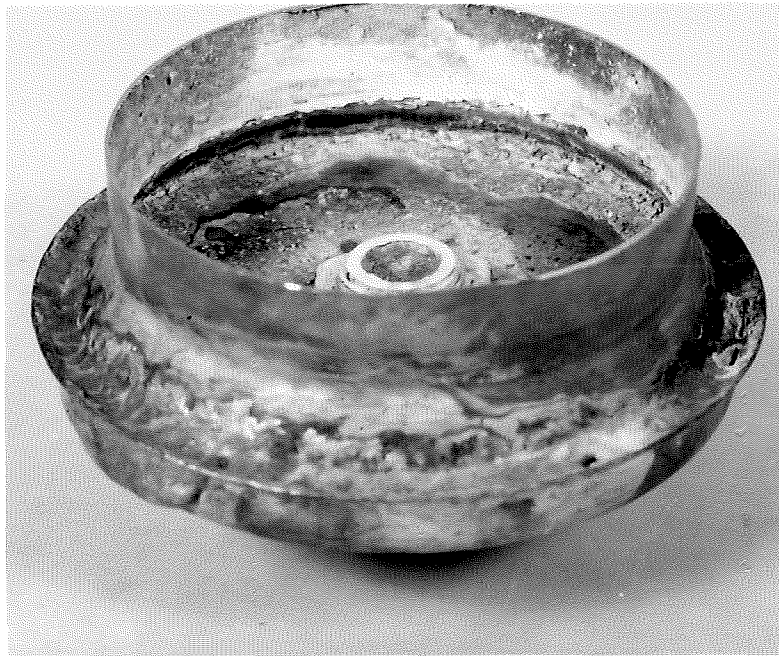
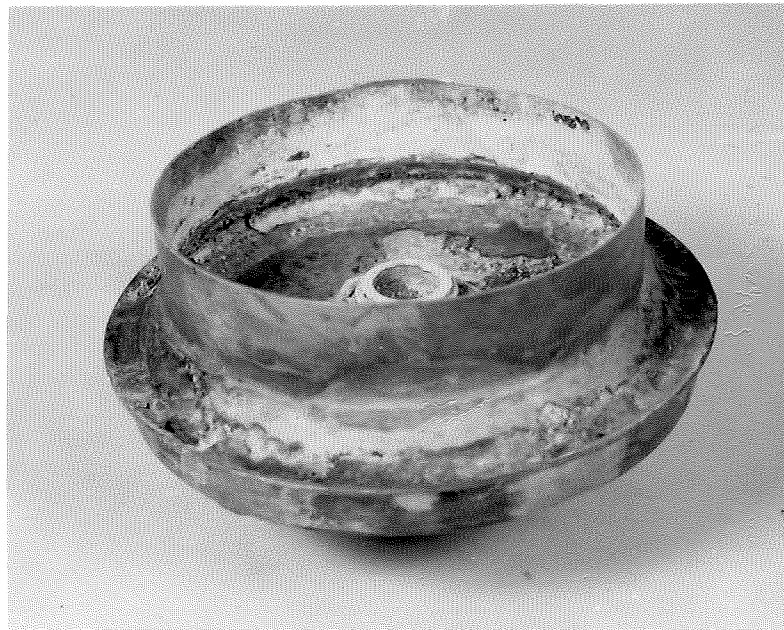
Figure 30

Inside of Capsule Showing Cracking of 89Zn-7Al-4Cu Soldered Joint after 1000 hr at 90 psig and 250°F. No failure had occurred at this time.

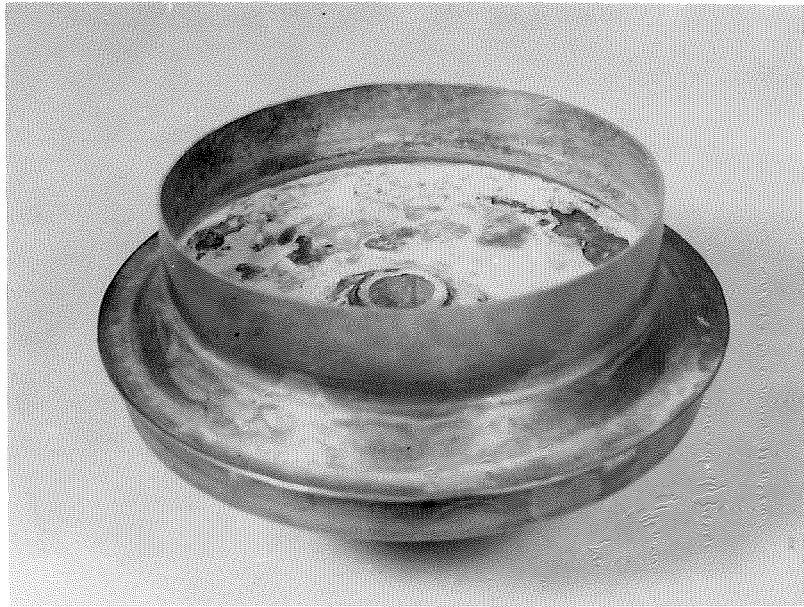
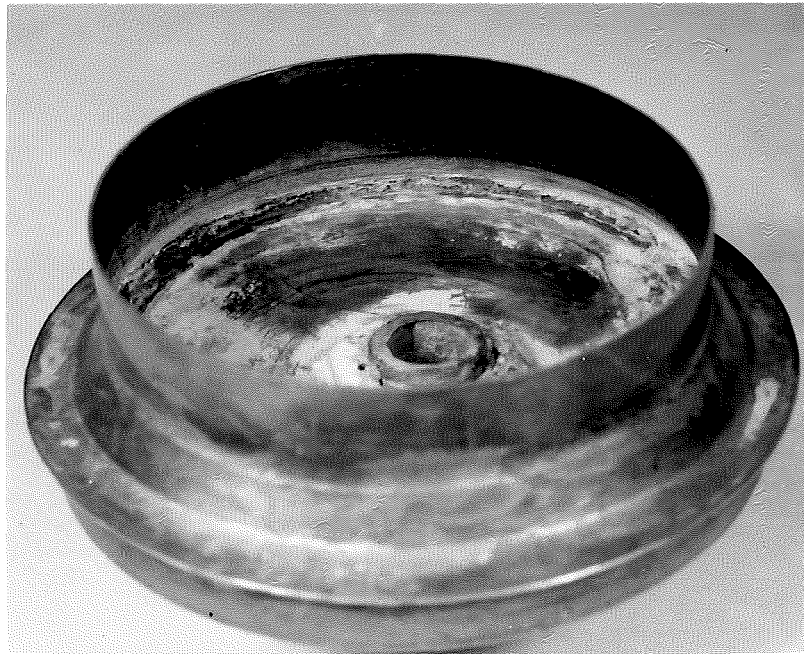
Figure 31

Inside of Capsule Soldered with 97.5Pb-1.0Sn-1.5Ag
after 1000 hr at 90 psig and 250°F. No failure had
occurred at this time.

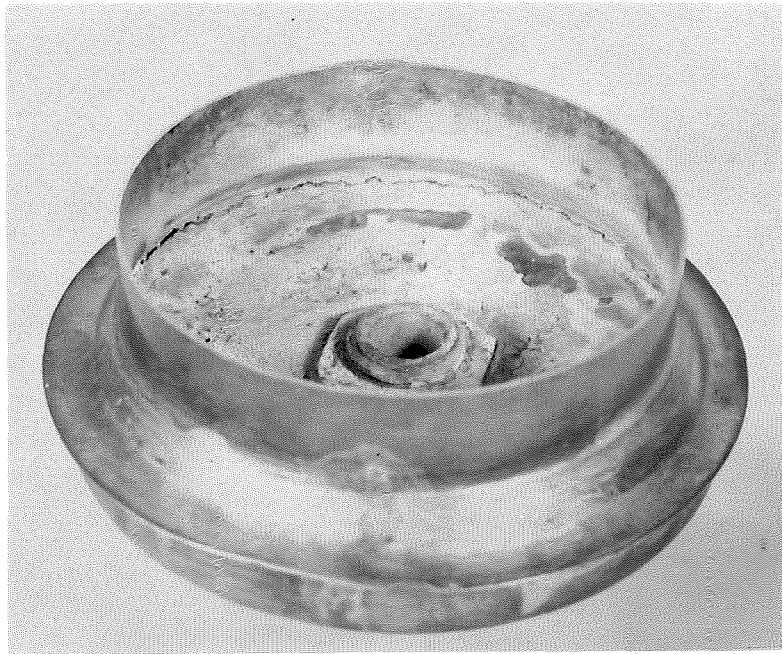
Figure 32

Inside Capsule with 70Pb-30Sn Soldered Joint
Showing Extensive Cracking All Around
the Internal Periphery.

The zinc-based solders and the 97.5Pb-1.0Sn-1.5Ag soldered capsules all lasted the full 1000 hr without failure. A sectioned capsule of the 95Zn-5Al soldered joint is shown in Fig. 29. Cracks are present in the solder all around the inside of the capsule showing that cracking is proceeding, but the joint is still intact. An 89Zn-7Al-4Cu capsule is depicted in Fig. 30. Here, the mode of attack on the solder appeared to be by general corrosion rather than cracking. The corrosion was more severe than the 95Zn-5Al material, and of course the general joint quality is lower. Failure had not occurred, however, after the very severe simulated radiator operating test. The inside of a 97.5Pb-1.0Sn-1.5Ag capsule is seen in Fig. 31, as removed from test and after removal of some corrosion product. Some corrosion attack of the solder joint is seen with no cracking indications after 1000 hr at 90 psig and 250°F. Finally, the inside of a 70Pb-30Sn capsule is shown in Fig. 32. The solder joint had cracked around the internal periphery of the capsule producing a breakout crack at the surface as previously shown in Fig. 28.

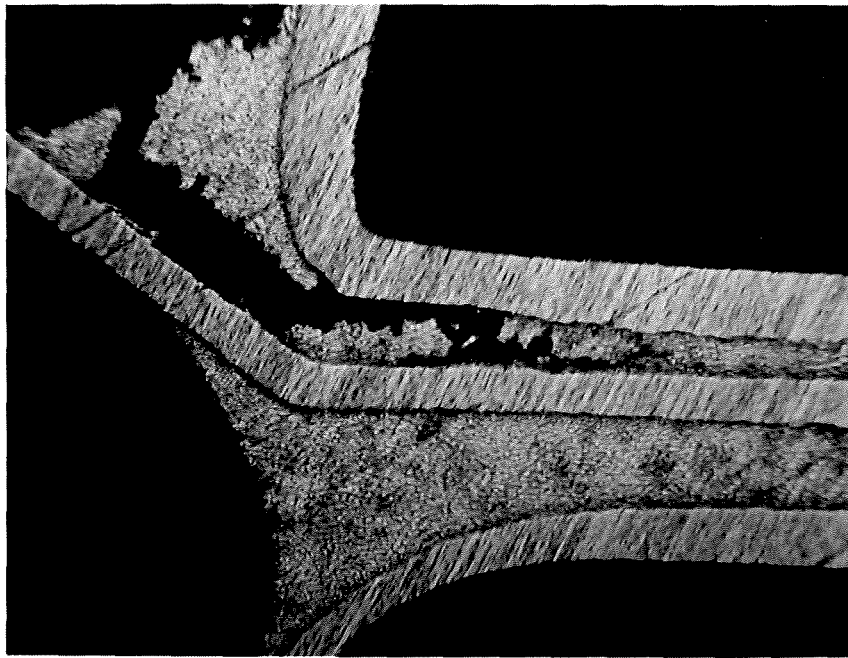
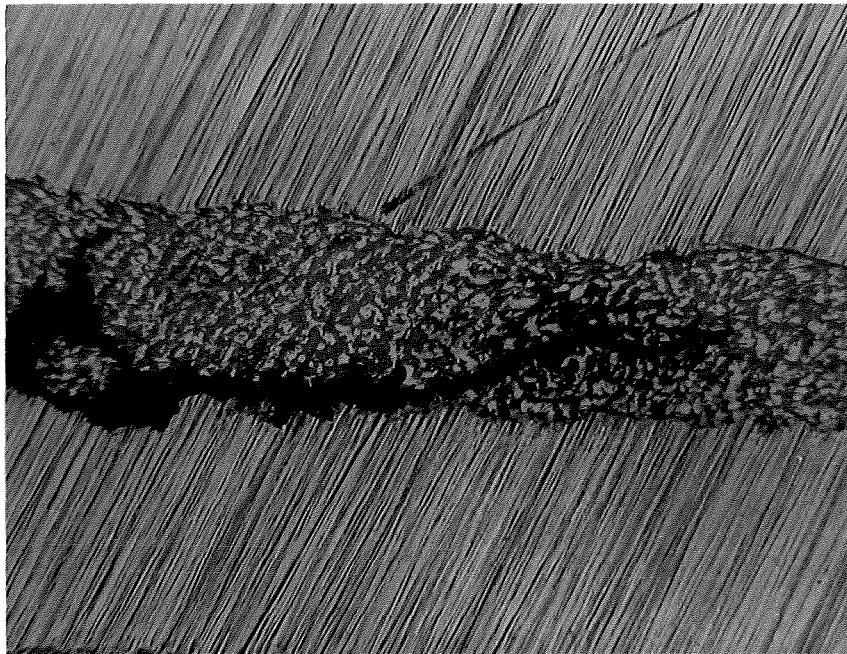
(a) Crack initiation in solder alloy

(b) Crack propagation through solder

Cracking of Soldered Joint Made with 70Pb-30Sn
Alloy after 90 psig Test

A brief metallographic examination was made of the soldered joint after the severe test cycle. Figure 33 depicts the 70Pb-30Sn soldered joint demonstrating a typical joint separation initially within the solder alloy, tending to traverse to the joint interface, and continuing through the solder. The failure mechanism is identified as tensile-peel initiation with crack propagation by a stress-corrosion mode. Note the branches in the crack shown in Fig. 33b.

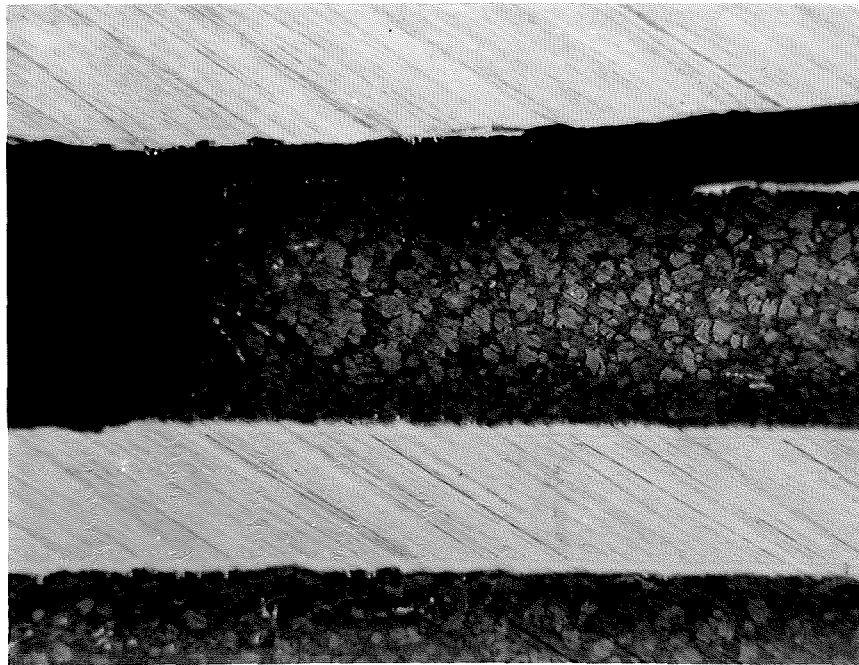
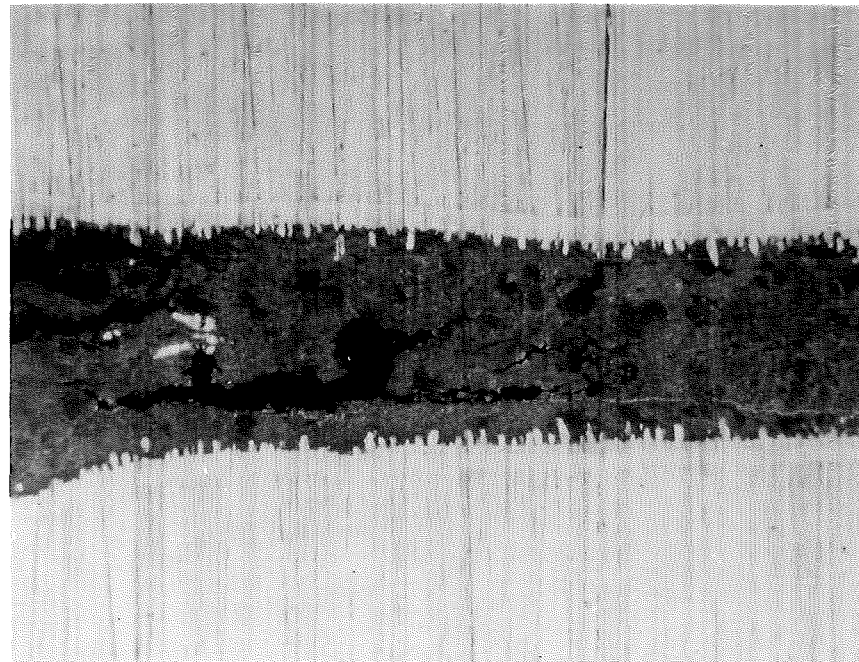
Cracks in 95Zn-5Al Soldered Joint after 1000 hr
Test at 90 psig.

The cracks found in the 95Zn-5Al soldered joint are presented in Fig. 34. Again, fracture has occurred within the solder, but in addition, at the interface as shown in Fig. 34a. Some stress-corrosion branch cracking is seen in the same figure

and in Fig. 34b. This joint had not failed, however, when the capsule was removed from test,

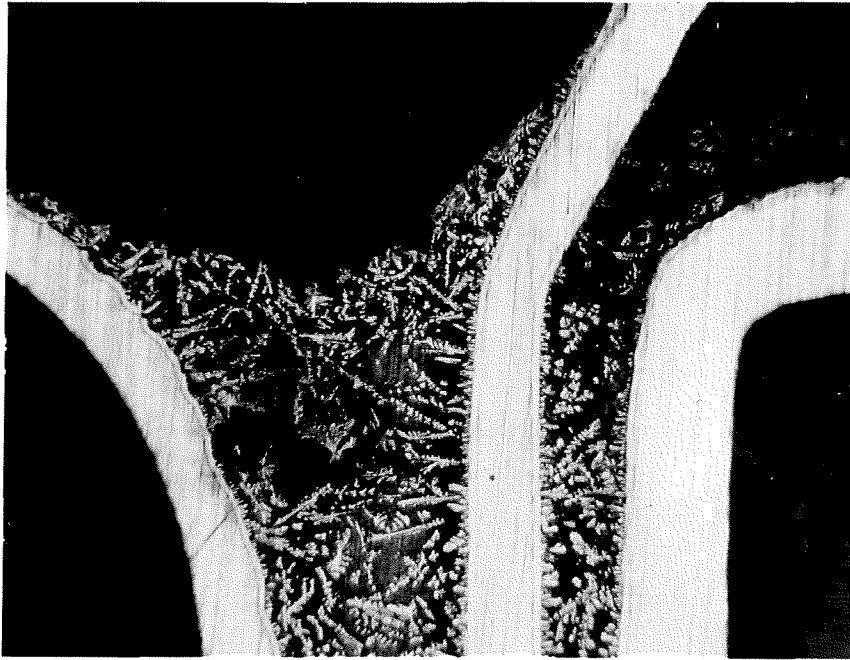
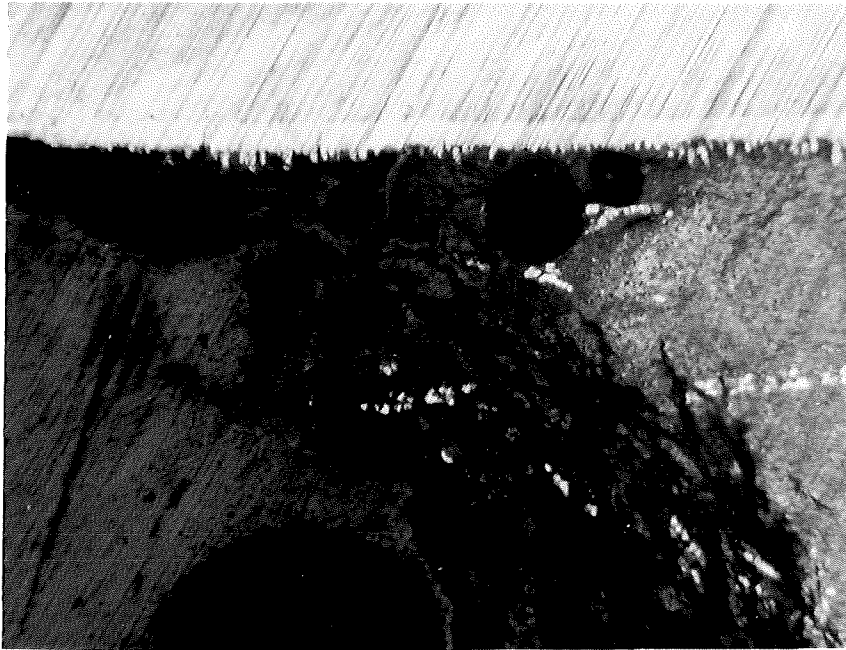
Figure 35

Cracks Developing in Joints Soldered with
89Zn-7Al-4Cu after 90 psig Test

The corrosion found in 89Zn-7Al-4Cu joints is shown in Fig. 35. A layering effect at the corroding surface of the solder can be seen with a family of small branching cracks parallel to the solder surface. The interfacial solder reaction product does not appear to have been affected at all. This solder was obviously capable of lasting considerably longer than the 1000 hr test,

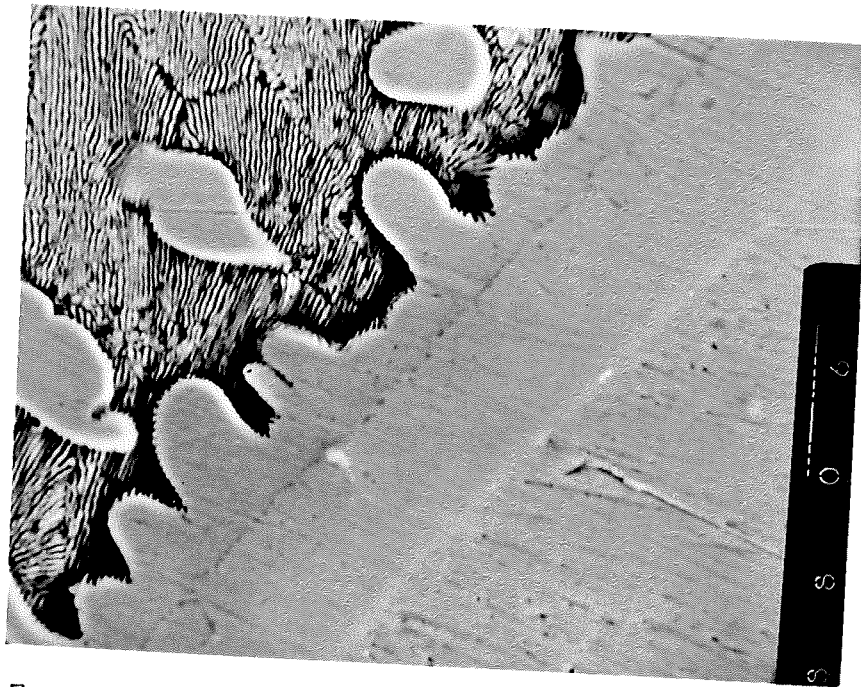
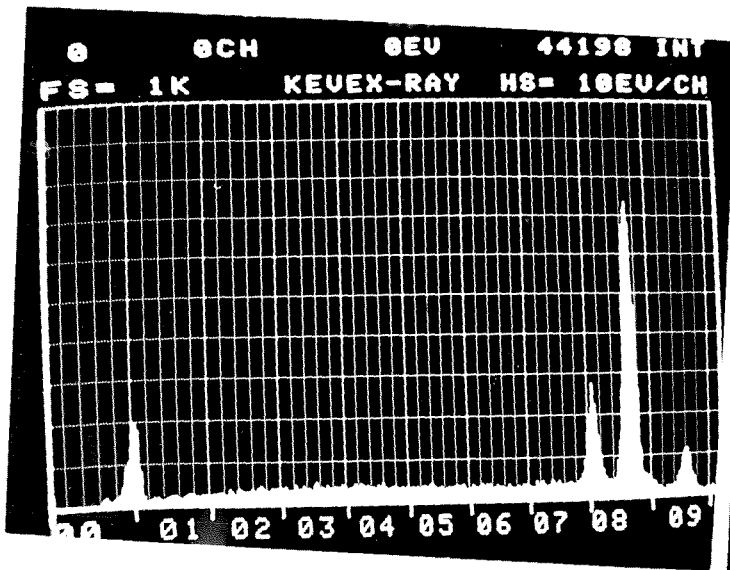
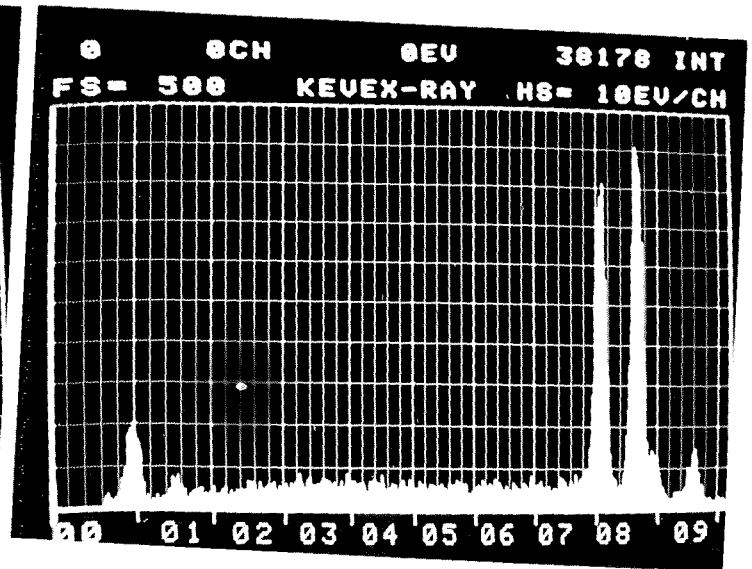
Figure 36

Interfacial Reaction Products Between 70Cu-30Zn Brass and 95Zn-5Al Solder. Zone A is ϵ phase and Zone B is γ phase, only traces of Al present.

The interfacial product resulting when soldering with zinc-based solders was briefly examined as shown in Fig. 36 because of the twin layers of reaction product at the brass surface. Zone A near the solder is identified as ϵ phase, and Zone B is identified as γ phase; only traces of Al were found in these zones which were principally copper-zinc alloy layers. Note the eutectic rods growing directly from the surface dendrites on the brass surface. No nickel layer remnants were identified,

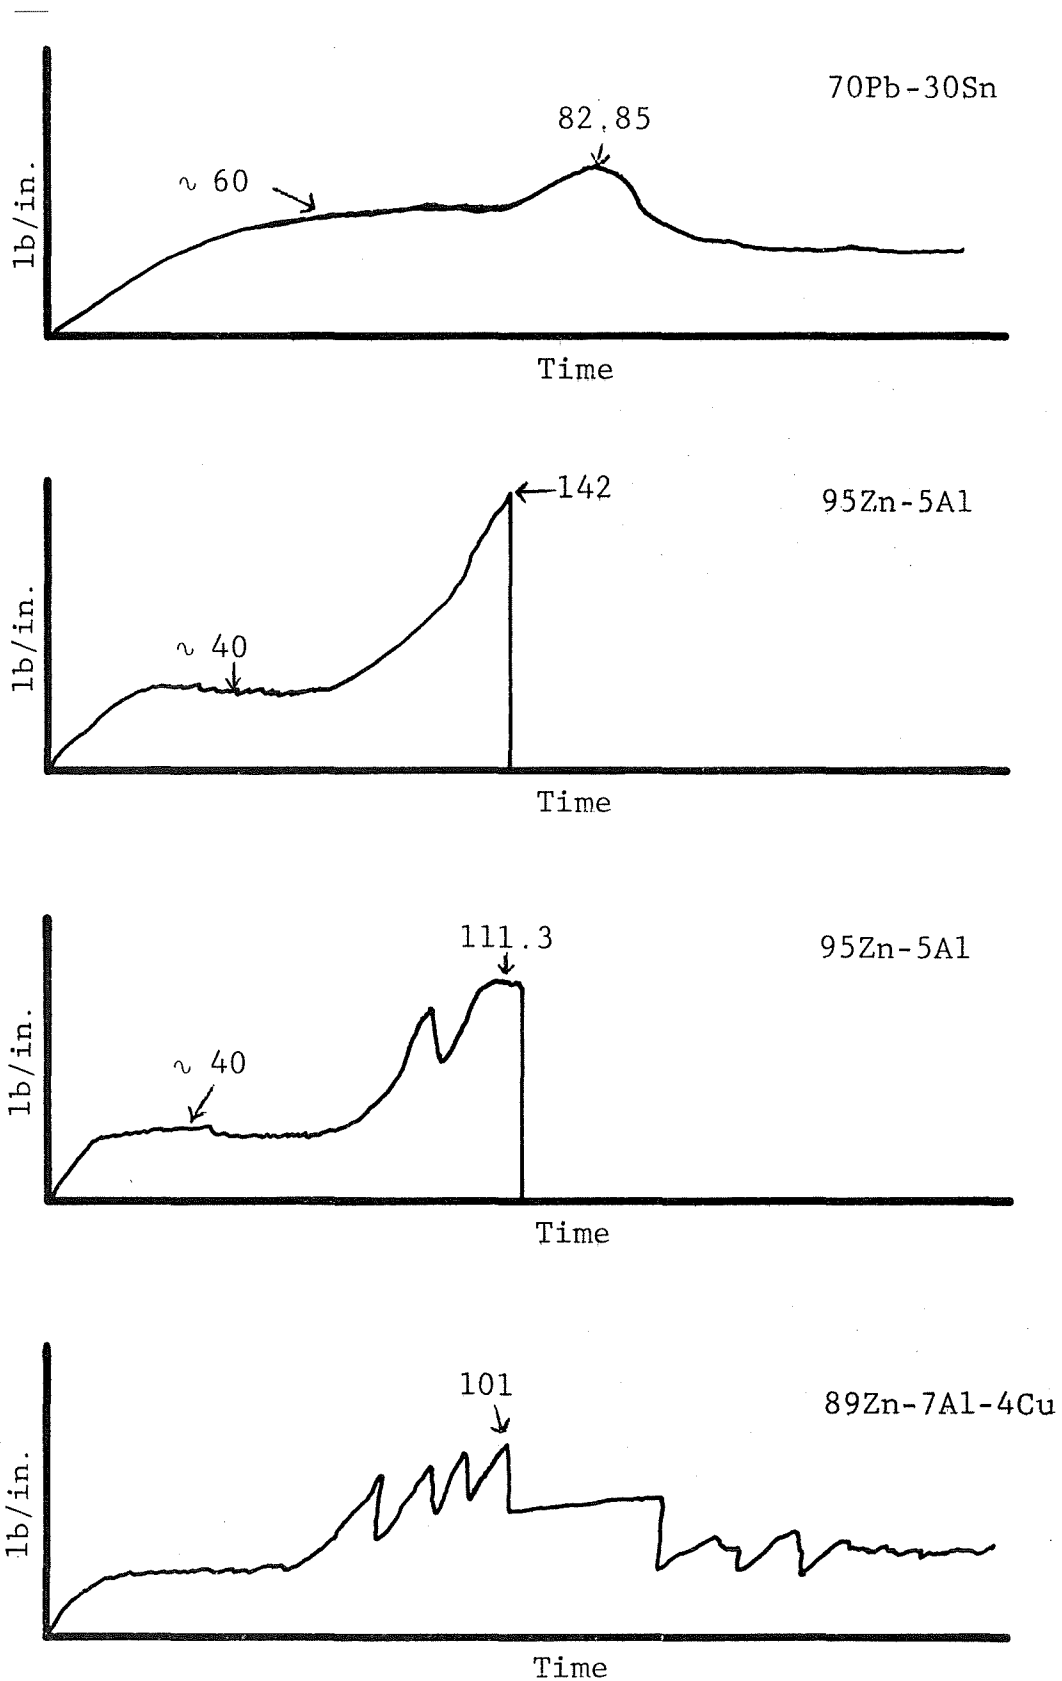
Figure 37

Tensile-Peel Properties of Capsule Soldered Joints
 at Room Temperature
 (All samples 1/4-1/8 in. wide.)

A limited number of tensile-peel mechanical tests were made on the soldered joints used on the test program. Results are shown in Fig. 37. Clearly, the 95Zn-5Al solder produces the strongest joint at room temperature. Tests were made at a strain rate of 0.1 in/min. The lead-tin solders show a typical fracture initiation peak and substantial propagation strength. The zinc-based solders have higher fracture initiation loads and then separate very rapidly. The preliminary nature of these observations must be recognized, and much further work is needed for positive strength comparison data to be developed.
