## Noise Control of an Underground Load-Haul-Dump Machine

**Final Report**

**Contract No. USBM ~~H026013~~ H0262013**  
**Noise Control of Underground Load-Haul-Dump Machines**

**July 1977**

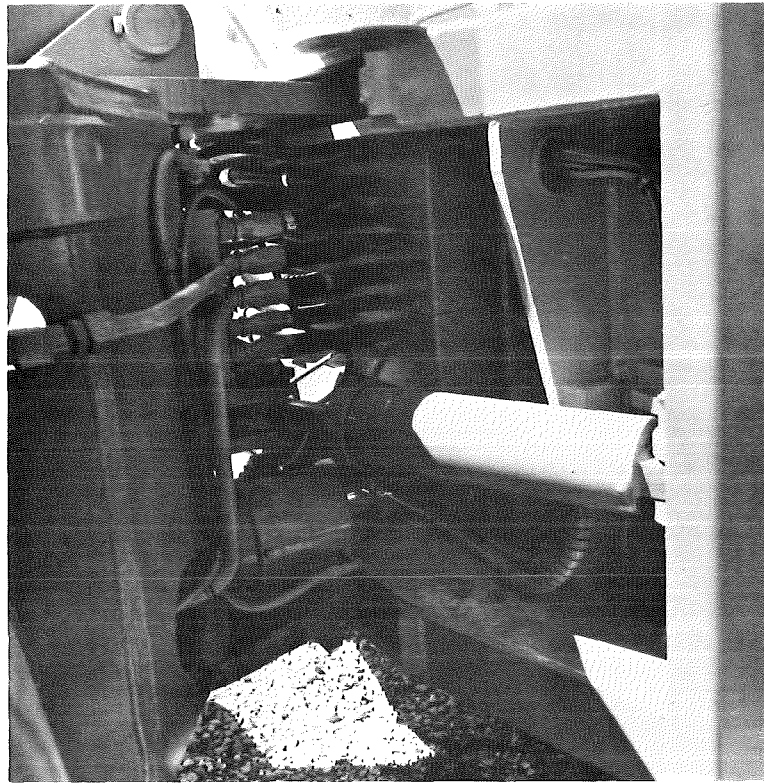
FIG. 25. TRANSMISSION FRONT COVER.

Figure 25 shows a cover plate which seals holes from the transmission compartment in the center where the machine is

pivoted. Noise coming through this area is reflected off the forward structure of the machine to the operator. This cover, which was made of 10-gauge steel, had 1/2 in. of polyurethane foam with 1/8-in. leaded rubber bonded to it to provide acoustical absorption and mass addition. The acoustical treatment weighed 1.7 lb/ft<sup>2</sup>. A final path for transmission noise included radiation from the belly pan, ground reflection, and passage through the grate at the operator's feet to the operator. This path was eliminated by welding a plate underneath the grate.

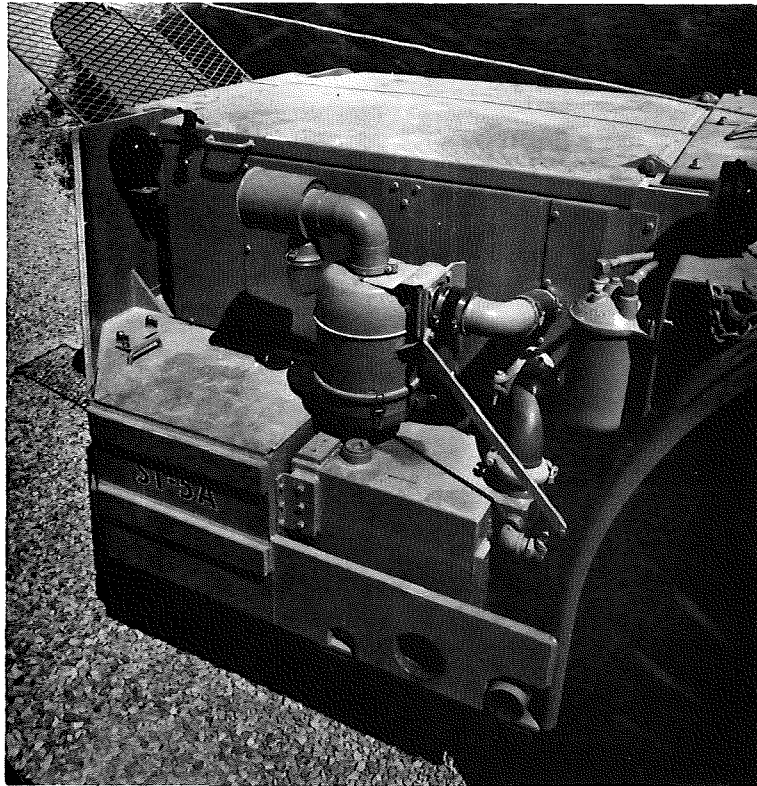
FIG. 31. ENGINE ENCLOSURE.

A major noise treatment for the machine involved the development of an enclosure for the diesel engine. The complete enclosure, shown in Fig. 31, consisted of a hood, side panels, and a

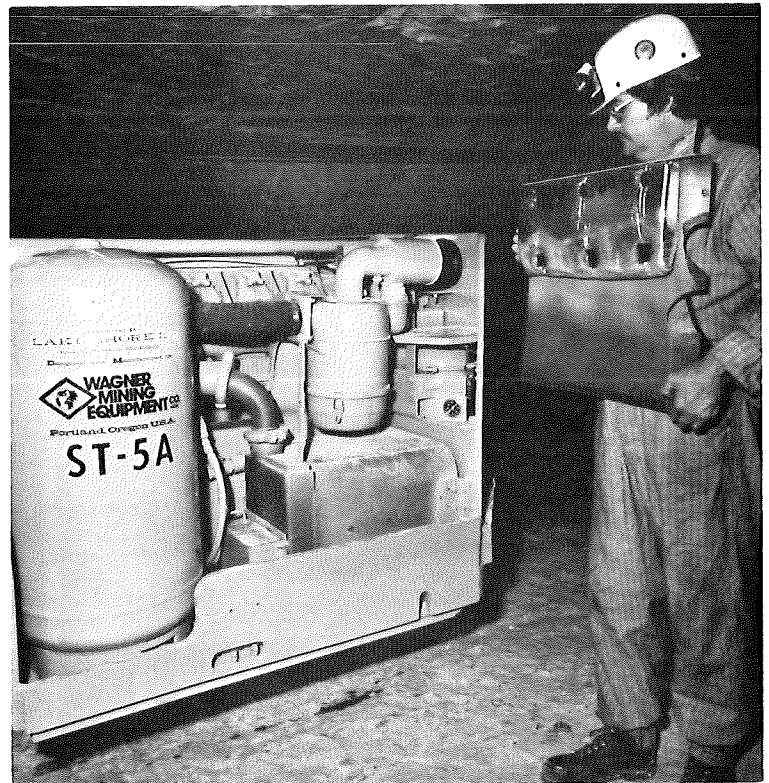
FIG. 32. COMPONENTS OF ENGINE ENCLOSURE.

belly pan with ducts for cooling air exhaust. The components are shown in Fig. 32. The major problem with enclosing the air-cooled engine was to ensure that sufficient cooling was provided for the engine and that the temperature did not build up in the compartment to a point where other components are damaged. This problem was solved with a two-step procedure: First, an enclosure and lined exhaust duct were designed; second, they were simulated in a test wherein temperature and pressure differential tests were conducted on the machine during operation. These tests were conducted in conjunction with the engine manufacturer, who, in addition, performed his own set of cooling tests. The results of the cooling tests, which indicate that there is
