**Information Circular 8983**

# **Improved Personnel Access for Surface Mining Equipment**

**By Dennis A. Long**

**BUREAU OF MINES**  
**Robert C. Horton, Director**

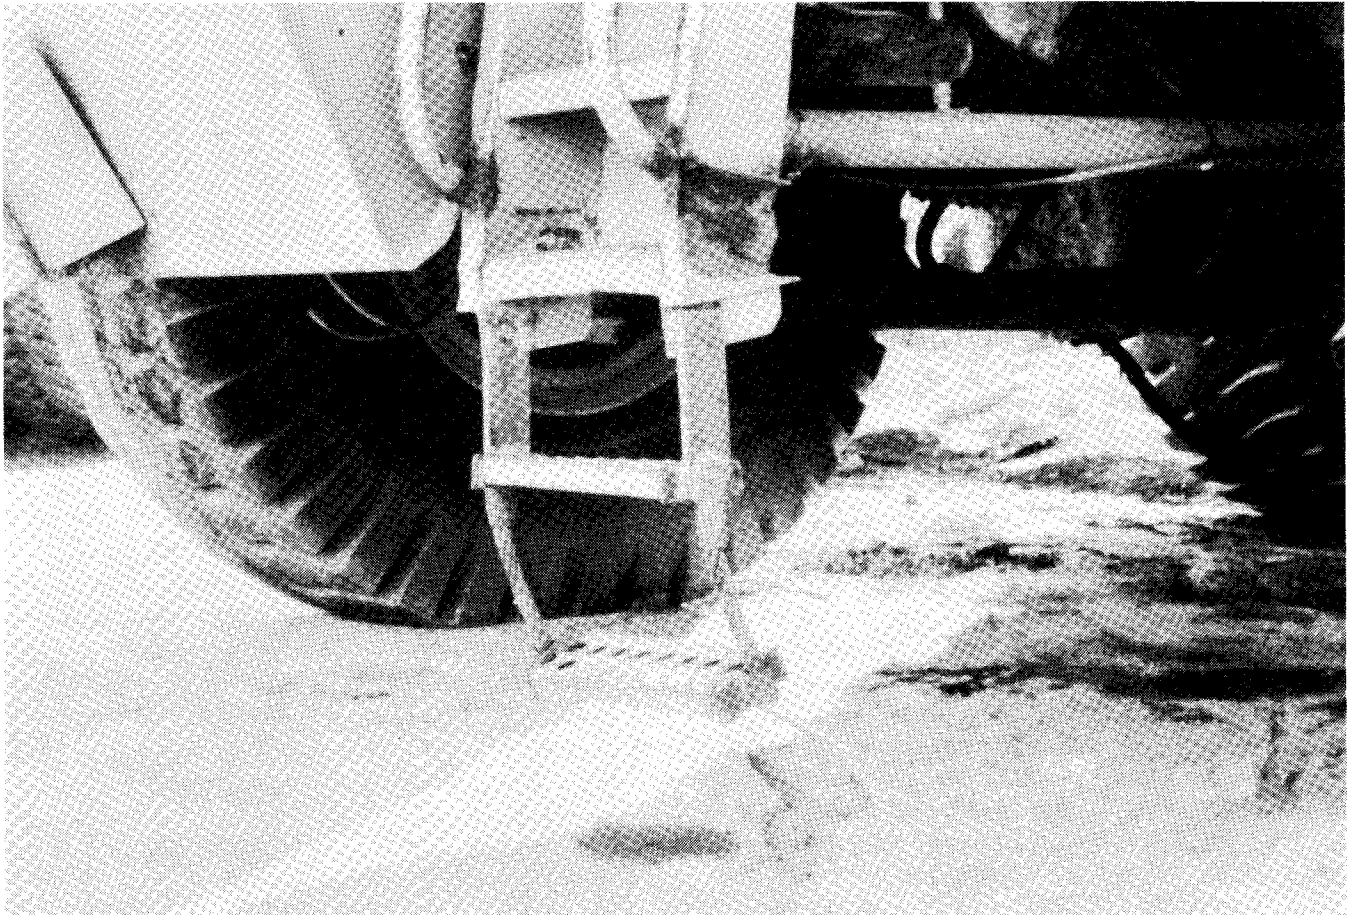
FIGURE 1. - Typical ladder on off-highway haulage truck.

adjacent to the left side of the engine compartment (figs. 1-2), with the angle of inclination between 75° to 90° (vertical). On some model trucks, the bumper

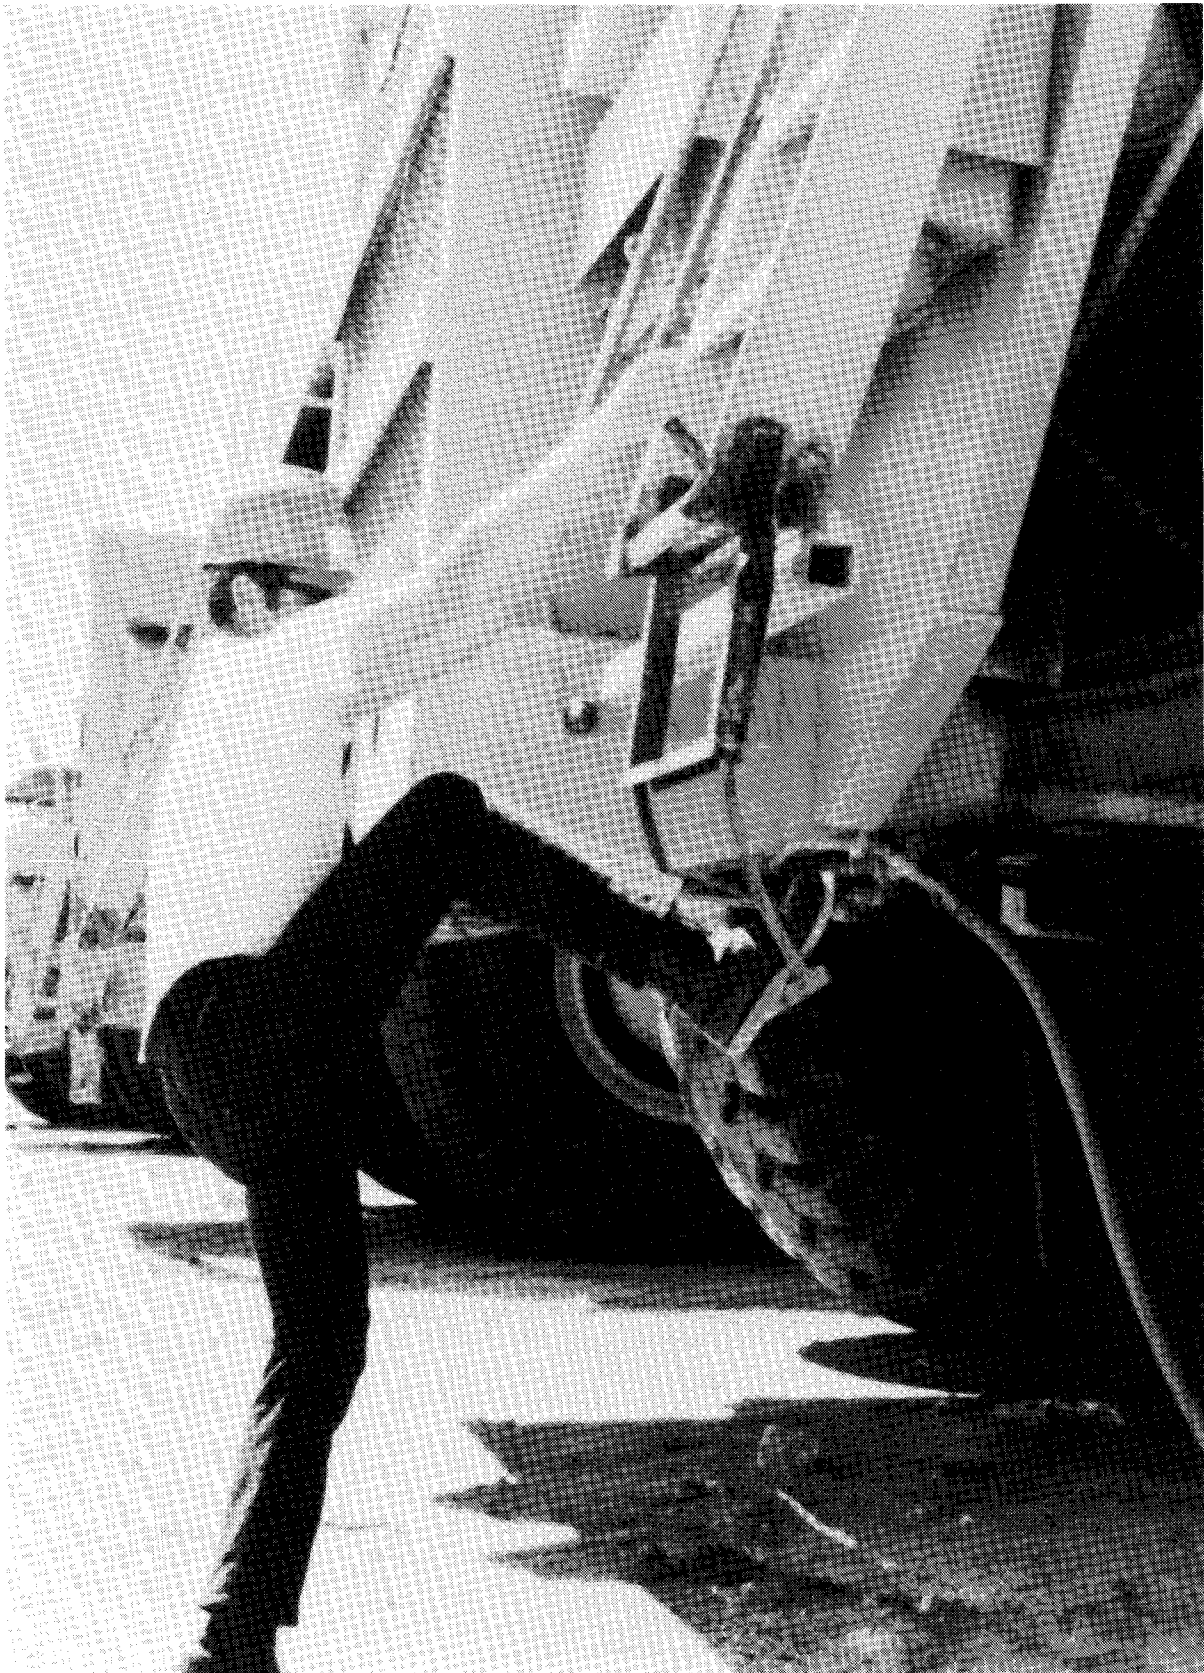
FIGURE 5. - Cable ladder showing height of first step.

To minimize damage, lower ladder supports are usually constructed from a very flexible material. Usually this means suspending the lower one or two steps on a cable which is then mounted to the bumper or the ladder. These wire rope or cable ladders are invariably knocked out of position, and do not return to their initial configuration (figs. 5-6). The height of the lower rung is usually about 36 to 42 in above the ground. Drivers and other personnel ascending or descending the vehicle using these damaged lower steps are subject to knee and shin bruises, scrapes, or worse. The flexibility of the ladder supports for the lower steps and the fact that the steps are too high for the operator to mount and dismount the machine safely contributes to the slip and fall accidents.

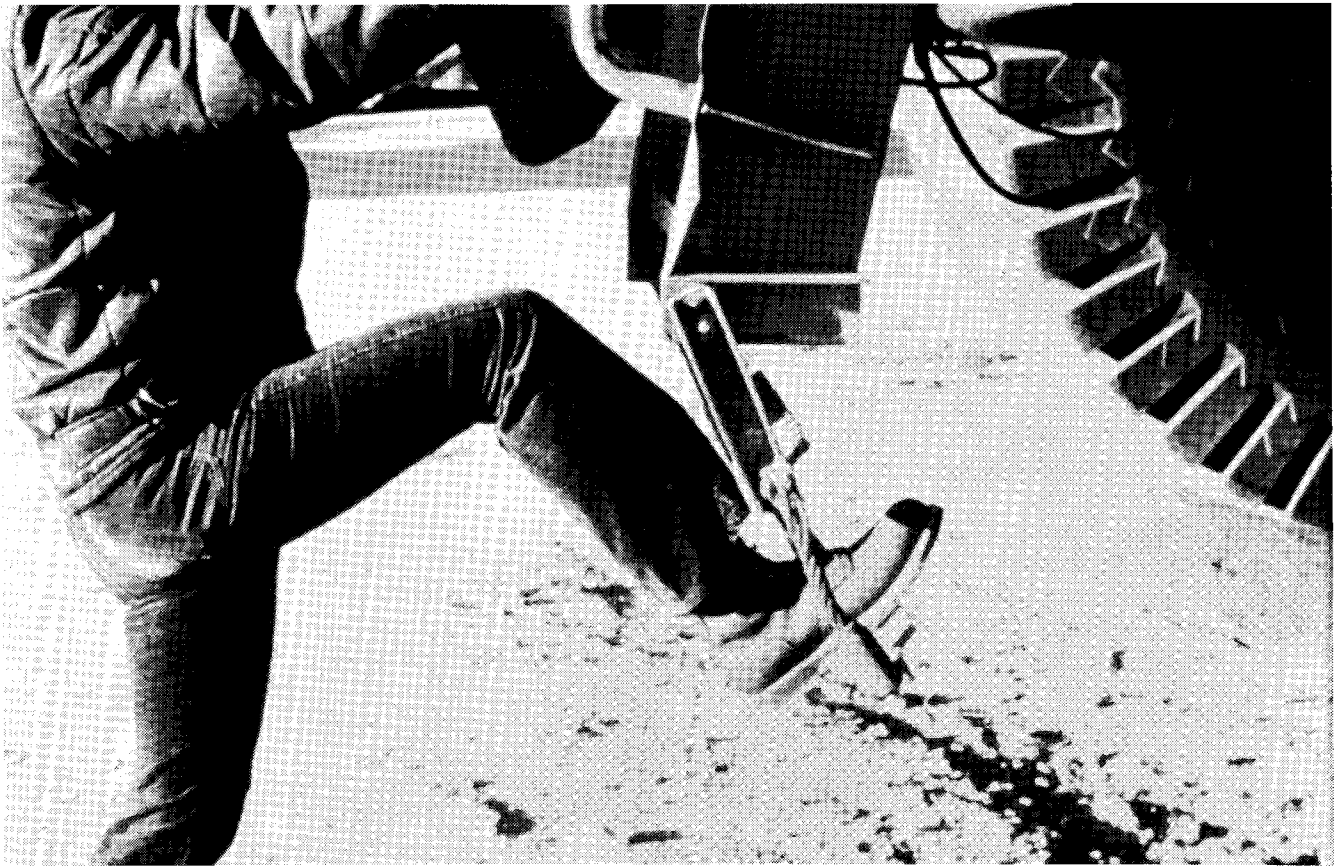
FIGURE 6. - Cable ladder showing lack of rigidity when stepped on.

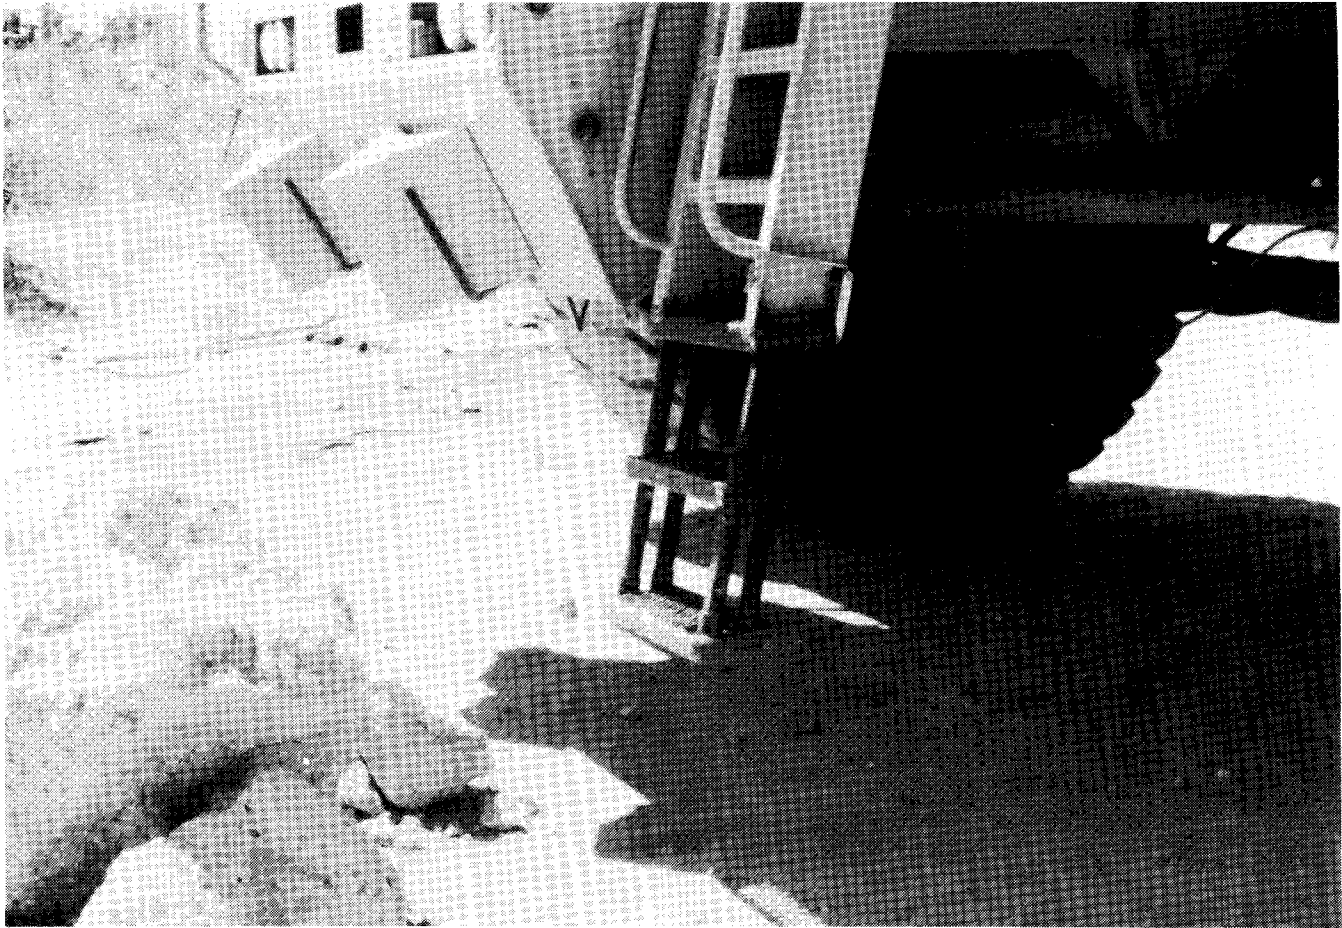
FIGURE 8. - Spring step retrofitted to truck ladder.

Several primary lower ladder designs were subjected to use by mine personnel and field evaluation, and structural-testing demonstrations. As a result of the initial field demonstrations, it was concluded that the four-spring design (figs. 7-8) could appreciably reduce slip
