Information Circular 9199

Mining and Reclamation of a Central Florida Forested Wetland: A Case Study

By J. R. Boyle, Jr.

BUREAU OF MINES
T S Ary, Director

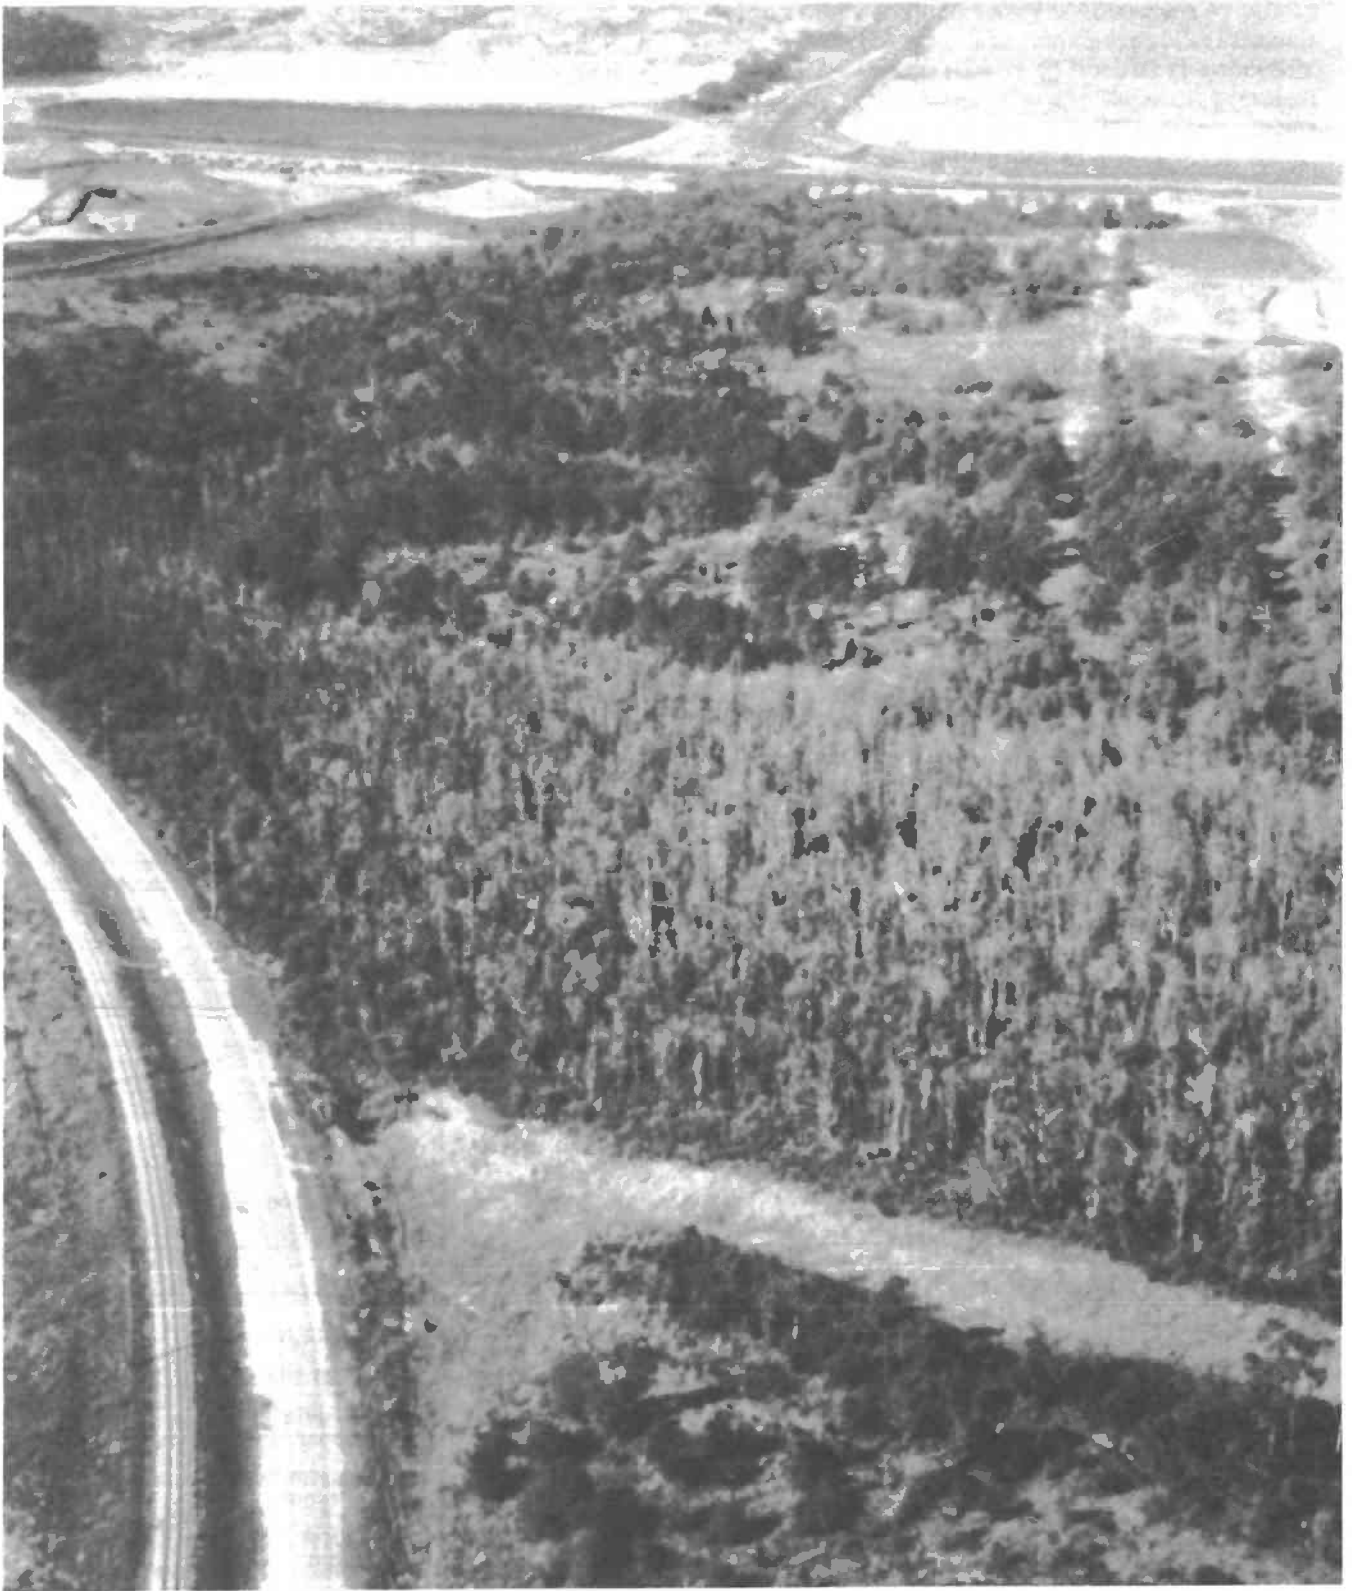
FIGURE 3.—Aerial photograph showing wetlands test site.

(fig. 3) and was part of a 37.2-ha tract of land designated by AMAX, Inc., as Mining Unit No. 1C. The site was in the central portion of No. 1C (fig. 4) and was permitted for mining as a part of this unit.

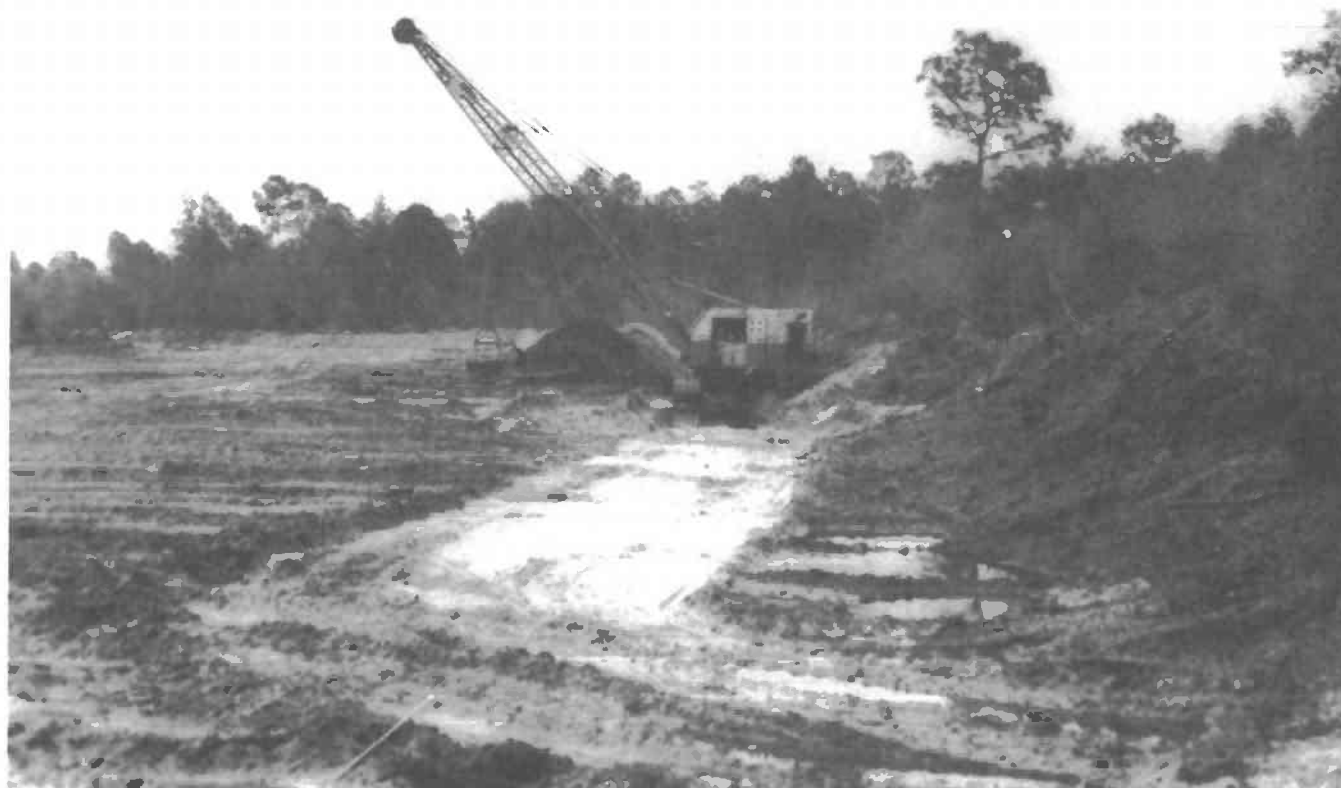
FIGURE 12.—Dike construction during test site preparation.

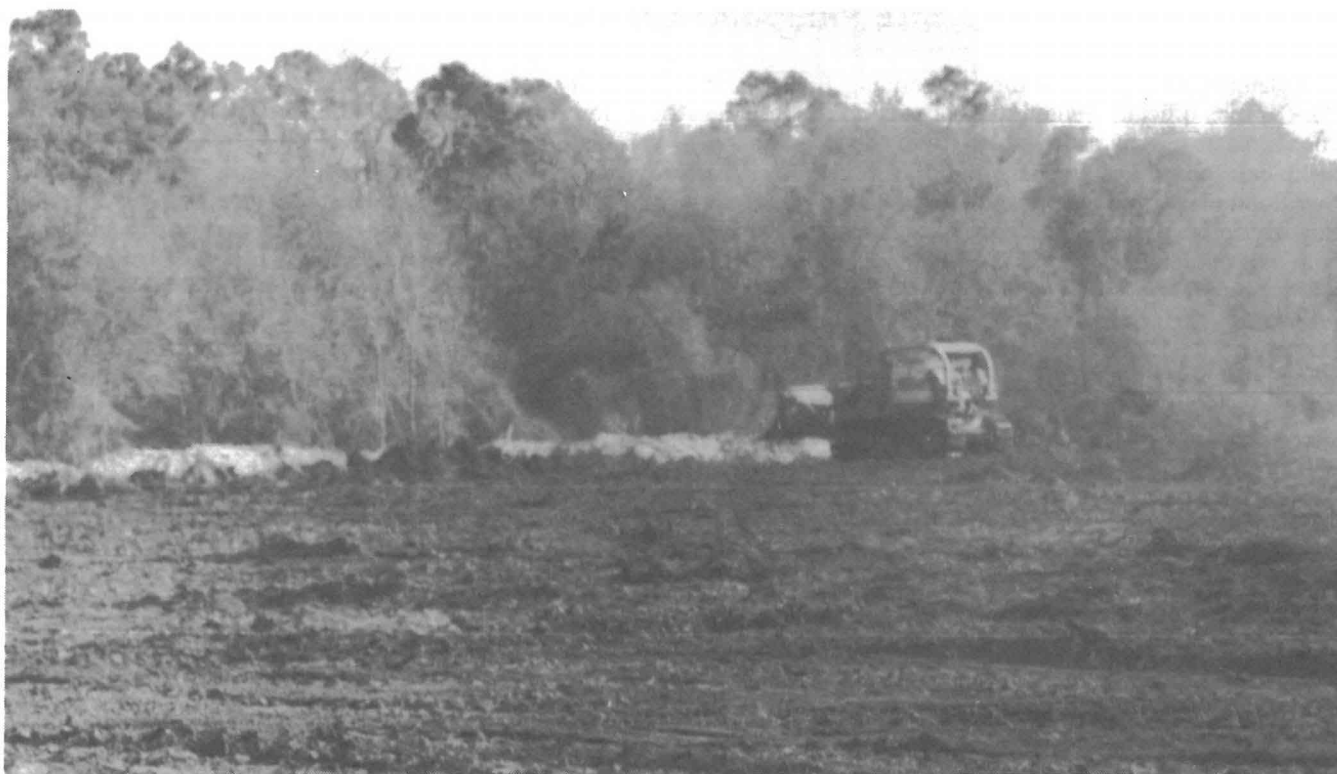
FIGURE 13.—Bulldozers clearing overstory before mining.

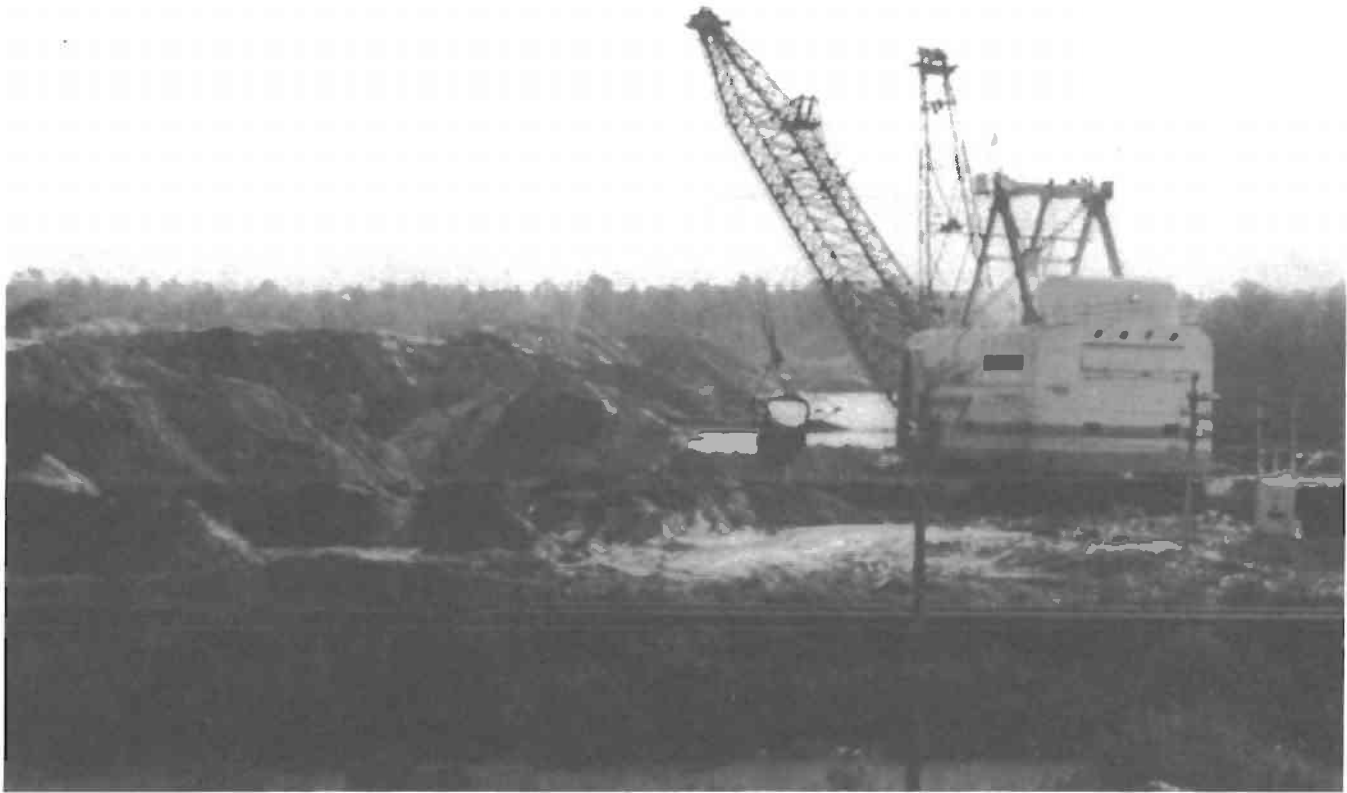
FIGURE 15.—Dragline mining test site.

Site preparation and mining began in October 1983 and was completed by April 1984. Mining was accomplished using a 22.9-m³ dragline operating through a sequence of cuts as shown in figure 14. Because the area did not include a clay lens or any other hardpan aquiclude, standard overburden spoil placement techniques were used during mining. Figure 15 shows the dragline as it mined the test site.

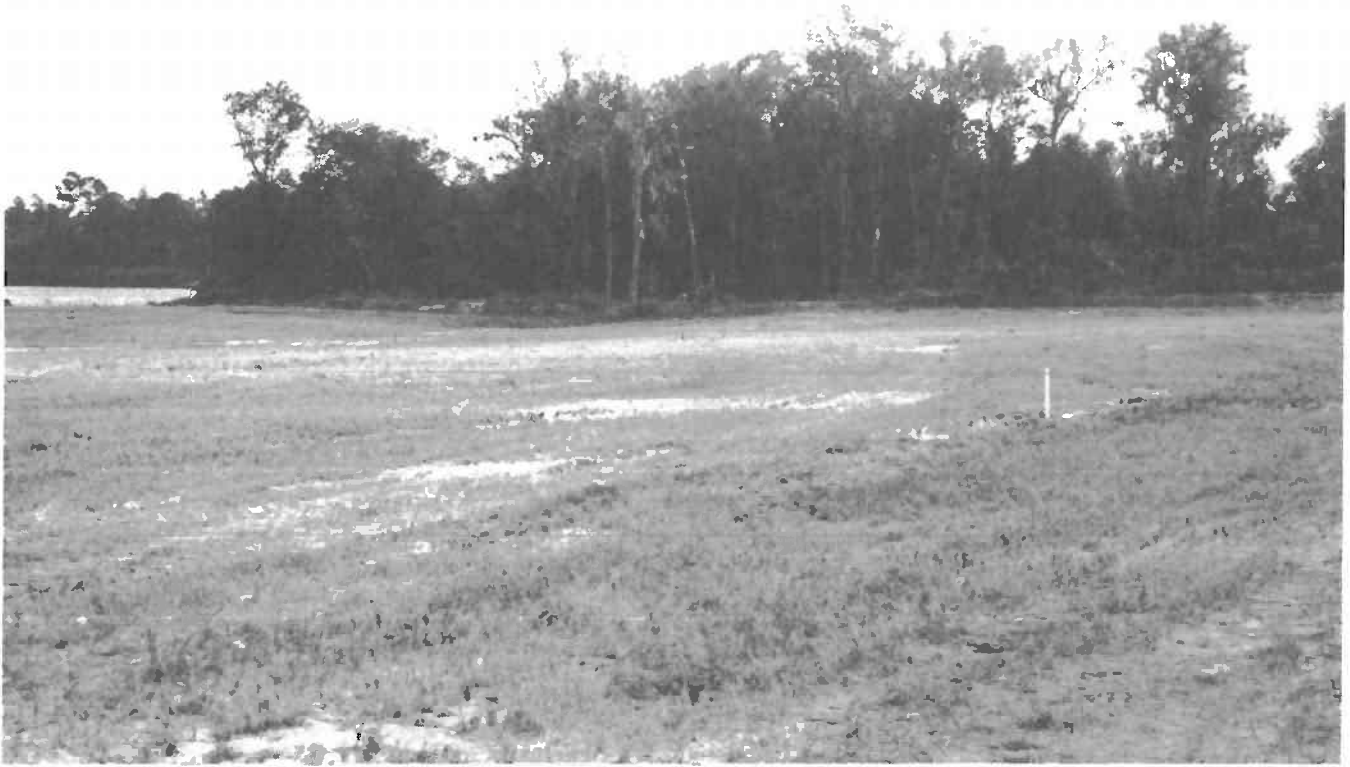
FIGURE 16.—Site after completion of grading, with cover crop established.

When final grading was completed, a cover crop of millet (fig. 16) was sown and 10-10-10 fertilizer was applied at the rate of 500 kg/ha. This planting was initiated to control erosion, provide mulch to limit sunlight, conserve soil moisture, and out compete weed species.

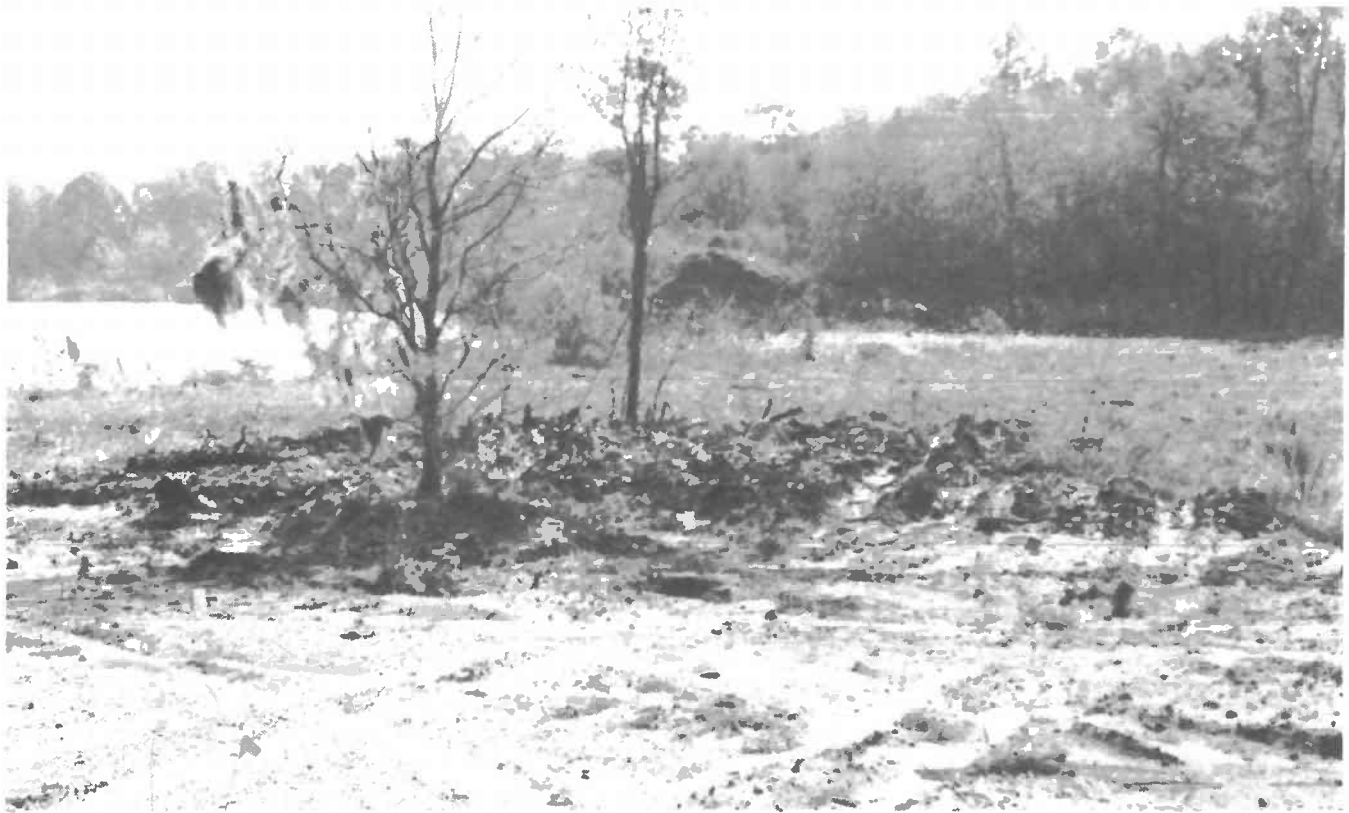
FIGURE 19.—Transplanted vegetation island.

During January and February 1987, vegetative islands were transplanted along the reestablished meandering swale (fig. 19). The islands, made up of vegetation and several feet of surface soil, were transplanted using a large front-end loader. Two trees were spaded with each island to provide ground cover shading.
