# Chemical Analysis of Slickensides From Coal Mine Roof Shale

Report of Investigations 7858

By George A. Savanick and Rayfield W. Cabaniss  
Twin Cities Mining Research Center, Twin Cities, Minn.

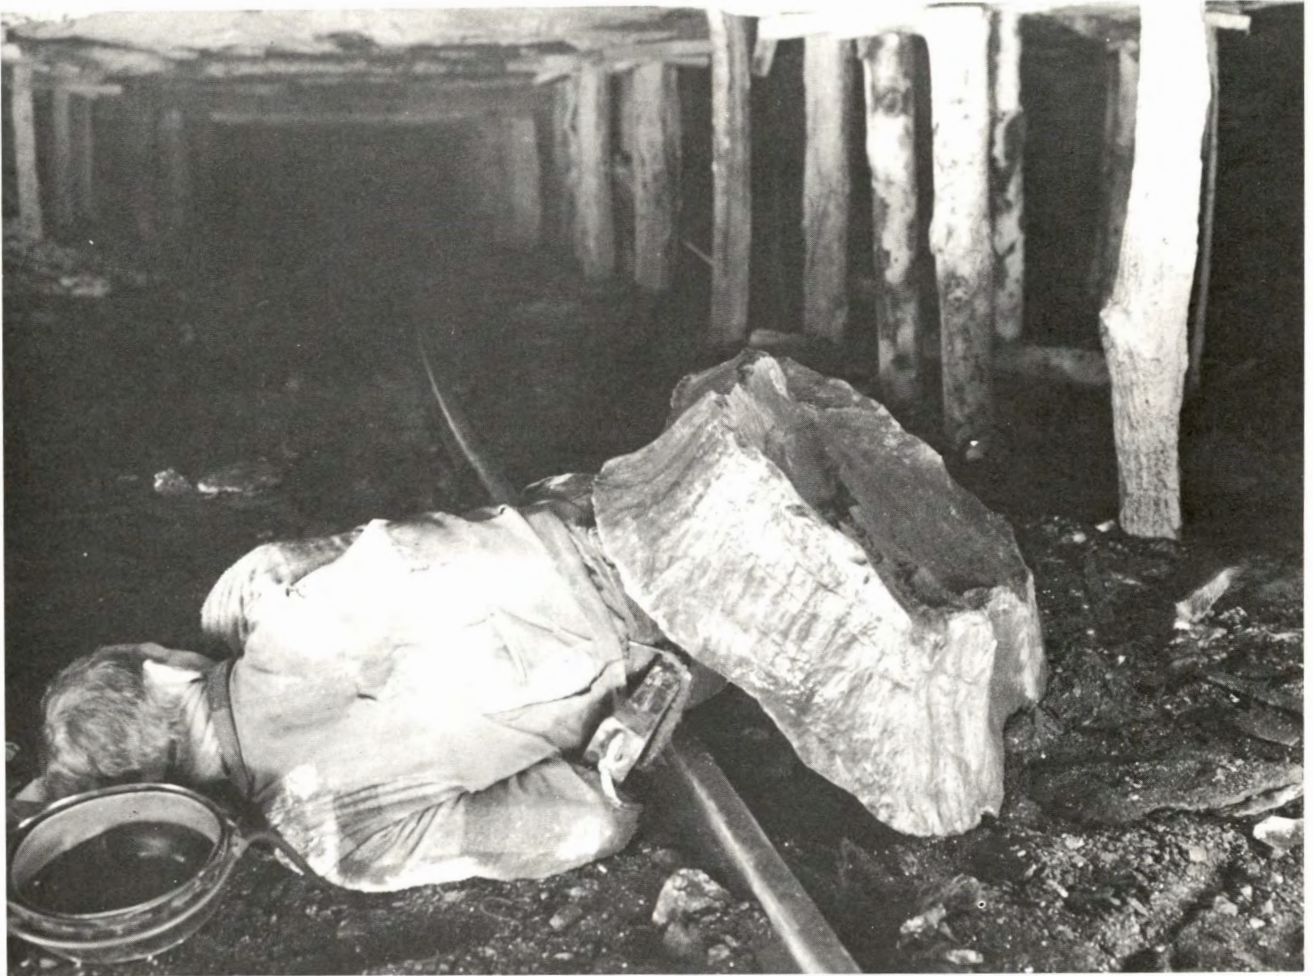
FIGURE 1. - Illustration of the hazards posed by fall of a kettle bottom.

Shales in the roof of coal mines often break preferentially along slickensided surfaces forming blocks of rock which are loosely held in the roof. These rock blocks can fall without warning and cause serious injury to miners (fig. 1) (4).<sup>3</sup> These rock masses are especially treacherous because their presence cannot always be detected and because their dimensions are often smaller than the roofbolt spacing in a normally adequately supported area of the roof so that they can fall between the bolts.

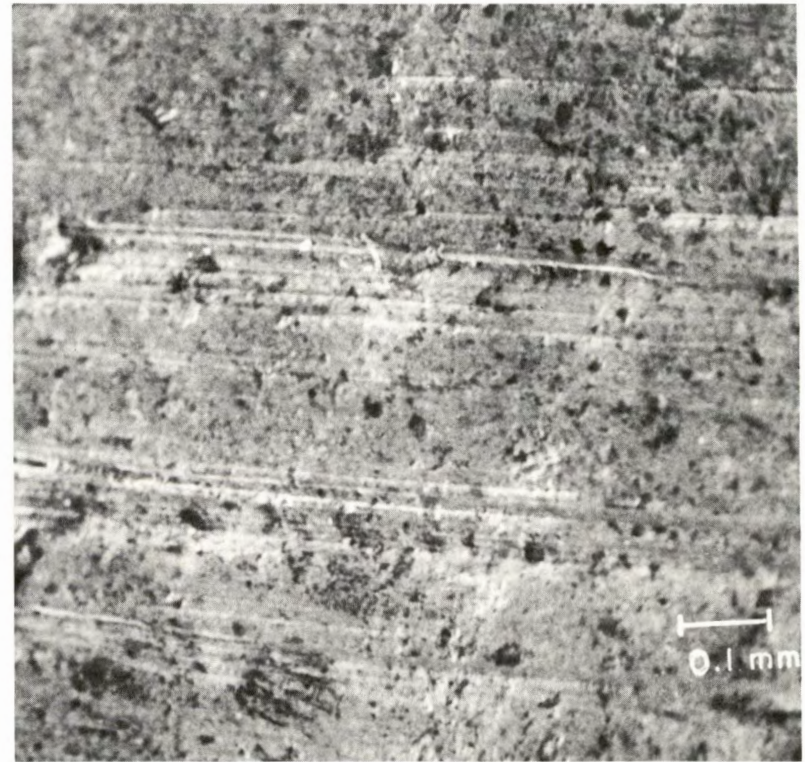
FIGURE 4. - Grooves in a slickensided surface.

Scanning electron microscopy of such slickensided surfaces revealed that the texture of the slickensides is much different from that of the bulk of the shale (fig. 3), and showed grooves in some of the slickensides (fig. 4).

The differences in texture might be a reflection of crushing caused by the motion of the shale on one side of the slickensided surface with respect to the adjacent shale. The presence of grooves in the slickensides is also evidence of differential motion across the slickensided surface.
