**Bureau of Mines Damage-Resistant
Brattice**

Report of Investigations 8270

By Edward D. Thimons, Joseph E. Matta, and Fred N. Kissell

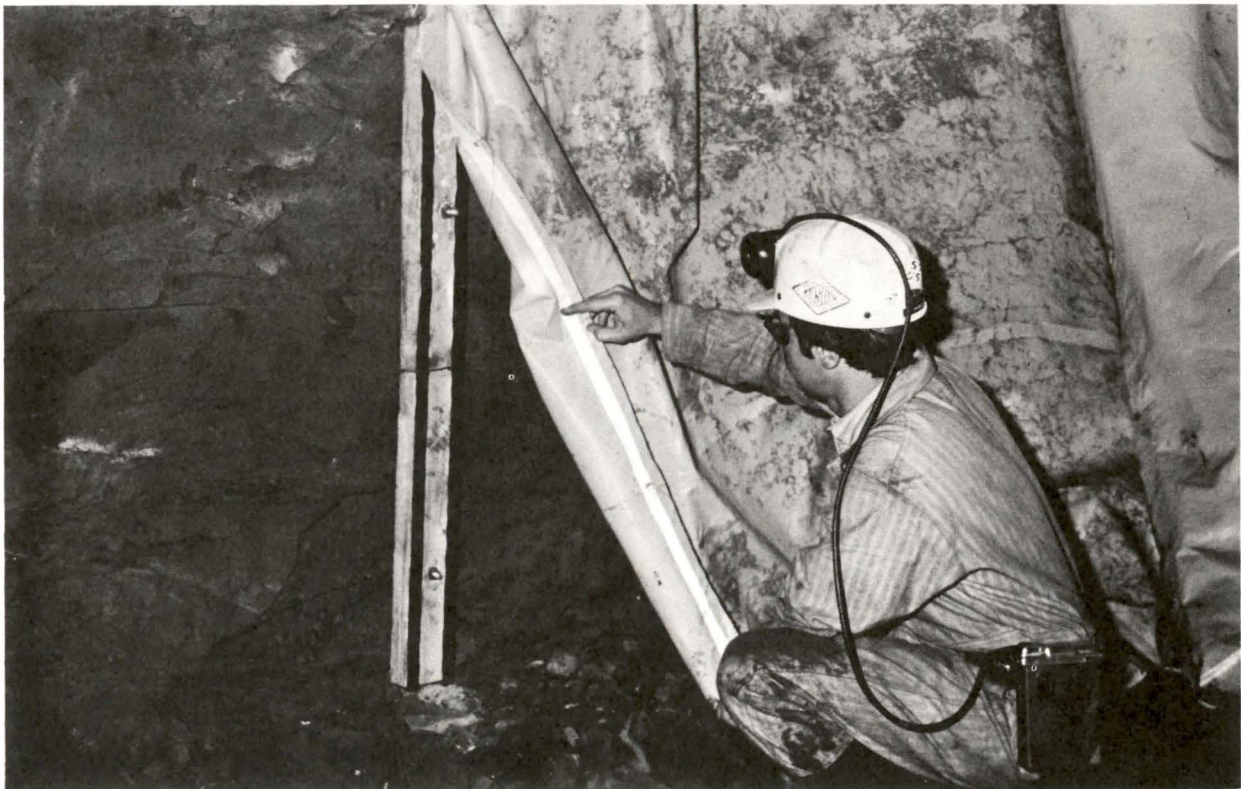
The end panels of the damage-resistant brattice can be attached to the walls or left to hang free, depending upon how complete an air seal is needed. If the brattice is to be attached to the walls, a Velcro seal is obtained by attaching boards down the walls and stapling Velcro hook or pile strips to these boards (fig. 5). The end panel edges can be attached to these boards. It is important to leave 1 foot or more of excess material on the end panels to make these wall attachments.

FIGURE 5. - End panel being attached to wall with Velcro seal.

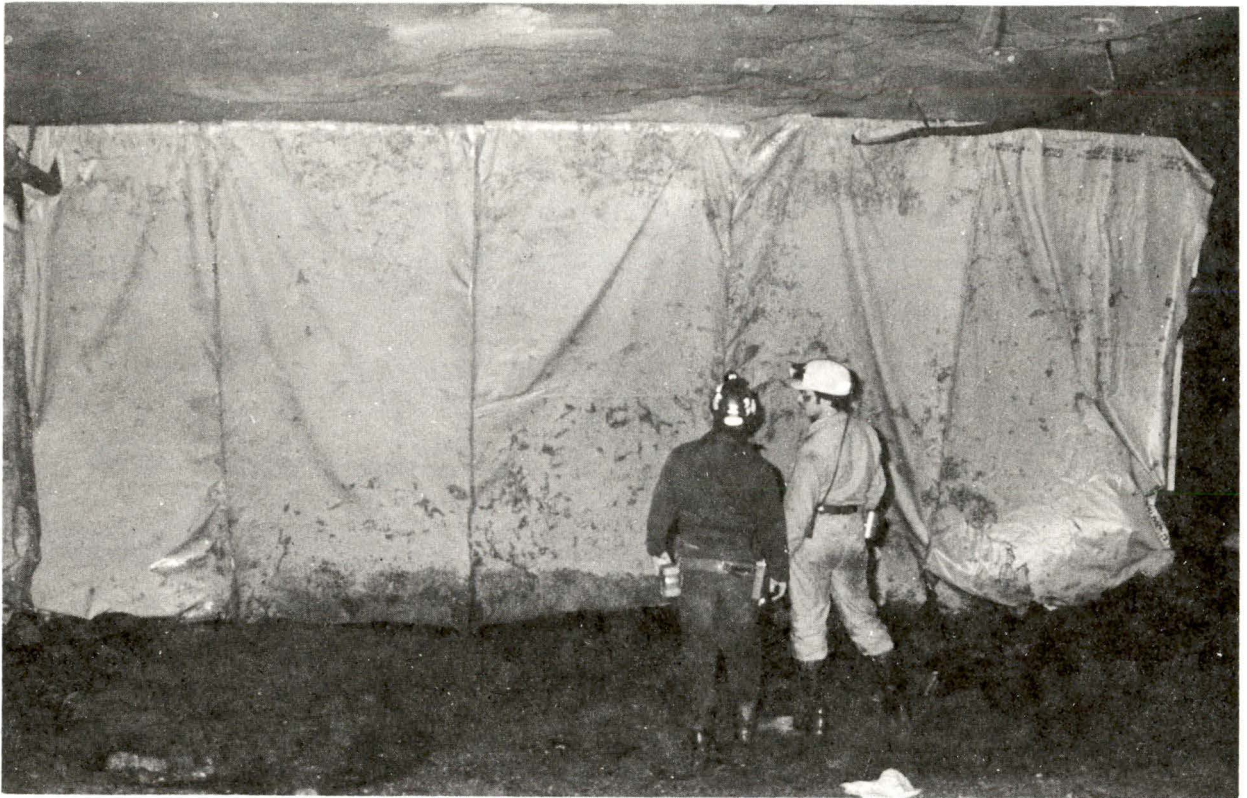
through it. When the damage-resistant brattice was completed (fig. 7), there was no measurable airflow in the airway, although some leakage occurred at the walls where the brattice hung unattached.

FIGURE 7. - Damage-resistant brattice at White Pine copper mine.

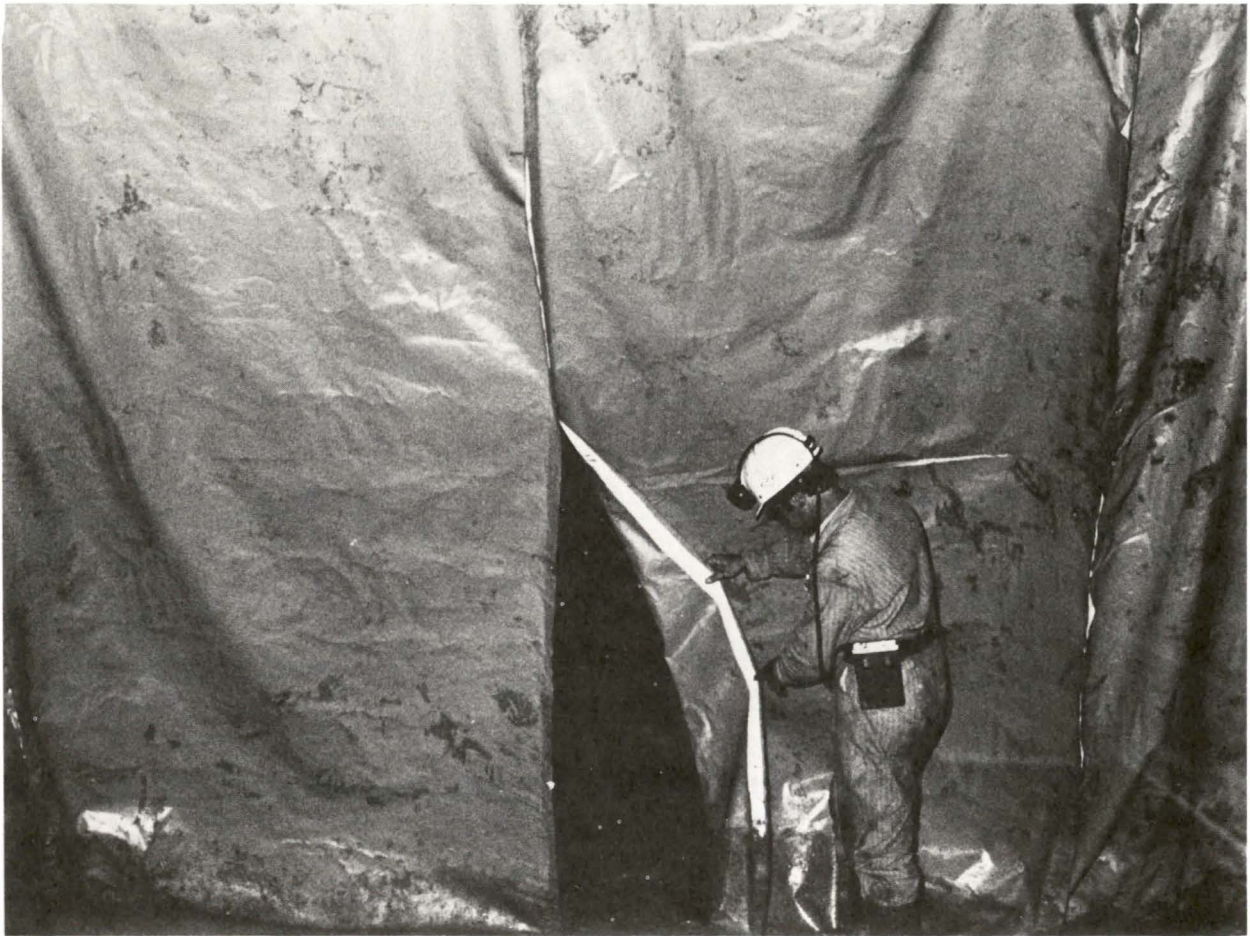
This brattice withstood a blast of 500 pounds of nitrate and 35 pounds of dynamite originating only 180 feet away. The brattice peeled open at one wall, and a few of the center panels opened slightly.

FIGURE 8. - Brattice peeled open by blast.
