Public Health Assessment

Former Gopher Ordnance Works

ROSEMOUNT, DAKOTA COUNTY, MINNESOTA

**Prepared by
Minnesota Department of Health**

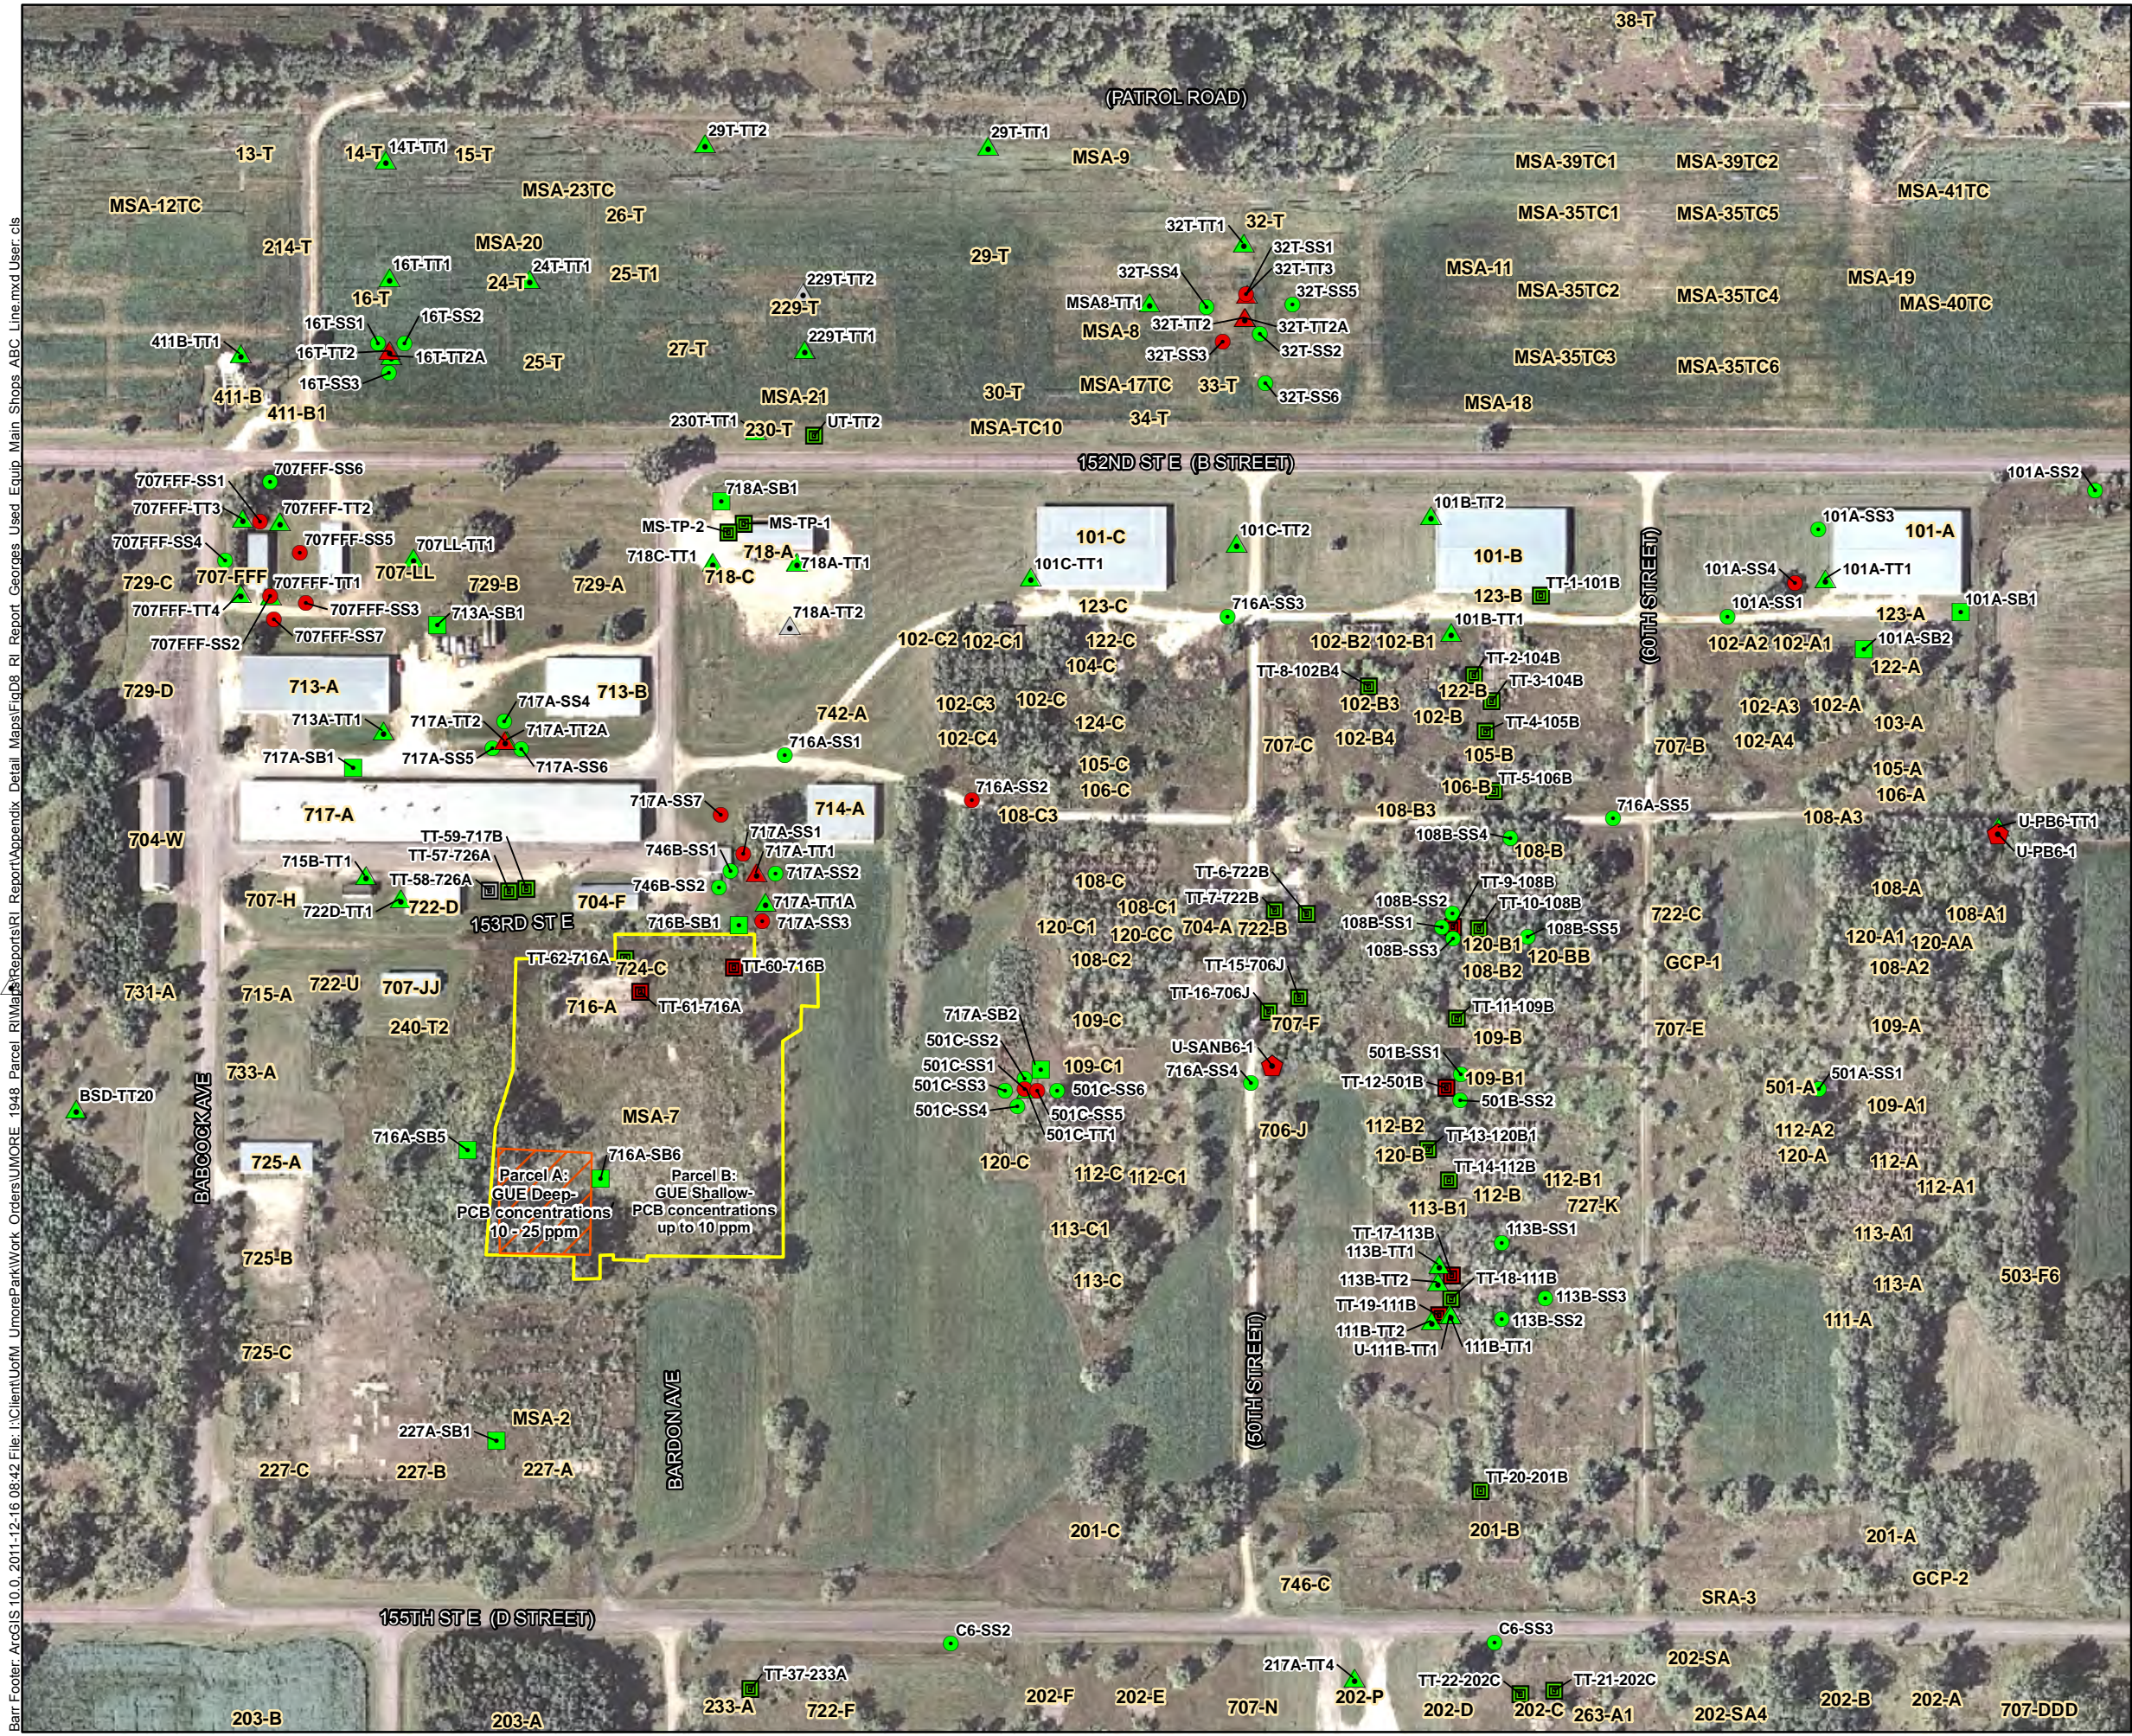
- Pre-RI Sample Locations**
- Pre-RI Sample Location
 - Wells and Borings Surveyed by Barr
- 2011 RI Investigation Locations**
- Sewer Sediment Sample
 - Soil Boring
 - Surface Soil Sample
 - Test Trench
- Laminex Woodbox Sewer

*Red symbols indicate locations of soil samples with Tier I SRV exceedances
*Gray symbols indicate investigation locations where no soil data was collected

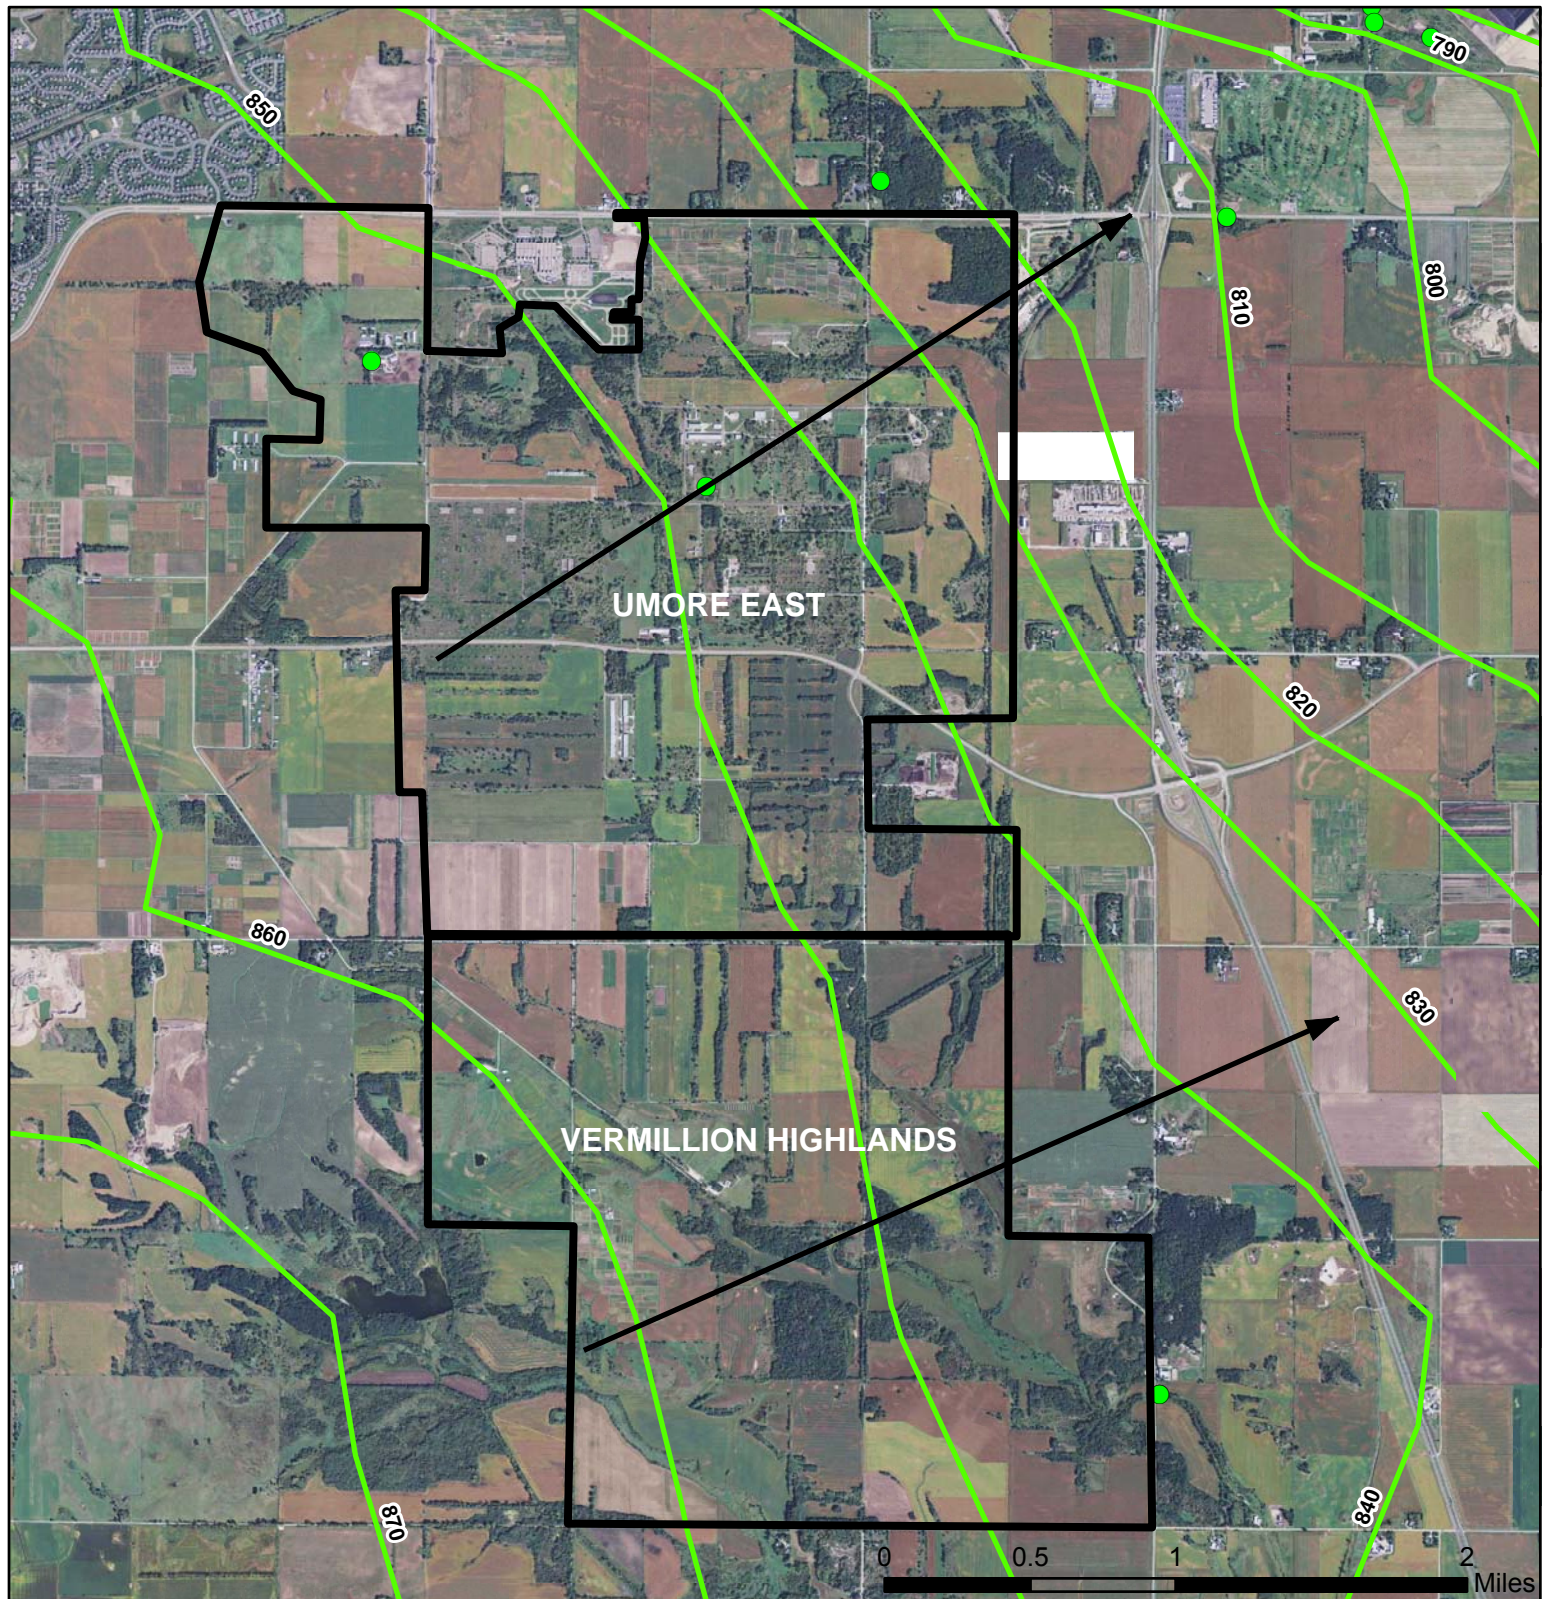
Figure 18: Flow Directions in Quaternary Aquifer

- Quaternary aquifer well
- Water level elevation contour (ft. above mean sea level)
- ➔ Groundwater flow direction

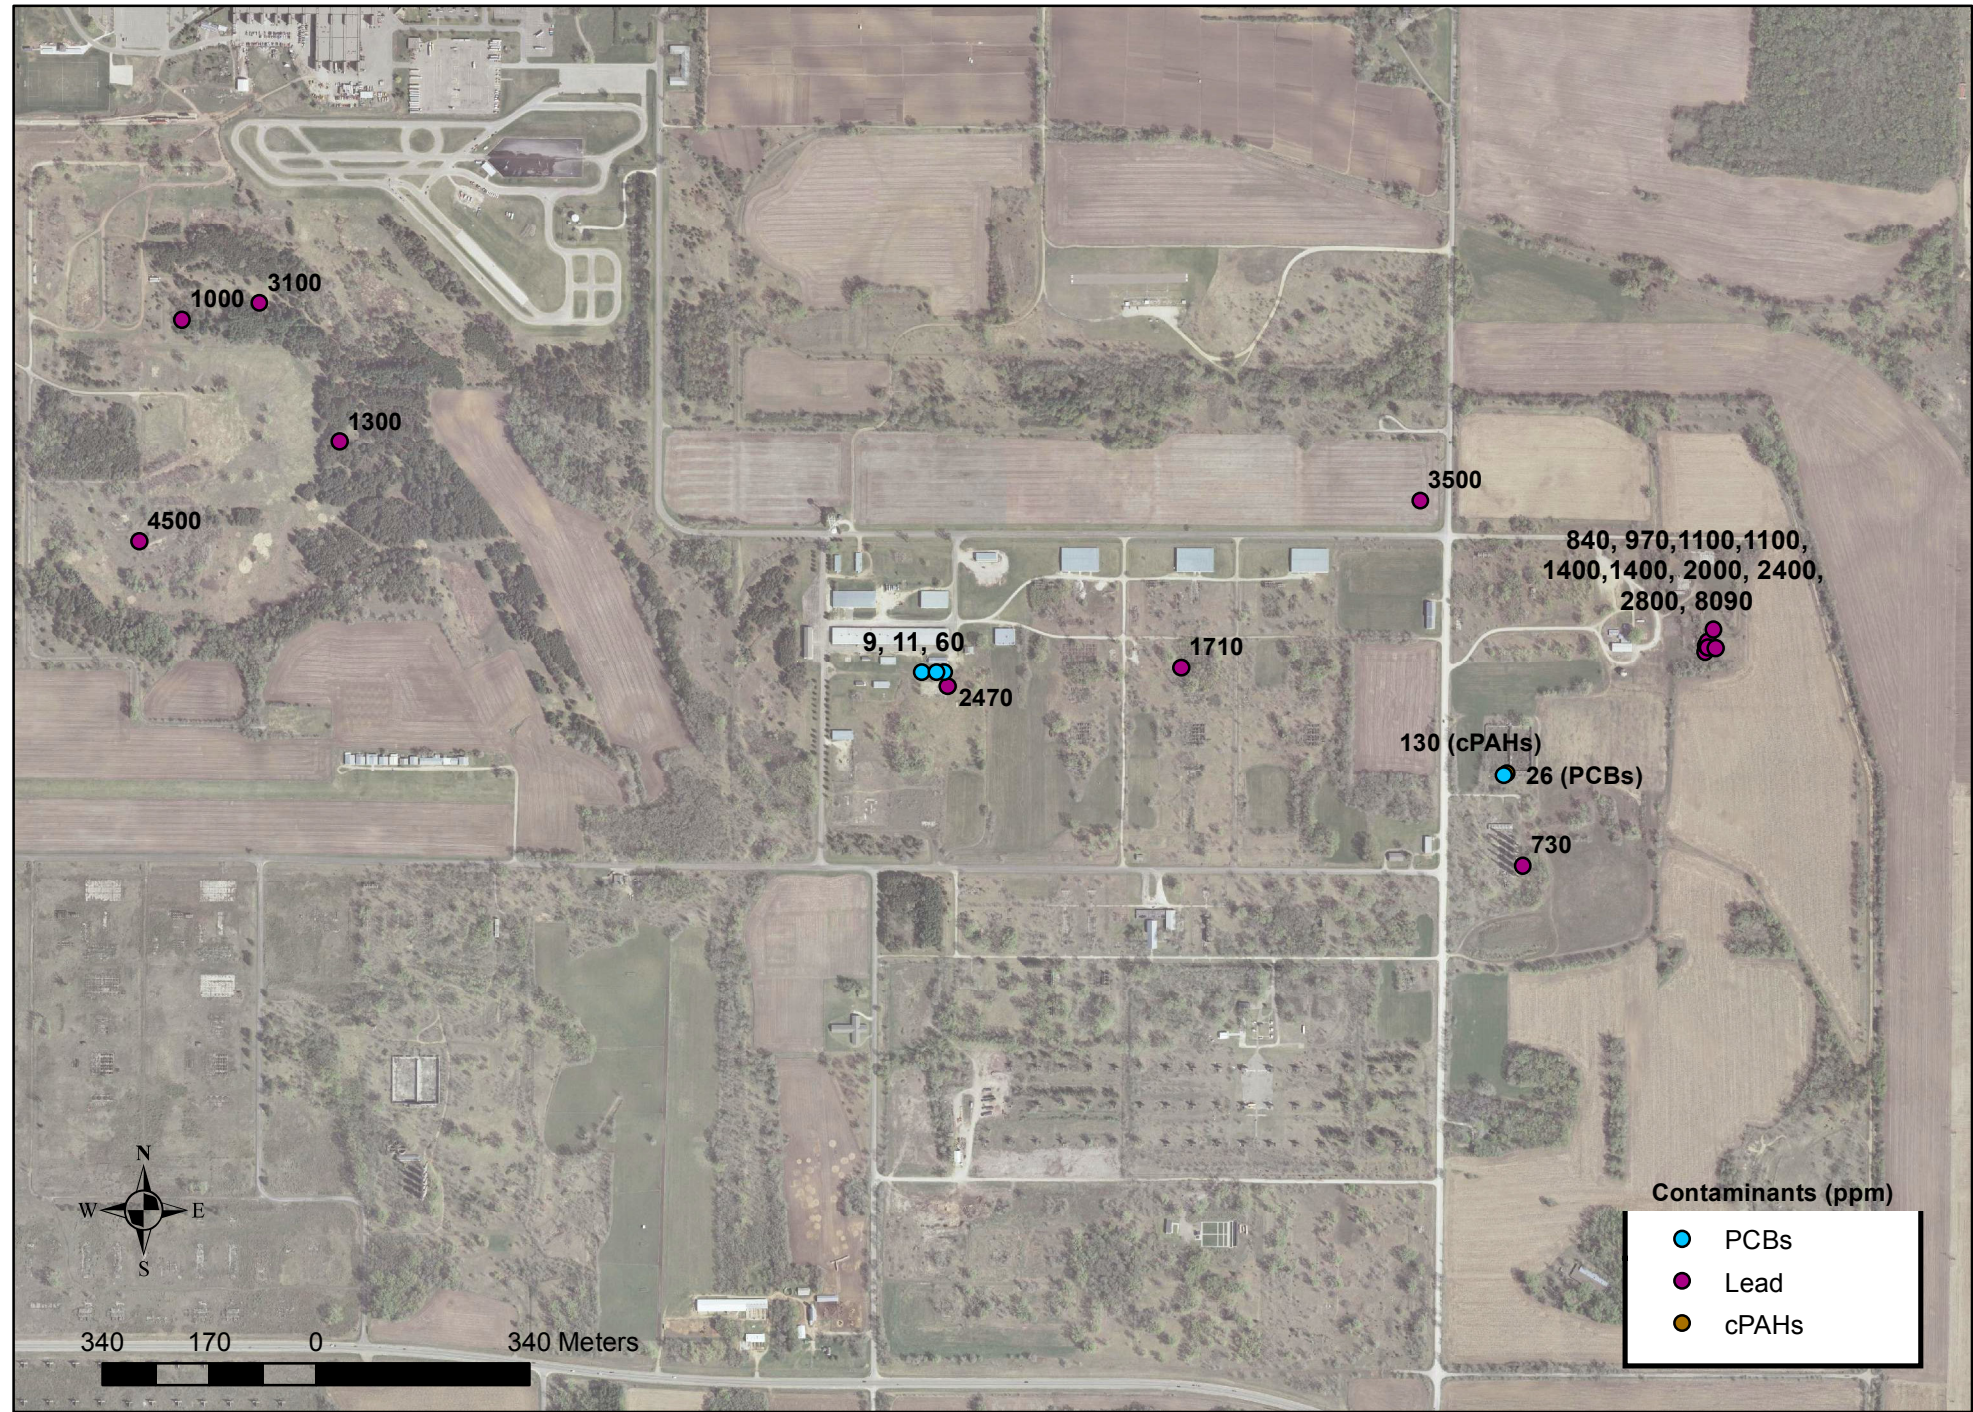
A concentration of cPAHs of 260 ppm is located off of the map in the southern portion of the former GOW drainage basin in the Vermillion Highlands.

Figure 24: Highest PCB, lead, and cPAH concentrations in surface soil that are recommended for removal
