**REPORT#:** 23CA004

## A Tow Truck Operator Dies on a Highway When He Is Struck by a Car While Loading a Vehicle onto a Tow Truck — California

#### Fatality Assessment and Control Evaluation (FACE) Program

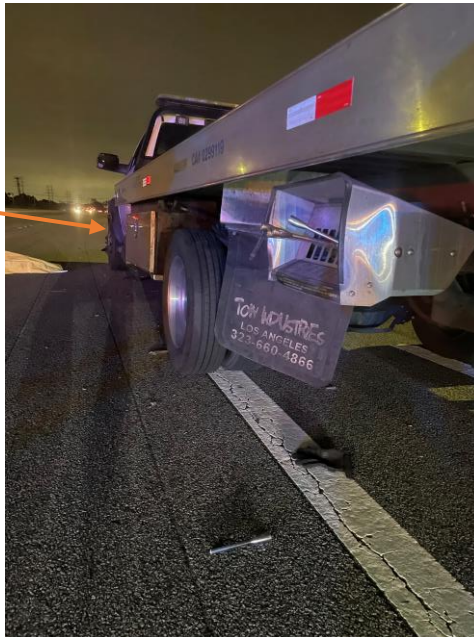
Tow truck  
control levers

The victim arrived on scene with flashing amber lights and pulled in front of the disabled vehicle in preparation for towing. Photos from the scene show that the flatbed truck was partially in the #6 southbound lane (Exhibit 3) and the southbound onramp (Exhibit 4) due to the relatively narrow triangular area of the gore.

Exhibit 3. The tow truck partially in the #6 lane with control levers in front of the back tire. Photo courtesy of the CHP.

***Recommendation #3: Ensure tow truck operators work with law enforcement/emergency service providers to secure the work area prior to loading and securing a vehicle.***

Discussion: Tow truck operators often work in areas where shoulder or other workspace is narrow, and they are facing away from oncoming traffic while securing loads. In this situation, or when there are weather-related concerns or other hazards, tow truck operators should request traffic-control assistance from law enforcement or other organizations (e.g., fire department, Department of Transportation, etc.). Operators should wait to load and secure the vehicle until the traffic control assistance arrives. At a minimum, the CHP should leave their light bar engaged during the entire duration of the loading procedure. In certain instances where the tow truck driver is lacking shoulder space to load safely, law enforcement officers should position their vehicles to temporarily block the adjacent traffic lane until towing procedures are concluded.
