# State FACE™ Fatality Narrative

## Indoor Shooting Range Instructor Killed in Fire

**REPORT #:** 71-276-2026s REPORT

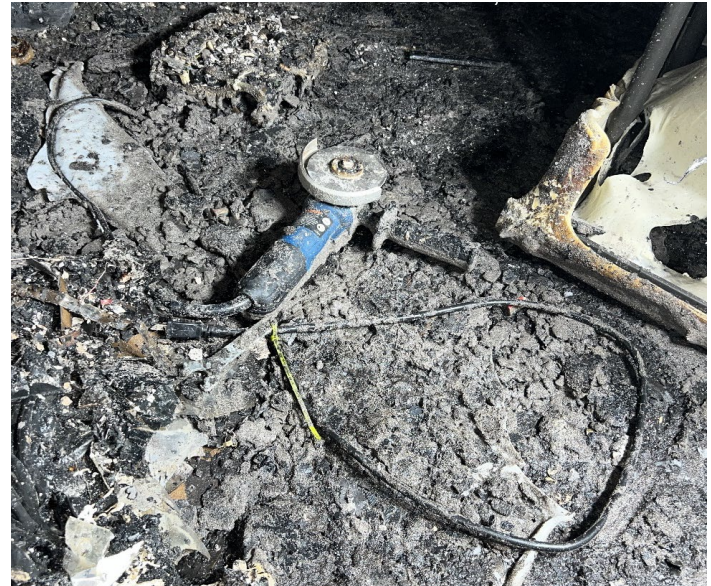
Image 1. Angle grinder where fire started.

- **Restrict hot work to designated areas.** Establish and enforce a hot work program restricting torch cutting, welding, brazing, and use of spark-producing tools to areas designated for hot work. Ensure work is permitted and monitored. Areas should be free of flammable and combustible materials and equipped with ventilation to effectively exhaust dust, gas, and fumes. Install dry chemical extinguishers specified for ordinary combustibles, flammable liquids/gases, and electrical fires (Class ABC). Develop and follow an accompanying training program.

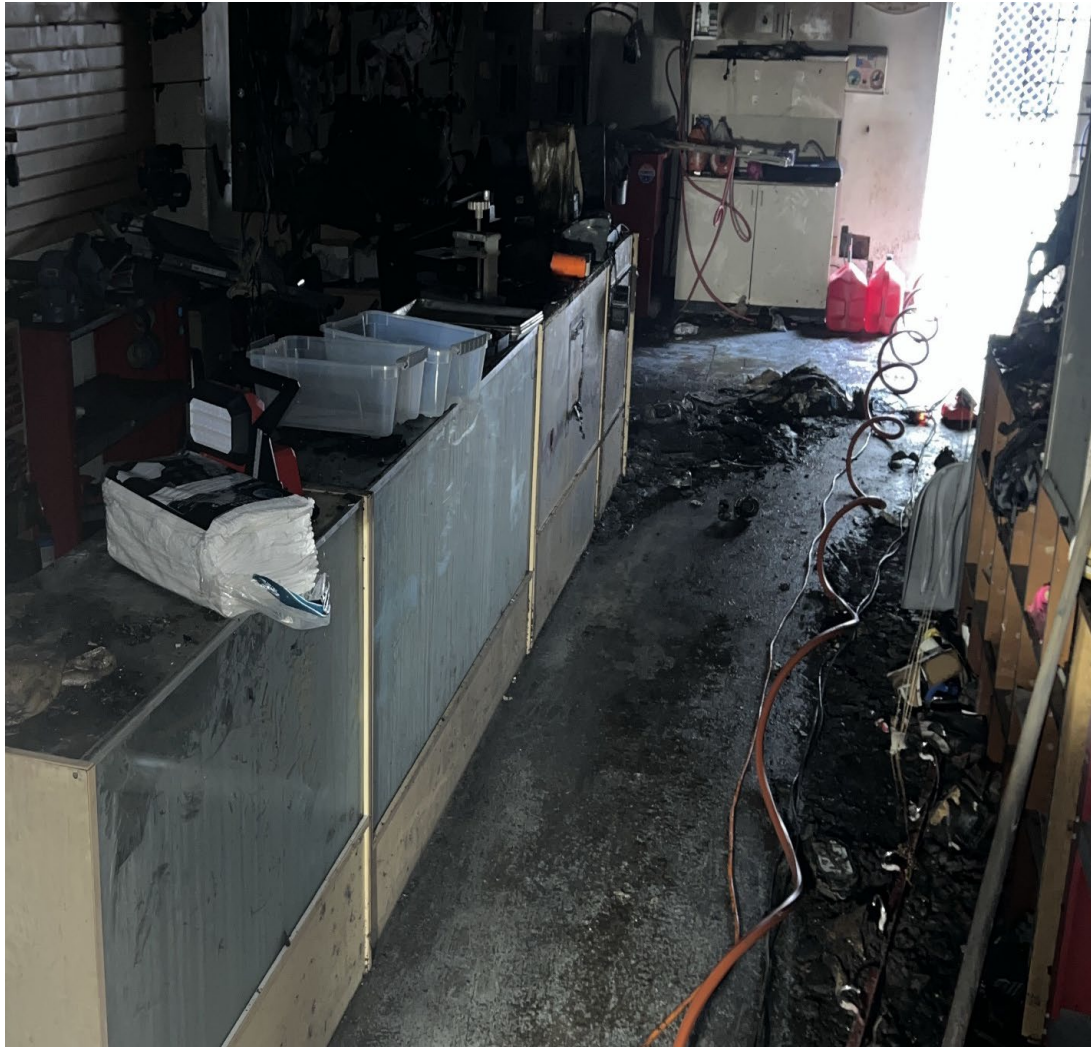
**Image 2.** Retail area in the second-floor lobby where one coworker was when the fire started and front exit the worker was blown out.

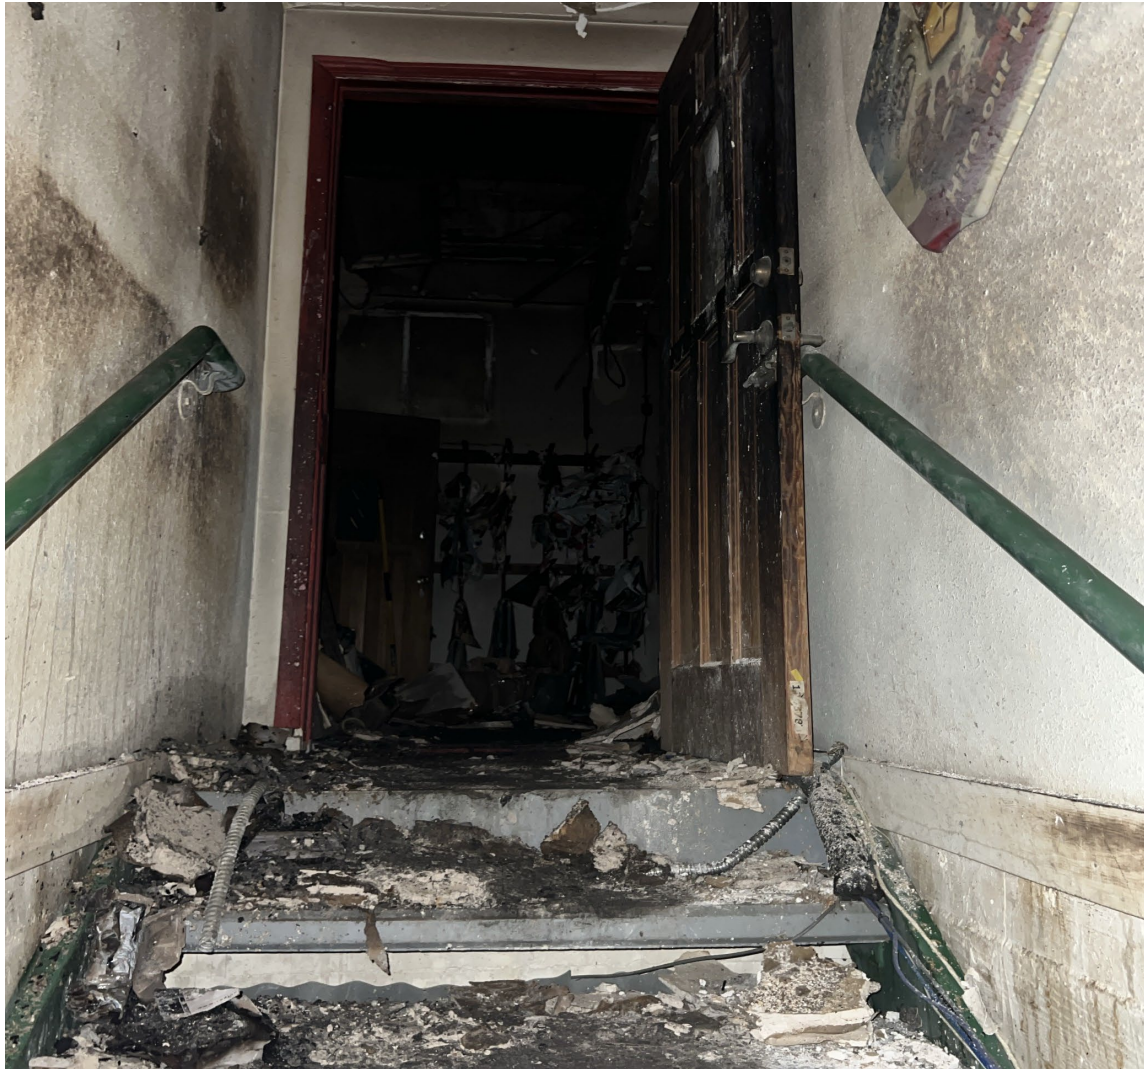
**Image 3.** Stairway and entrance to second-floor corridor leading to classroom, workshop, lobby, and firing range.

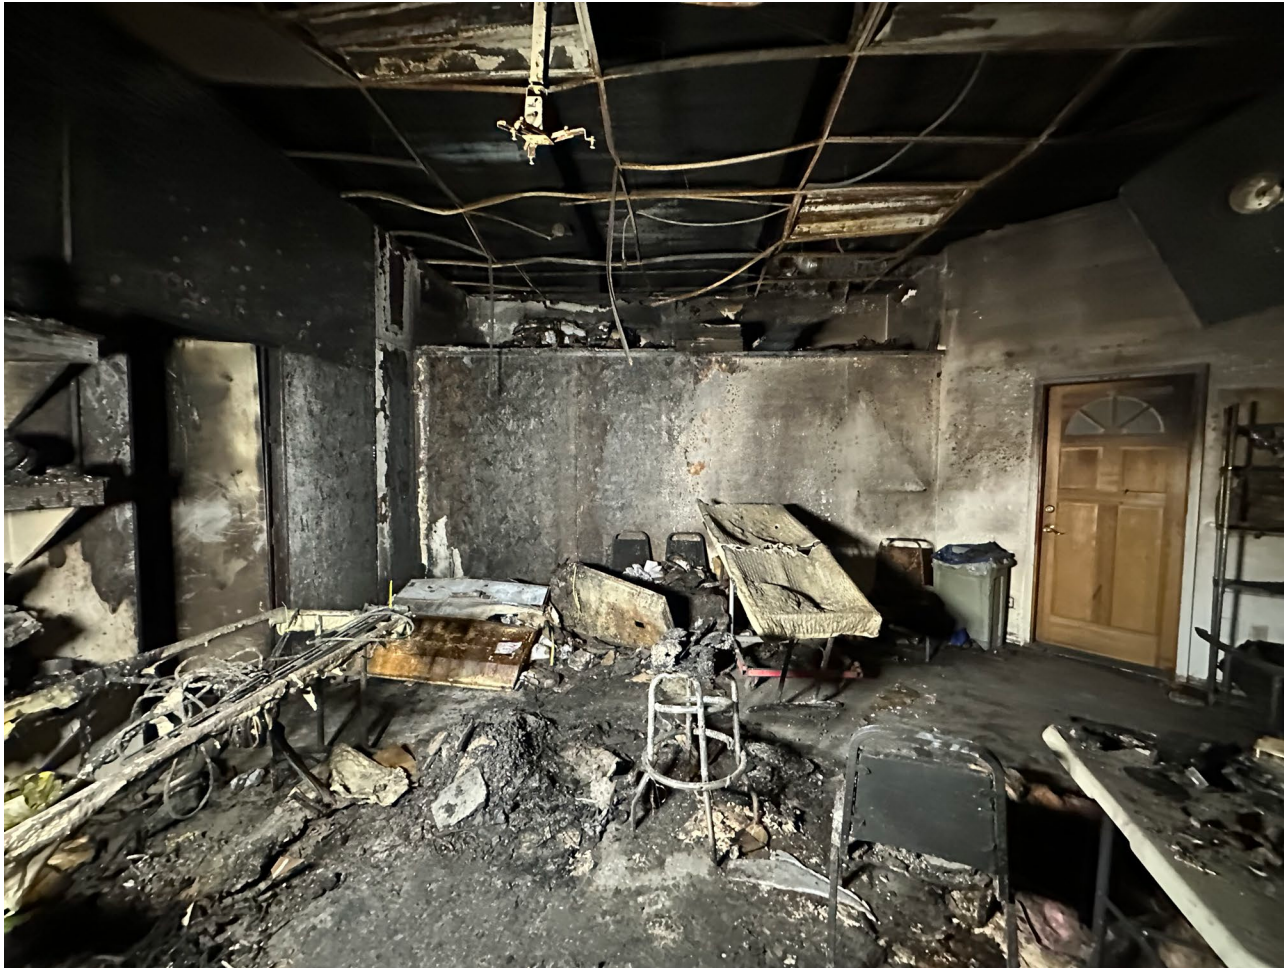
**Image 4.** Classroom where fire started and door to the instructor's workshop, lobby exit, and stairwell to first floor on the left.

He brought the grinder that day, and the owner believed the cart had been brought previously. The classroom contained flammable and combustible materials including ammunition, solvents, paper, and range sweep-off dust that contained unspent gunpowder.

- **Develop a range cleaning and waste disposal program.** Add a cleaning and waste storage and disposal program to your APP. Collect and dispose of settled dusts frequently and safely. Include a focus on storing flammable and combustible materials in a fire safe area and promptly disposing of them.

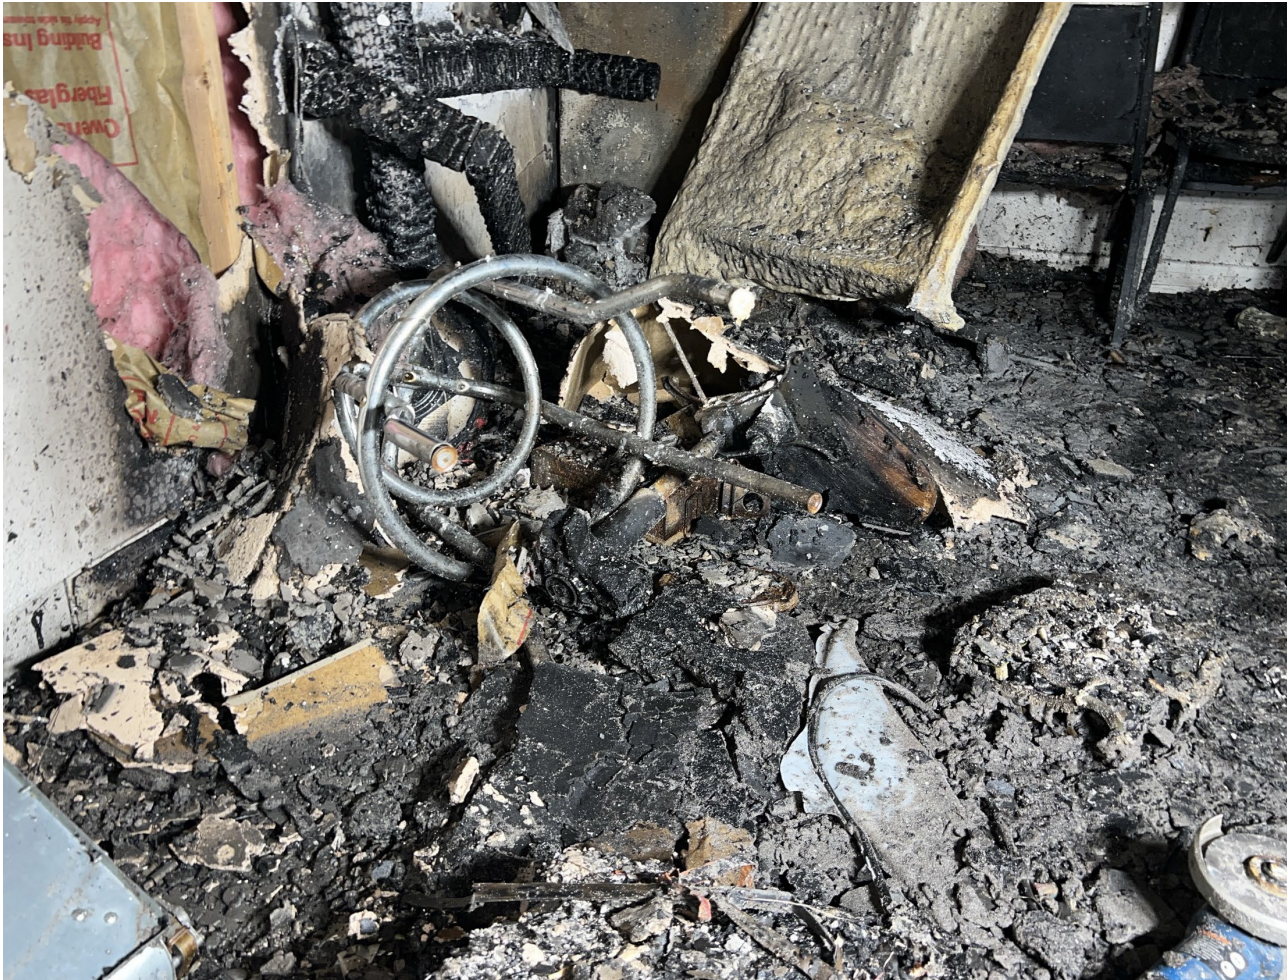
**Image 5.** Area where instructor was modifying the cart and fire started.

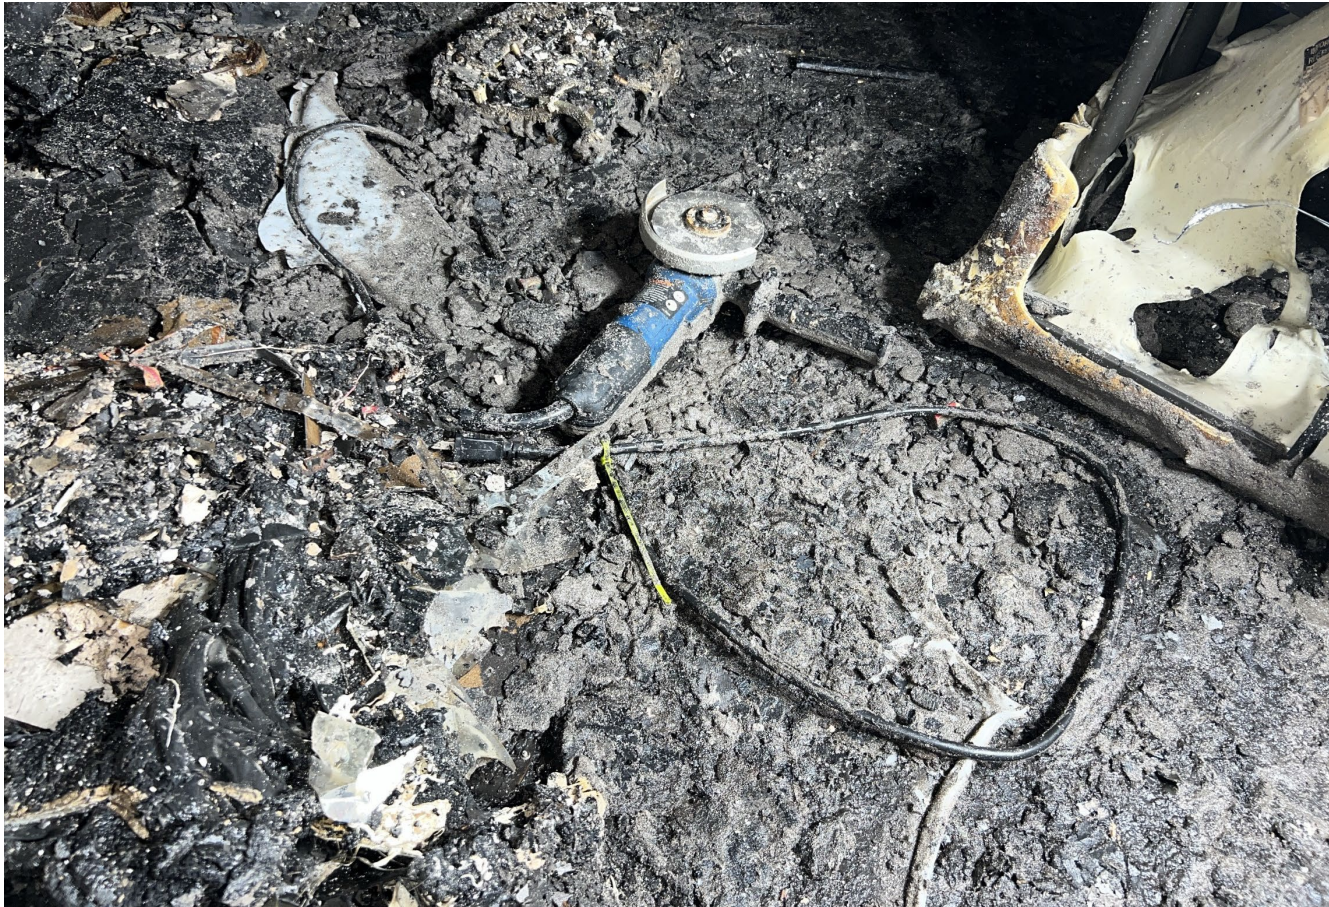
- Fire investigators reported the fire started in the classroom as indicated by burn patterns. They concluded that the source of ignition was either sparks from cutting metal or an electrical short circuit. The grinder was found unplugged.
- The employer had an accident prevention program (APP), but it did not include safe use of angle grinders as they were not used by workers. The employer believed the instructor knew that he should do metal work or hot work only in the workshop.
- One second-floor exit door and stairway were closed due to break-ins.
- One worker described seeing large accumulations of settled dust in the space above the ceiling tiles.

**Image 6.** Angle grinder instructor was using to cut the cart.

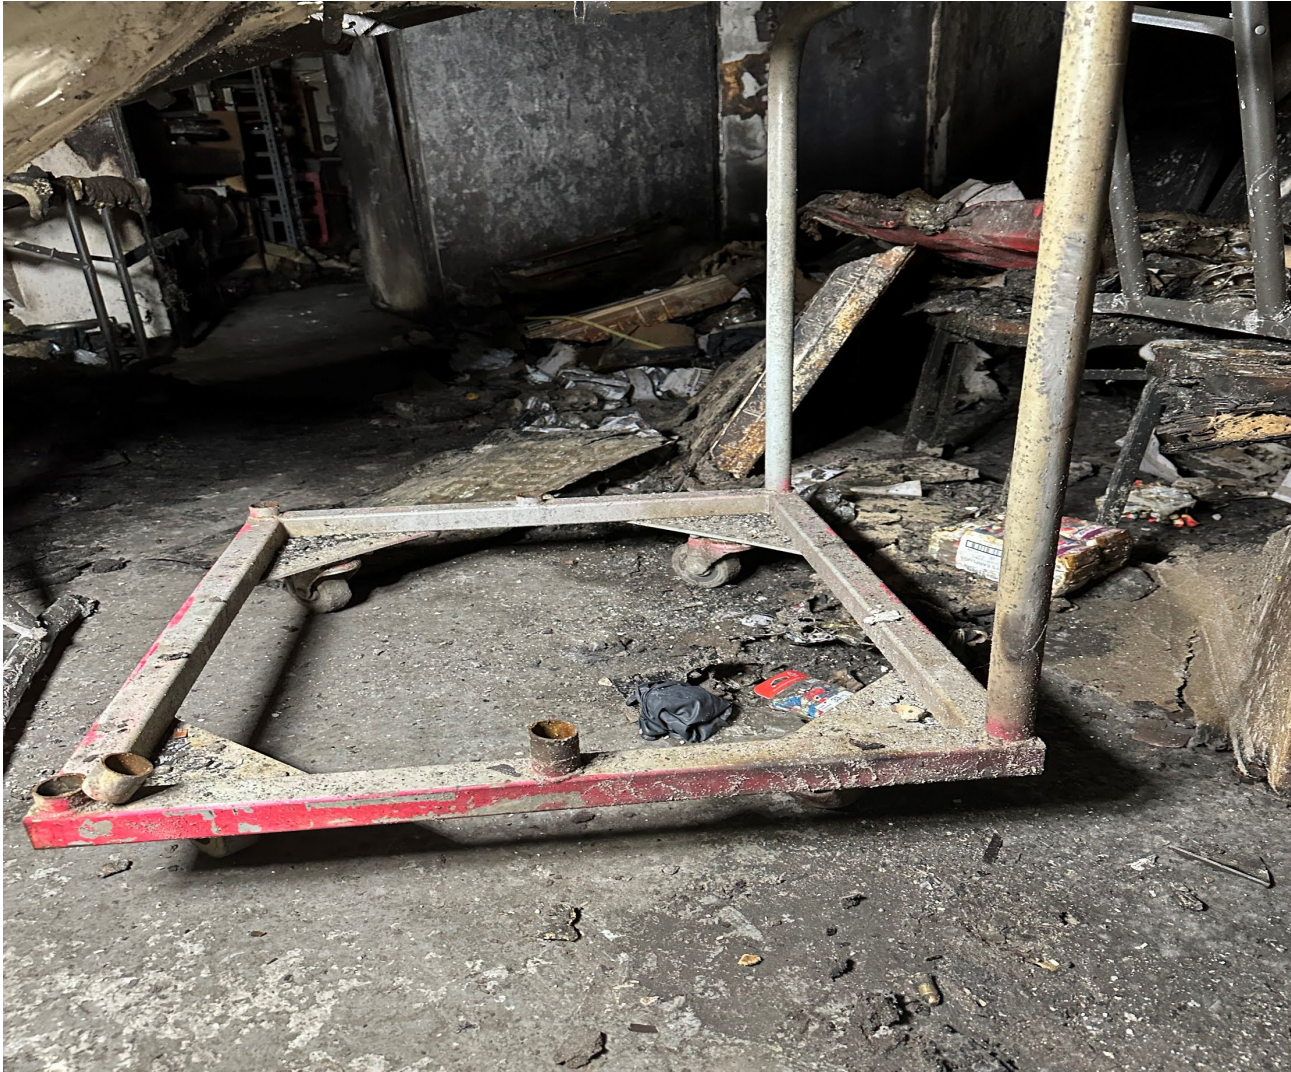
Image 7. Metal cart the instructor was modifying.

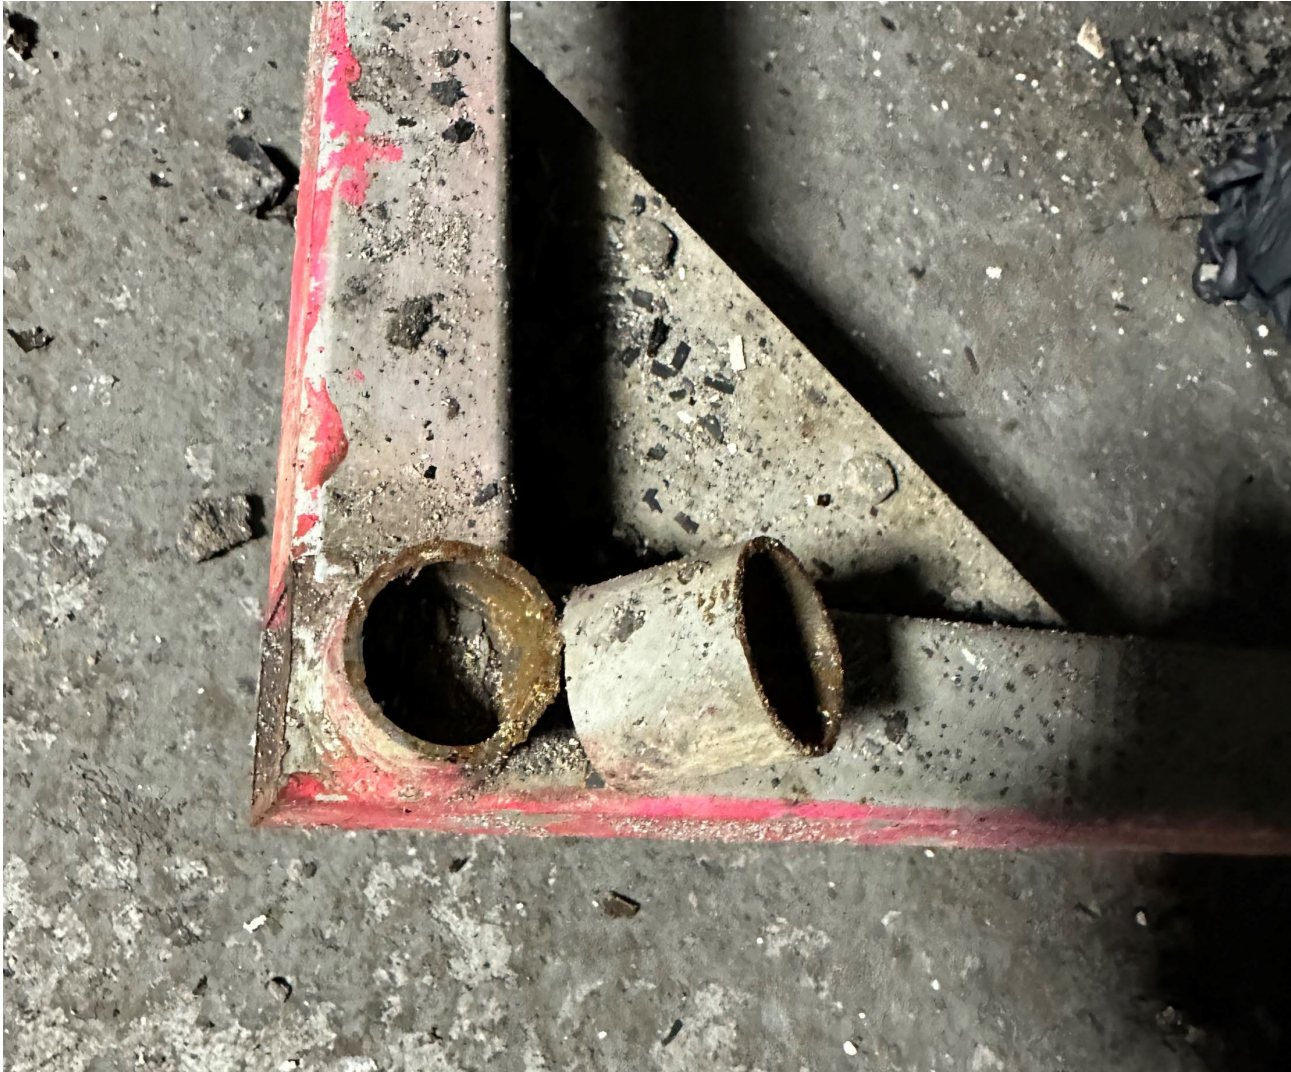
**Image 8.** Section of metal cart the instructor was cutting.

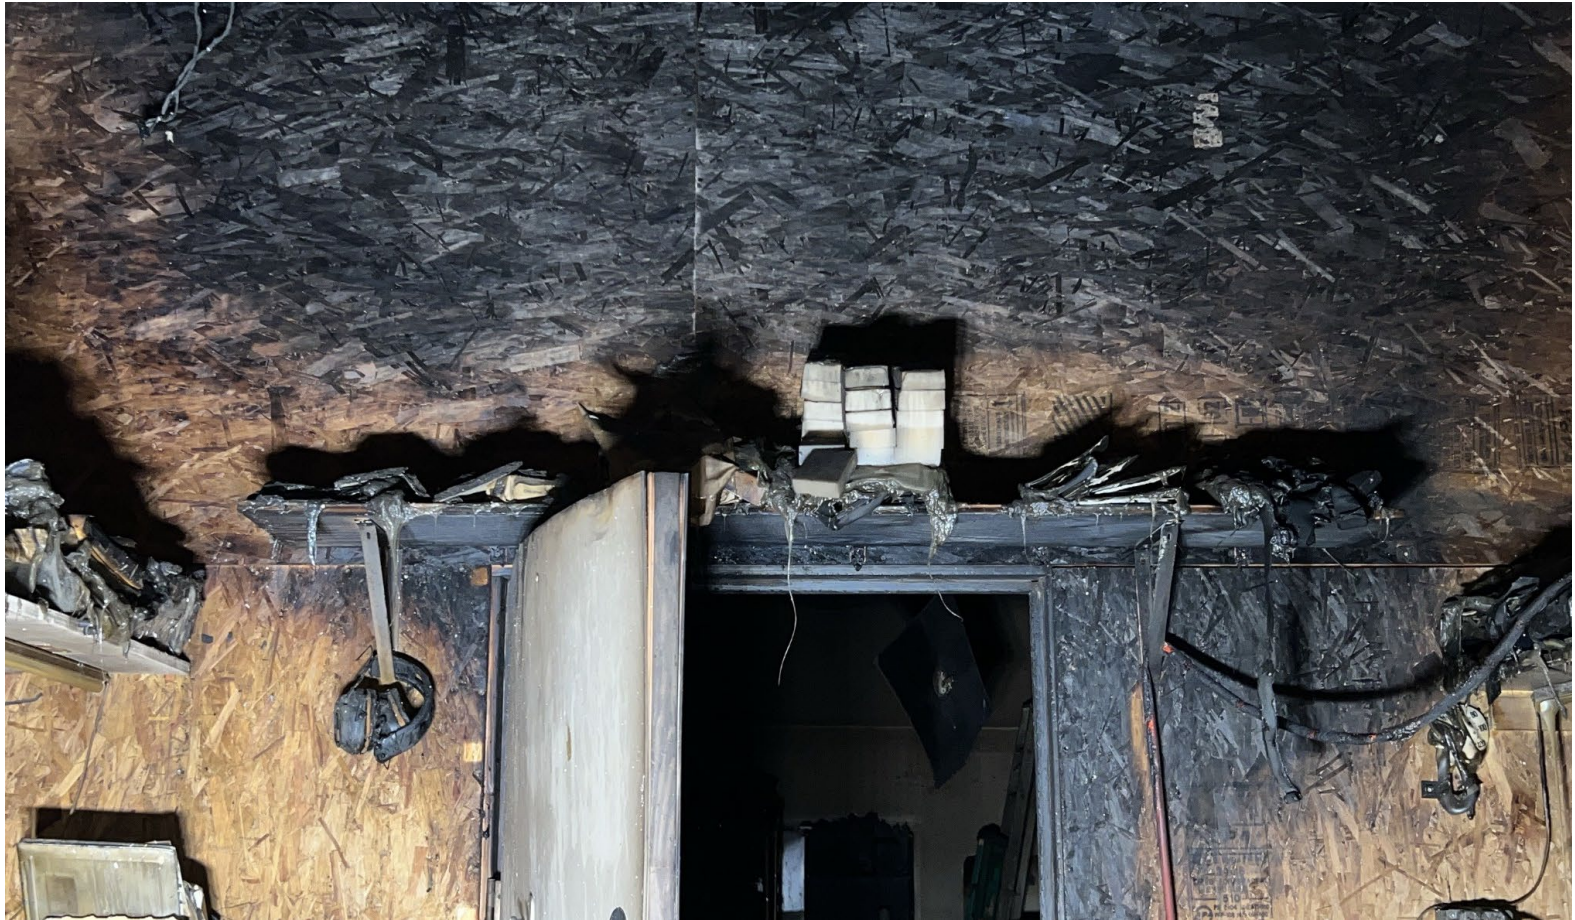
**Image 9.** Burn pattern on wall of workshop adjacent to classroom showing how the fire spread between rooms.

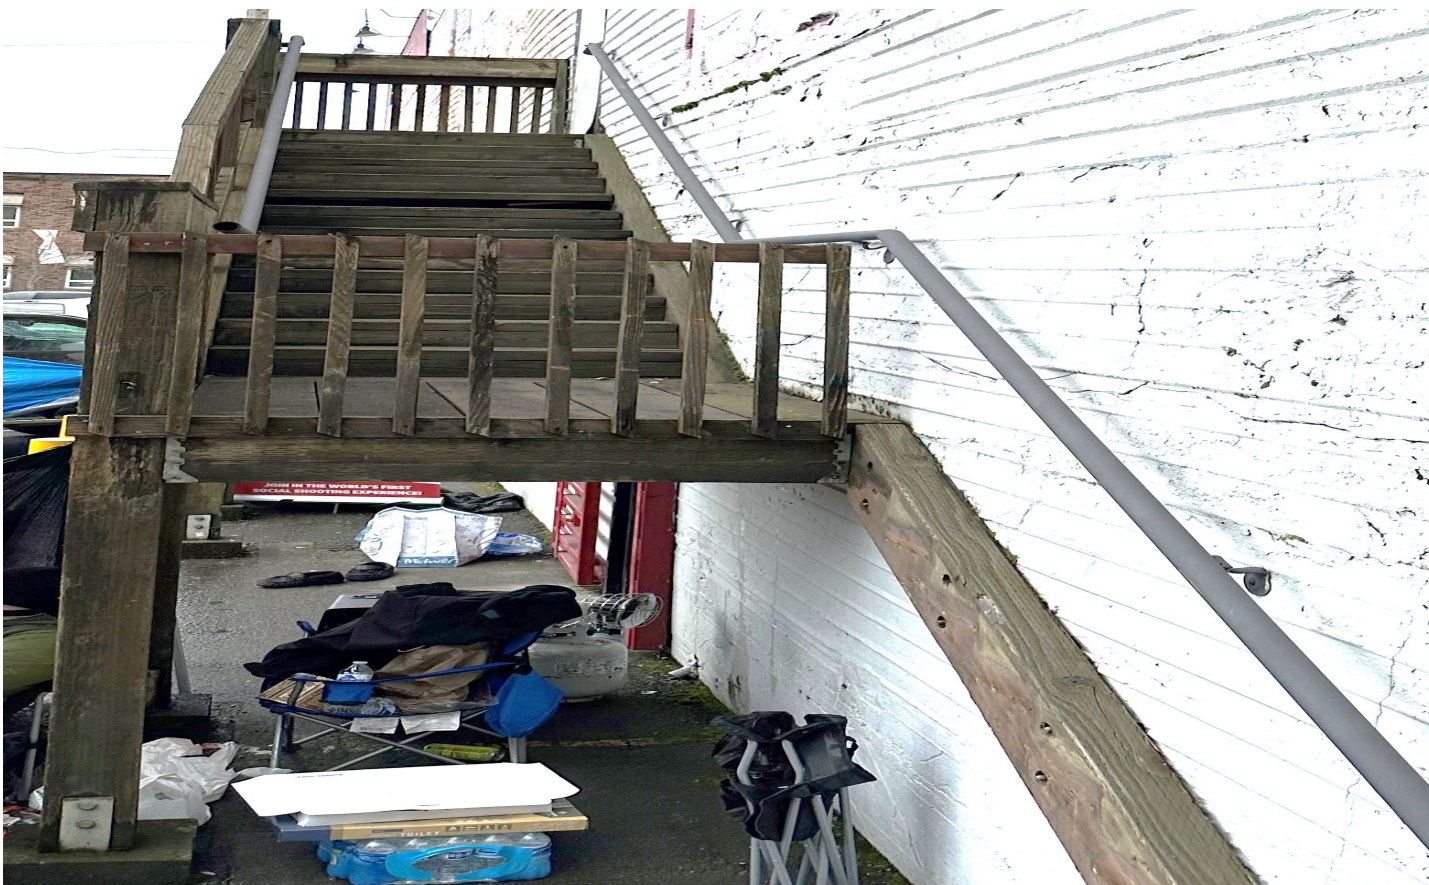
**Image 10.** Closed external stairway leading from locked second-floor exit door.

- **Maintain exit routes to permit prompt evacuation during an emergency.**
