**REPORT #:**  
71-274-2026

## CONSTRUCTION FATALITY NARRATIVE

### Framer Struck by Wall, Falls through Floor Opening

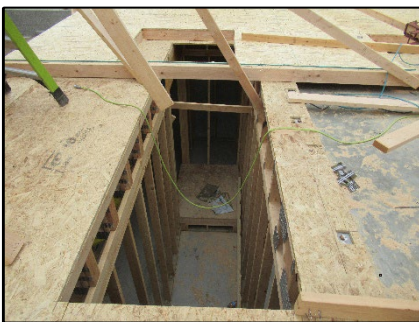
Unguarded floor opening.

The impact made him fall through an unguarded four-foot by eight-foot floor opening beside him. He fell eight feet to the concrete floor below.

- The floor opening had been covered by the wall before it was raised. The employer did not ensure that workers used a guardrail, cover, or other fall protection system to prevent falling into the opening.
- Crew stated they did not have enough lumber to cover the opening as they usually did.
- The crew had recent guardrail systems and overhead hazards training and much experience raising walls.

- Protect employees from falling into or through holes four feet or more to the ground or lower level by one of the following fall protection systems: (i) A standard guardrail system, or the equivalent, as specified in [WAC 296-880-40005](#), on all open sides, except where there is entrance to a ramp, stairway, or ladder. The guardrail must be provided with a standard toeboard wherever, beneath the open sides, persons can pass, or there is moving machinery, or there is equipment with which falling materials could create a hazard; (ii) A cover, as specified in [WAC 296-880-40015](#); (iii) A warning line system erected at least 15 feet from all unprotected sides or edges of the hole and meets the requirements of [WAC 296-880-40040](#); (iv) When the cover, guardrail system, or warning line system must be temporarily removed to perform a specific task, an employee must remain at the hole until the cover, guardrail system, or warning line system is replaced. The only duty the employee must perform is to warn persons entering the area of the fall hazard. The employee must be protected from the fall hazard by a personal fall arrest system or personal fall restraint system; or (v) Personal fall arrest systems or personal fall restraint systems. See [WAC 296-880-20005\(3\)\(a\)](#)

- **Develop accident prevention program (APP) policies.** Policies should require workers to (1) manually support and secure walls after raising, and (2) install and secure covers before working around openings.
- **Create a restricted access zone.** Its length and width should equal the wall plus 4 feet on both sides of it. Mark the zone and continuously monitor it to prevent access while the wall is being raised and secured.
