# State FACE™ Fatality Narrative

## Farm Equipment Operator Crushed by Cone Bottom Nurse Trailer

**REPORT #:** 71-278-2026s REPORT

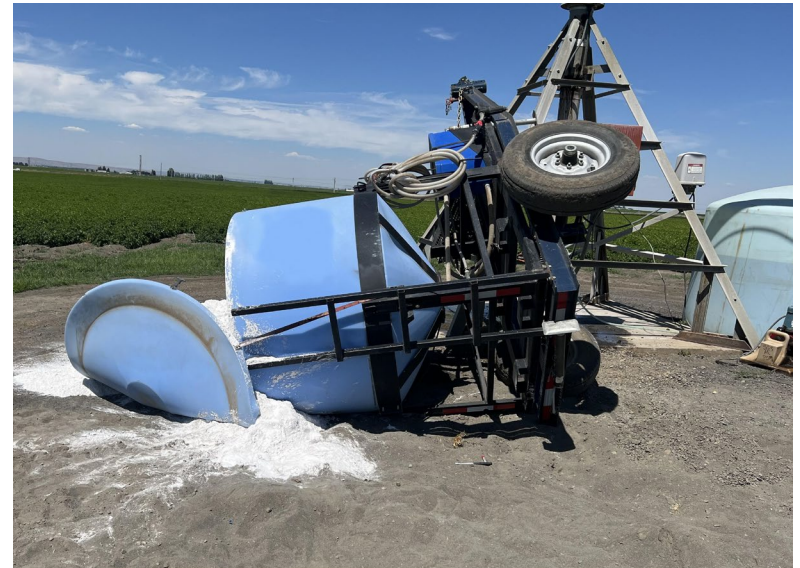
**Image 1.** Trailer tipped on side at incident scene.

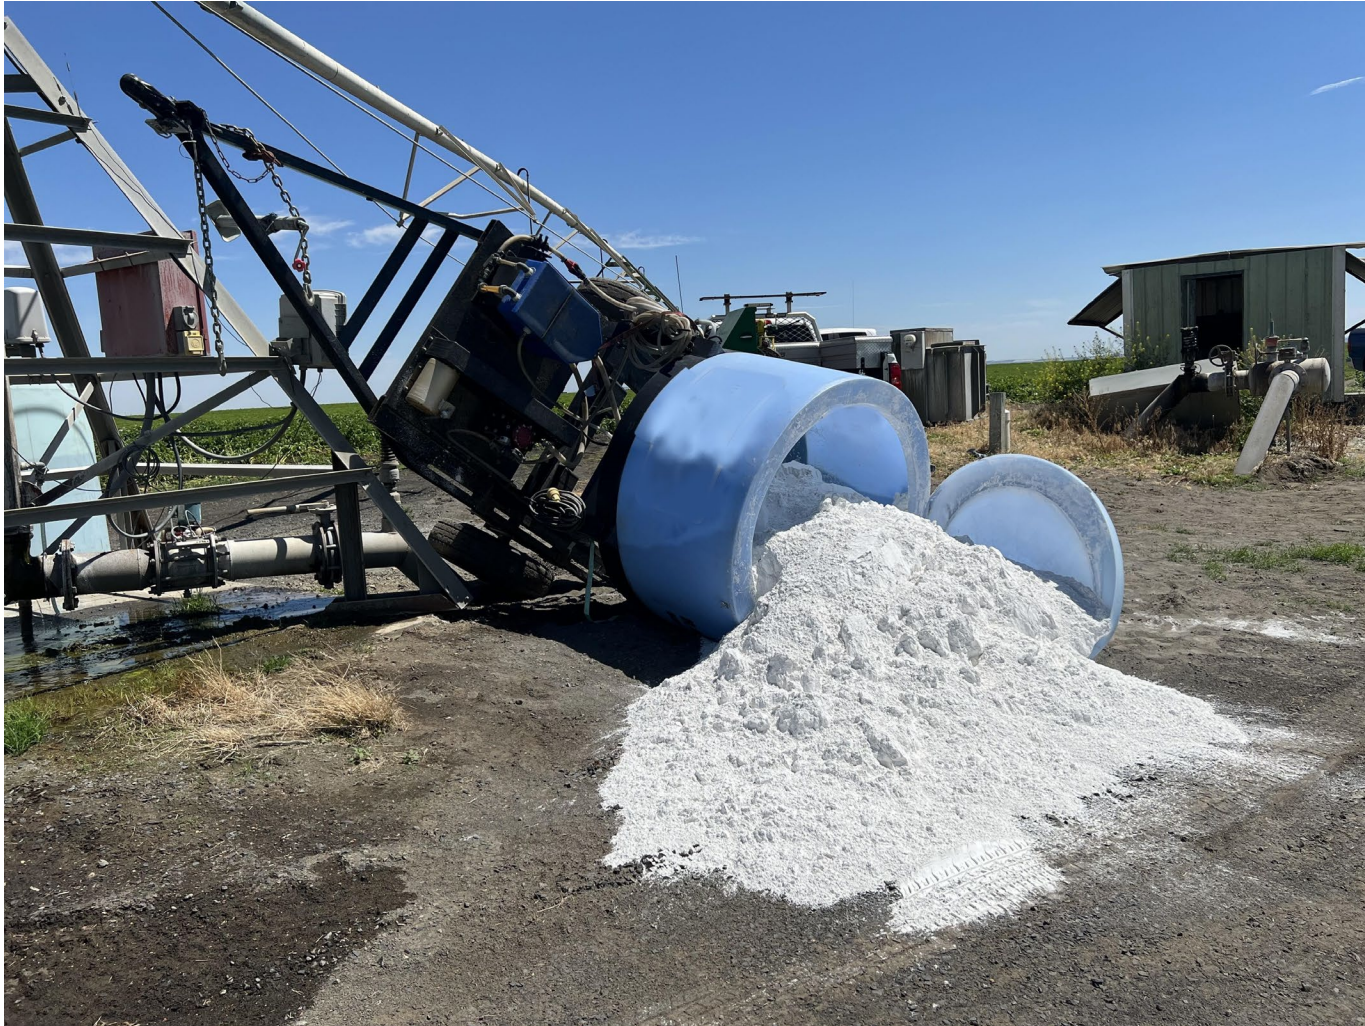
**Image 2.** Alternate view of trailer tipped over at incident scene.

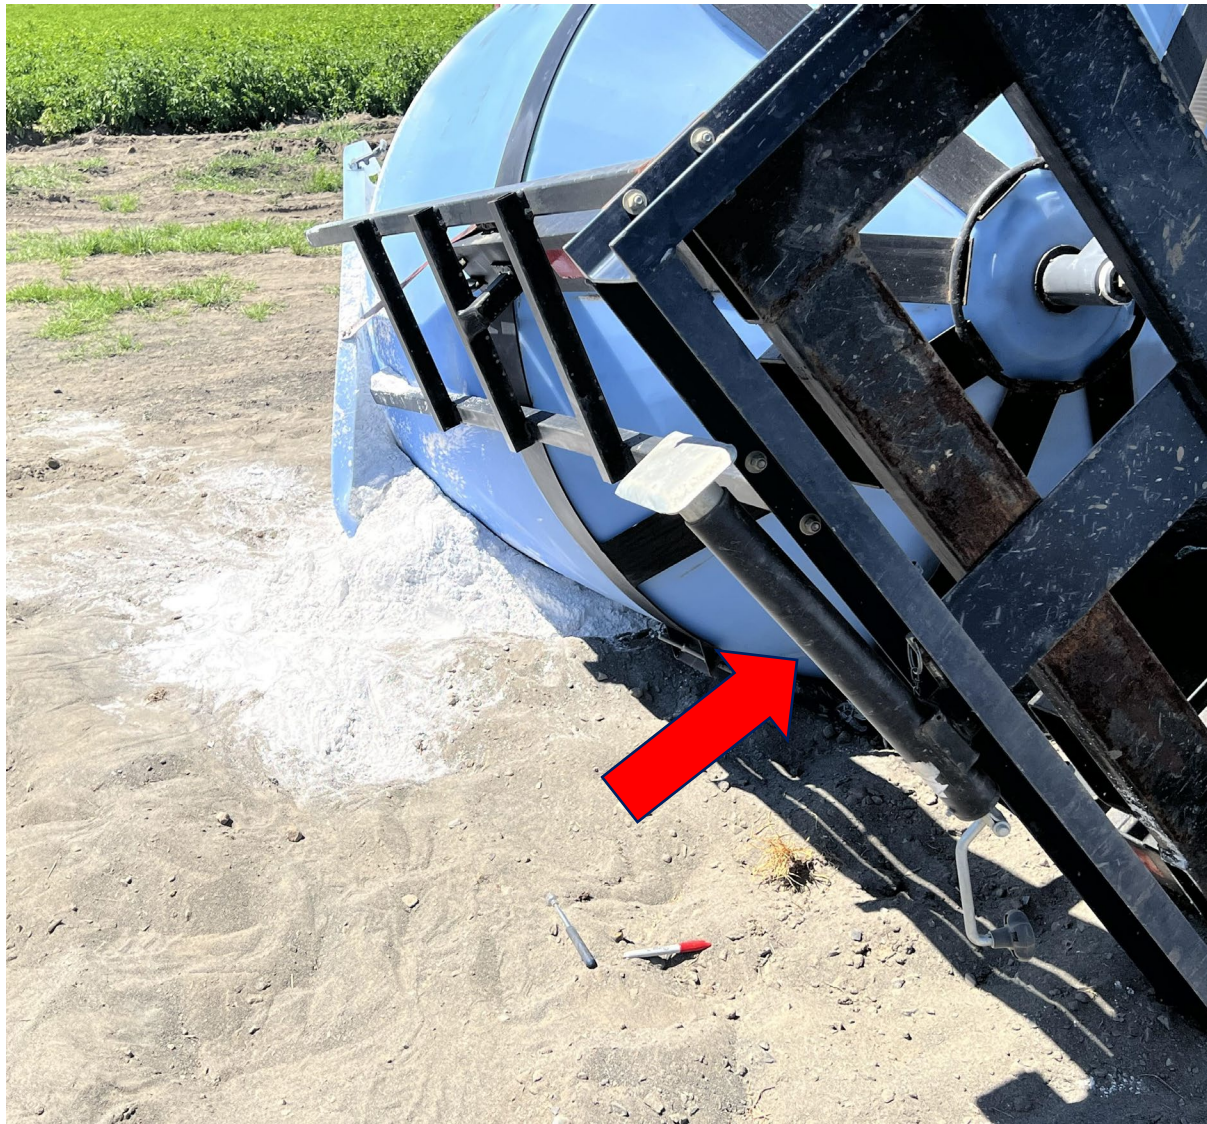
- The employer had attached a rear jack to the trailer to prevent it from tipping over due to its high center of gravity. The operator did not use the jack when he unhooked the trailer and climbed the ladder.
- The employer did not train the operator and his coworker in the company's step-by-step trailer parking procedure, which included how to set the rear jack before unhooking the trailer.
- The trailer was left parked on soft sandy ground against the manufacturer's safety instructions to place it on a level surface strong enough to support its total weight.

**Image 3.** Rear view of trailer and tank resting on soft sandy ground.  
Arrow points to unused jack attached to rear of trailer frame.

- **Develop trailer parking policies and procedures.** Include policies and step-by-step trailer parking procedures for workers to follow in your written accident prevention program (APP) developed according to the equipment manufacturer's safety instructions. Instruct supervisors how to implement the policies.
- **Perform a job hazard analysis (JHA).** Supervisors and equipment operators should jointly identify trailer hazards and develop solutions before putting equipment into use. JHAs should be documented and updated whenever equipment is modified or replaced. Ensure workers always have access to JHAs.
- **Provide trailer safety training.** Training should be hands-on, recurrent, documented, and tailored to each specific type of trailer. Do not allow workers to operate trailers until they demonstrate safe usage.

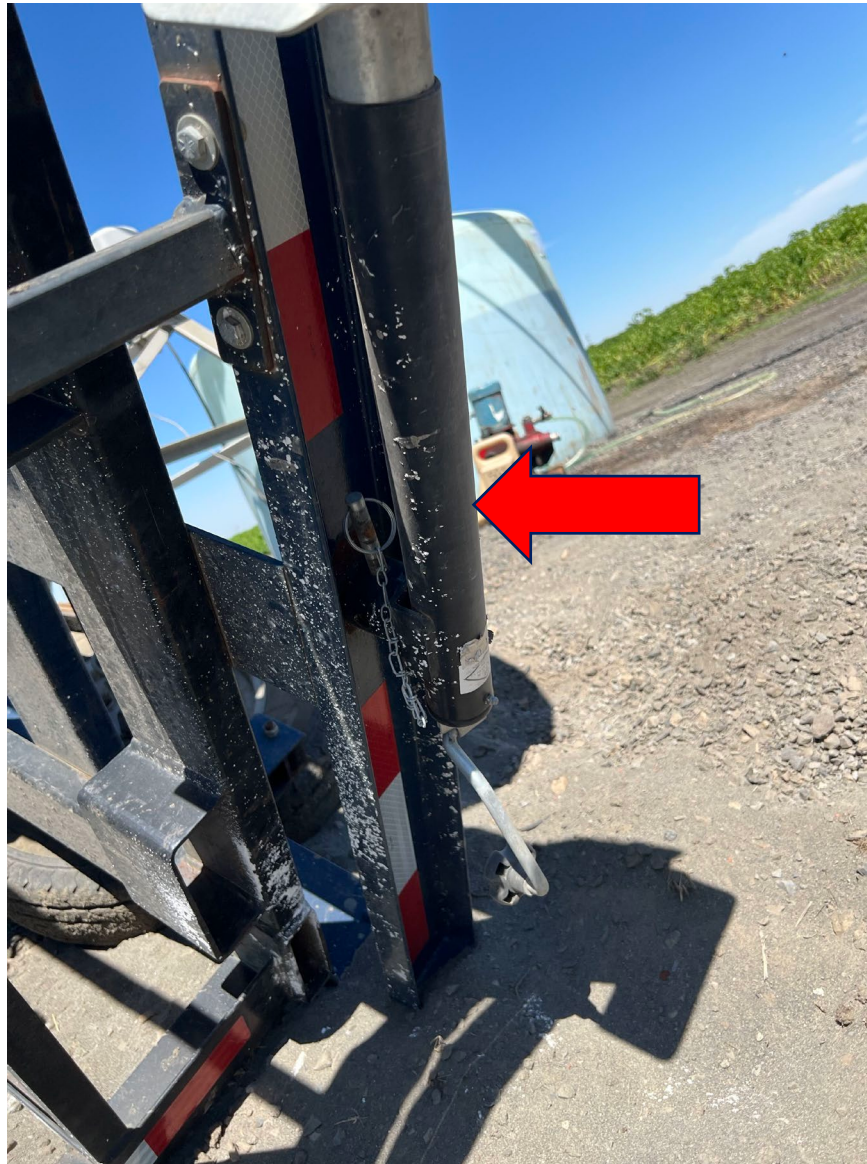
**Image 4.** Close-up of unused rear parking jack on trailer.

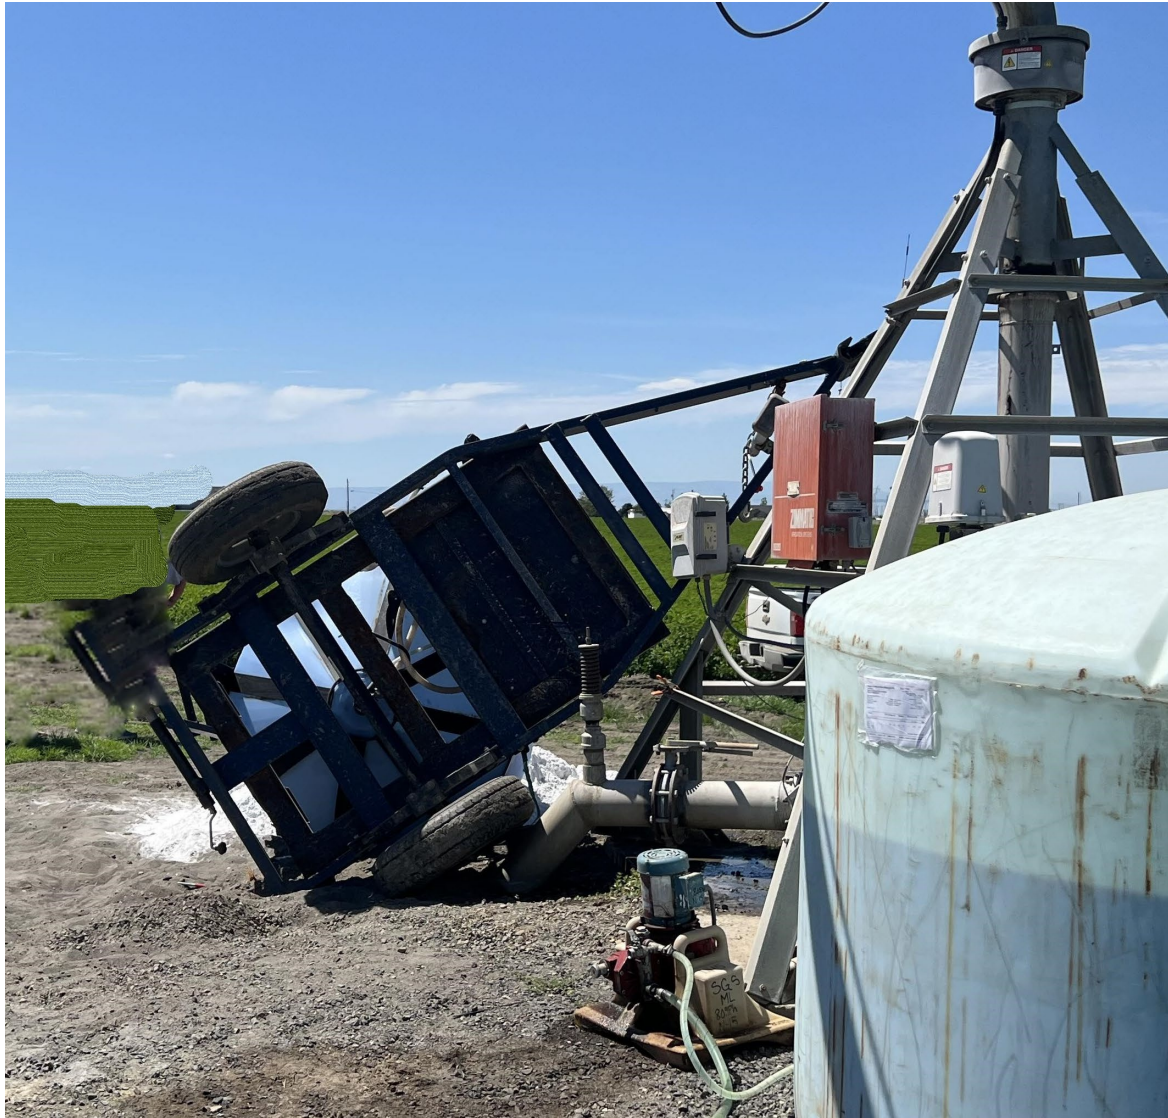
**Image 5.** Undercarriage view of trailer at incident scene.

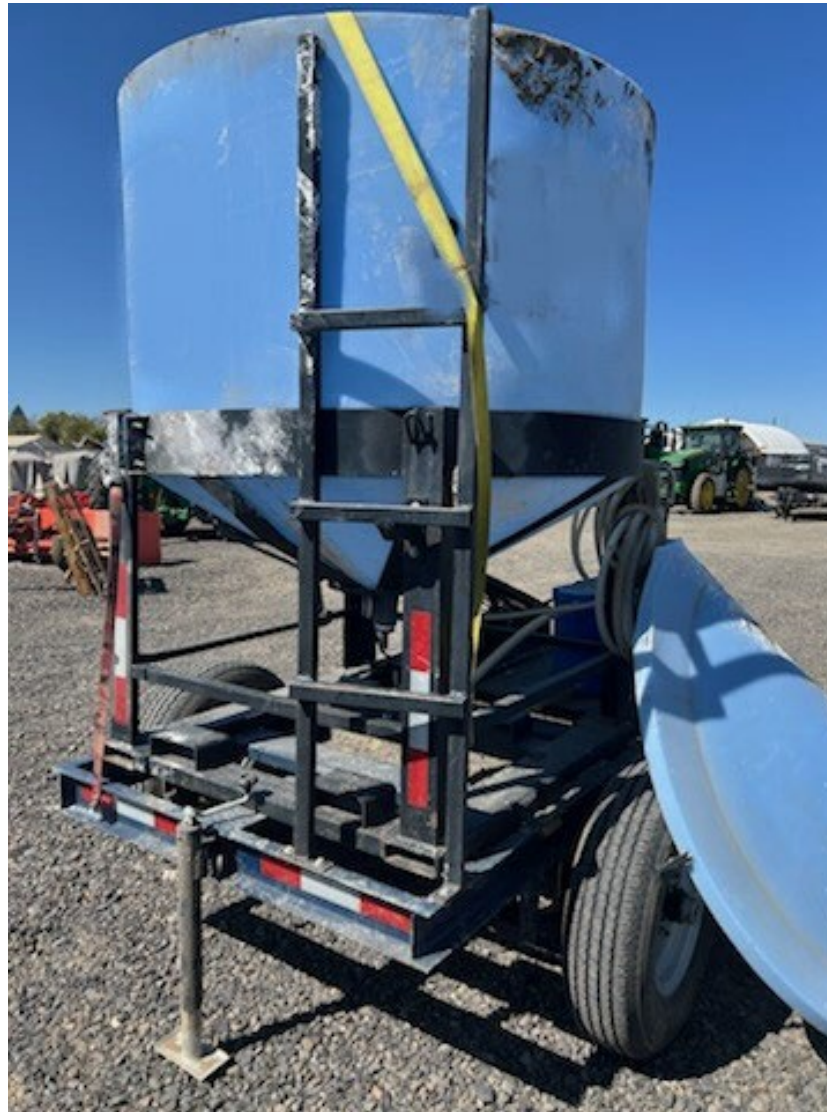
**Image 6.** Trailer in upright position after incident with ladder and rear parking jack set on hard, level surface.
