Author manuscript *J Occup Environ Hyg.* Author manuscript; available in PMC 2015 August 28.

# An Evaluation of an Aftermarket Local Exhaust Ventilation Device for Suppressing Respirable Dust and Respirable Crystalline Silica Dust from Powered Saws

# Alberto Garcia, Erica Jones, Alan S. Echt, and Ronald M. Hall

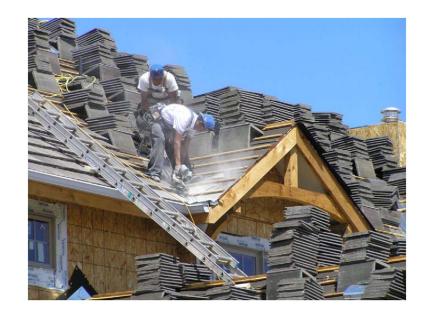
**Figure 1.** Roof arrangement while installing tiles

A total of thirty-five samples were collected at three different sampling locations over a three day period. During the installation of the concrete roofing tiles, employees cut the tiles to accommodate the shape of the roof structure (e.g., peaks, hips, and valleys). Employees used an electric Skil<sup>®</sup> saw with the aftermarket LEV control installed to cut the tiles. During cutting activities, exposures to respirable crystalline silica exceeded occupational exposure limits such as the OSHA PEL, NIOSH REL, and ACGIH<sup>®</sup> TLV<sup>®</sup>. The experimental design of this evaluation is listed in Table II. The two cutters/roofers had higher levels of exposure than the roofers. A leaf blower was used to clean the tiles to prevent staining from water or moisture (Figure 4). This process generated a considerable amount of visible airborne concrete dust, comparable or even greater than the dust created when cutting the tiles.

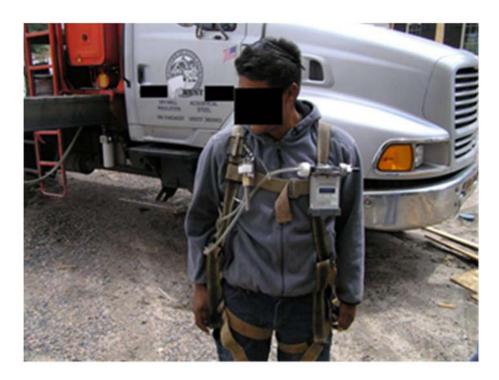
# Figure 2.

Cutter/Roofer wearing the sampling equipment

Full-shift sampling was conducted to determine the respirable dust and silica exposures of two roofers and two cutter/roofers at each site. Personal breathing zone samples (PBZ) were collected on 37-millimeter (mm) diameter Polyvinyl chloride (PVC) filters with a 5-micrometer pore size at a flow rate of 1.7 liters per minute. A 10-mm nylon cyclone preselector was used to limit the collected particles to respirable sizes.

Additionally, for the two cutter/roofers that were mainly responsible for cutting the tiles, direct reading PBZ respirable dust sampling was conducted concurrently using an active sampling portable laser photometer (MIE personal DataRAM model pDR1200, Thermo Electron Corporation, Waltham, Massachusetts). The direct reading instruments were up-todate on calibration and were zeroed at the beginning of each sampling period according to the manufacturer's recommendations. Downstream from the photometer, a 37-mm PVC filter with 5-micrometer pore size was fitted connected via Tygon<sup>®</sup> tubing to a sampling pump calibrated to a flow rate of 2.2 liters/minute to provide simultaneous collection of the analyzed dust. By fitting the photometer with a BGI4L metal cyclone (BGI Inc. Waltham, Massachusetts) dust pre-selector, a calibration filter was used to determine the concentration of sampled respirable dust (Figure 2). This was conducted to compare real-time and filterbased exposure estimates and to calculate the respirable silica content of the real-time exposures. Real-time sampling was stopped during the workers' lunch break to limit the analysis to time spent performing roofing activities. The filter samples from the photometers were analyzed for respirable dust and for silica using the modified NIOSH analytical methods discussed previously.

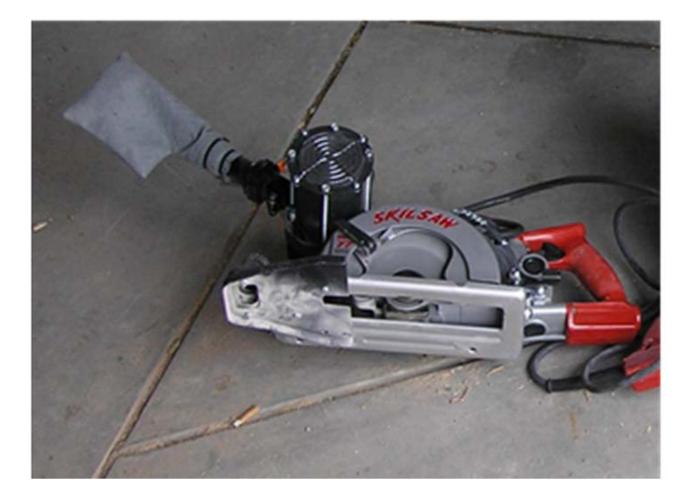
**Figure 3.** Circular saw with aftermarket local exhaust ventilation

This study evaluated the exposures when using a 7–1/4 inch worm-drive electric circular saw (model hd 77 m, Skil<sup>®</sup>, Ontario, Canada), with aftermarket LEV installed. The LEV consisted of a shroud attached to the cutting plane of the saw; the shroud was then connected to a small electric axial fan (Pneo model 77 mag), which is intended to collect dust at the point of generation (Figure 3). After passing through the fan, the dust is collected on a cloth bag which also serves as a filter media. Periodically, the bag would need to be emptied or replaced as it filled with dust. The bag material was laboratory tested by NIOSH using a characteristic aerosol typically used for testing respirator filters. When tested, the LEV control bag had penetration values between 55% and 61% over a flow rate range of 80 - 100 liters per minute.

The dust collection system was activated automatically when the trigger switch on the saw was depressed, and shut down when the trigger was released. The local exhaust ventilation was installed as a permanent attachment which added to the weight of the tool. In addition,

the installation of the dust collector required the saw to be used by the worker pulling the saw toward himself, necessitating the removal of the lower blade guard.

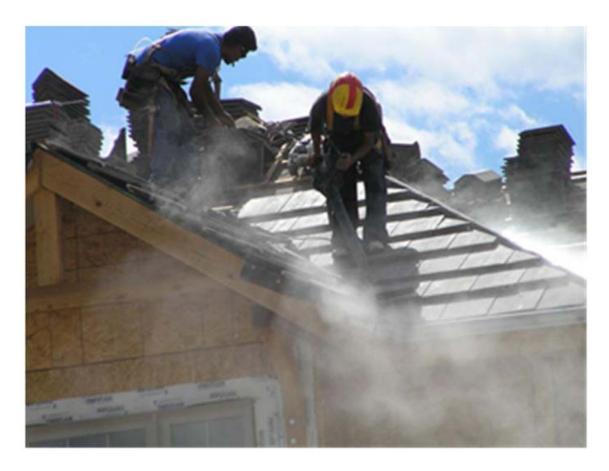
**Figure 4.** Workers using a leaf blower to clean dust from tiles

The video exposure monitoring images displayed more visible dust during tile cleaning than tile cutting, but the real-time monitoring indicated that higher respirable dust concentrations were observed during tile cutting. Also, the leaf blower is used to remove settled dust which will tend to have a larger particle size, hence the lower respirable concentrations.

As mentioned in the results and discussion section, a leaf blower was used to remove dust from the tiles. This process should be carefully reviewed as it creates an unnecessary exposure to all employees, whether they cut or lay the tiles. Alternative means of cleaning the tiles without making particles airborne should be used. The use of manual roofing tile cutters has proven to reduce exposures below the OSHA PEL and the NIOSH REL. Further investigation of manual cutters or improved local exhaust ventilation should be conducted. The results reported here indicate that workers should use respiratory protection when they are using the saw and/or the leaf blower.
