Improving stopping construction to minimize leakage

Roy H. Grau III, Andrew L. Mazzella, and Anu L. Martikainen

Office of Mine Safety and Health Research (OMSHR), National Institute for Occupational Safety and Health (NIOSH) Pittsburgh

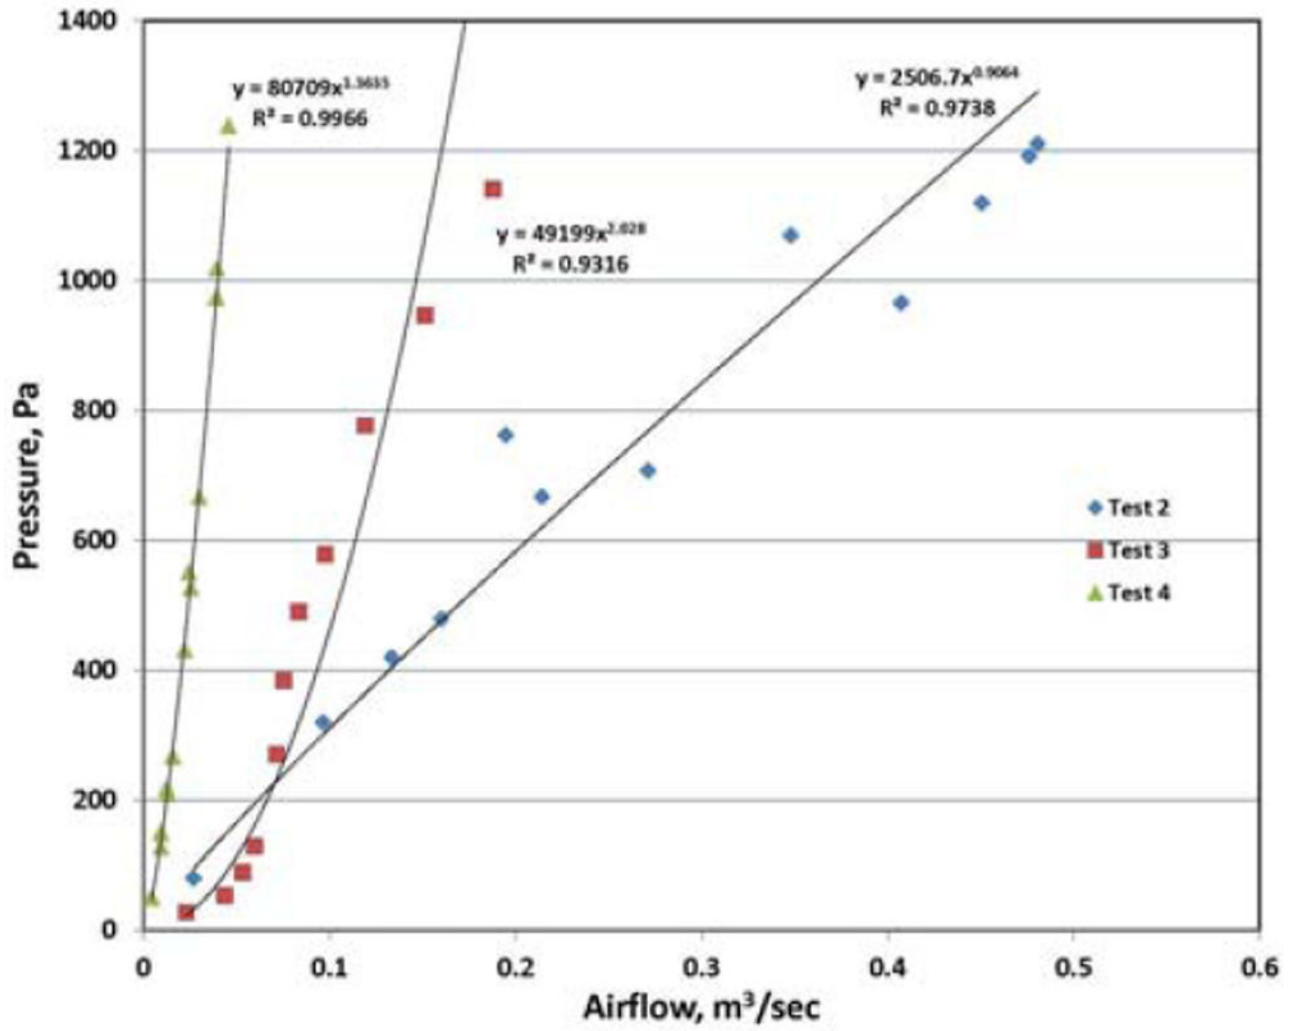
Figure 2.
Airflow leakage at different pressures for stoppings tested

Preparation for the third pressure-leakage test (Test 3) included adding polyurethane foam sealant to the perimeter of the high-pressure side of the stopping as shown in Figure 4 and around the man-door. These improvements resulted in a leakage reduction of 62% to 0.177 m³/sec (375 cfm) at 1245 Pa (5 in WG). The pressure increase followed the relationship shown in Figure 2.

Preparations for Test 4 consisted of removing the polyurethane foam at the roof perimeter by hand scraping and removing some of the wedges. The foam was then reapplied between the stopping block and the roof, rib, and roof control screen material. This foam application differed from the previous test in that, rather than superficially spraying the stopping, the wand applicator tip was inserted in any cracks or leakage paths, allowing the foam to flow from inside to outside the crack. The surface area of the low-pressure side of the stopping also was sealed with B-Bond. These changes produced a dramatic reduction in stopping leakage. Figure 2 shows the leakage function being nearly linear for Test 4. A pressure of 1245 Pa (5 in WG) pressure was achieved in the sealed room at a leak-age flow of 0.019 m³/sec (40 cfm). This result was obviously more favourable than that for the first test, which had 0.472 m³/sec (1,000 cfm) leakage at the same pressure.

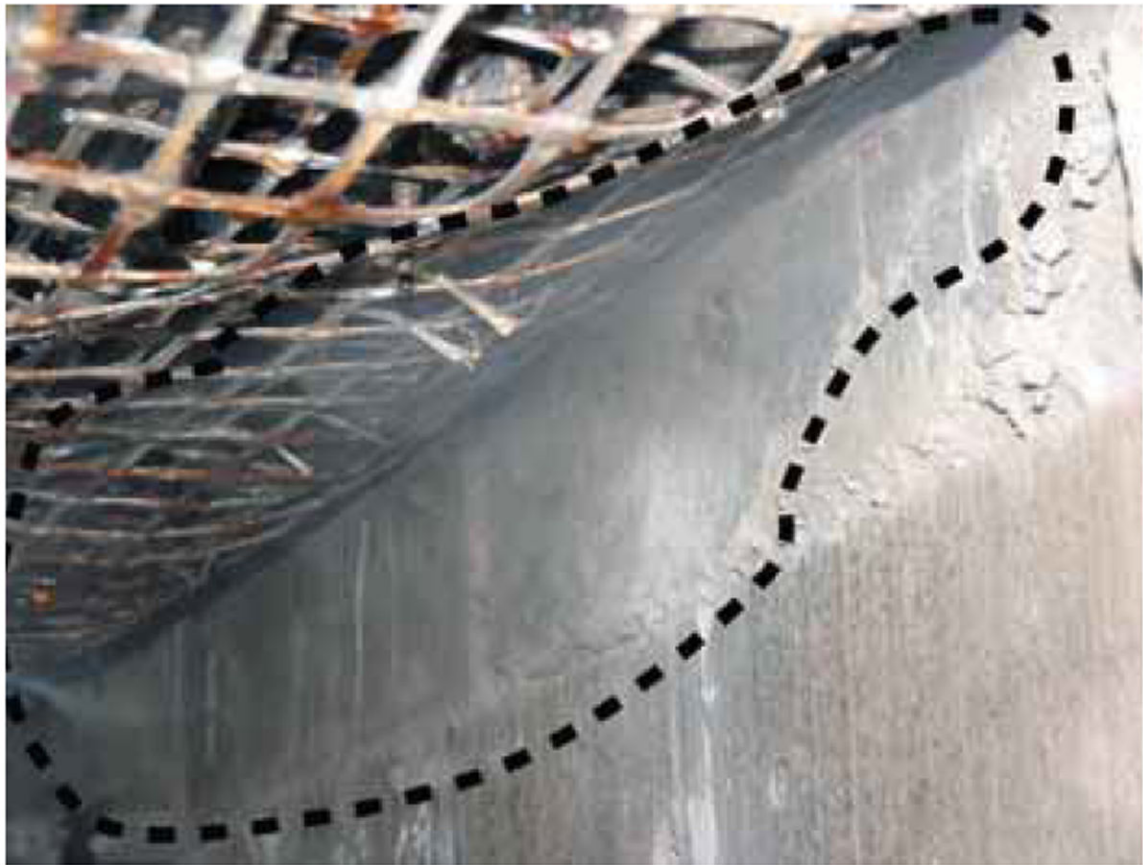
Figure 3.
Smoke leaking through the stopping perimeter at the roof for Test 2

The first pressure-leakage test, Test 1, was performed without sealant applied to the stopping. As compressed air was introduced into the enclosed room, the numerous leakage paths prevented air pressure to develop. During subsequent pressure-leakage tests, the stopping was progressively sealed more thoroughly. In preparation for Test 2, B-Bond MS Mine Sealant was applied to the high-pressure side of the stopping and along the stopping perimeter. B-Bond Mine Sealant, manufactured by Quickrete, is a surface bonding cement containing a blend of Portland cement, fiberglass fibers, and special additives. After a drying period of four weeks, Test 2 was performed with the room being pressurised to 1245 Pa (5 in WG) with a flow of 0.472 m³/sec (1,000 cfm). During pressurisation, the relationship between pressure and leakage was linear as shown in Figure 2. Leakages were easily detected by feeling the airflow with the hand and by sight using smoke from ventilation smoke tubes as shown in Figure 3. The leakage was located primarily at the top and sides of the stopping and around the man-door.

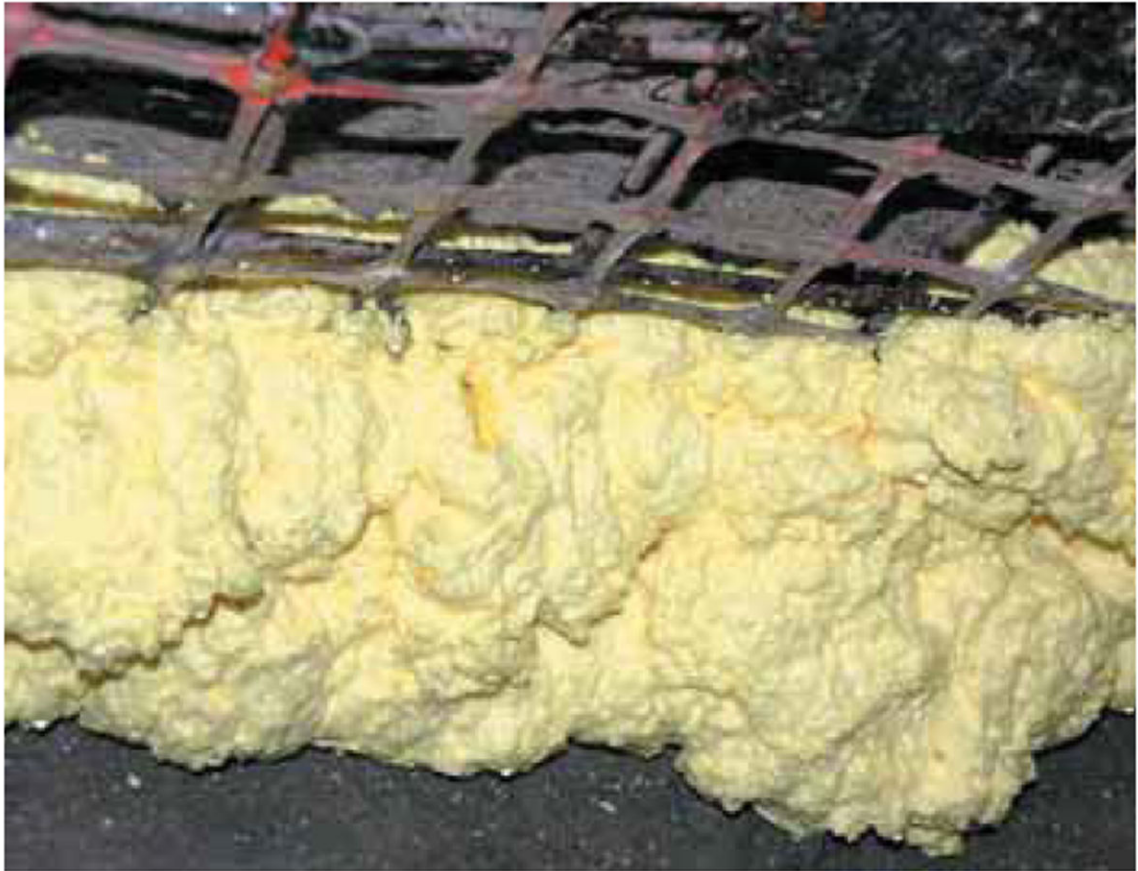
Figure 4.
Polyurethane foam sealing stopping at roof on pressurised stopping side for Test 3

Although airflow leakage was significantly reduced during Test 3, leakage was still evident even though the stopping was sealed with polyurethane foam. Ventilation tube smoke released on the high-pressure side readily passed between the roof and foam, showing that the interface between the stopping and the roof provided minimal resistance to airflow leakage. Although the foam appeared to thoroughly seal the stopping perimeter, the foam was covering the stopping and roof control screen only superficially, which did not create an adequate seal. This test showed that there were two hindrances to effectual sealing of the stopping: the presence of roof control screen and the presence of wooden wedges that are typically used to keep the stopping in place. Both the roof control screen and the wooden wedges blocked the penetration of the polyurethane foam and prevented the foam from filling voids between the blocks and the roof or ribs. The wooden wedges were positioned in the normal manner with the wedges extended out past the plane of the stopping wall.

Nevertheless, the placement of the wedges in this manner prevented the foam from being sandwiched between the stopping block and the roof and allowed only a superficial foam coating.

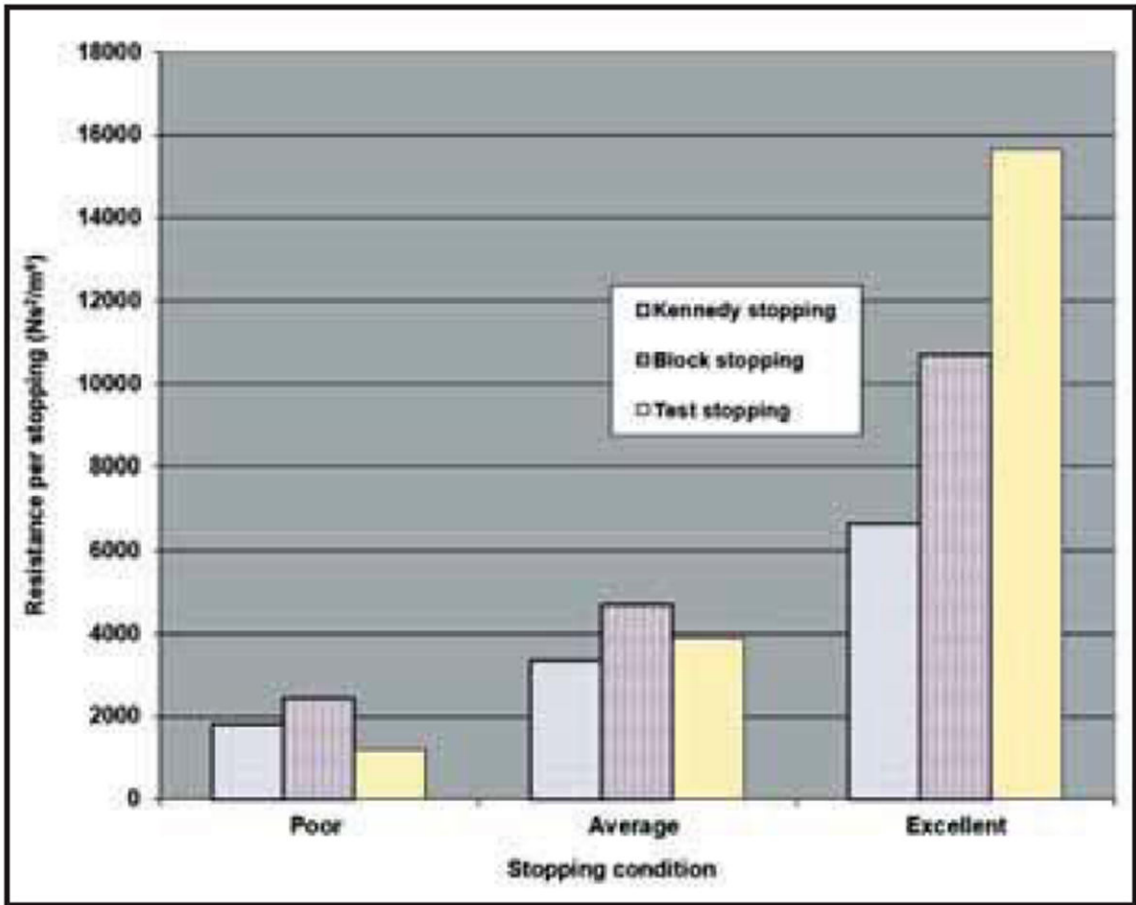
Figure 5.
Resistance factors for various stopping types

In order to determine the benefit of sealing the stoppings and to relate the test results with those for other types of stoppings, resistance factors for the stoppings performed in Tests 2 to 4 are compared to those found by Oswald (2008) and are detailed in Figure 5. The chart shows varying resistance factors compared to stopping quality and provides ratings for Kennedy (steel) stoppings and concrete block stoppings on a scale of poor, average, and excellent based on observation criteria reported by Oswald. Stoppings rated in poor condition have several cracks that allow significant leakage and are in need of repair. Average stoppings are the most common stopping condition found in underground coal mines and would be stoppings that although not near perfect in both condition and construction, are adequate in their application in the mine. Stoppings in excellent condition have high air resistance and have minimal leakage; generally, these stoppings are those that have been coated with a sealant. The stopping assessed in Test 1 was not considered in this evaluation due to its high leakage quantity. The stopping in Test 2 fell into the poor category and had slightly lower resistance than both the block stopping and Kennedy stopping. The stopping in Test 3 fell into the average stopping category, as it had a resistance lower than the block stopping but higher than the Kennedy stopping. The stopping in Test 4 fell into the excellent category; and had a resistance nearly 50% greater than the block stopping with excellent condition, and 140% greater than the Kennedy stopping.
