## Roof Instability:

### What Reportable Noninjury Roof Falls in Underground Coal Mines Can Tell Us

T.S. Bajpayee, Deno M. Pappas, and John L. Ellenberger

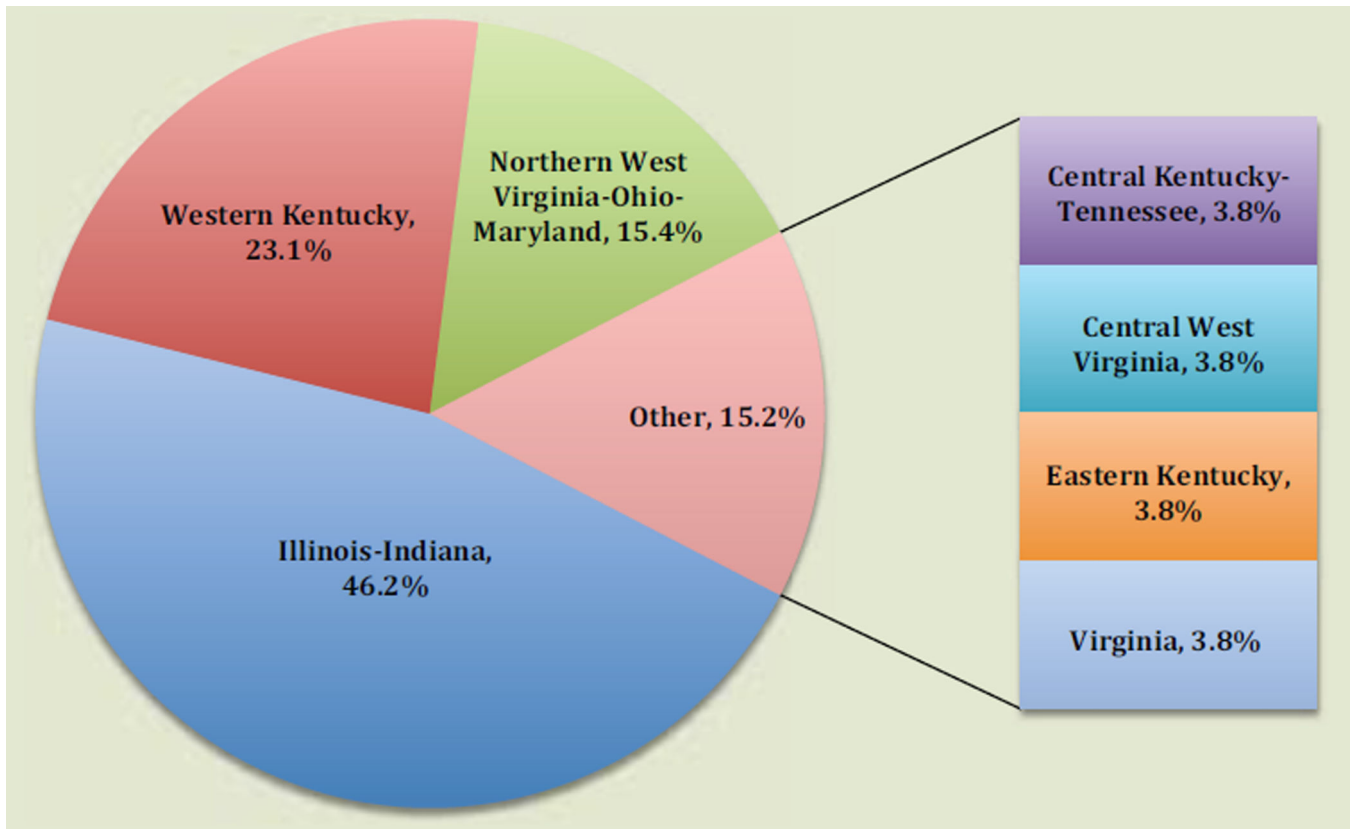
Figure 3. Region-Wise Distribution of Mines Listed in Table 1

responsible for 37.7% of all reported roof falls. Figure 3 (p. 60) shows the region-wise distribution of these 26 mines, 18 of which are located in the the Illinois Coal Basin.

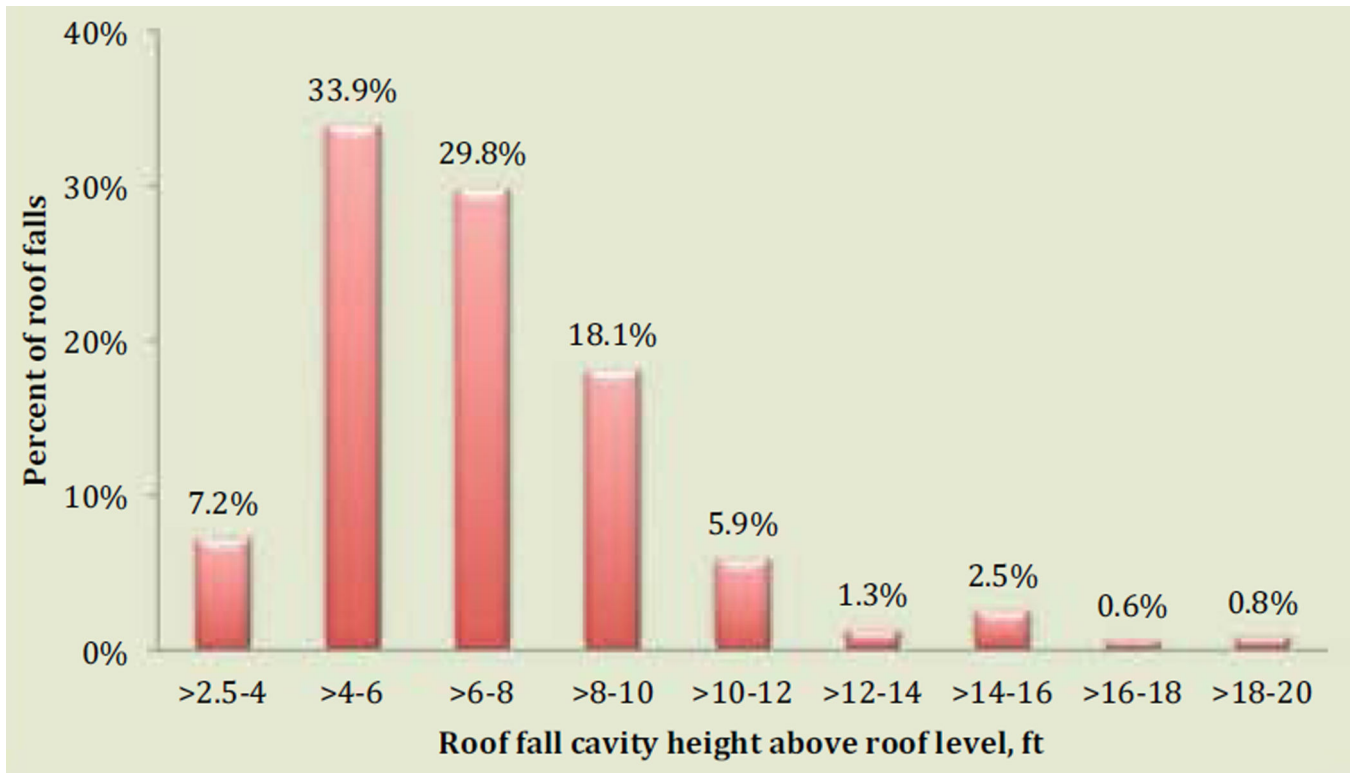
Figure 4. Roof Fall Cavity Height Above Roof Level

Roof falls with a cavity height of 2 ft or less are considered skin failures (Tadolini & Dolinar, 2001). Noninjury roof falls reviewed for this study were generally larger than skin failures. Pertinent cavity height information was obtained from the incident narratives. Cavity height above the roofline was available for 5,514 falls (Figure 4, p. 61). The cavity height of 33.9% of falls ranged from greater than 4 to 6 ft and 29.8% ranged from greater than 6 to 8 ft. The cavity height of 11.1% of falls exceeded 10 ft. In coal mines, roof bolts are commonly 4 to 6 ft in length.

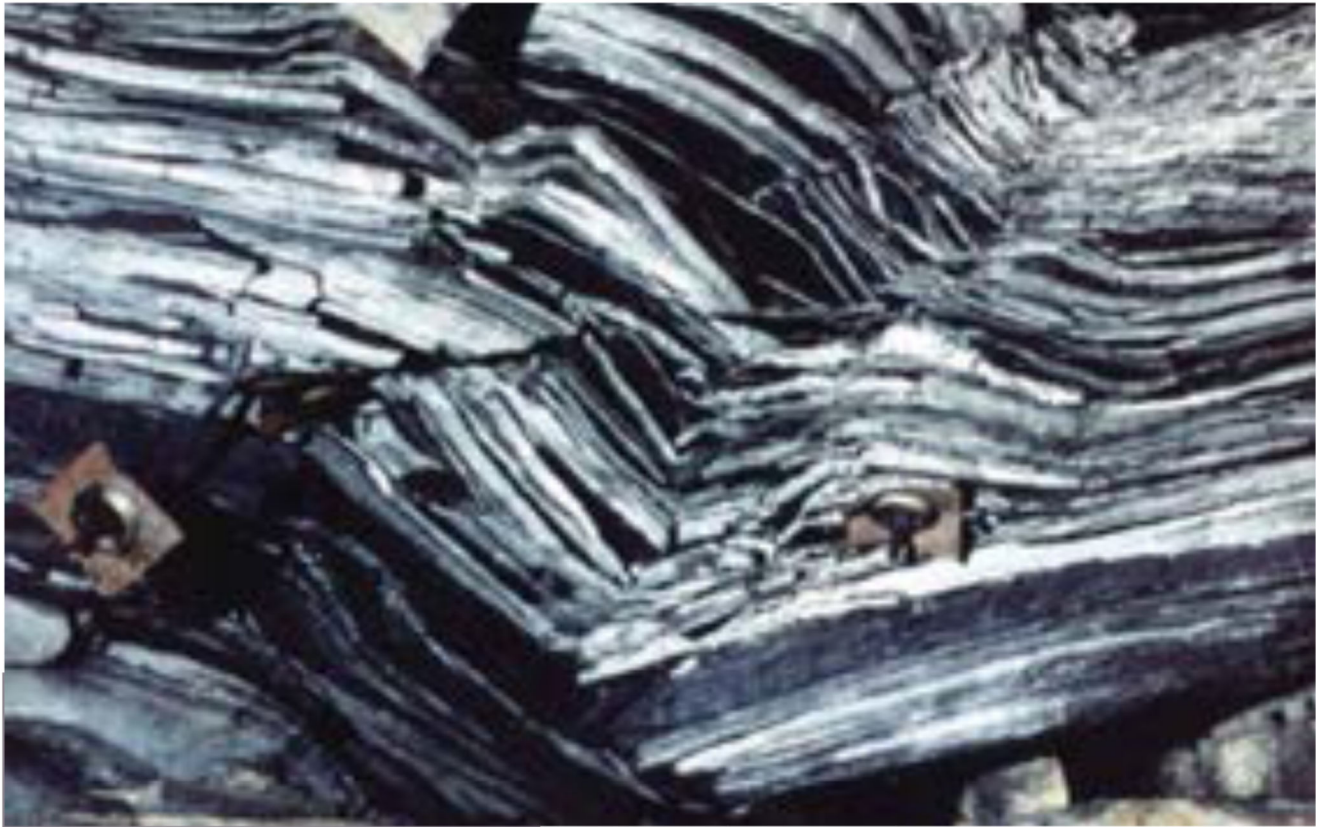
**Photo 1.**  
Failure of laminated roof layers in a coal mine.

**Laminated Roof**—Presence of thin laminations in a weak roof beam can contribute to entry failure. Laminations in the roof beam cause it to be subdivided into multiple thin beams. Weak, thin beams tend to separate and deflect downward into the mine entry. In addition, mining-induced stress could initiate progressive shear failure in thin layers of roof beam (Iannacchione, Esterhuizen, Bajpayee, et al., 2005). The interface material between adjacent layers may fail as well, causing differential movement in the layers and thereby weakening the overall rockmass strength. In the narratives, the presence of laminations in the immediate roof beam was reported as the second largest contributory factor for roof falls (Figure 6). Photo 1 shows failure of laminated roof in a coal mine (Esterhuizen & Bajpayee, 2012).

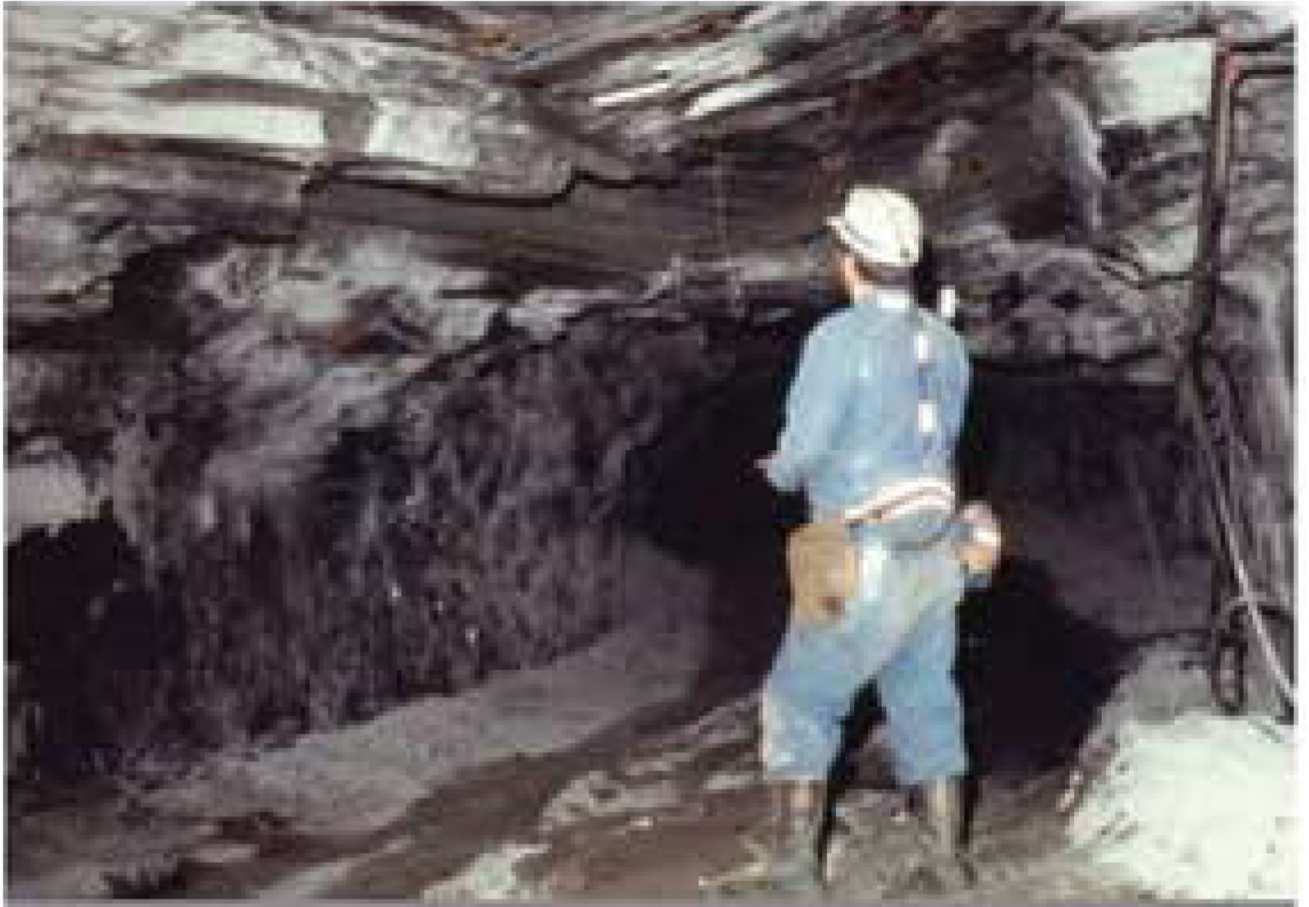
**Photo 2.**  
Initiation of roof cutter in a coal mine.

**Cutter**—The cutter category also includes roof falls due to the presence of high horizontal stress. Horizontal stress associated with poor rock quality is known to have initiated cutter failure in the Illinois Coal Basin (Molinda, 2003). (In this context, the word *cutter* is synonymous with the term *gutter* or *roof gutter*.) Furthermore, when the horizontal stress exceeds the vertical stress, it may cause cutter failure. Photo 2 shows initiation of roof cutter in a coal mine (Esterhuizen & Bajpayee, 2012). No unique solution exists for controlling or avoiding cutter roof failure (Hill, 1986). Even at shallow depths, horizontal stress is a concern for entry stability. Mark and Mucho (1994) and Su and Hasenfus (1995) reported that horizontal stress is often higher than the vertical stress in coal-bearing rock formation.
