Shale Failure Mechanics and Intervention Measures in Underground Coal Mines: Results From 50 Years of Ground Control Safety Research

M. M. Murphy¹

¹NIOSH-Office of Mine Safety and Health Research, 626 Cochran Mill Road, Pittsburgh, PA 15236, USA

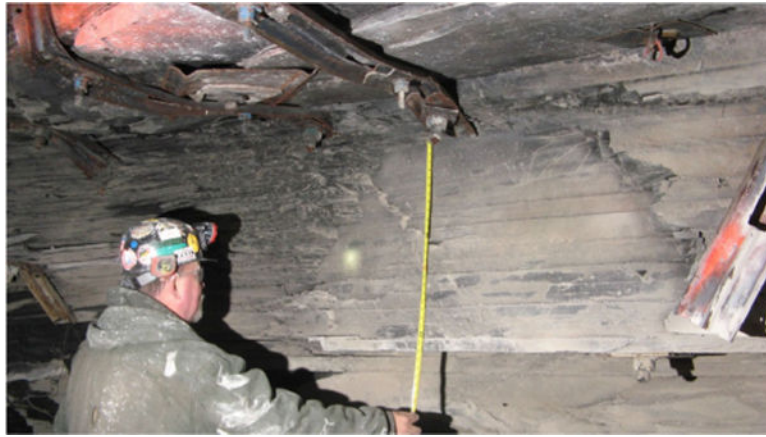
Fig. 2.
Photograph showing a shale mine roof with thin beds

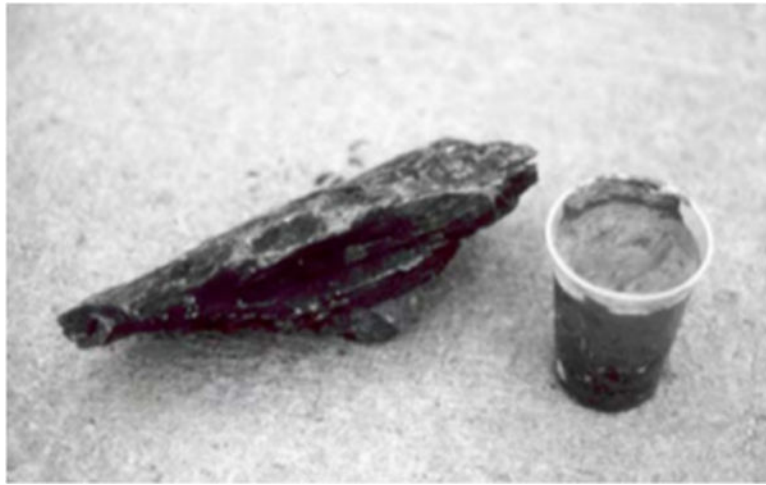
Fig. 3.
The effect of water on a moisture-sensitive shale (from Mark and Molinda 2007)

One of the factors that makes shale particularly weak is its susceptibility to moisture degradation. Some shales encountered in coal mine roof contain clay minerals in the montmorillonite family that will readily absorb moisture and expand. Numerous past studies have shown that roof shales degrade when coming into contact with humid mine air (Fletcher and Cassidy 1931; Aughenbaugh and Bruzewski 1973; Cummings et al. 1983). A study conducted by NIOSH found that roof falls were 15 % higher in the humid months than the annual average for the same time period (Molinda et al. 2006). The deterioration of shale caused by the seasonal weather changes can occur within days, months, and years after exposure. Some shales might not appear to be moisture sensitive when immersed in water, but will fail when subjected to repeated wetting and drying cycles, such as years of seasonal weather changes (Aughenbaugh 1981).

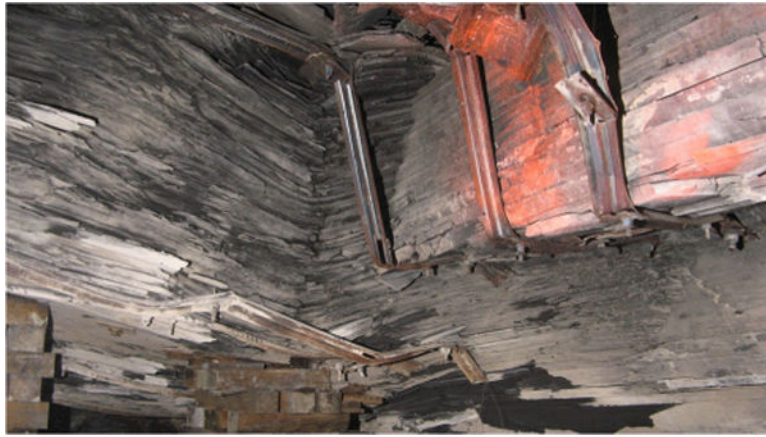
Fig. 5.
Cutter roof failure of a weak shale rock at the roof-rib intersection

Historically, cutter roof-related failures are one of the most common failure modes in coal mines, and they still create ground control-related problems today (Thomas 1950; Gale 1986; Hill 1986; Gadde and Peng 2005). An up-close picture of a cutter roof failure at the roof and rib intersection can be seen in Fig. 5. In the photo, a large vertical crack has formed at the start of the roof and extends vertically through all the laminations (middle of photo). A roof fall at this location allowed for this visual observation of the cutter propagation.

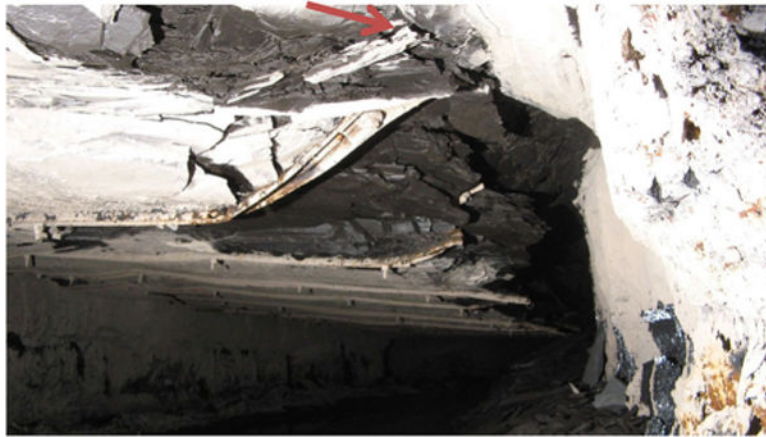
Fig. 7. Buckling of strata associated with cutter formation has defined a vertical discontinuity (seen by the *arrow*), which in turn has allowed cantilevering off the opposite rib

Cutters can also form in roof consisting of strata other than weak shale. In stack rock, represented by sequences of interlaminated sandstone and shale, horizontal stress can concentrate in the stiffer sandstone layers. These stress concentrations can cause tensional delamination and deflection along the interfaces, which crush the weaker shale layers at the rib abutment (Molinda 2003), causing the cutter roof failure. In most cutter roof-type failures, the fracture propagates at an angle greater than 60° from horizontal and normally requires a strong, competent layer such as sandstone to prevent the failure from propagating further. However, the fracture reaching the strong layer is also likely to cause separation at the interface, resulting in a detached block of roof rock as depicted in the previous photographs.

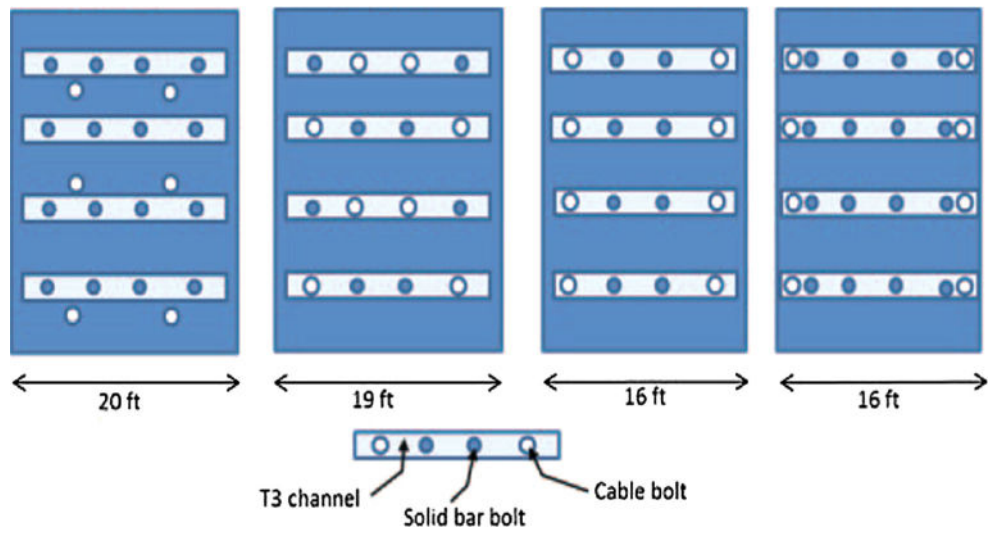
Fig. 9. Schematic illustration of different support patterns showing locations of primary support (*solid bar bolts*), cable bolts and T3 channels (*not to scale*) (from Esterhuizen 2015)

In a mine roof susceptible to damage by cutter failures, installing more bolts per row can aid in roof control (Peng 2008). More bolts per row can simply increase the support density and provide more steel to act as a bulwark against interlaminar sliding. Also, adding more bolts per row causes the two outside bolts to be positioned closer to each respective ribline, which helps resist cutter development. By resisting cutter development, the reduction of strength in the competent beam can be minimized. In some cases in the Illinois basin, the two bolts nearest to the rib are angled over the coal pillar so that the bolt gets anchorage in the undamaged rock material (Peng 2008). By anchoring the bolt into undamaged rock, the suspension of the competent beam is improved. Adding in cable bolts between rows of primary support, with lengths often between 10 and 16 ft, is also a standard practice in weak roof conditions. Figure 9 shows a schematic illustration of several roof support systems that had been employed at two study mines. The illustration shows configurations for cable bolt locations as secondary support in between primary support rows and also cable bolts included in the same row as primary support. For these scenarios, a study was conducted to evaluate the general ground response to gauge the effects of the support system configurations (Esterhuizen 2015).

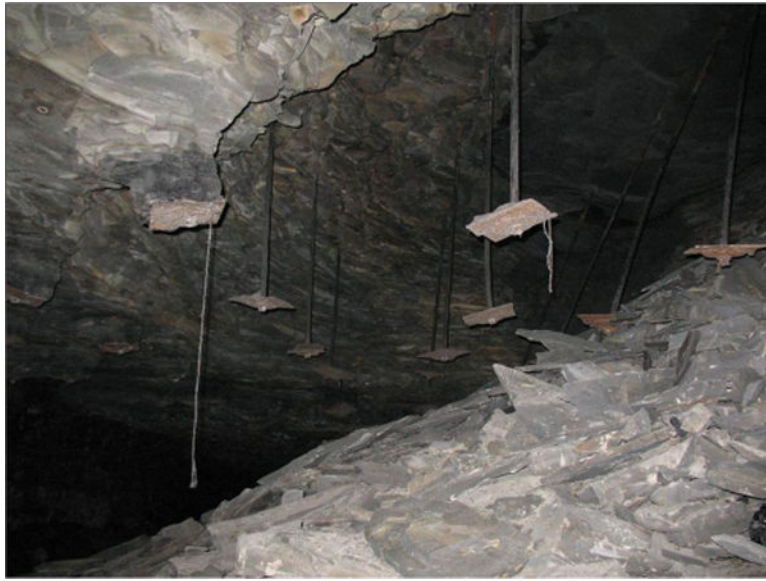
Fig. 11. Photograph showing how moisture-sensitive rock unraveled between bolts and fell to the ground

Moisture-sensitive shale deterioration starts off as a skin control problem, meaning it can cause pieces of rock to fall in between the roof bolts. When the roof initially relaxes as a result of coal extraction, microtensile failures can occur. These tension cracks produce an increased infiltration of moisture, leading to swelling. The swelling of the rock causes a downward pressure and can create more tensile fractures within the weakly bonded material (Huang et al. 1986). This progressive deterioration is what causes the unraveling process between the roof bolts. If not controlled, it can lead to a larger problem because the unraveling process can progress upwards, eventually rising above the bolted horizon and leading to a massive roof fall. An illustration of the process is given in Fig. 10. Figure 11 shows an example of weak shale that has unraveled between roof bolts in an underground coal mine. In this example, the rock unraveled vertically until a more competent layer was reached to stop the failure, and the bolts remained anchored in the stronger strata.

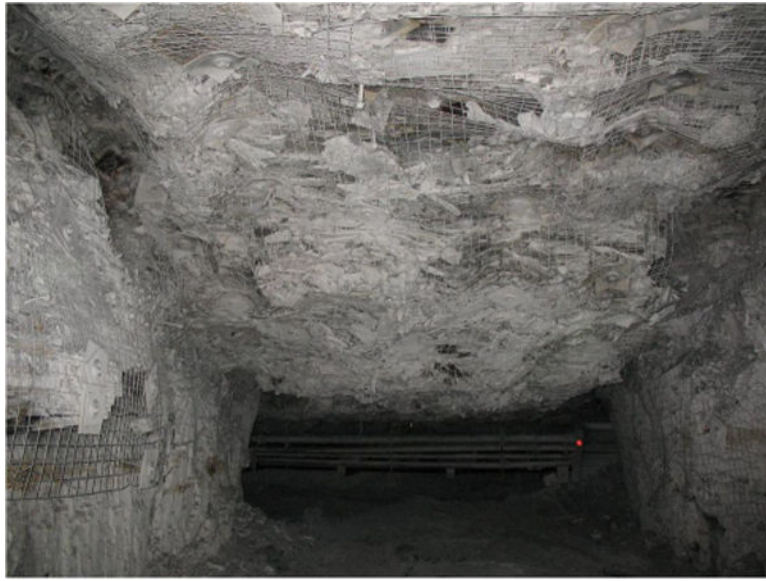
Fig. 13.
Example of roof screen used to control deteriorated roof

To control moisture-sensitive shale in the roof, skin type support needs to be installed. Skin support, such as roof screen, helps contain the broken rock and prevents further deterioration from progressing vertically above the bolted horizon (Gadde et al. 2006). Roof screen can provide sufficient confinement to fractured shale to help support the deteriorated roof rock and slow the process of progressive unraveling between bolts. A photograph displaying the use of roof screen to control deteriorated roof at an Illinois mine is shown in Fig. 13. At the same mine, since the inception of roof screening in 1994, injuries due to roof falls have diminished, as seen in the data represented in Fig. 14 (Molinda and Klemetti 2008). Areas that were not screened showed a roof fall rate five times higher than the areas that had screen installed.
