## Volumetric measurement of rock movement using photogrammetry

Donovan J. Benton<sup>\*</sup>, Stephen R. Iverson, Lewis A. Martin, Jeffrey C. Johnson, and Michael J. Raffaldi

National Institute for Occupational Safety and Health, Spokane 99207, USA

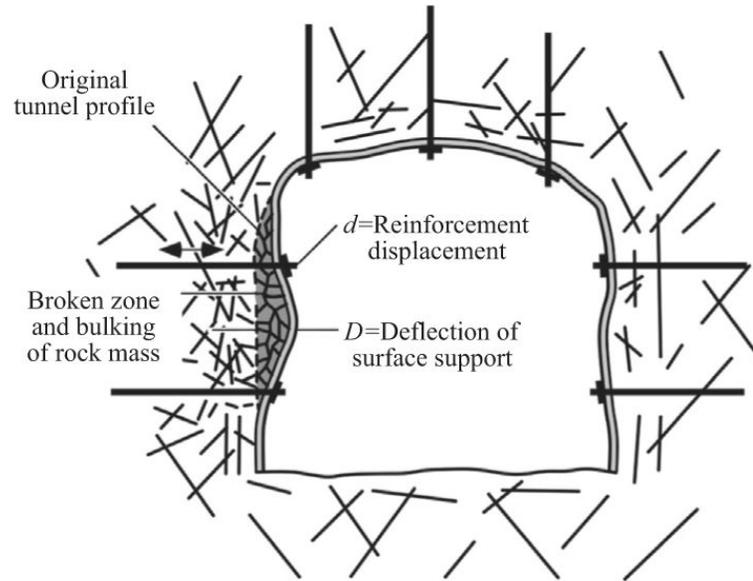
**Fig. 1.**  
Diagram of the reinforced shotcrete system [2].

Ground control safety often depends on supporting, or at least containing, the ground between rock bolts. Shotcrete and mesh, in various combinations and with other components, are often called upon to do this, as shown in Fig. 1.

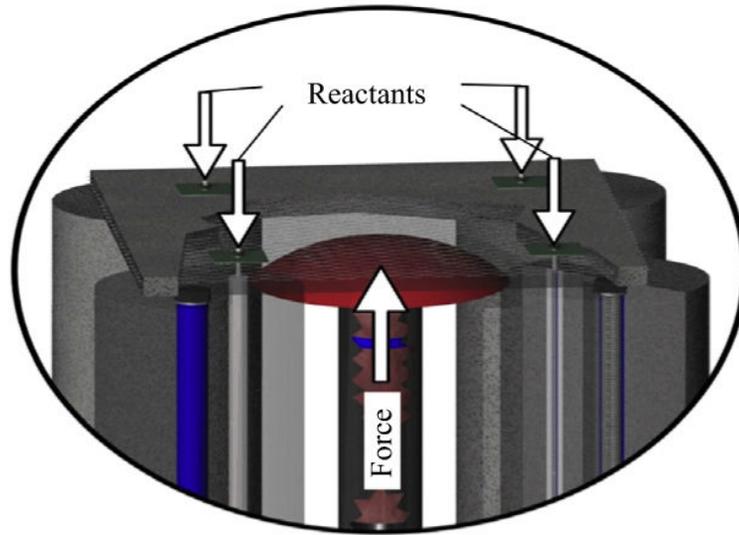
**Fig. 2.** Diagram of the force during the high-energy displacement panel test and tester.

The HEHD testing process begins as aspherically-shaped hydraulic ram head is pushed through the test panel while being restrained by paddle anchor D-Bolts® embedded in the four columns of the test frame, as shown in Fig. 2.

D-Bolts are designed specifically to absorb energy in dynamically loaded rock masses [8]. Load and displacement data are collected during the test using an advanced data acquisition system. Once the ram reached 25 cm displacement, the system was de-energized and photogrammetric monitoring ended.

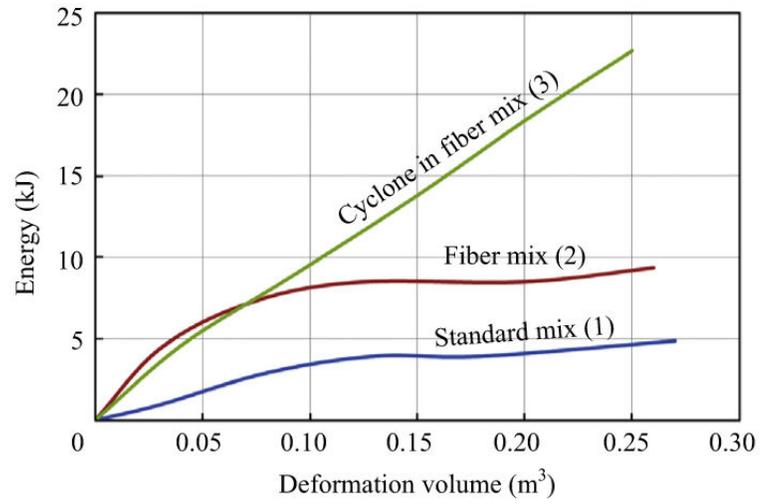
**Fig. 4.** Relationship between energy and volume for shotcrete support systems, as determined through photogrammetric measurement.

More significant, however, is the relationship between deformation volume, deformation height, and energy. Fig. 4 shows volume-energy relationship. The effect of shotcrete reinforcement is clear in terms of energy absorption capacity.

Cyclone-reinforced fiber shotcrete can withstand energies over 400% greater than standard mix shotcrete while undergoing the same volume of deformation. A clear difference in performance between the three types of shotcrete can be identified from this analysis. Assuming a 1.2 m × 1.2 m bolt spacing pattern, the potential exists for a yield “volume” to

be assessed in field settings. While standard and fiber mix shotcretes appear to lose load-bearing capacity at deformation volumes of  $0.10 \text{ m}^3$ , cyclone-reinforced fiber shotcrete can still assume more loading even at deformation volumes of  $0.25 \text{ m}^3$ . At present, it is not possible to determine whether the better performance of cyclone-reinforced fiber shotcrete is the result of fencing reinforcement, or the fiber in combination with the fencing. Future tests of cyclone-reinforced standard mix shotcrete panels still need to be conducted.

Energy estimations were calculated by interpolating the data obtained from laboratory testing of cyclone mesh, shown previously in Fig. 4. Due to unreliability of data for displacements less than 15 cm, the energy for Area 3 could only be estimated as less than 100 J. Confidence in the accuracy of the calculated volumes is based on their apparent correlation with volumes calculations derived from laboratory testing of panels having similar 1.8 by 1.8 m surface areas. Refinement of field volume calculations would include calibration and optimization of Agisoft's Photo Scan software in both laboratory and field settings. Further applications of these techniques include usage at shotcrete reinforced sites, and calculations of volume loss in areas of key blocking. At present, photogrammetric calculations of deformation volumes appear as a viable technique for understanding rock mass behavior and increasing information for use in ground control safety.

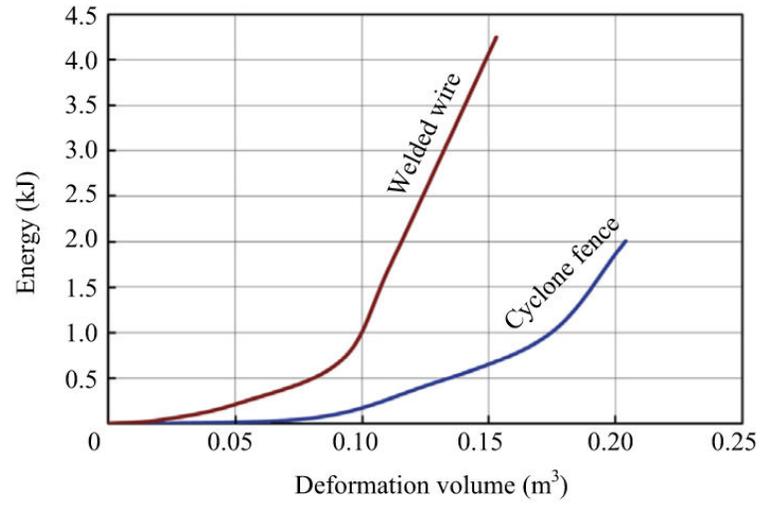
**Fig. 5.** Relationship between energy and deformation volume for cyclone fence and welded wire support systems, as determined through photogrammetric measurement.

The cyclone fence test provided less conclusive results. It required approximately 9 cm of ram displacement before the fencing started to provide significant resistance. This is due to the fact that the fencing is relatively loose and that there is play in the system until the links make contact/interlock and start to develop tension in the steel strands. The force then begins to increase linearly with further displacement as the chain link fence begins to tighten and the wire strands are loaded in tension within their elastic region. With enough displacement, the chain link fence would be expected to exhibit ductile deformation. The welded wire mesh tests provided slightly better results, requiring less displacement (3 cm) before reaction began. However, no point of failure was reached, due to the same factors that limited the cyclone fence testing. Without shotcrete, both types of mesh have, on their own, essentially no load carrying capacity until excessive deformations occur. Since the test stopped at 25 cm of displacement, behavior of the cyclone fencing and welded wire mesh at failure was not observed. The energy-volume relationship for each type of mesh can be seen in Fig. 5.

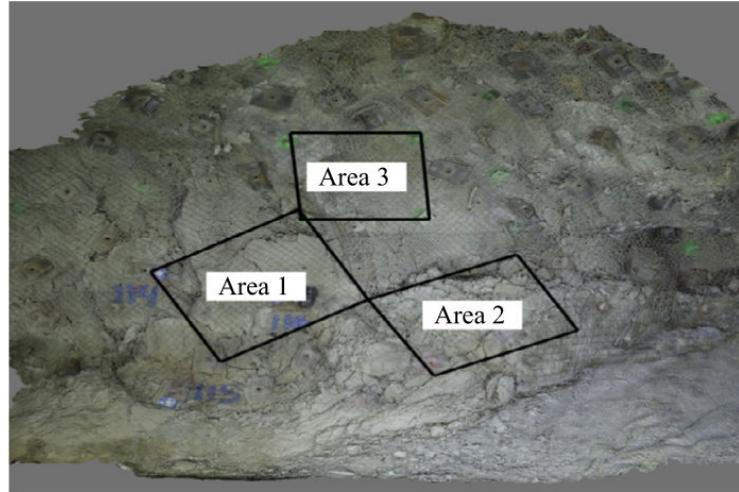
**Fig. 6.**  
Selected rib for volumetric deformation analysis.

Field deformation volumes were calculated similarly to laboratory testing volumes. Site selection was based on two factors: range of deformation at the site, and orientation of bedding planes. The chosen site displayed varying levels of deformation ranging from minor ( $<3 \text{ cm}$ ) to severe ( $>30 \text{ cm}$ ). Areas of the rib with roughly 1.8 by 1.8 m sides were chosen for both minor and severe cases of deformation, as well as an additional area of significant (approximately 15 cm) deformation. These areas are shown in Fig. 6, with Area 1 representing significant deformation, and Areas 2 and 3 representing severe and minor deformation, respectively.

As noted in Fig. 6, Areas 1, 2 and 3 correspond to significant (approximately 15 cm), severe (approximately 30 cm), and minor (approximately 3 cm) deformation, respectively.

Additionally, bedding planes at the site were parallel to the rib face, an orientation that leads to greater deformation. Parallel bedding also allowed for the closest comparison to be made of field deformations to laboratory panel testing.

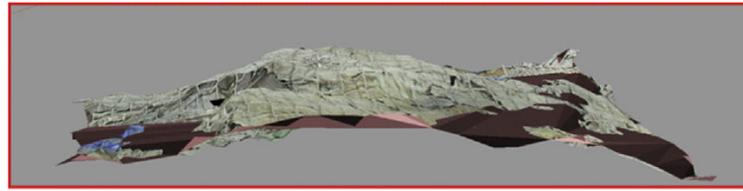
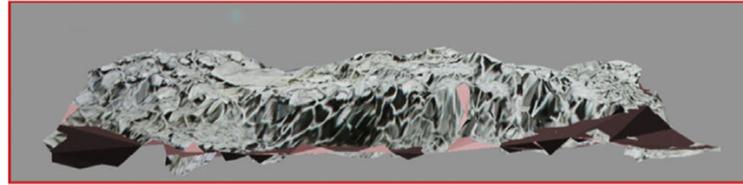
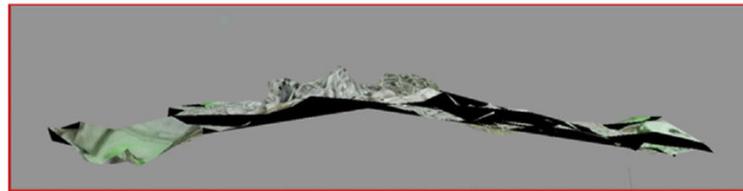
(a) Area 1 significant deformation

(b) Area 2 severe deformation

(c) Area 3 minimal deformation

**Fig. 7.** Side views of deformation areas selected for field deformation monitoring volume calculations.

transformed into standalone solids by bridging low points along the perimeter across the area. Side views of each area are shown in Fig. 7.

As shown in Fig. 7, Areas 1, 2 and 3 correspond to slabbing, fractured and competent rock masses, respectively.

Area 1 was composed of loose slabs being pushed out between bolts, while Area 2 was primarily highly fractured material bagging in the mesh between the bolts. Conversely, Area 3 consisted of competent rock, with minimal extrusion between bolts. The volume calculations and related estimations of energy for each area can be seen in Table 3.

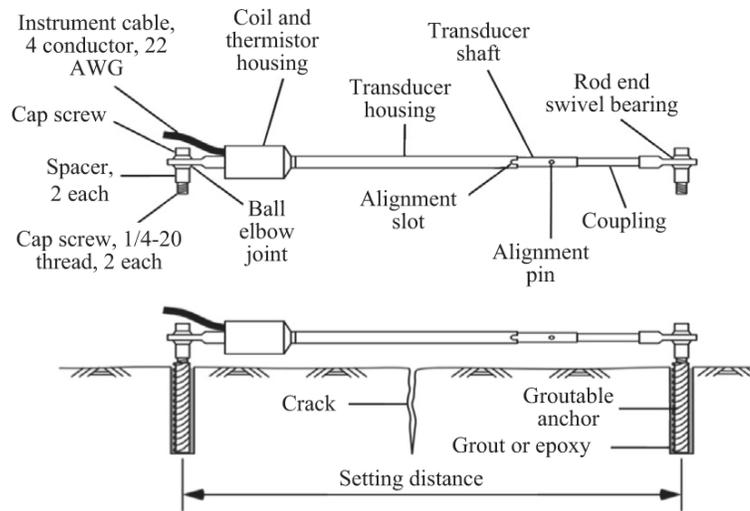
**Fig. 8.** Crackmeter schematics showing instrument components and installation [9].

Site measurements made using the field photogrammetry system were compared to crackmeter data from the deep underground mine. The participating mine uses Geokon® model 4420 vibrating wire crackmeters to monitor fault movement. These meters are designed specifically for monitoring movement across natural rock joints in the civil and mining industries. As shown in Fig. 8, each crackmeter consists of a vibrating wire displacement transducer contained within a stainless steel housing rod.

The displacement transducer is a vibrating wire sensing element with a spring connected to one end and a rod connected to the other. The instrument is placed across the joint of interest and anchored into the rock.

As movement occurs along the joint, the connecting rod is displaced from the body of the gauge causing an increase or decrease in tension in the wire. This change in tension is directly proportional to the extension or compression, allowing the movement along the fault to be determined. The frequency measurements are converted to displacements via manufacturer-calibrated gage factors and the difference between the current and initial reading at the time of installation.

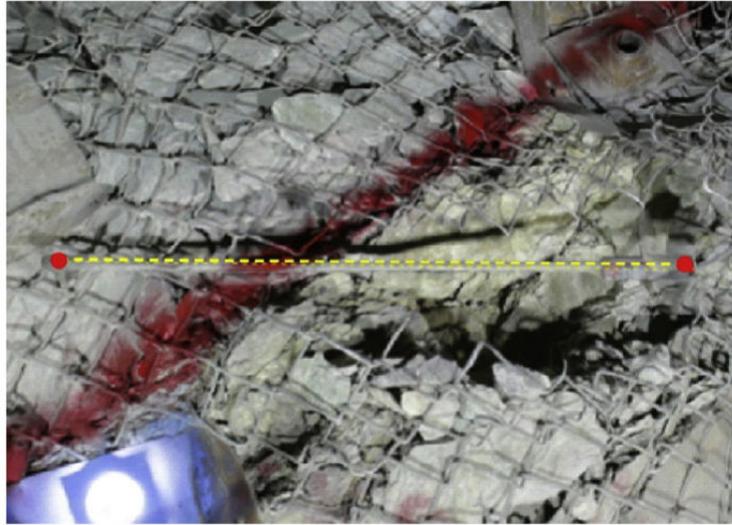
**Fig. 9.** Crackmeter installation (yellow dotted-line) across fault (red spray paint).

A photogrammetric reconstruction was completed for each individual crackmeter, creating a “virtual” crackmeter for analysis within a 3D point cloud. Mine survey data are then used to reference each photogrammetry survey to global coordinates, thus scaling each virtual crackmeter. Photogrammetric measurements of the crackmeters are made within the Shape Metrix<sup>3D</sup> software by affixing a measuring point to each end. The scene depicted in Fig. 9 is a reconstruction of a crackmeter location.

As noted in Fig. 9, length measurements are made using points (red dots).

The red dots represent the Shape Metrix<sup>3D</sup> measuring points, and the yellow dashed line marks the distance between the measuring points. The coordinates of the measuring points give the location of the crackmeter anchors in 3D space, and can be used to determine length, location, and orientation.

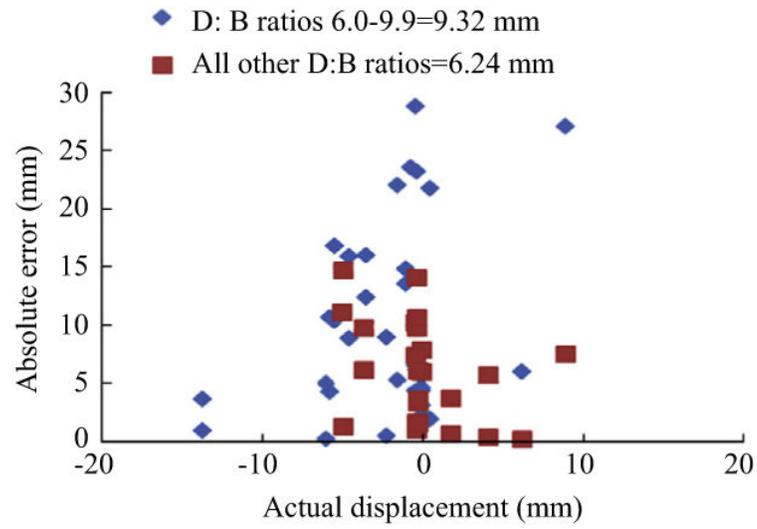
**Fig. 10.** Comparison of photogrammetric error and actual crackmeter displacement, coded by D:B ratio, reveals and average error of 8 mm.

Several variables have been investigated as causes of this additional error. Fig. 10 codes absolute error in terms of depth-to-base (D:B) ratio, which is the distance to the target relative to the spacing between cameras. The red markers indicate measurements made using D:B ratios between 6.0 and 9.9, typically the optimal range. Differing demands of area coverage and site accessibility made it difficult to stay in this range, thus there were a significant number of measurements made using D:B ratios less than 6.0, or greater than 9.9. Curiously however, as can be seen in Fig. 5, D:B ratios between 6.0 and 9.9 actually produced less accurate measurements (average 9.32 mm error) than D:B ratios outside the range (average 6.24 mm error). The crackmeter's shape and appearance is the probable cause for this discrepancy.

Higher D:B ratios tend to provide more planimetric (perpendicular field) accuracy, while lower ratios provide more depth (parallel field) accuracy. Ratios between 6.0 and 10.0 generally provide the best compromise between these two types of accuracy. However, when an object occupies very little space in one or the other field, balancing the two may become less significant due to the loss of three-dimensionality of the object. As a result of the crackmeter's slenderness, it will appear more two-dimensional, thus reducing the importance of balancing planimetric and depth fields. Though a conclusion cannot presently be made, it may even be the case that favoring one field over the other, depending on crackmeter orientation would produce the best results, as indicated by Fig. 10.

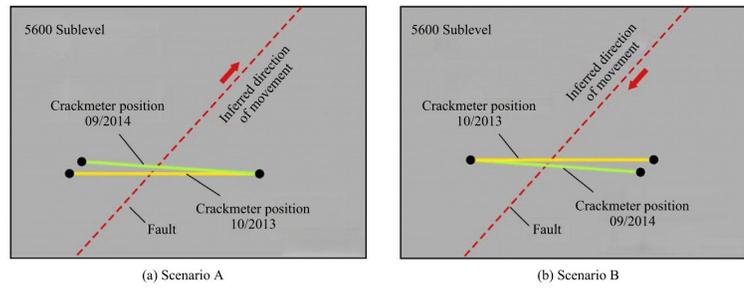
**Fig. 11.** Representations of 5600 sublevel crackmeter analysis based on observed shortening of the crackmeter.

Analysis of crackmeter data focuses on shortening and lengthening of the crackmeter. Depending on the orientation of the fault crossing the crackmeter, a sense of direction of fault motion can be ascertained. This technique is illustrated in Fig. 11.

In Scenario A, the initial crackmeter location (gold bar, October 2013) is oriented such that upward movement of the hanging wall would result in shortening of the crackmeter. The final crackmeter position (green bar, September 2014) represents the scene after movement has occurred. Alternatively, as shown in Scenario B, the footwall could have moved downwards, also resulting in a shortening of the crackmeter. In either scenario, the relative motion is the same, suggesting dip-slip offset of the fault.

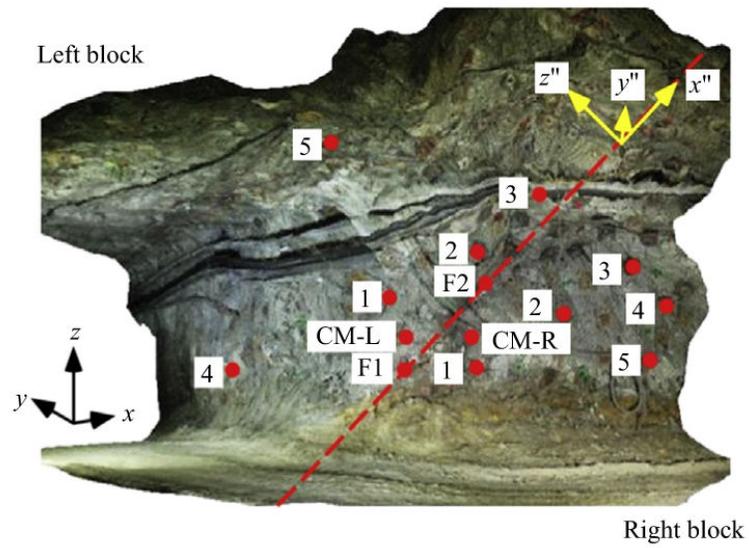
**Fig. 12.** Illustration of measuring points (red dots), global axis system (lower-left in black), local axis system (upper-right in yellow) and left and right fault blocks at the 5600 sublevel site.

Additional points on either side of the fault were selected for similar treatment. Global displacements for all these points were produced in mine global coordinates of easting, northing, and elevation ( $x$ ,  $y$ , and  $z$ , respectively). To more fully understand fault activity at the 5600 sublevel site, the global  $x$ ,  $y$ , and  $z$  displacements were transformed into local coordinate displacements oriented on strike and dip of the fault. Photogrammetric data indicated a strike of  $N63^\circ E$ , which served as the new  $y$ -axis. A fault dip of  $58^\circ$  was used for the second transformation, which served as the direction of the new  $x$ -axis. The final  $x''$ ,  $y''$ , and  $z''$  axes represent movement in the dip, strike, and dilation orientations of the fault. All measurement points, both axis systems, and the left and right fault blocks are identified in Fig. 12.

As noted in Fig. 12, the thrust, slip, and convergence vectors of the fault are represented by  $x''$ ,  $y''$ , and  $z''$ , respectively.
