Int J Min Sci Technol. Author manuscript; available in PMC 2016 April 20.

Volumetric measurement of rock movement using photogrammetry

National Institute for Occupational Safety and Health, Spokane 99207, USA

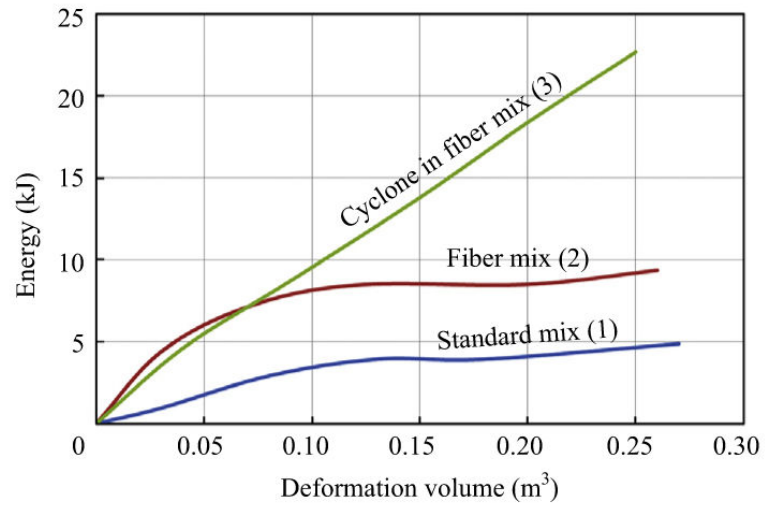
Fig. 4. Relationship between energy and volume for shotcrete support systems, as determined through photogrammetric measurement.

More significant, however, is the relationship between deformation volume, deformation height, and energy. Fig. 4 shows volume-energy relationship. The effect of shotcrete reinforcement is clear in terms of energy absorption capacity.

Cyclone-reinforced fiber shotcrete can withstand energies over 400% greater than standard mix shotcrete while undergoing the same volume of deformation. A clear difference in performance between the three types of shotcrete can be identified from this analysis. Assuming a 1.2 m × 1.2 m bolt spacing pattern, the potential exists for a yield "volume" to

be assessed in field settings. While standard and fiber mix shotcretes appear to lose load-bearing capacity at deformation volumes of 0.10 m^3 , cyclone-reinforced fiber shotcrete can still assume more loading even at deformation volumes of 0.25 m^3 . At present, it is not possible to determine whether the better performance of cyclone-reinforced fiber shotcrete is the result of fencing reinforcement, or the fiber in combination with the fencing. Future tests of cyclone-reinforced standard mix shotcrete panels still need to be conducted.

Energy estimations were calculated by interpolating the data obtained from laboratory testing of cyclone mesh, shown previously in Fig. 4. Due to unreliability of data for displacements less than 15 cm, the energy for Area 3 could only be estimated as less than 100 J. Confidence in the accuracy of the calculated volumes is based on their apparent correlation with volumes calculations derived from laboratory testing of panels having similar 1.8 by 1.8 m surface areas. Refinement of field volume calculations would include calibration and optimization of Agisoft's Photo Scan software in both laboratory and field settings. Further applications of these techniques include usage at shotcrete reinforced sites, and calculations of volume loss in areas of key blocking. At present, photogrammetric calculations of deformation volumes appear as a viable technique for understanding rock mass behavior and increasing information for use in ground control safety.

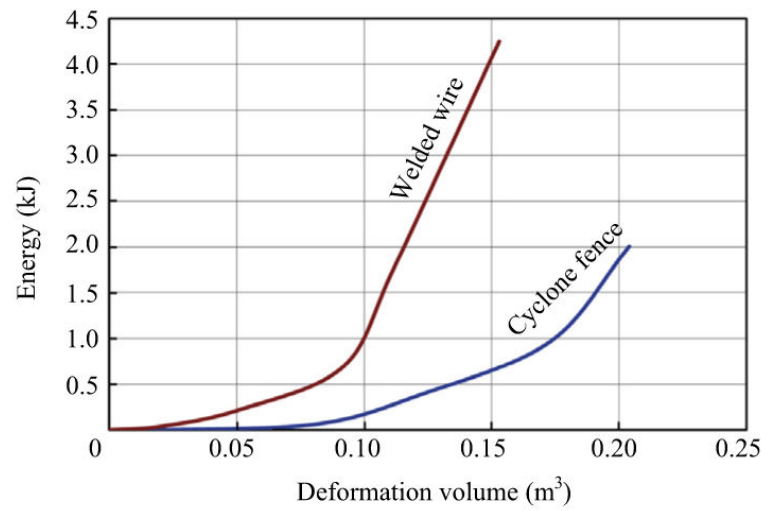
Fig. 5. Relationship between energy and deformation volume for cyclone fence and welded wire support systems, as determined through photogrammetric measurement.

The cyclone fence test provided less conclusive results. It required approximately 9 cm of ram displacement before the fencing started to provide significant resistance. This is due to the fact that the fencing is relatively loose and that there is play in the system until the links make contact/interlock and start to develop tension in the steel strands. The force then begins to increase linearly with further displacement as the chain link fence begins to tighten and the wire strands are loaded in tension within their elastic region. With enough displacement, the chain link fence would be expected to exhibit ductile deformation. The welded wire mesh tests provided slightly better results, requiring less displacement (3 cm) before reaction began. However, no point of failure was reached, due to the same factors that limited the cyclone fence testing. Without shotcrete, both types of mesh have, on their own, essentially no load carrying capacity until excessive deformations occur. Since the test stopped at 25 cm of displacement, behavior of the cyclone fencing and welded wire mesh at failure was not observed. The energy-volume relationship for each type of mesh can be seen in Fig. 5.

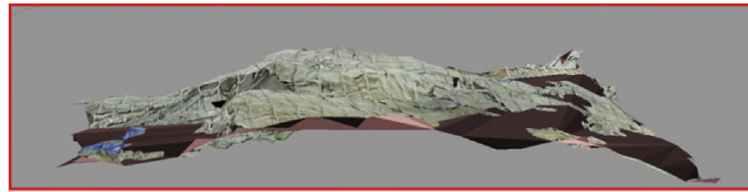
(a) Area 1 significant deformation

Fig. 7. Side views of deformation areas selected for field deformation monitoring volume calculations.

transformed into standalone solids by bridging low points along the perimeter across the area. Side views of each area are shown in Fig. 7.

As shown in Fig. 7, Areas 1, 2 and 3 correspond to slabbing, fractured and competent rock masses, respectively.

Area 1 was composed of loose slabs being pushed out between bolts, while Area 2 was primarily highly fractured material bagging in the mesh between the bolts. Conversely, Area 3 consisted of competent rock, with minimal extrusion between bolts. The volume calculations and related estimations of energy for each area can be seen in Table 3.

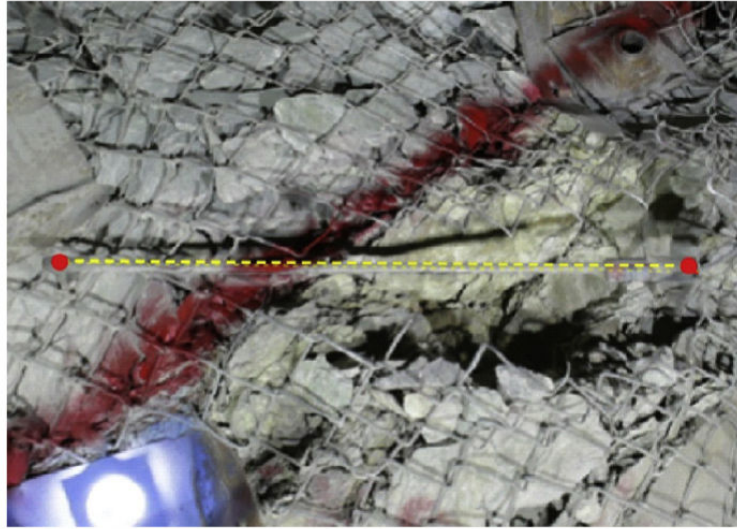
Fig. 9. Crackmeter installation (yellow dotted-line) across fault (red spray paint).

A photogrammetric reconstruction was completed for each individual crackmeter, creating a “virtual” crackmeter for analysis within a 3D point cloud. Mine survey data are then used to reference each photogrammetry survey to global coordinates, thus scaling each virtual crackmeter. Photogrammetric measurements of the crackmeters are made within the Shape Metrix^{3D} software by affixing a measuring point to each end. The scene depicted in Fig. 9 is a reconstruction of a crackmeter location.

As noted in Fig. 9, length measurements are made using points (red dots).

The red dots represent the Shape Metrix^{3D} measuring points, and the yellow dashed line marks the distance between the measuring points. The coordinates of the measuring points give the location of the crackmeter anchors in 3D space, and can be used to determine length, location, and orientation.

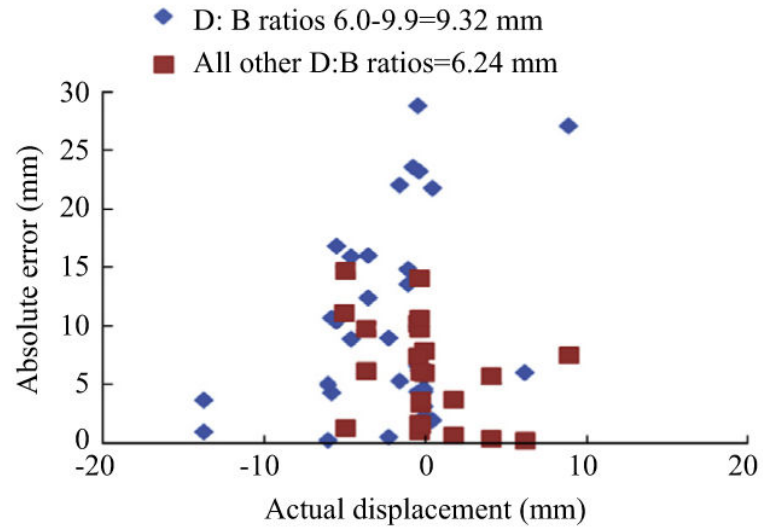
Fig. 10. Comparison of photogrammetric error and actual crackmeter displacement, coded by D:B ratio, reveals and average error of 8 mm.

Several variables have been investigated as causes of this additional error. Fig. 10 codes absolute error in terms of depth-to-base (D:B) ratio, which is the distance to the target relative to the spacing between cameras. The red markers indicate measurements made using D:B ratios between 6.0 and 9.9, typically the optimal range. Differing demands of area coverage and site accessibility made it difficult to stay in this range, thus there were a significant number of measurements made using D:B ratios less than 6.0, or greater than 9.9. Curiously however, as can be seen in Fig. 5, D:B ratios between 6.0 and 9.9 actually produced less accurate measurements (average 9.32 mm error) than D:B ratios outside the range (average 6.24 mm error). The crackmeter's shape and appearance is the probable cause for this discrepancy.

Higher D:B ratios tend to provide more planimetric (perpendicular field) accuracy, while lower ratios provide more depth (parallel field) accuracy. Ratios between 6.0 and 10.0 generally provide the best compromise between these two types of accuracy. However, when an object occupies very little space in one or the other field, balancing the two may become less significant due to the loss of three-dimensionality of the object. As a result of the crackmeter's slenderness, it will appear more two-dimensional, thus reducing the importance of balancing planimetric and depth fields. Though a conclusion cannot presently be made, it may even be the case that favoring one field over the other, depending on crackmeter orientation would produce the best results, as indicated by Fig. 10.
