Volunteer Fire Fighter Dies While Lost in Residential Structure Fire- Alabama

SUMMARY

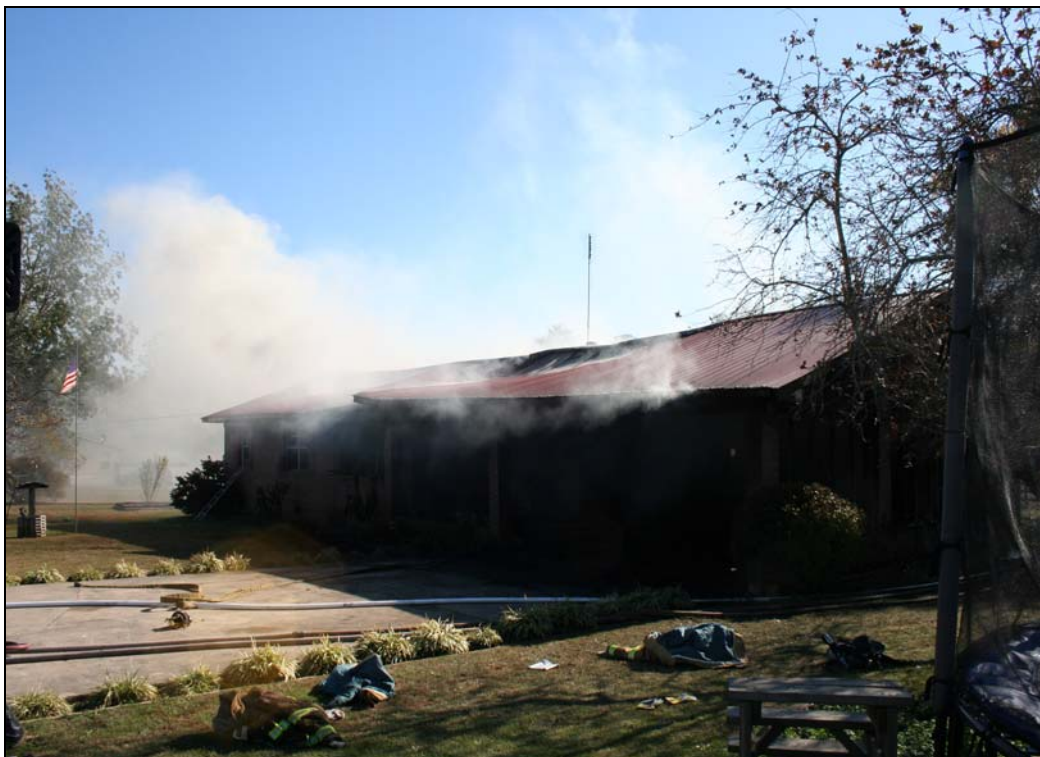
Incident Scene after Victim Removed
(Photo courtesy of sheriff's office)

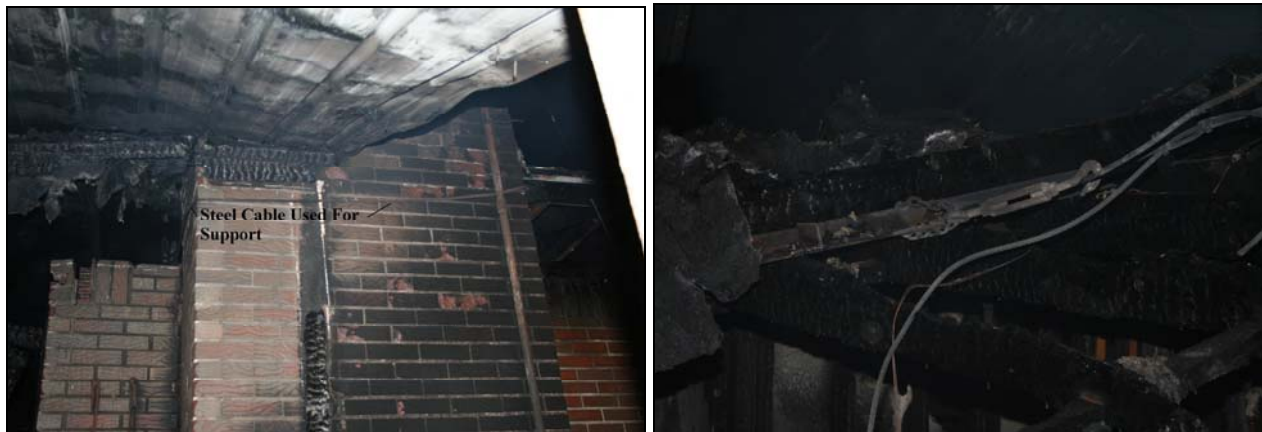
turnbuckle to connect the cable ends; this supported the chimney while pulling it back against the house (see Photo 1).

Photo 1. Steel cable used to support the chimney against the house with a turnbuckle.
(Photos courtesy of sheriff's office)

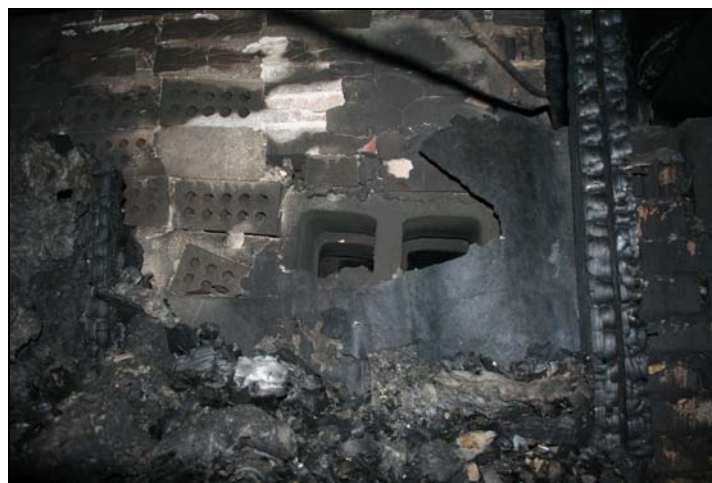
After the chimney was repositioned, the owner noticed that bricks from the chimney's flue had cracked and shifted. The owner removed the damaged bricks and replaced them with hollow cinder blocks. These blocks had been laid with the hollows horizontally positioned towards the attic space (see Photo 2). The residents of the house were safely evacuated prior to the fire department's arrival. The structure was completely destroyed by a rekindle several days later.

Photo 2. The picture shows the area of the brick chimney flue that was replaced with cinder blocks. The cinder blocks allowed heat and flame to impinge on the exterior wall allowing fire to spread into the attic space.
(Photo courtesy of sheriff's office)

During their investigation, the fire marshal and sheriff’s office investigators believed that the chimney flue failed allowing radiant heat and flame to travel through the open sides of the cinder blocks and impinge on combustible materials in the attic. It is believed that the fire smoldered for a while in the attic before finding a reliable fuel source. Fire burned across the C-side of the structure’s attic before burning down into the living area where the wood stove was located (see Photo 6). Thick black smoke was filling the structure when the victim and FF2 entered through the carport for the first time. No flames were immediately visible according to FF2. FF1 was met with the same smoke conditions when he opened the front door and the bay window broke under extreme heat conditions. Flames throughout the house erupted moments later. FF1 and FF2 do not recall any type of explosion or “puffs” of smoke before the house erupted in flames. The sheriff’s office investigator believed that the house “flashed,” trapping the victim and exposing him to extreme heat and fire conditions after the door and window were opened, which would have allowed fresh air (oxygen) to join the fuel mixture (heavy dark smoke) inside, ultimately leading to the flashover.

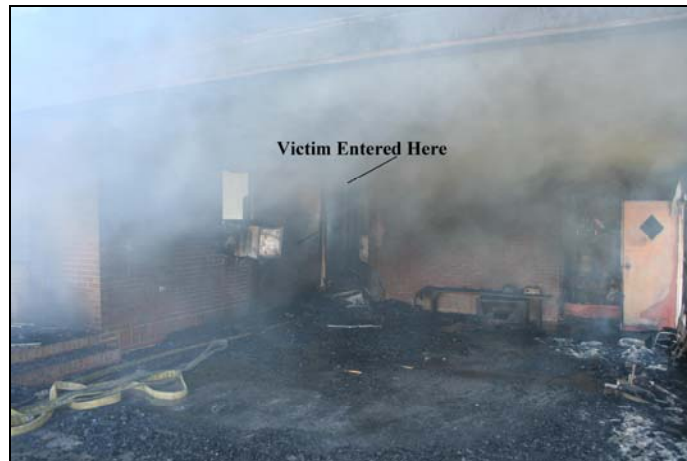
Photo 3. Door under carport that victim entered through.
(Photo courtesy of sheriff's office)

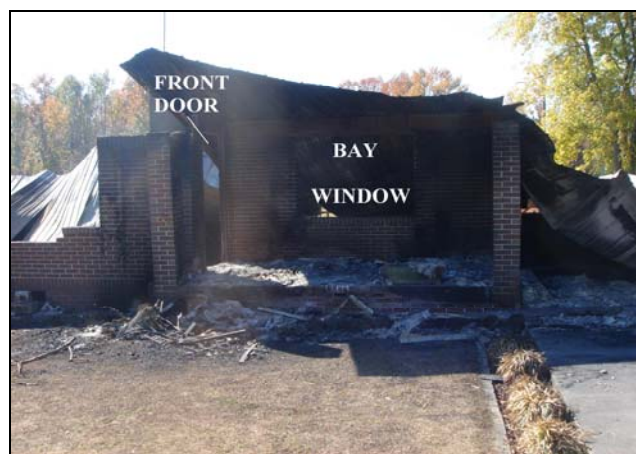
Photo 4. Incident scene after rekindle and collapse showing the front door and bay window.
(NIOSH photo)

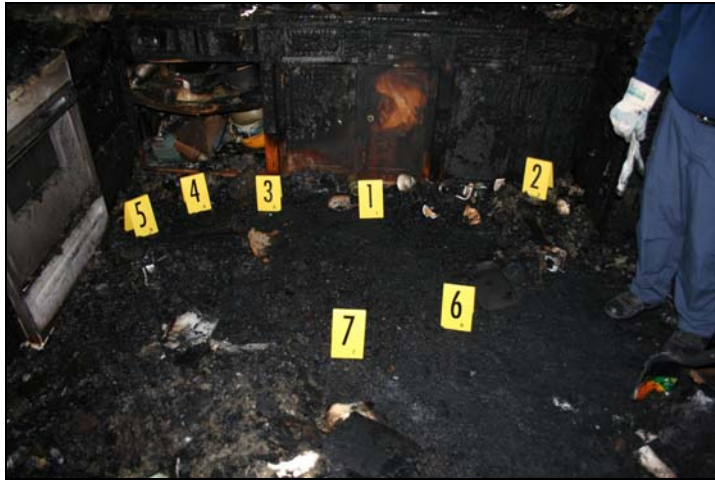
1. Victim – 112” from carport door
2. SCBA – 85” from carport door
3. Face Piece – 128” from carport door
4. Helmet – 139 ½” from carport door
5. Radio – 147” from carport door
6. Boot – 94” from carport door
7. Nozzle – 101” from carport door

Photo 5. Number cues placed to document victim and items discovered.
(Photo courtesy of sheriff’s office)

During this incident, it was never determined whether the victim's PASS device was heard. The victim radioed for assistance but did not declare a Mayday. The victim was found within arms reach of his hoseline that led outside (approximately eight feet to the door).

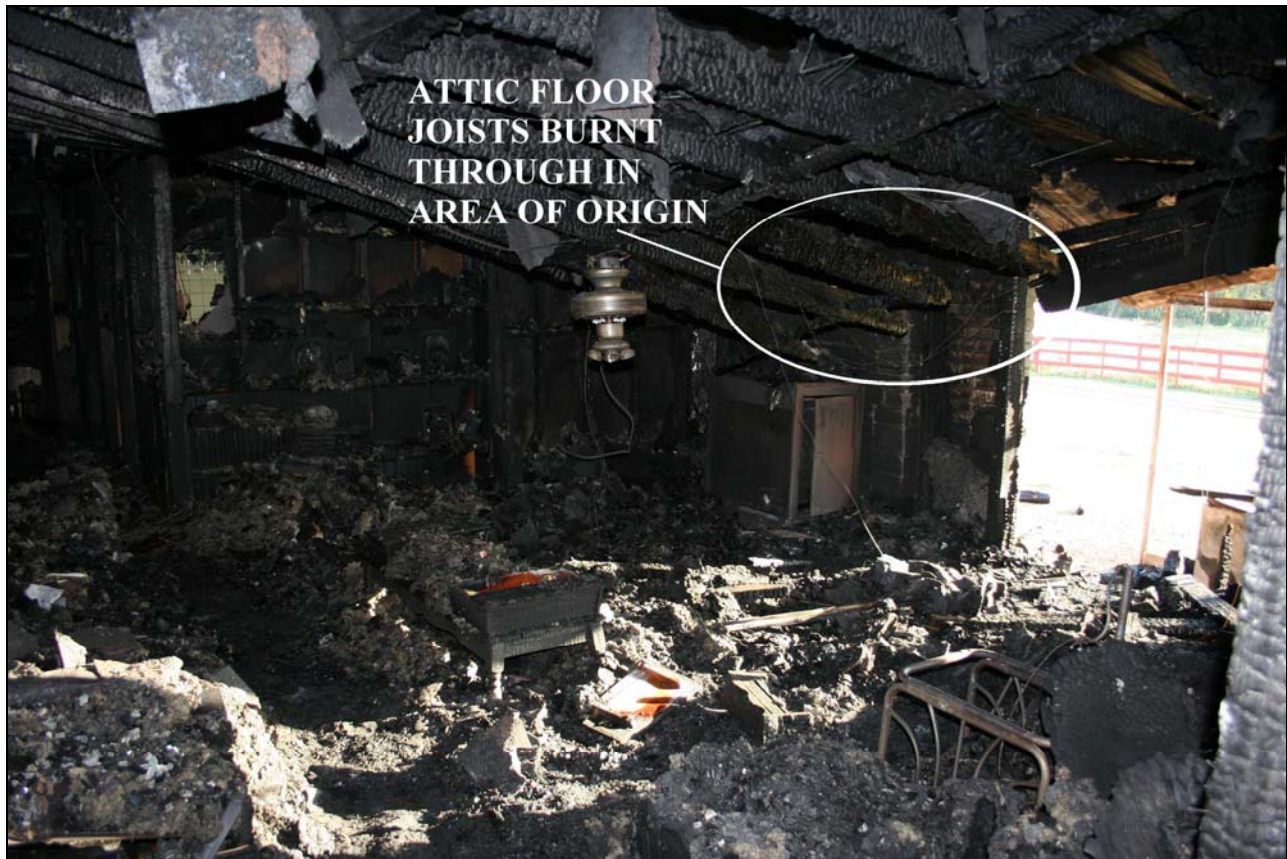
Photo 6. Fire damage to living room area before rekindle and structural collapse.
(Photo courtesy of sheriff's office)

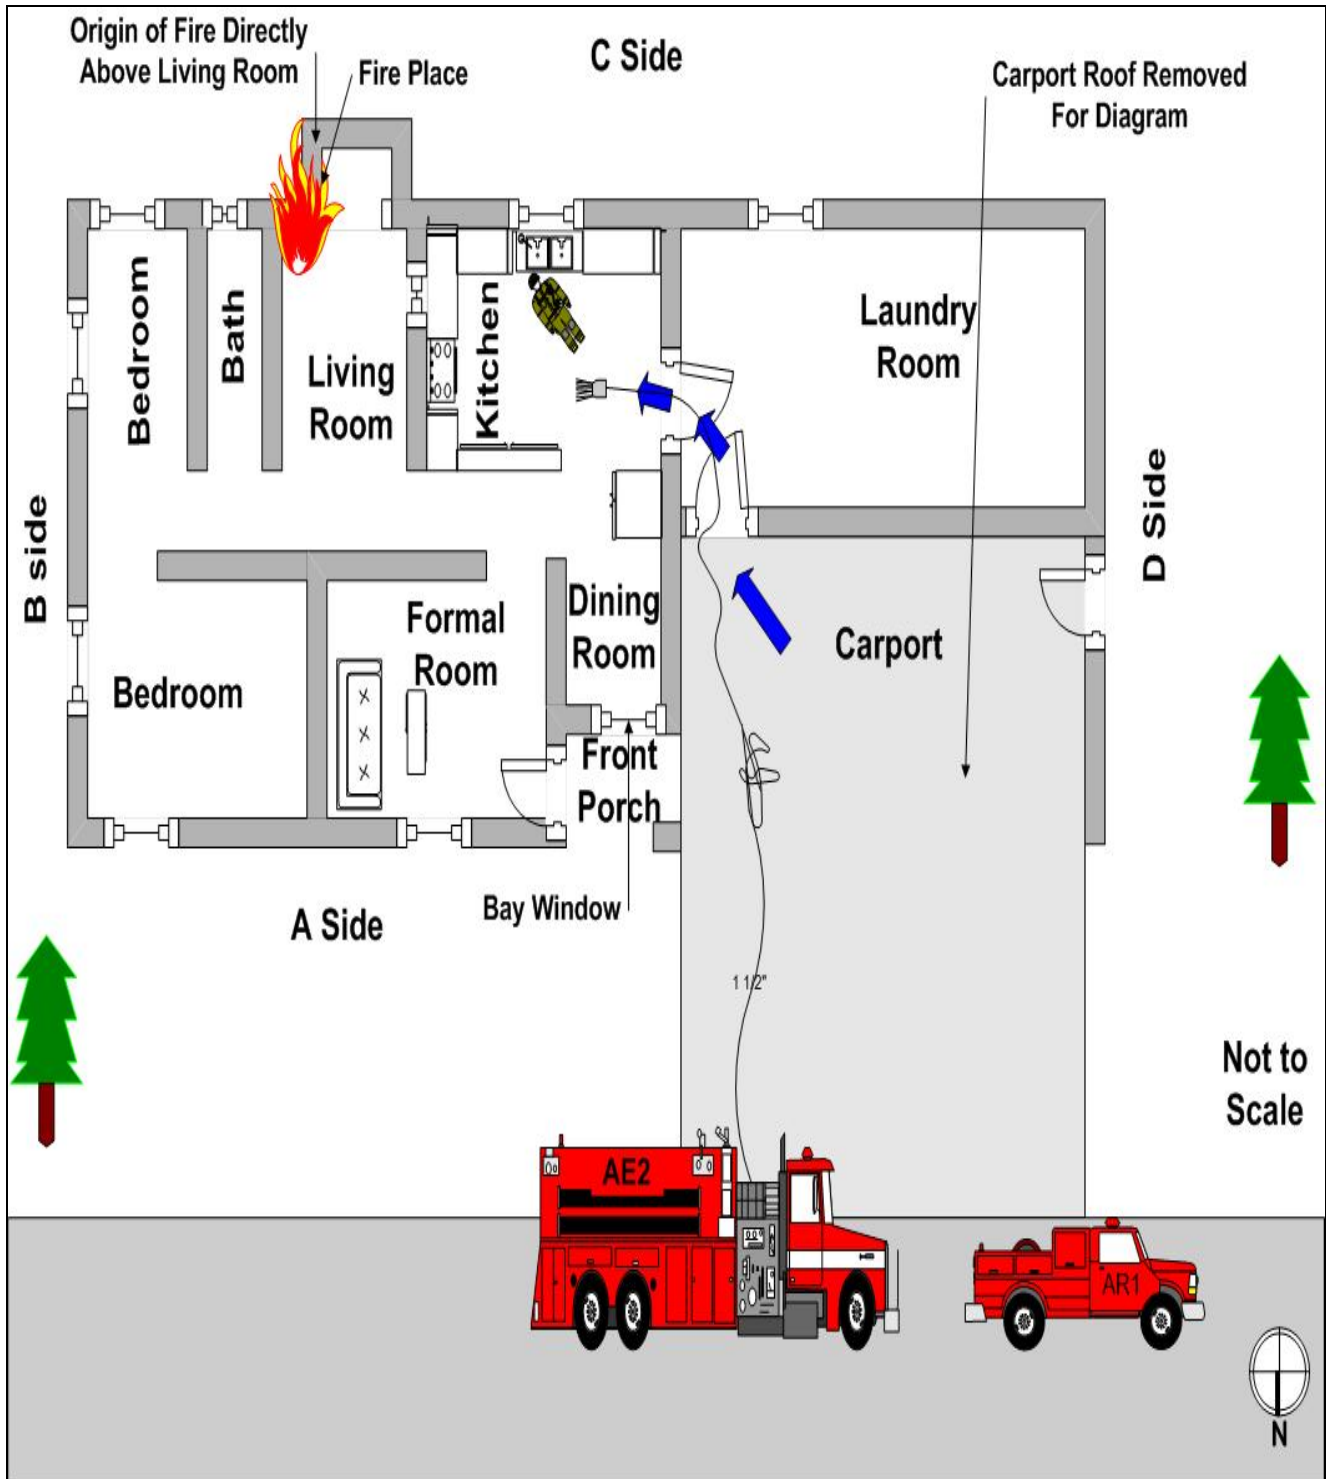
Diagram. Incident scene when victim called for help.
