Volunteer Fire Fighter Dies While Lost in Residential Structure Fire- Alabama

SUMMARY

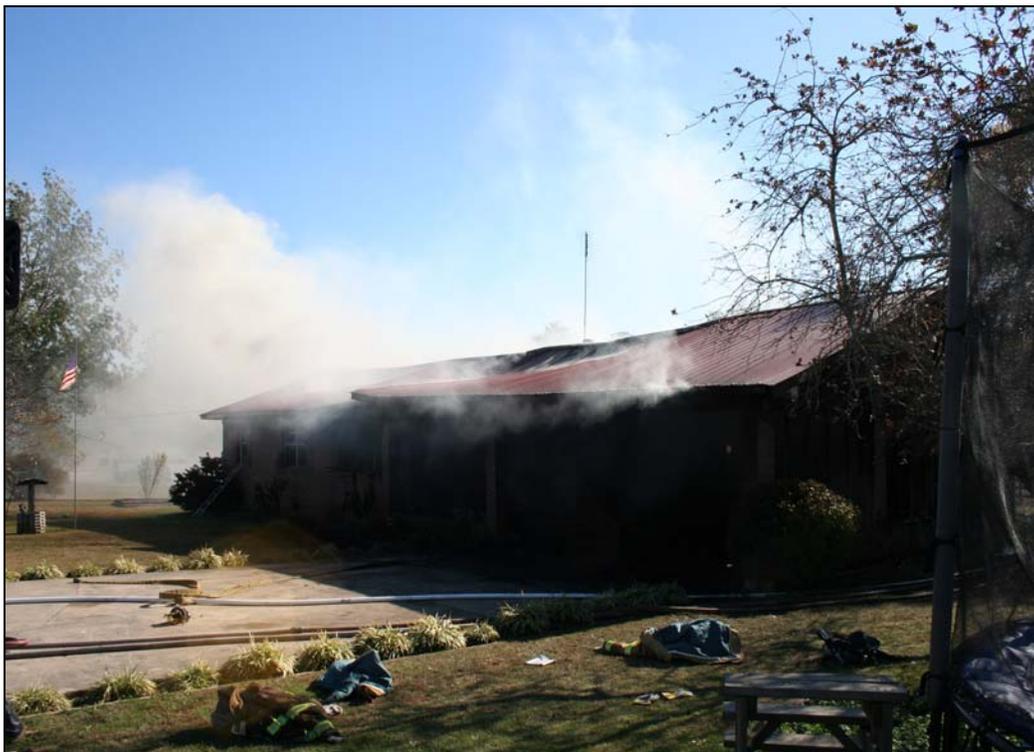
Incident Scene after Victim Removed
(Photo courtesy of sheriff's office)

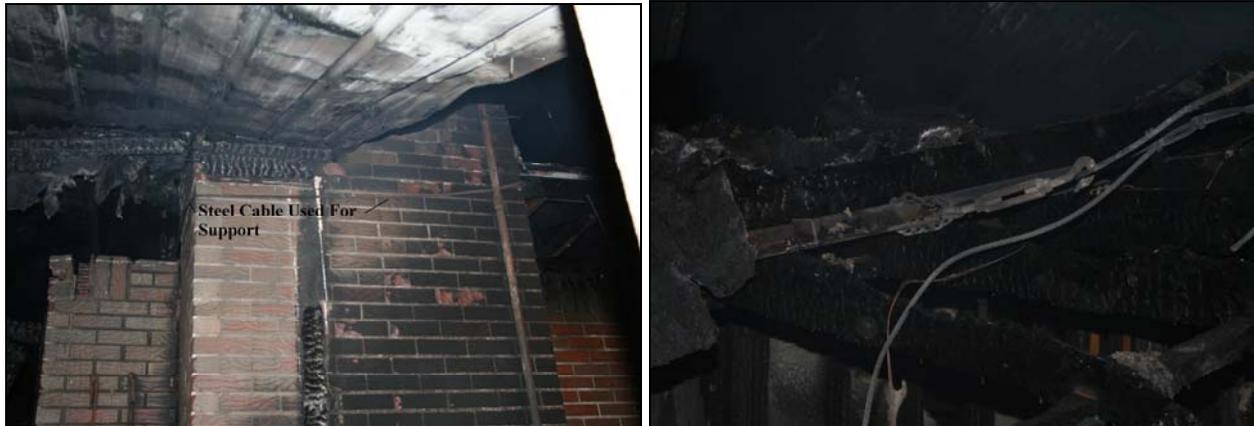
turnbuckle to connect the cable ends; this supported the chimney while pulling it back against the house (see Photo 1).

Photo 1. Steel cable used to support the chimney against the house with a turnbuckle.
(Photos courtesy of sheriff's office)

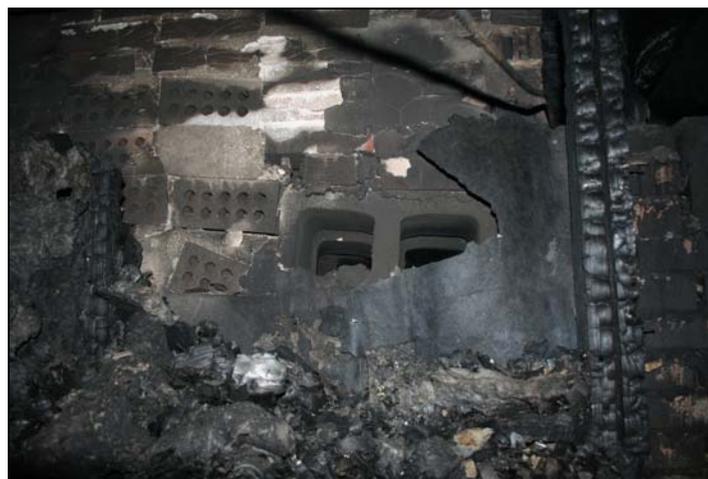
After the chimney was repositioned, the owner noticed that bricks from the chimney's flue had cracked and shifted. The owner removed the damaged bricks and replaced them with hollow cinder blocks. These blocks had been laid with the hollows horizontally positioned towards the attic space (see Photo 2). The residents of the house were safely evacuated prior to the fire department's arrival. The structure was completely destroyed by a rekindle several days later.

Photo 2. The picture shows the area of the brick chimney flue that was replaced with cinder blocks. The cinder blocks allowed heat and flame to impinge on the exterior wall allowing fire to spread into the attic space.
(Photo courtesy of sheriff's office)

During their investigation, the fire marshal and sheriff's office investigators believed that the chimney flue failed allowing radiant heat and flame to travel through the open sides of the cinder blocks and impinge on combustible materials in the attic. It is believed that the fire smoldered for a while in the attic before finding a reliable fuel source. Fire burned across the C-side of the structure's attic before burning down into the living area where the wood stove was located (see Photo 6). Thick black smoke was filling the structure when the victim and FF2 entered through the carport for the first time. No flames were immediately visible according to FF2. FF1 was met with the same smoke conditions when he opened the front door and the bay window broke under extreme heat conditions. Flames throughout the house erupted moments later. FF1 and FF2 do not recall any type of explosion or "puffs" of smoke before the house erupted in flames. The sheriff's office investigator believed that the house "flashed," trapping the victim and exposing him to extreme heat and fire conditions after the door and window were opened, which would have allowed fresh air (oxygen) to join the fuel mixture (heavy dark smoke) inside, ultimately leading to the flashover.

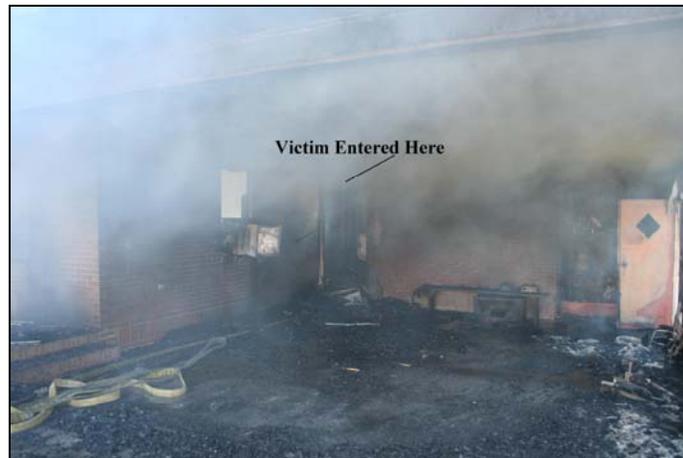
Photo 3. Door under carport that victim entered through.
(Photo courtesy of sheriff's office)

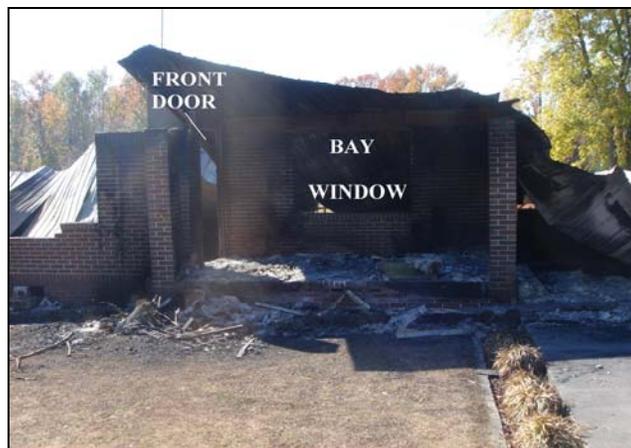
Photo 4. Incident scene after rekindle and collapse showing the front door and bay window.
(NIOSH photo)

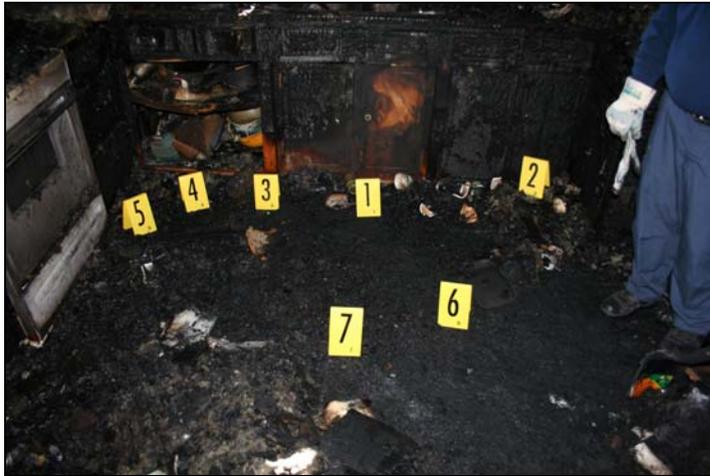
1. Victim – 112” from carport door
2. SCBA – 85” from carport door
3. Face Piece – 128” from carport door
4. Helmet – 139 ½” from carport door
5. Radio – 147” from carport door
6. Boot – 94” from carport door
7. Nozzle – 101” from carport door

Photo 5. Number cues placed to document victim and items discovered.
(Photo courtesy of sheriff's office)

During this incident, it was never determined whether the victim's PASS device was heard. The victim radioed for assistance but did not declare a Mayday. The victim was found within arms reach of his hoseline that led outside (approximately eight feet to the door).

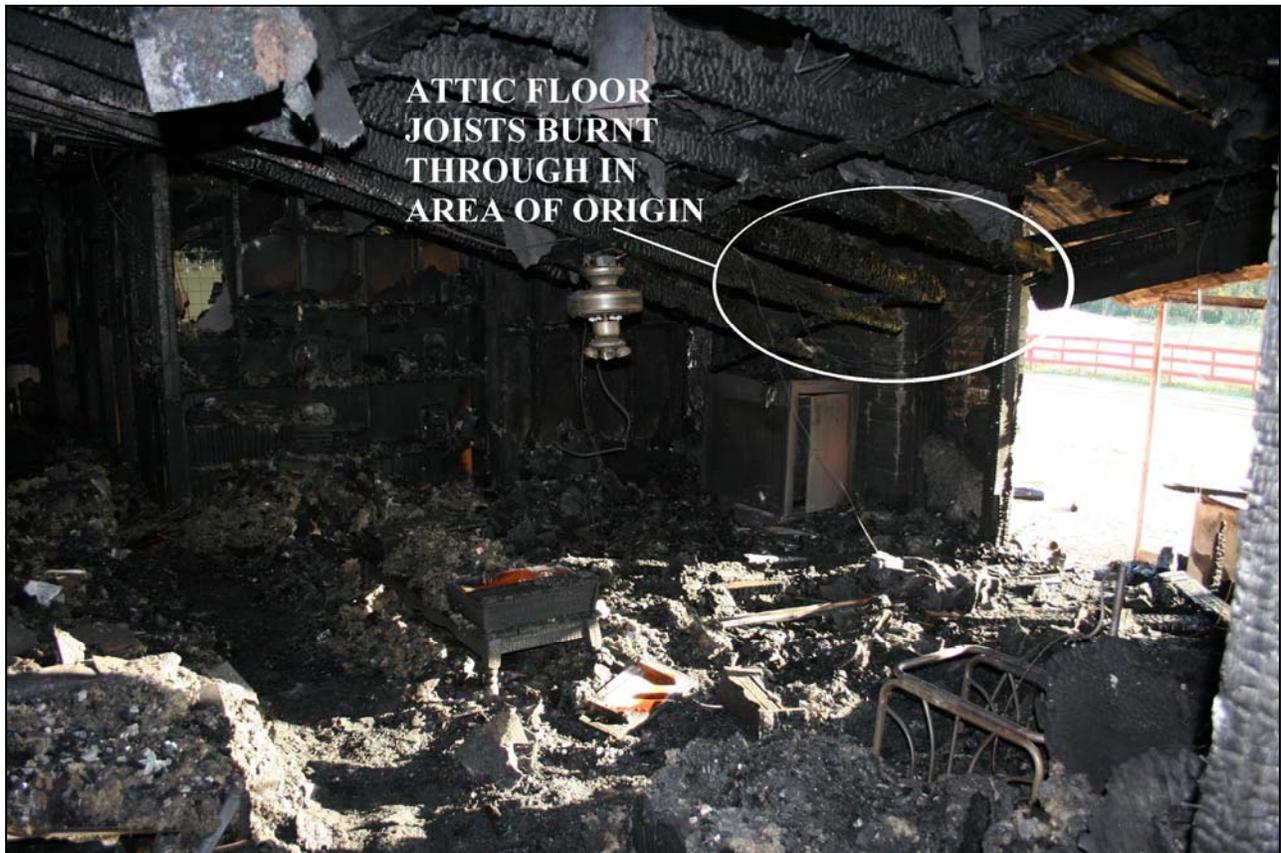
Photo 6. Fire damage to living room area before rekindle and structural collapse.
(Photo courtesy of sheriff's office)

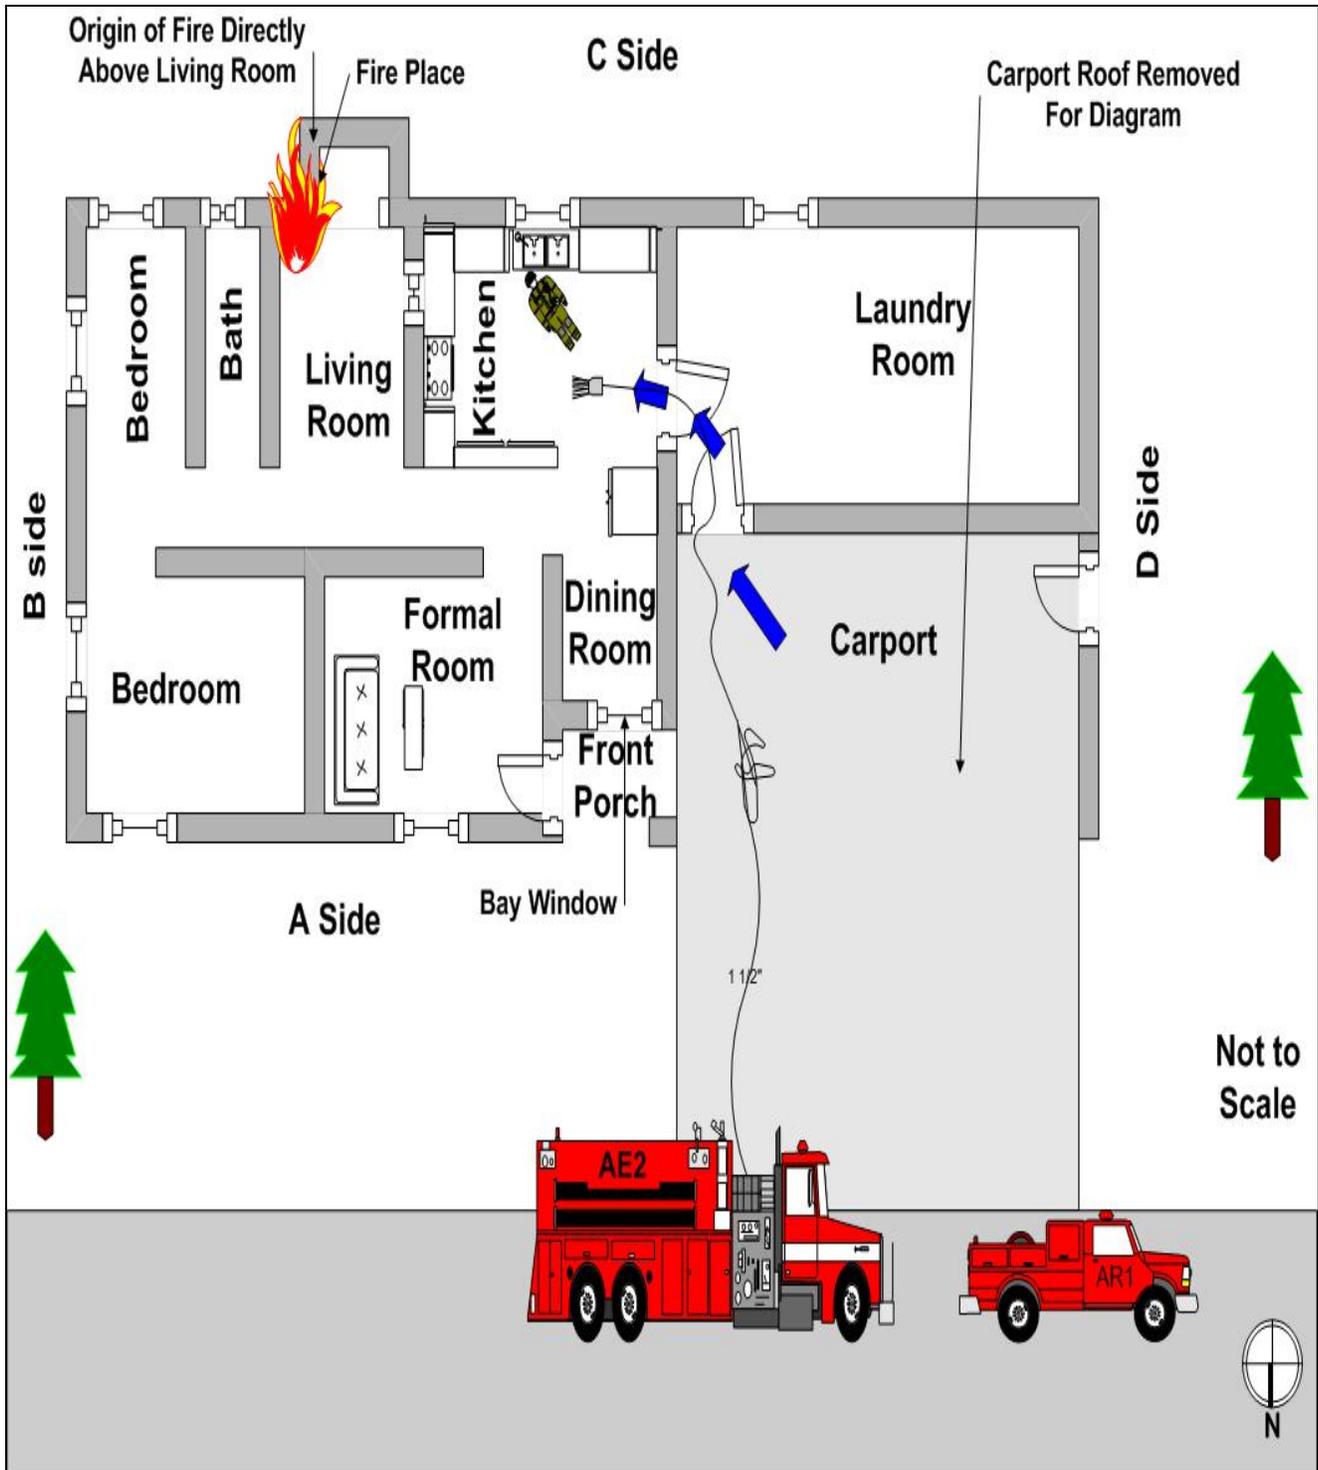
Diagram. Incident scene when victim called for help.
