Fire Fighter Fatality Investigation and Prevention Program – Selected Investigation Reports

DHHS (NIOSH) Publication No. 2011-122
December 2010

Career Fire Fighter Dies When Backed Over While Spotting an Apparatus—New Jersey

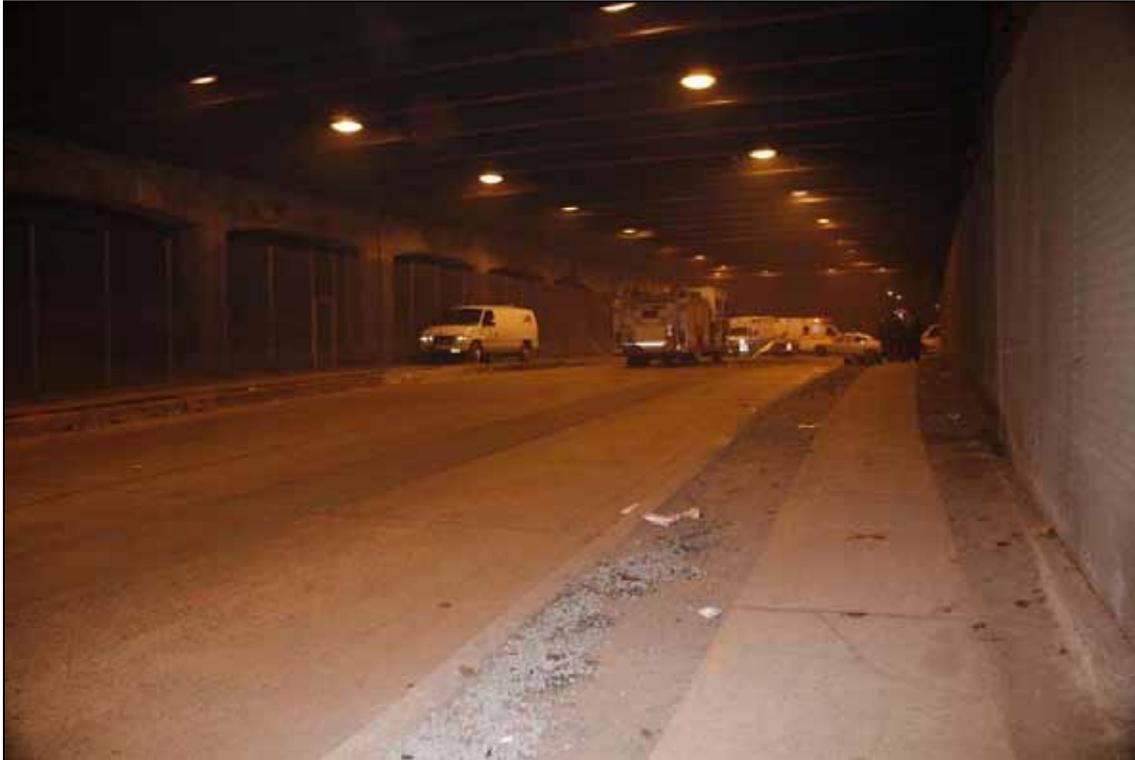
*Incident scene
(Photo courtesy of police department.)*

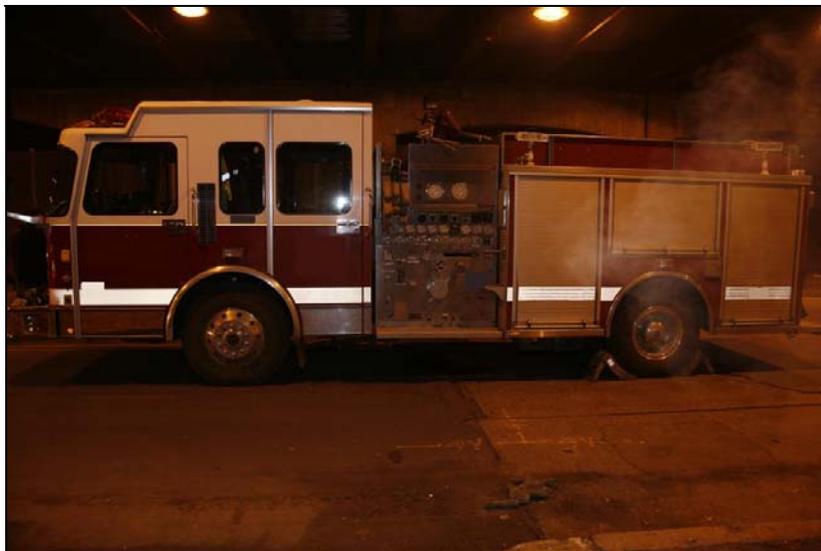
The victim was the acting officer on the engine along with the chauffeur and fire fighter. The apparatus involved in the incident was a 1996 enclosed cab engine with an automatic transmission, diesel engine, and an air brake system (see Photo 1). The apparatus' gross vehicle weight rating (GVWR) was 32,360 lbs. The engine had two axles with six wheels (two in the front and four in the rear). The engine measured 28 ft (length) x 8 ft 7 in (width) x 9 ft 5 in (height). The apparatus was also equipped with an automatic reverse braking system³ mounted to the rear step of the apparatus (see Photo 2).

Photo 1. Apparatus involved in the backing incident.
(Photo courtesy of police department.)

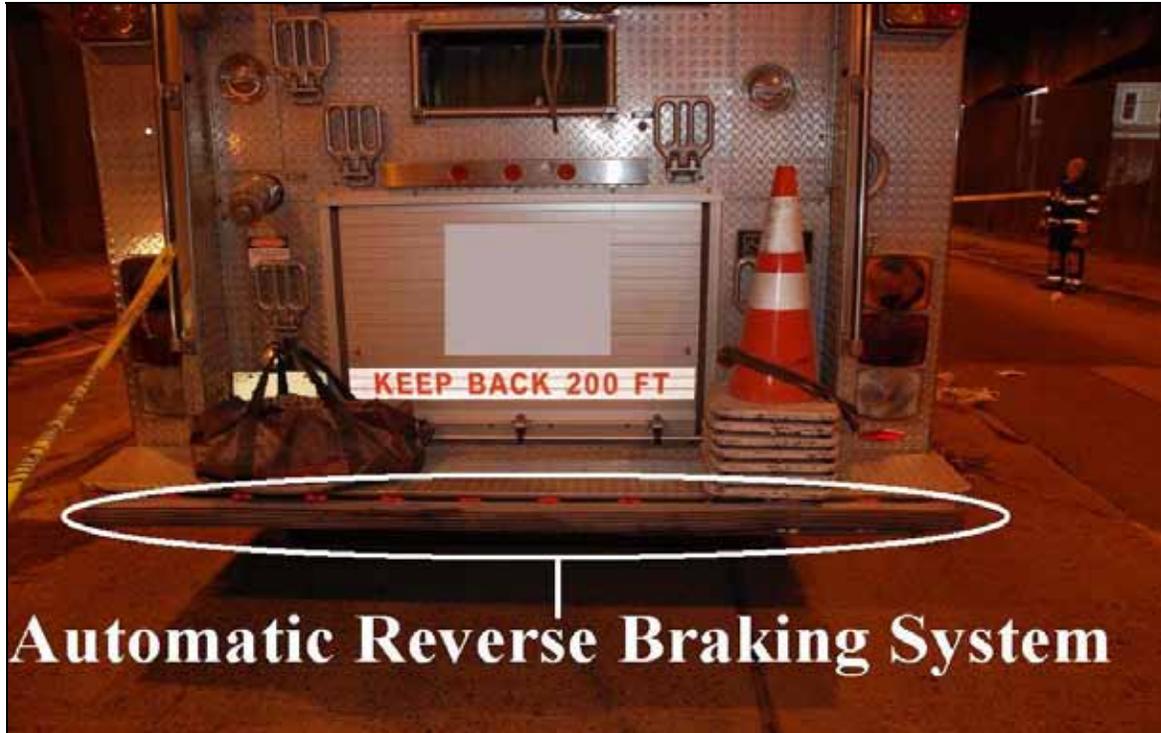
Photo 2. This reverse braking system is attached to the rear bumper of the apparatus and is designed to actuate the rear brakes when pressure is applied to the rubber sensor.
(Photo courtesy of sheriff's office.)

This automatic reverse braking system was developed in the early 1980s, introduced in the United Kingdom in 1983, and then became available in the United States in 1986. This reverse braking system was an optional safety feature that was installed on the apparatus prior to the fire department taking possession in 1996. The system aids driver/operators while backing an apparatus by locking the rear brakes when the system comes in contact with an object. *Note: The manufacturer's manual notes that this system does not exempt the driver/operator from using conventional backing aids such as side and rear mirrors or spotters.*³ The rubber sensor is mounted six inches beyond the vehicle's rear end to provide an area where vehicle damage could be reduced due to the short distance traveled after automatic brake application. The sensor has an air chamber which is sealed at either end. The air chamber detects or senses a compression of the wall of the chamber, as little as 0.05 psi, causing the pressure inside to increase and then transmit down to a control/switch unit which triggers the brakes to actuate. The system is designed to operate when the apparatus is in reverse gear and backing at a slow rate of speed. The instruction manual recommends a function test be done after initial installation and at least once a week thereafter. For the involved apparatus, the last documented function test was performed in March 2008; at that time, the system was working properly.

The apparatus involved in this incident was equipped with an after-market reverse braking system which was mounted to the rear bumper. The last documented service test was performed more than eight months prior to the fatal incident. The manufacturer recommends the system be checked daily or weekly to insure proper operation.³ The system was found to be not working when examined by New Jersey Fire Safety Division investigators during the state police commercial vehicle inspection. However, the system was not tested by the manufacturer or a third-party certification facility to verify that the device failed to actuate the rear brakes. A component for this reverse backing system needed to be replaced to allow it to operate again. *Note: It has not been determined beyond a reasonable doubt that the system failed to operate during the fatal incident or that the victim came into contact with the sensor, but these cannot be ruled out as potential contributing factors in the fatal incident.* Three other apparatus within the fire department’s fleet also needed maintenance performed on their installed systems.

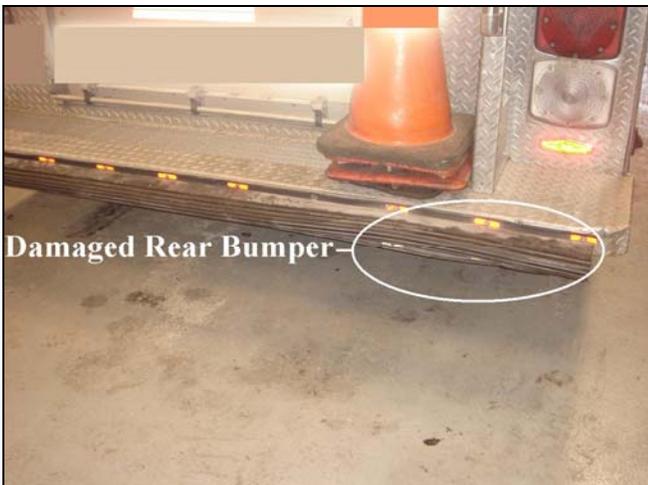
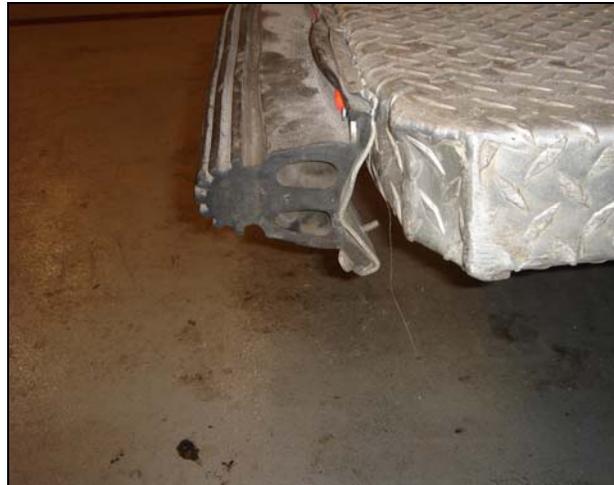
After the incident, the apparatus and scene were processed by local police before the apparatus was escorted by state police to the fire department's headquarters. The apparatus was secured there until state police could perform a vehicle inspection. The state police performed a standard commercial vehicle crash inspection in the presence of a fire department mechanic and investigators from the New Jersey Division of Fire Safety. Items inspected included the air brake system, brakes, steering, suspension, tires, lighting, and low air pressure indicators. The inspection was completed within three days of the incident and the apparatus was found to have no mechanical violations. The state police inspection did not include an inspection of the automatic reverse braking system because it was an optional device and their investigators were not certified to test it. However, when pressure was applied to the rubber sensor while backing, the system failed to actuate the brakes. It could not be determined whether the backing system was functional at the time of the incident, but there was damage to the bumper and rubber sensor that could not be attributed to the fatal incident (see Photos 3 and 4).

Photos 3 and 4. Pictures show damage to rear bumper and rubber sensor.
(Photo courtesy of PEOSH.)

From these findings, the New Jersey Division of Fire Safety recommended that repairs be made before placing the apparatus back in service. The automatic reverse braking system control unit was replaced following the inspection, and then placed back in service. The fire department also inspected eight other apparatus that had the same reverse braking system installed. Three of these apparatus had damaged or insufficient operating parts within the system that affected proper operation. These three systems were also repaired.

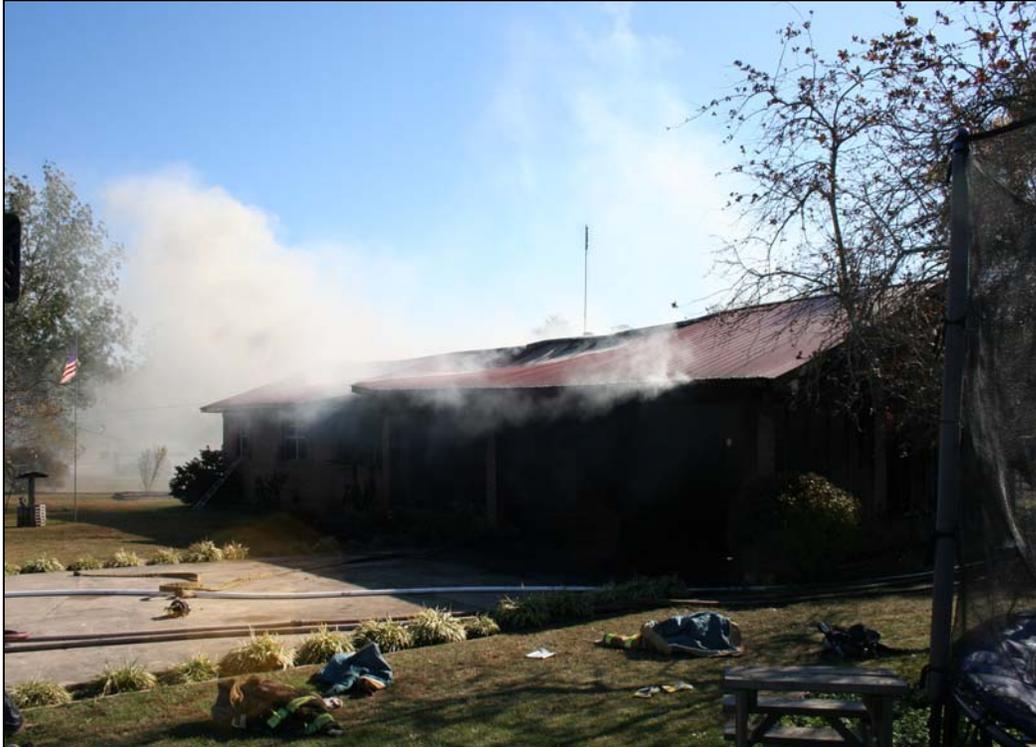
Incident Scene after Victim Removed
(Photo courtesy of sheriff's office)

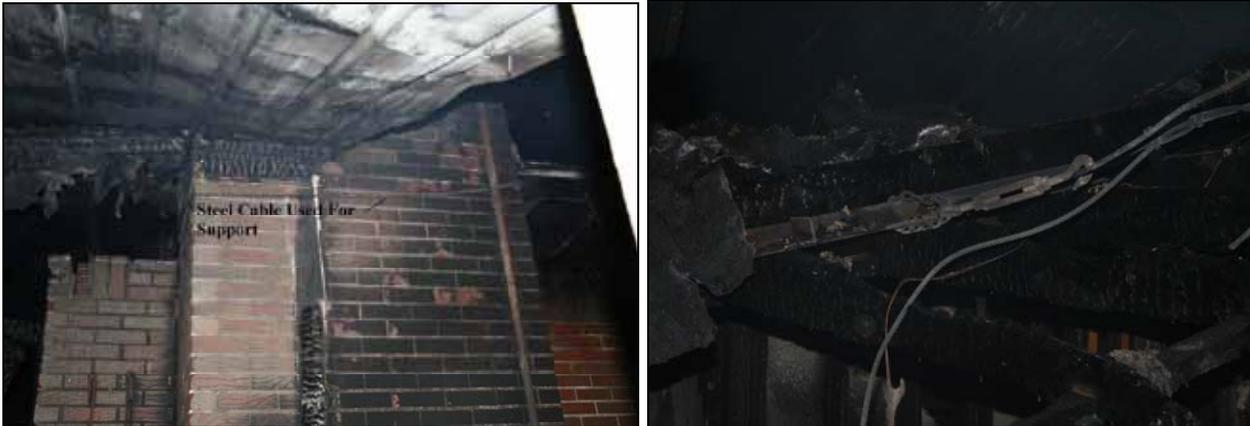
turnbuckle to connect the cable ends; this supported the chimney while pulling it back against the house (see Photo 1).

Photo 1. Steel cable used to support the chimney against the house with a turnbuckle.
(Photos courtesy of sheriff's office)

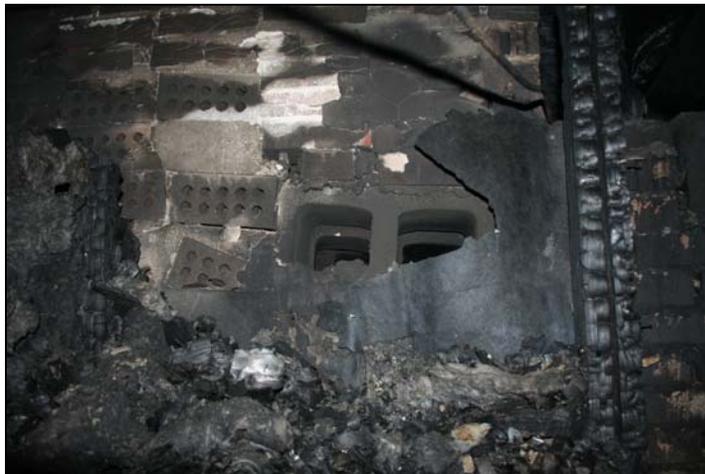
After the chimney was repositioned, the owner noticed that bricks from the chimney's flue had cracked and shifted. The owner removed the damaged bricks and replaced them with hollow cinder blocks. These blocks had been laid with the hollows horizontally positioned towards the attic space (see Photo 2). The residents of the house were safely evacuated prior to the fire department's arrival. The structure was completely destroyed by a rekindle several days later.

Photo 2. The picture shows the area of the brick chimney flue that was replaced with cinder blocks. The cinder blocks allowed heat and flame to impinge on the exterior wall allowing fire to spread into the attic space.
(Photo courtesy of sheriff's office)

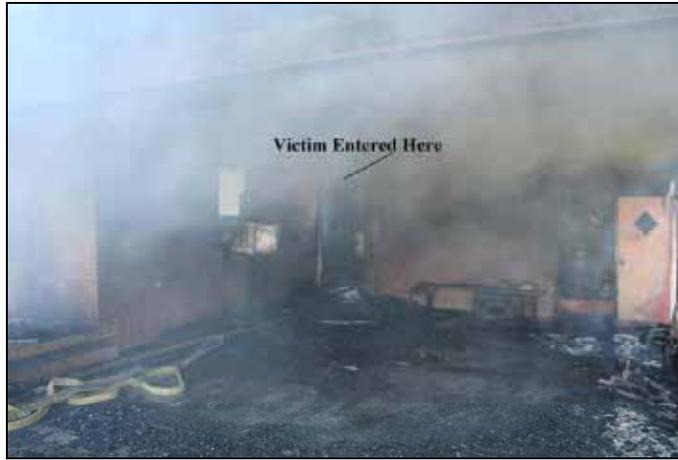
Photo 3. Door under carport that victim entered through.
(Photo courtesy of sheriff's office)

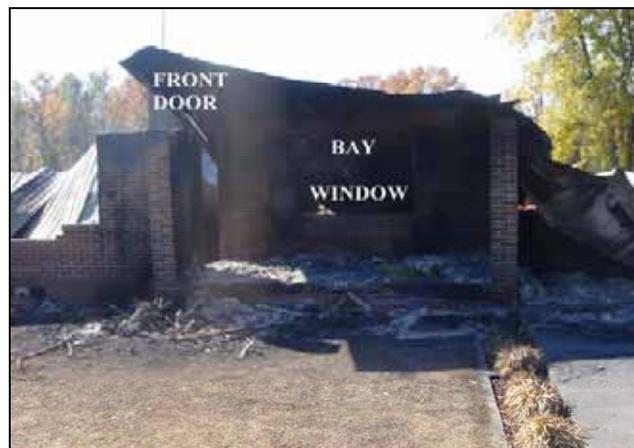
Moments after FF2 left with the flashlight, FF1 reported hearing the victim radio him and stating, "...at front door, can't get it opened." *Note: This was not heard on the 911 dispatch tape by NIOSH investigators and is believed to have been on a non-recorded fire department talk around channel.* FF1 retrieved an axe from AE2 and donned his SCBA over his bunker gear. He ran to the front porch and found the screen and exterior doors locked. He yanked the screen door off the frame and punched the exterior door open with the head of the axe. He was met with thick black smoke causing him to step back and clean the soot from his face piece. He then stood in the doorway yelling for the victim. FF1 then heard glass breaking from the bay window beside the front door. This window was between the front door and carport (see Photo 4).

Photo 4. Incident scene after rekindle and collapse showing the front door and bay window.
(NIOSH photo)

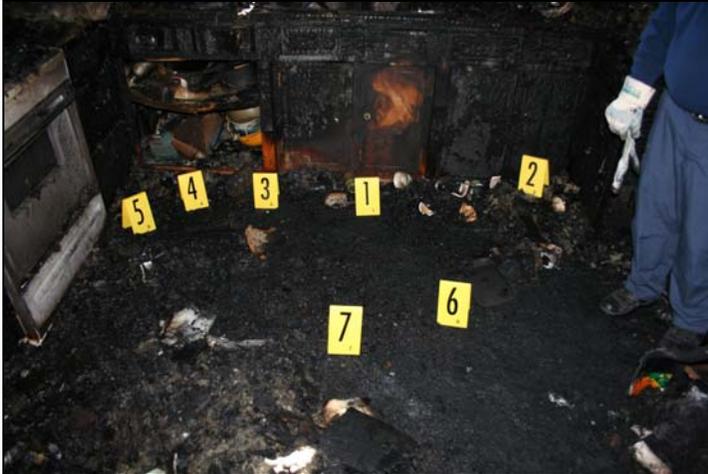
| <ol style="list-style-type: none">1. Victim – 112” from carport door2. SCBA – 85” from carport door3. Face Piece – 128” from carport door4. Helmet – 139 ½” from carport door5. Radio – 147” from carport door6. Boot – 94” from carport door7. Nozzle – 101” from carport door |

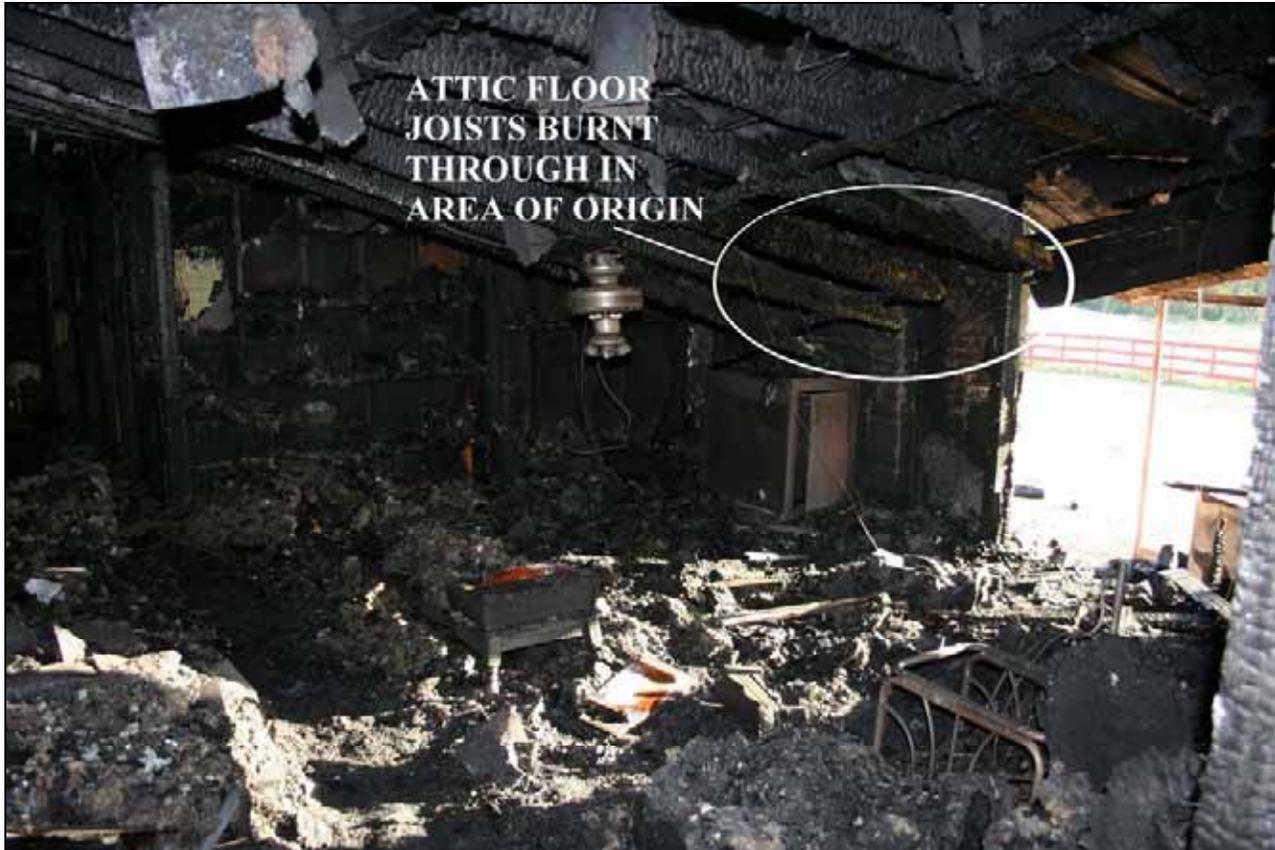
Photo 6. Fire damage to living room area before rekindle and structural collapse.
(Photo courtesy of sheriff's office)

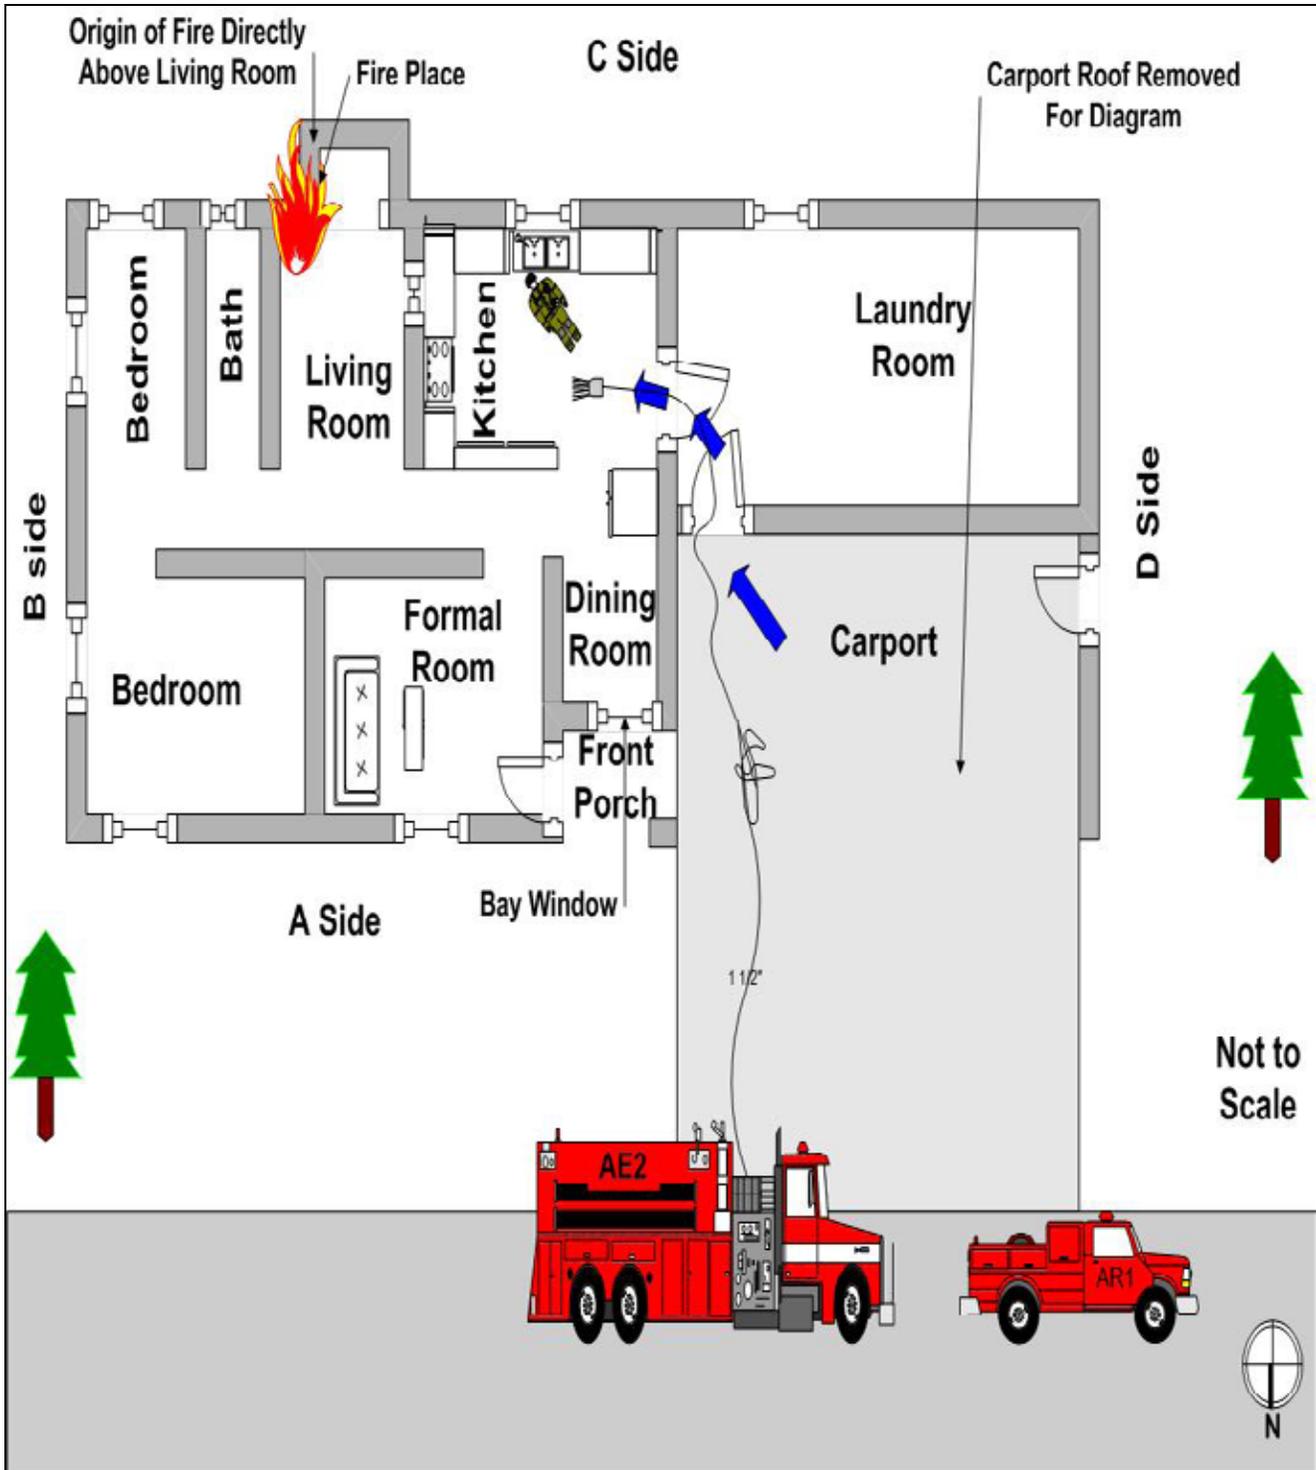
Diagram. Incident scene when victim called for help.

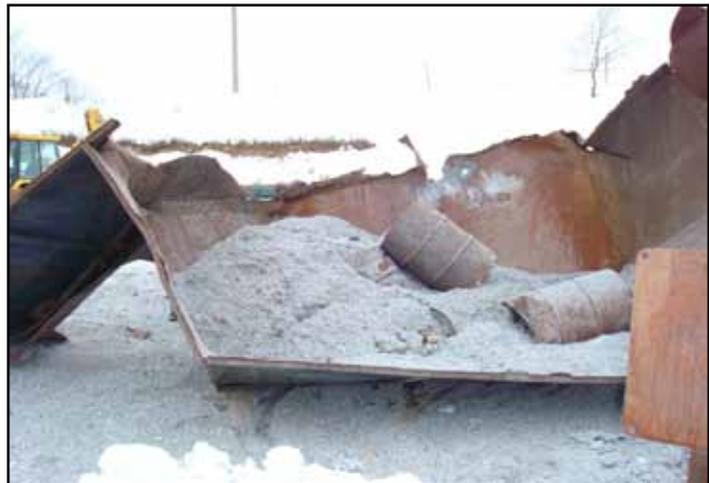
In December 2009, a 33 year old male fire fighter died and eight fire fighters, including a lieutenant and a junior fire fighter, were injured in a dumpster explosion at a foundry in Wisconsin. At 1933 hours, dispatch reported a dumpster fire at a foundry in a rural area. Eight minutes later, the initial responding crews and the incident commander (IC) arrived on scene to find a dumpster emitting approximately two-foot high bluish green flames from the open top and having a ten-inch reddish-orange glow in the middle of the dumpster's south side near the bottom. The IC used an attic ladder to

examine the contents of the dumpster: aluminum shavings, foundry floor sweepings, and a 55 gallon drum. Approximately 700 gallons of water was put on the fire with no affect. Approximately 100 gallons of foam solution, starting at 1 percent and increased to 3 percent, was then put on the fire, and again there was no noticeable effect. Just over twelve minutes on scene, the contents of the dumpster started sparking then exploded sending shrapnel and barrels into the air. The explosion killed one fire fighter and injured eight other fire fighters, all from the same volunteer department.

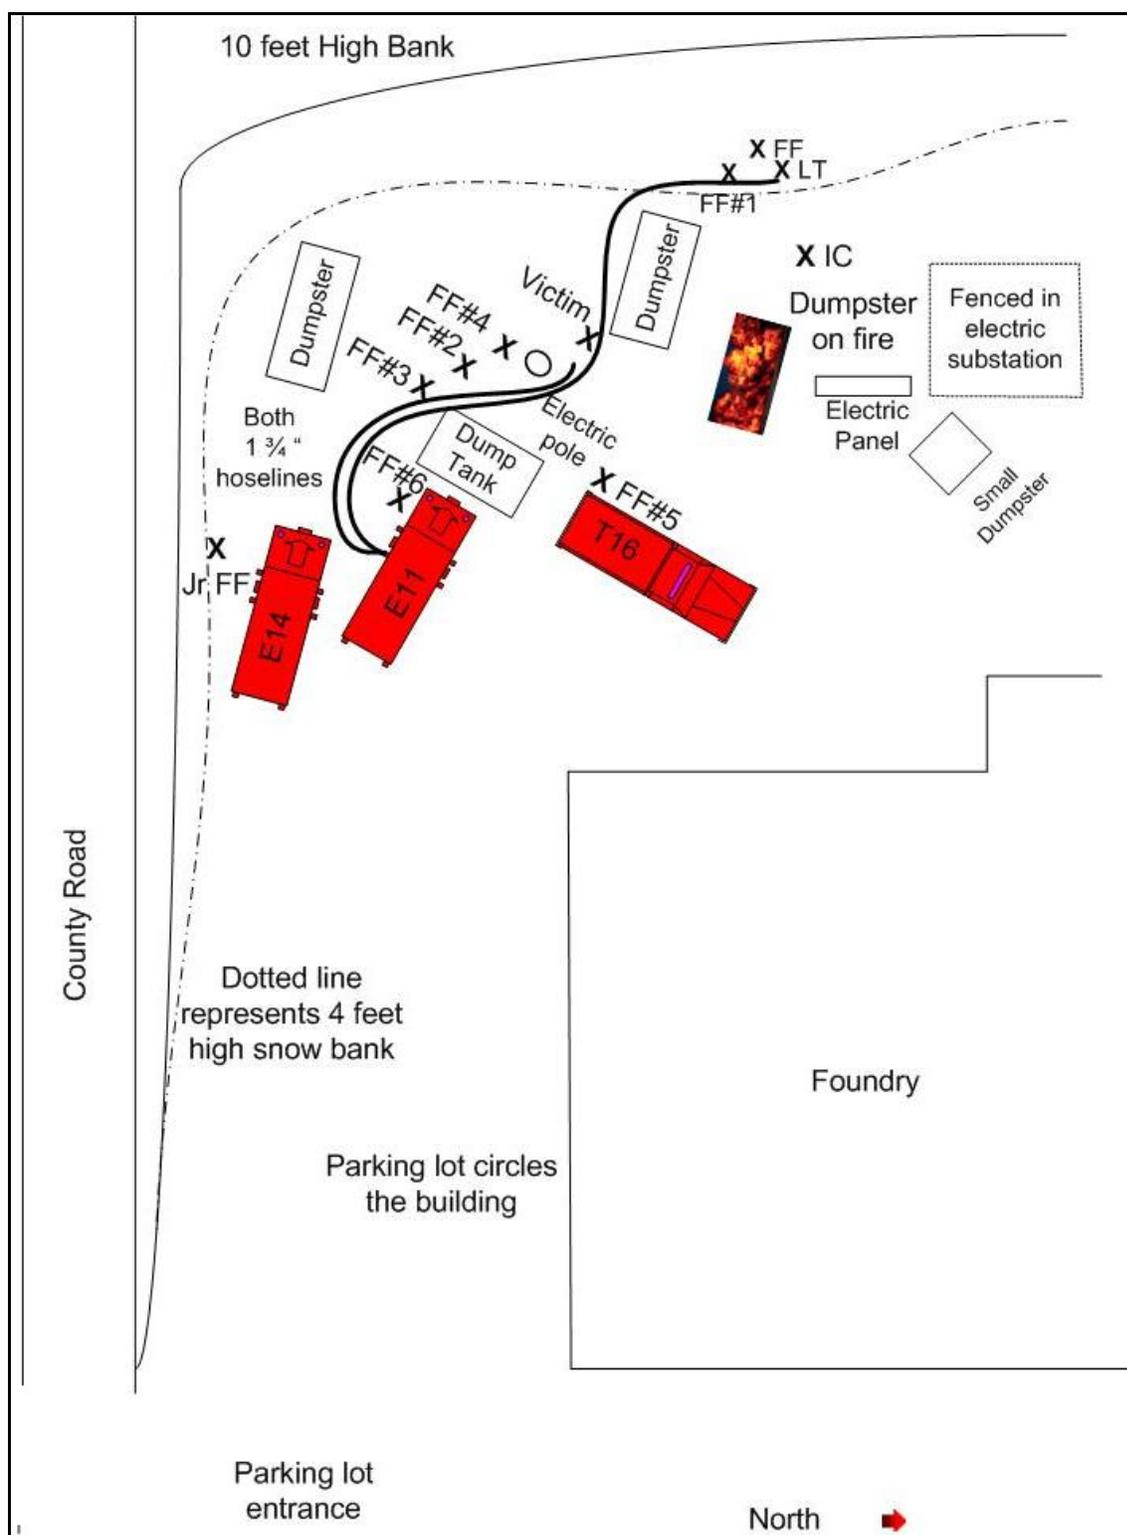
Diagram 1. Approximate locations of key apparatus and personnel just prior to the explosion.

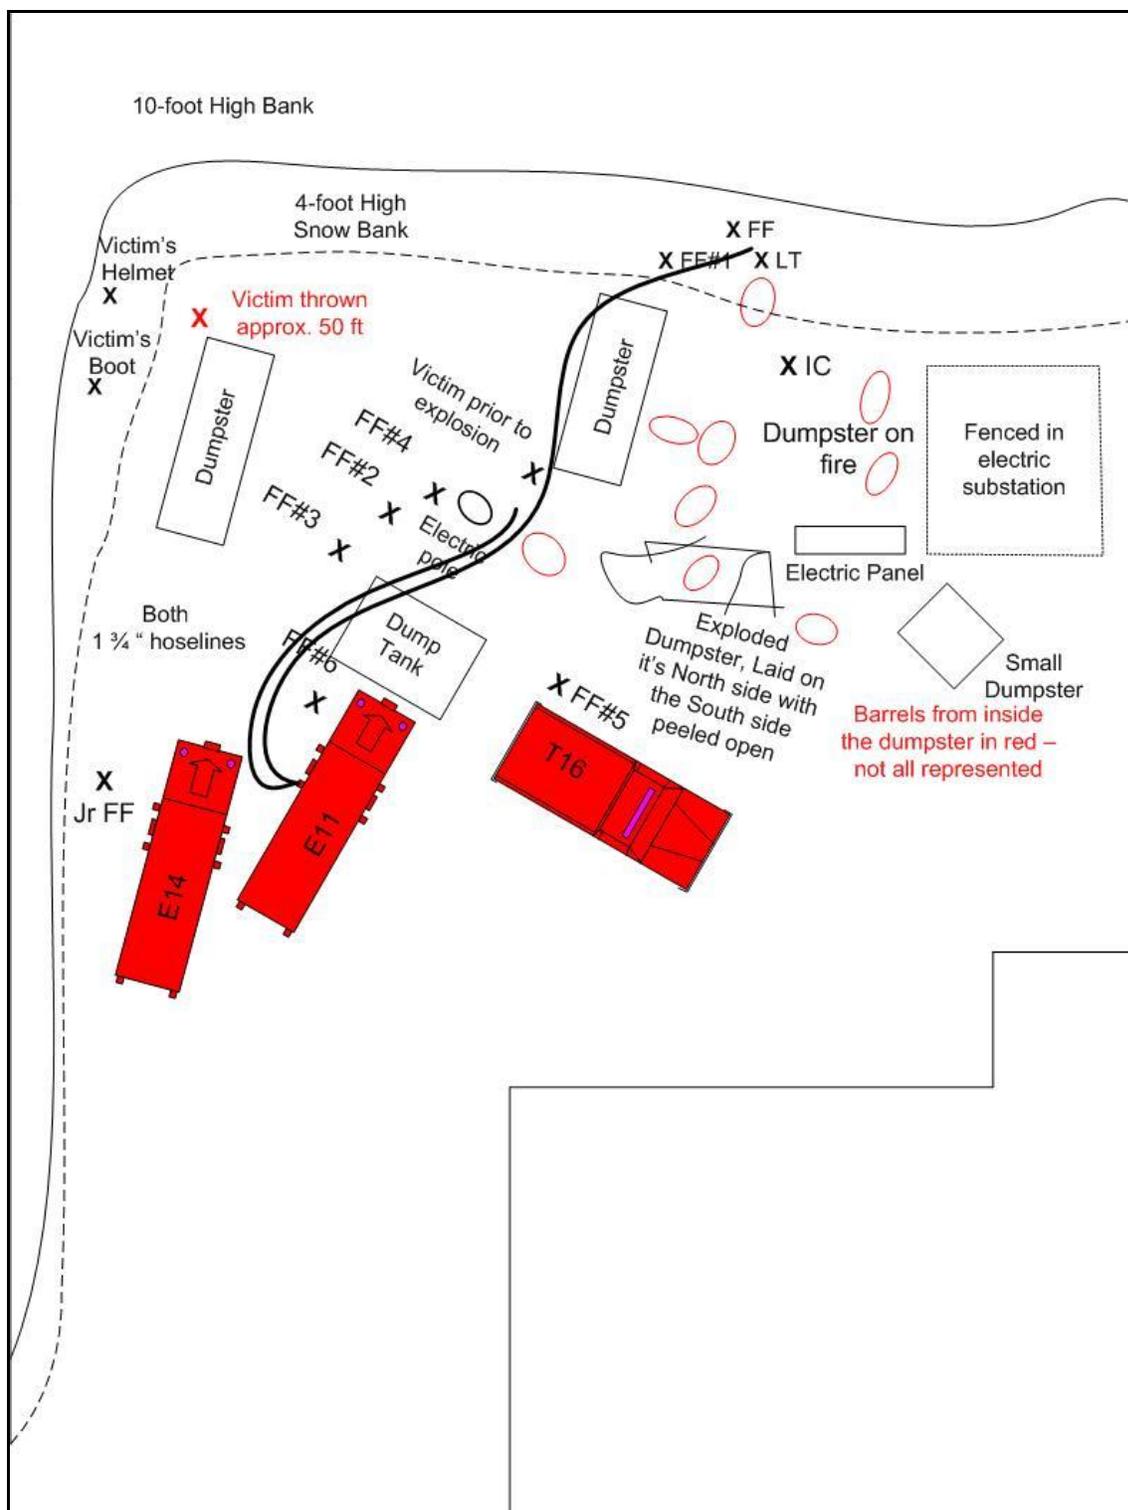
Diagram 2. Approximate location of dumpster and victim after the explosion.

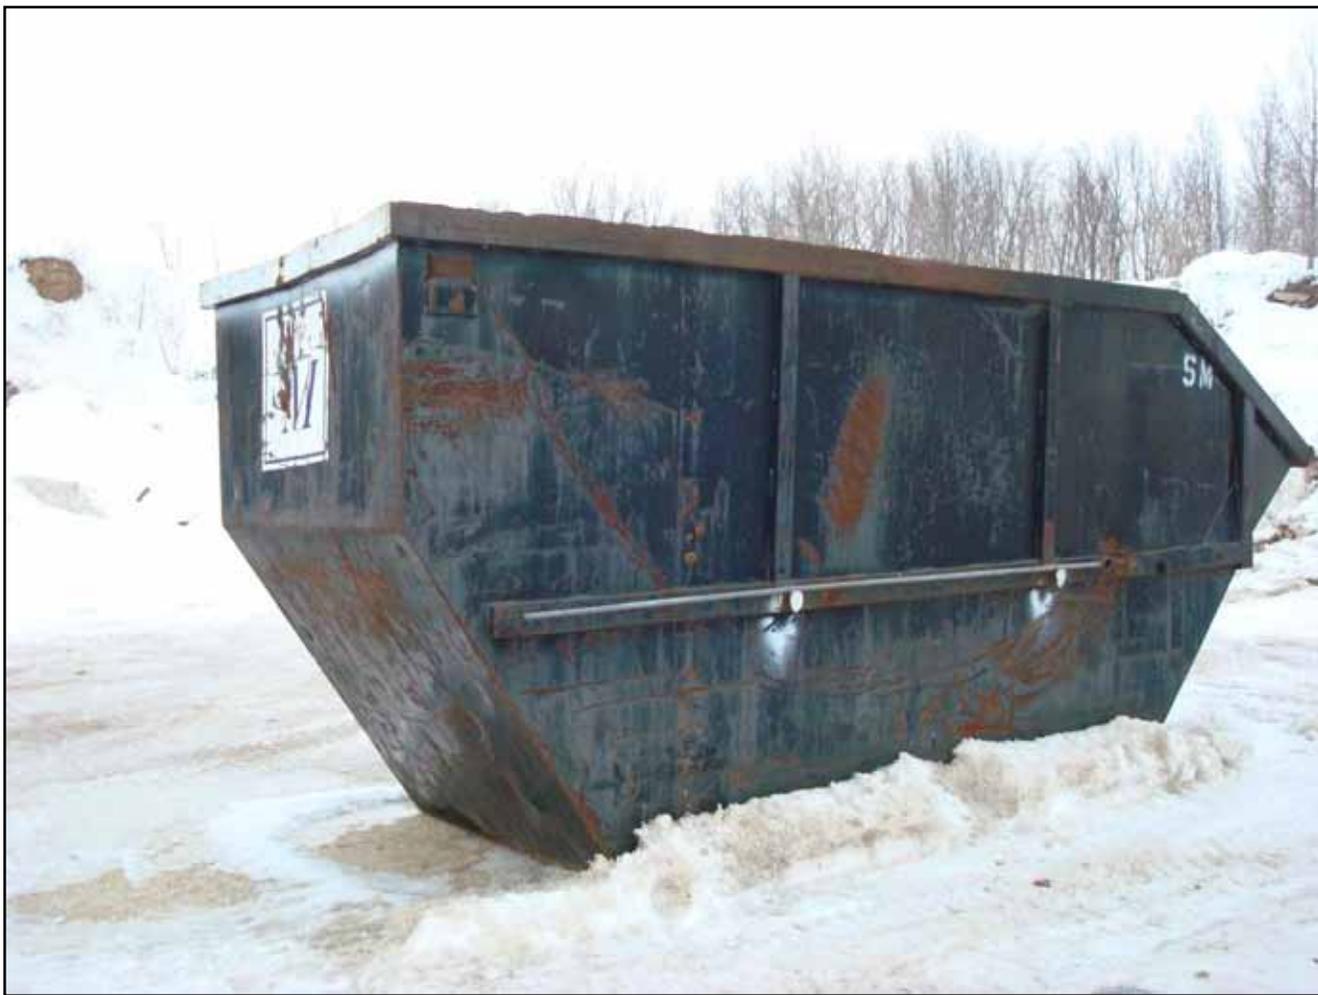
Photo 1. A dumpster similar in size and shape to the one that exploded. *(NIOSH photo)*

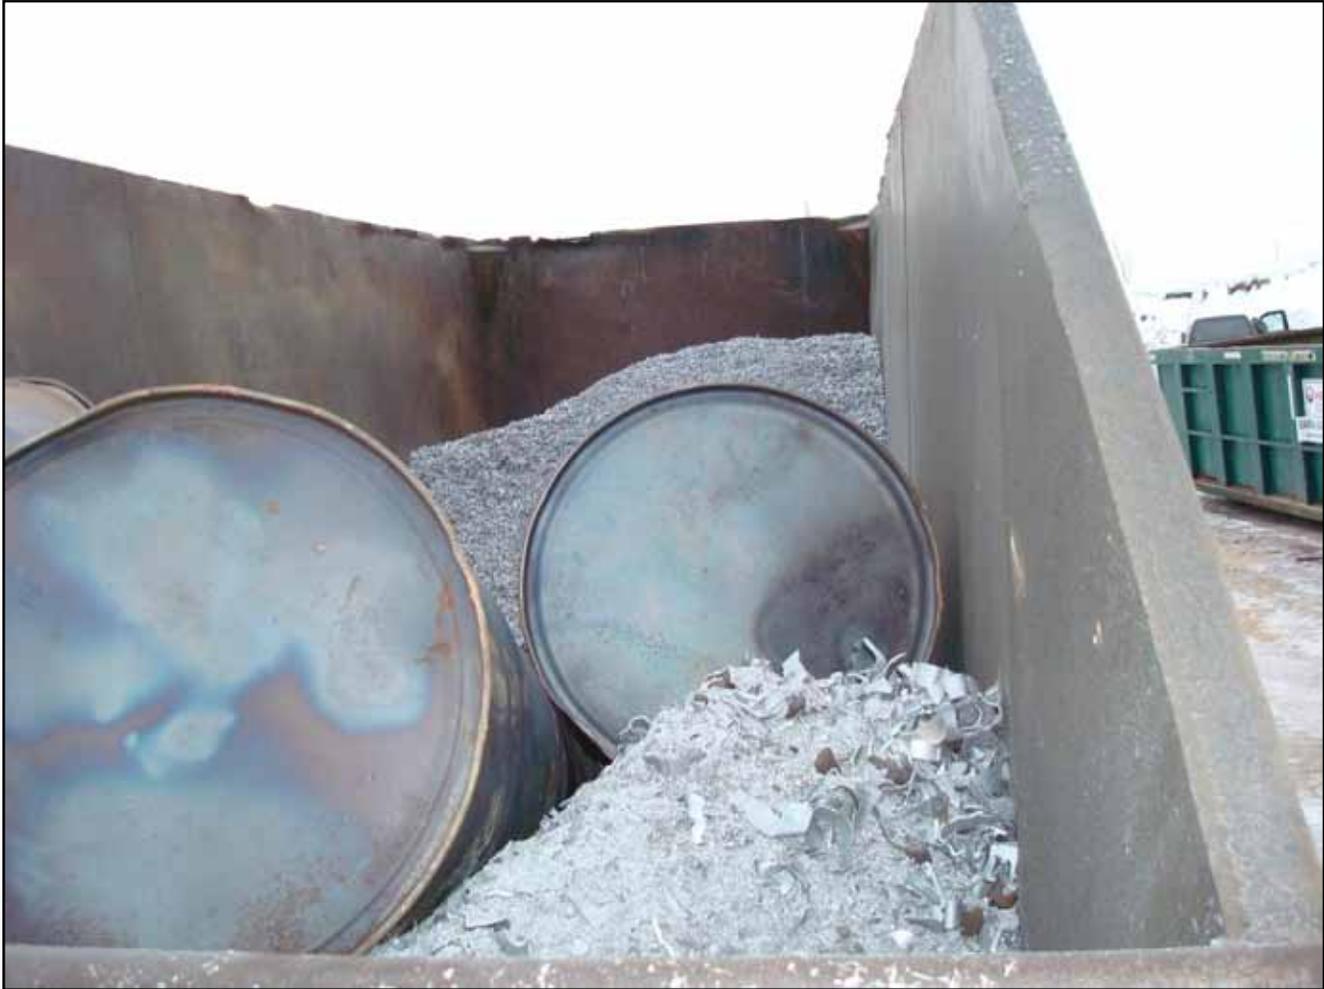
Photo 2. Dumpster contents similar to the contents of the dumpster that exploded. Note thermal pattern and iron oxide (rust) on slag barrels.
(NIOSH photo)

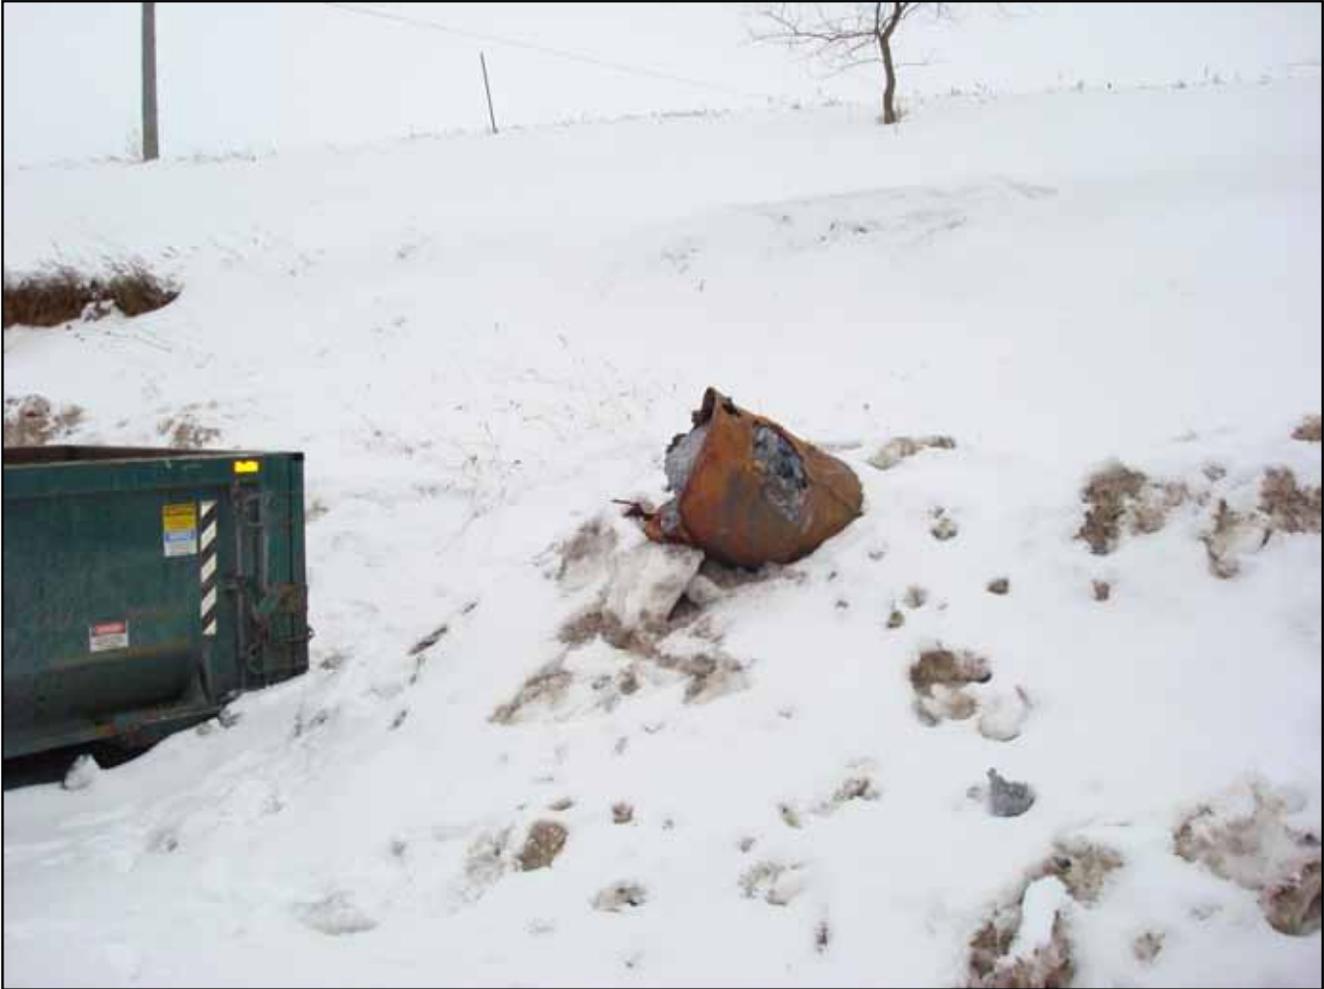
Photo 3. Barrel that was blown from the dumpster and believed to have impacted the lieutenant who had been standing at that spot on the snow bank with the 1 3/4" hoseline.
(NIOSH photo)

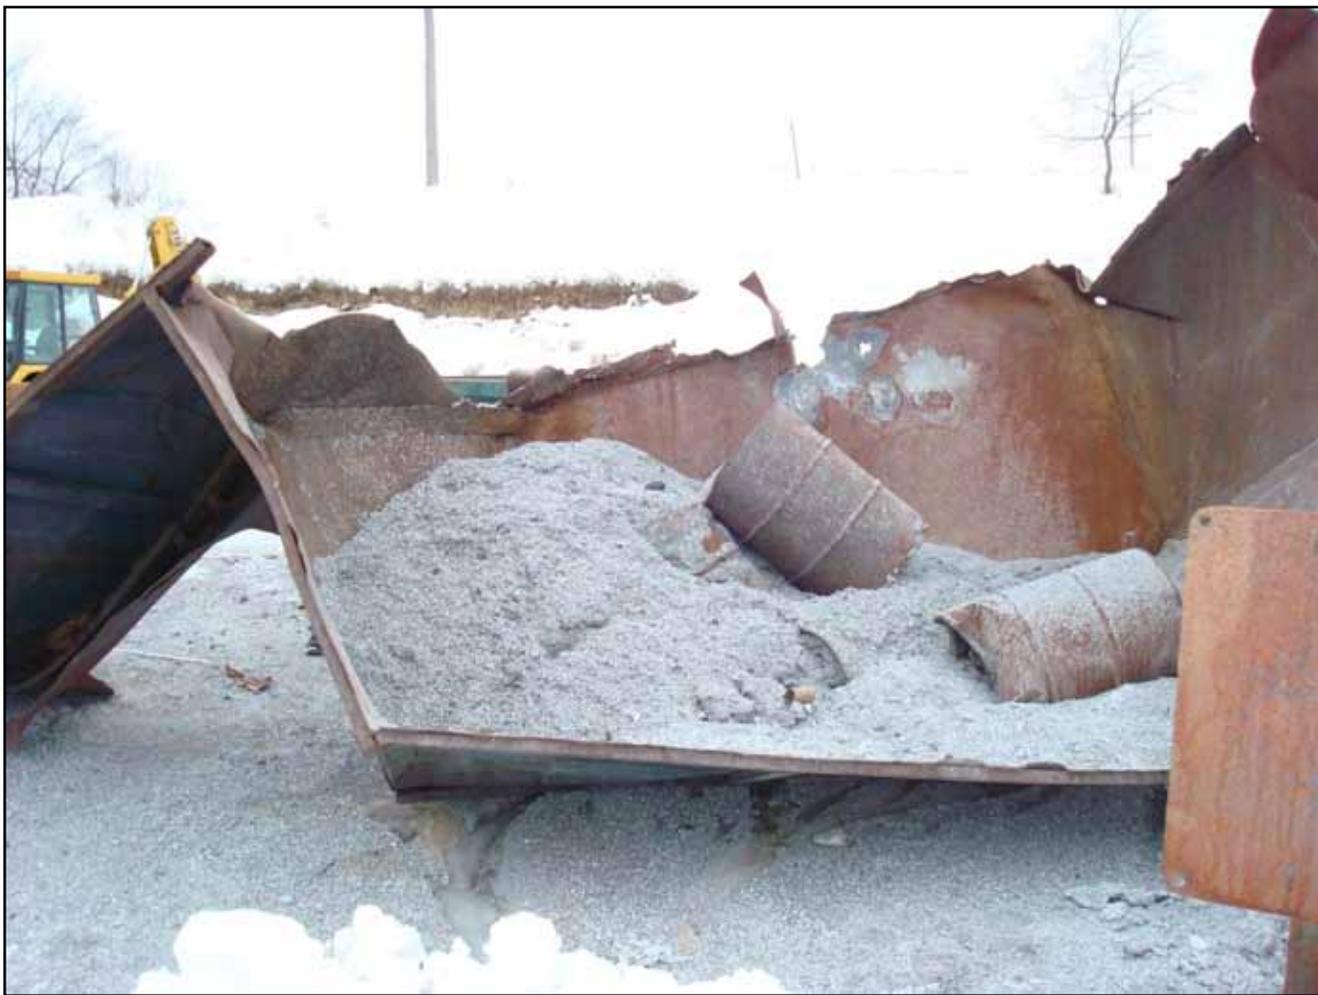
Photo 4. Exploded dumpster and its' remaining contents. *(NIOSH photo)*

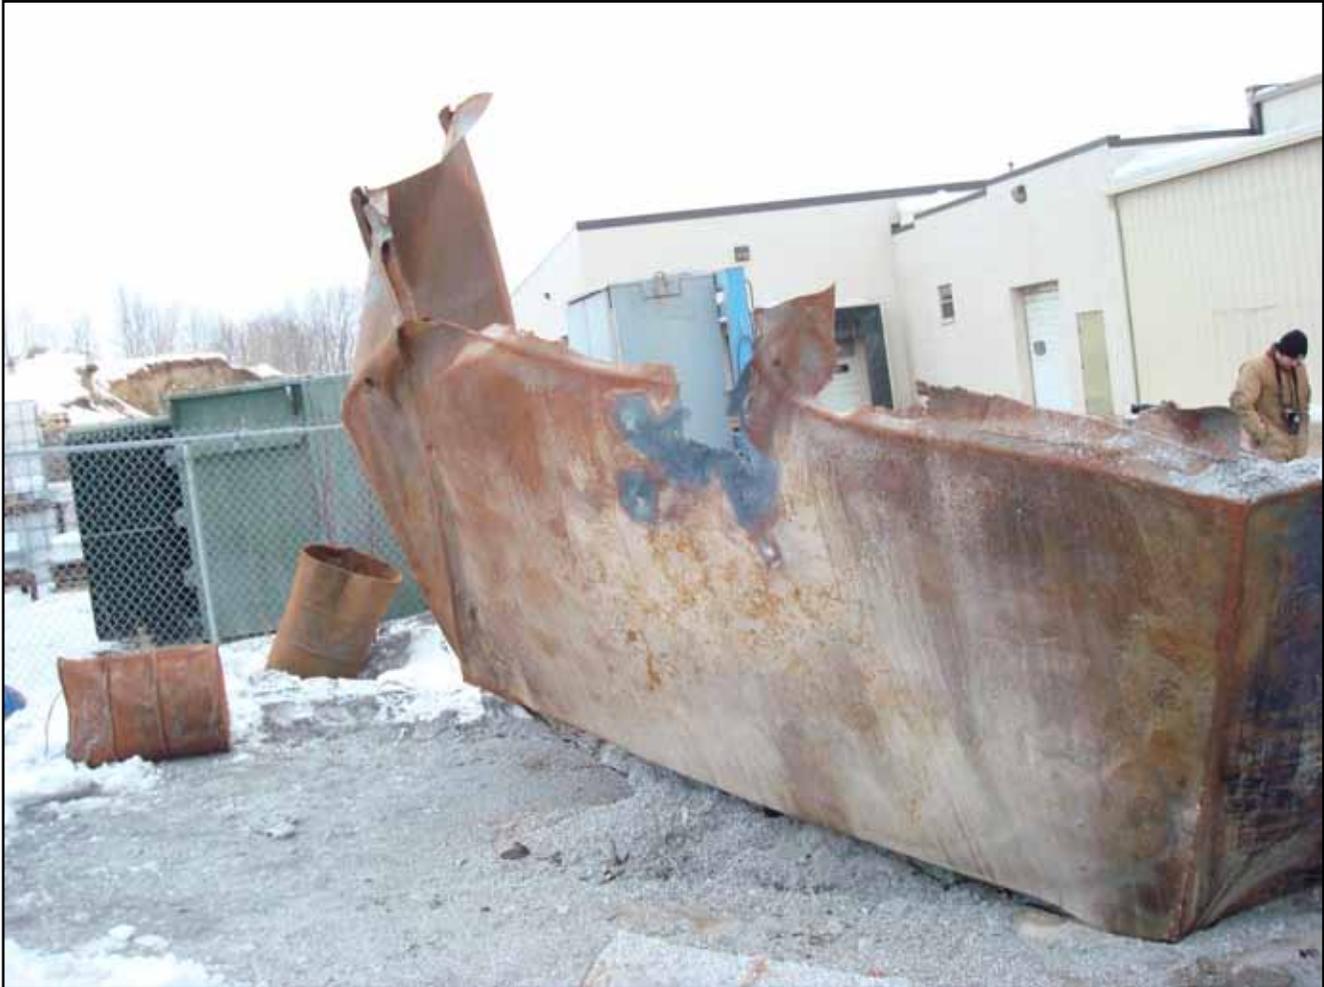
Photo 5. Bottom of the dumpster showing the origin of the fire in the dumpster.
