RI 9655

**Geomechanics of Reinforced Cemented Backfill
in an Underhand Stope at the Lucky Friday Mine,
Mullan, Idaho**

**T.J. Williams, D.K. Denton, M.K. Larson, R.L. Rains, J.B. Seymour, and
D.R. Tesarik**

July 2001

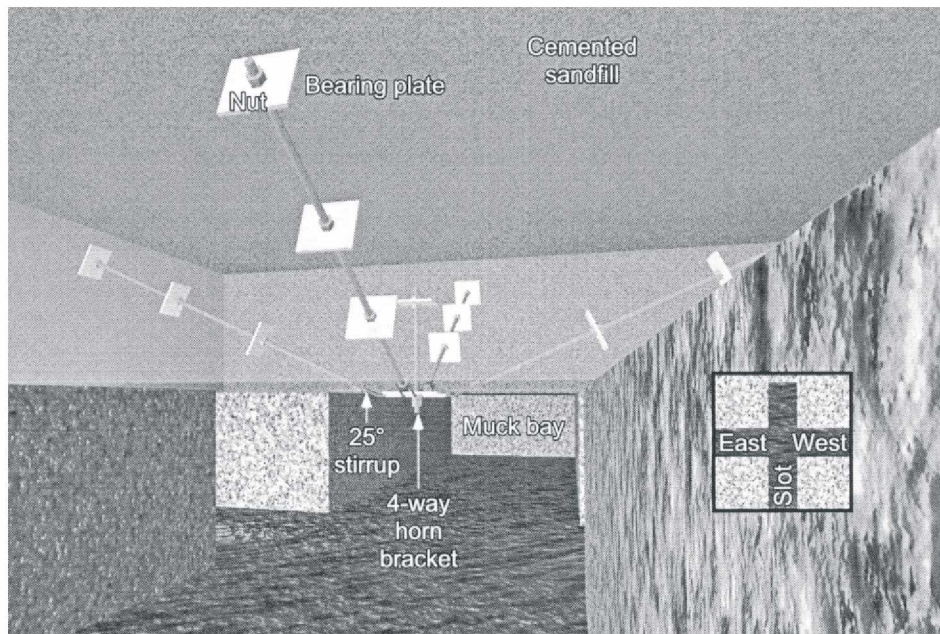
Figure 2.—Intersection truss system.

A four-way truss was installed at the center of the intersection in addition to the vertical rock bolts typically used as reinforcement. The truss was constructed using No. 7 Dywidag rock bolts having a minimum yield strength of 160 kN (36,000 lb). It consisted of one vertical rock bolt, four legs angled 15° to 20° from the horizontal, one four-way horn bracket, and four stirrup U-bolts bent upward at 25° from the horizontal. The horizontal legs consisted of two or three rock bolts joined together with couplings so that the ends of the legs lay outside the intersection into the east and west sides of the stope along the vein and into the slot and the muck bay (figure 2).

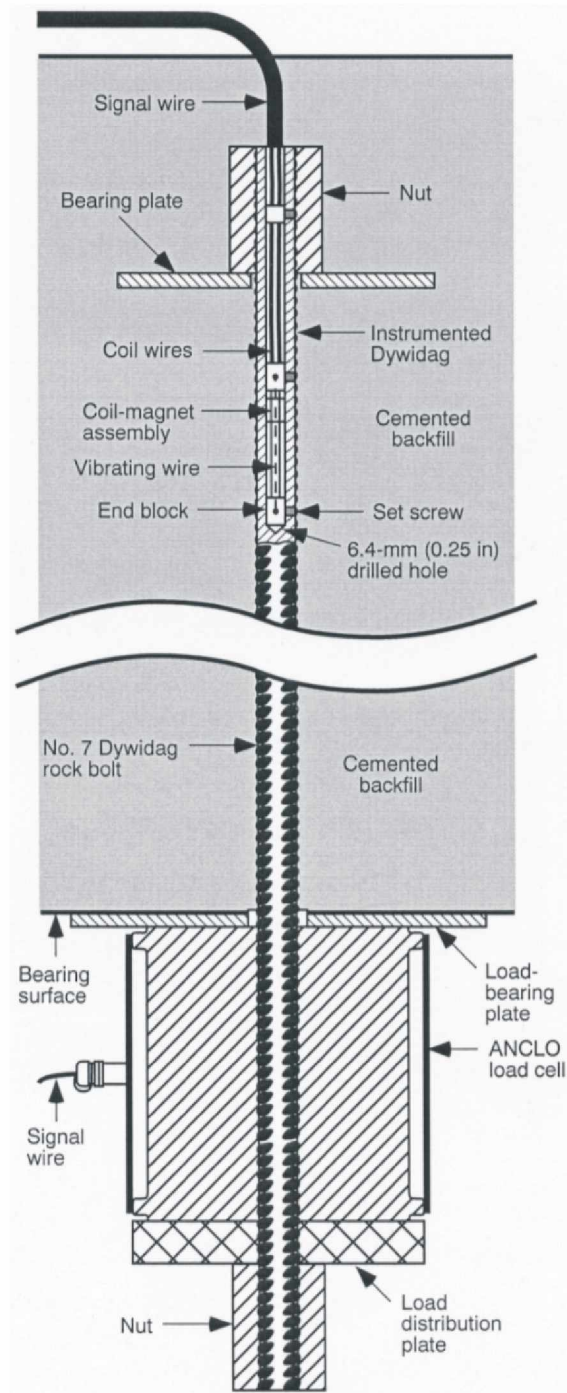
Figure 3.—Rock bolts instrumented with load cells.

Instrumented No. 7 Dywidag rock bolts were obtained from Roctest, Plattsburgh, NY, to measure induced load on the rock bolts used for backfill reinforcement. Roctest installed a vibrating-wire strain gauge and thermister in one end of each rock bolt. These instrumented rock bolts were placed at the ends of all the truss legs. They were also used to replace some of the vertical rock bolts throughout the stope. All instrumented

ALC10 rock bolt load cells were also obtained from Roctest to provide redundant readings on the vertical rock bolts and the truss. Load cells were the only instruments that could be used to obtain load readings at the junction of the stirrup and the horizontal legs at the truss bracket because blasting at this location would have destroyed the instrumented rock bolt wires. The load cells were installed on the lower end of instrumented rock bolts (figure 3) and on the truss legs after mining had passed. The load cells survived better than the instrumented rock bolts because the wires were not subjected to backfill deformation.

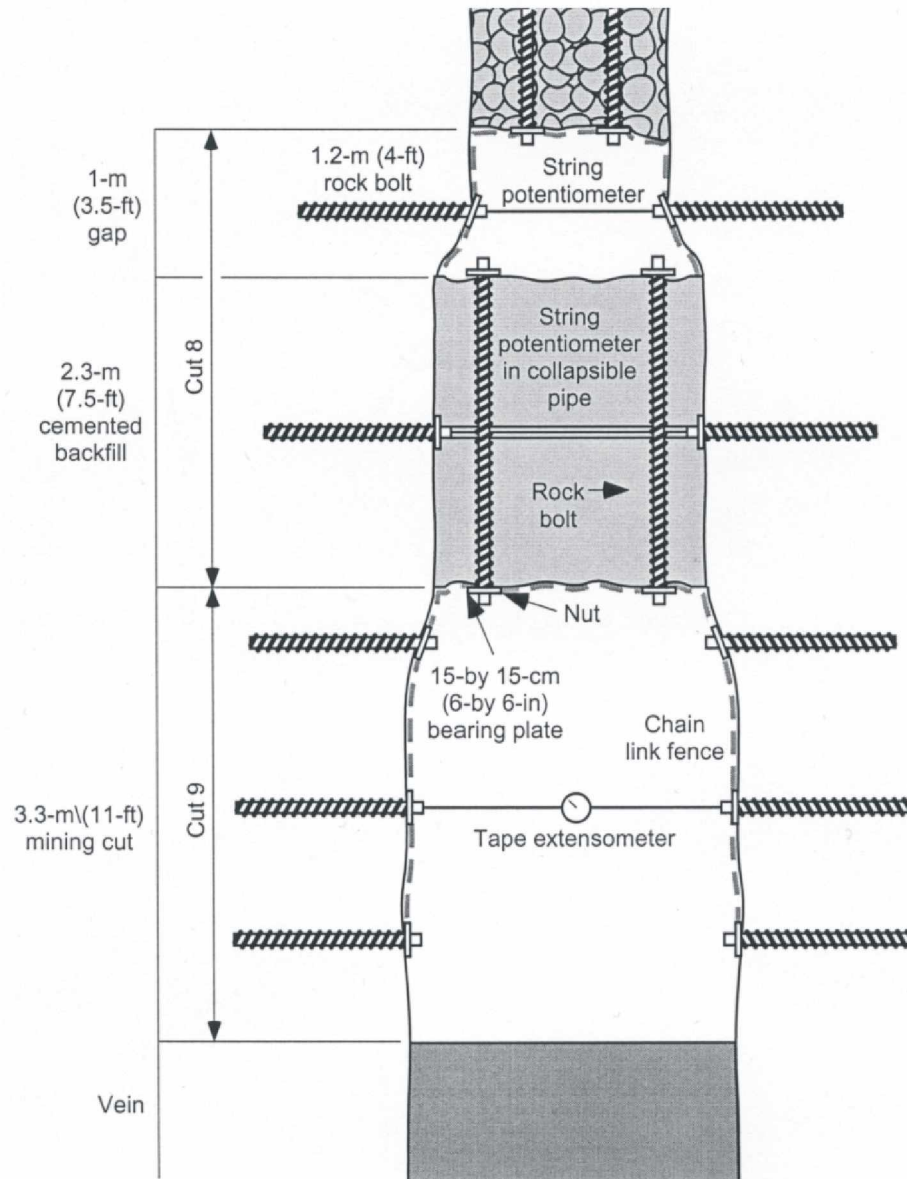
Figure 4.—Wall closure instrument locations.

At various locations, wall-to-wall closure was measured in three different vertical positions (figure 4). A closure plane in the 1-m (3-ft) gap above the backfill was measured with string potentiometers. Another closure plane across the backfill was measured with string potentiometers inside collapsible steel casings, and a closure plane in the new stope cut was measured with a tape extensometer. All closure readings were taken between 15- by 15-cm (6- by 6-in) bearing plates on 1.2-m- (4-ft-) long rock bolts to achieve as much accuracy as possible.

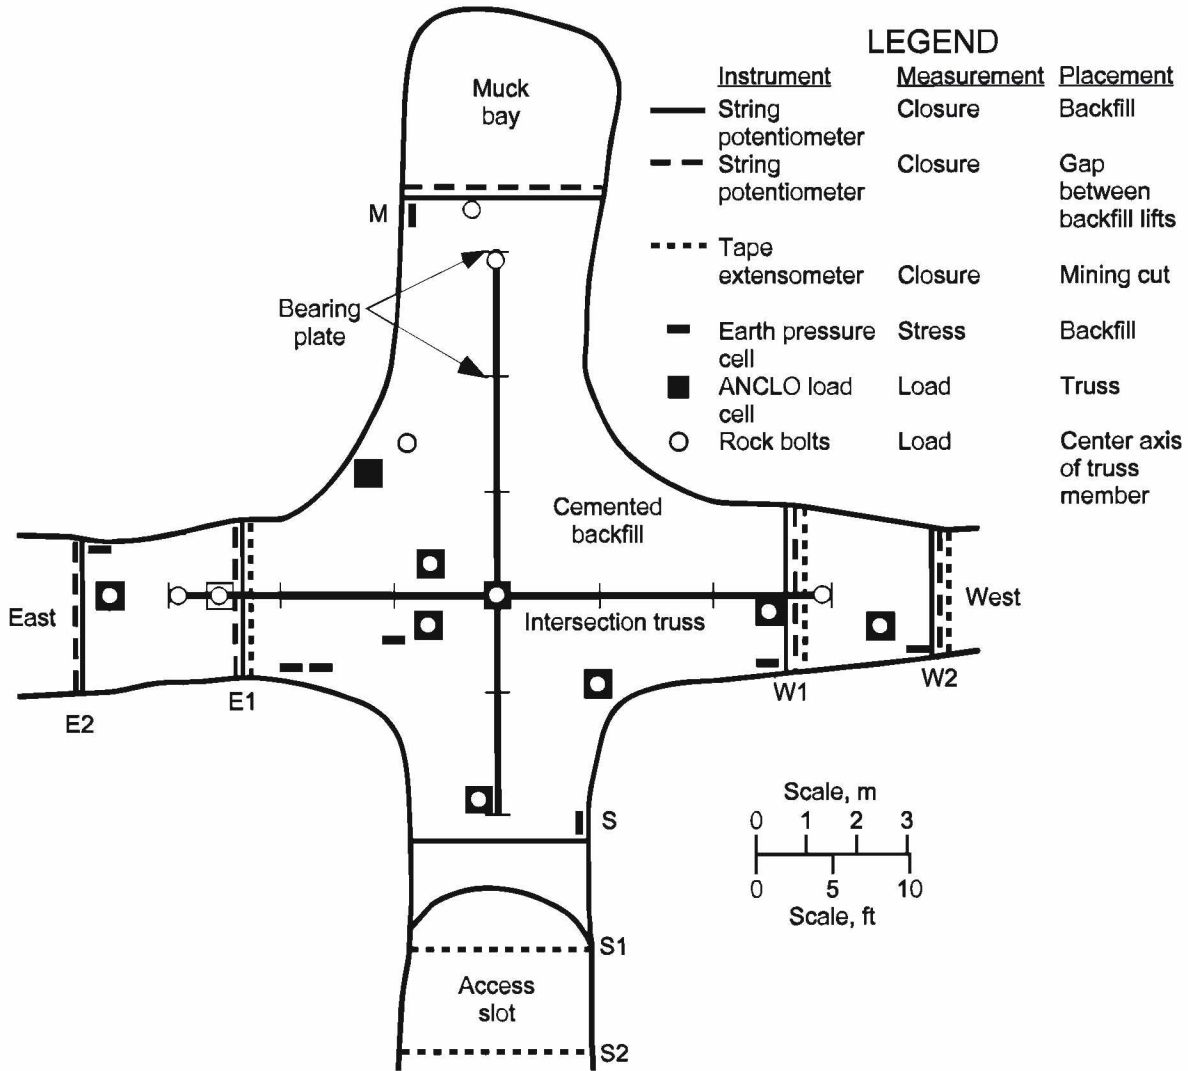
Figure 5.—Location of instruments in 5660-05-level intersection.

Figure 5 shows the location and types of instruments installed in the intersection.

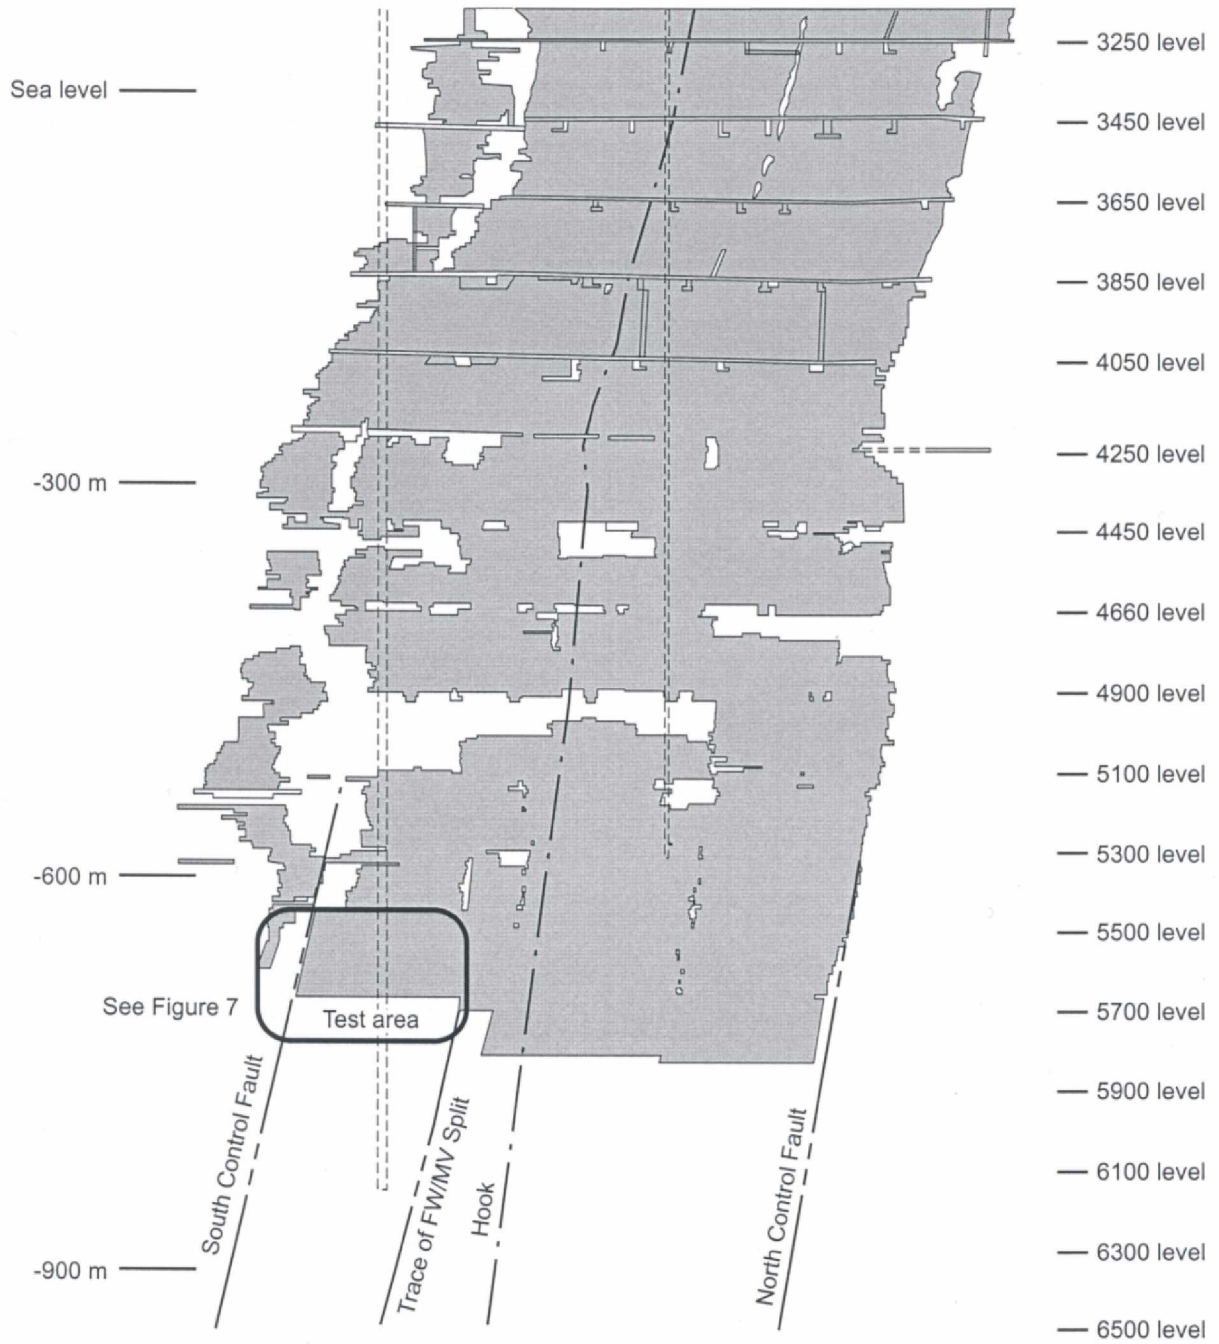
Figure 6.—Longitudinal projection of Lucky Friday Mine.

After the instruments were calibrated at SRL, they were installed in the mined-out cut 8 of the 5660-05 stope prior to placement of the backfill. Figure 6 is a longitudinal projection of the Lucky Friday Mine with the test stope location shown in the lower west corner. Figure 7 is an expanded view showing the cut sequence for the 5660 and 5750 sublevels and the location of the instrument site. On October 15, 1997, the intersection was backfilled with 2.3 m (7.5 ft) of cemented mill tailings so that the truss legs were completely covered. Because the stope was only filled for 2.3 m (7.5 ft) of its 3.3-m (11-ft) height, additional string potentiometers were installed wall-to-wall in the gap on October 16. The datalogger was then moved

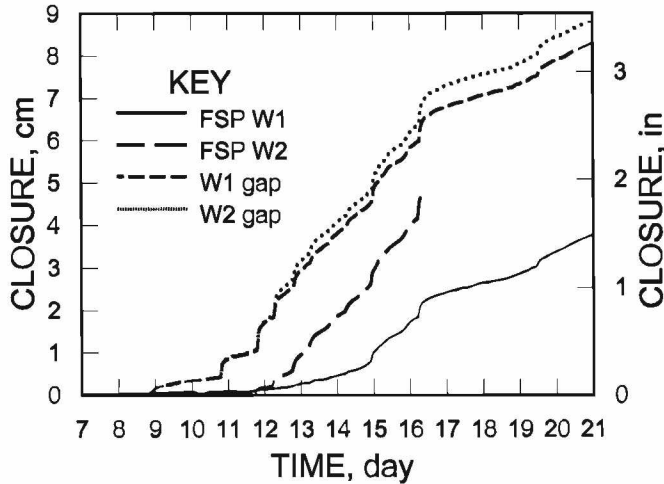
Figure 8.—Gap and backfill closure versus time.

before closure in the backfill (figure 8), a further indication that the backfill was supplying wall support. The amount of overall wall closure would probably be the same, but the backfill supplied enough support so that fractures in the stope walls closed before the backfill started to yield. There were no borehole closure extensometers in the walls, so this hypothesis could not be confirmed.

String pots placed in the backfill showed the vein walls had converged an average of 7.9 cm (3.1 in) during mining of cut 9 on the 5660 level, 8.9 cm (3.5 in) during mining of cut 1 on the 5750 level, and 8.0 cm (3.2 in) during mining of cut 2 on the 5750 level. At the same time, vein closure measured by string pots in the gap area averaged 14.0 cm (5.5 in) for cut 9 on the 5660 level, 11.5 cm (4.5 in) for cut 1 on the 5750 level, and 9.7 cm (3.8 in) for cut 2 on the 5750 level. Increased amounts of closure across the gap were caused by a lack of support for the walls in this area. Gap closure also began 1 or more days

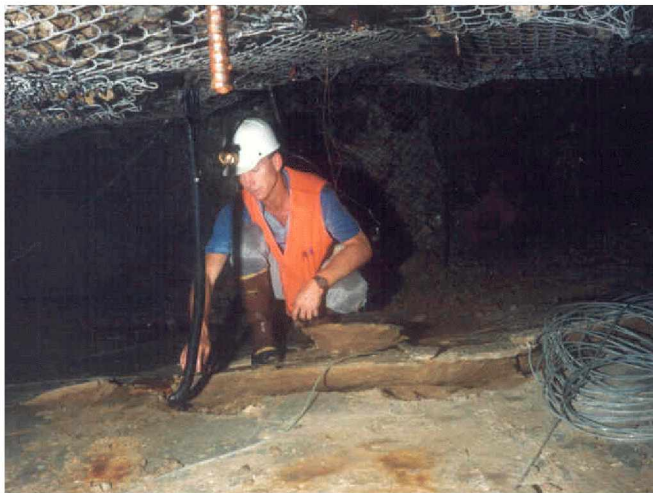
Figure 9.—Thrust-fault-type failure, November 4, 1997.

A thrust-fault-type of fracture (figure 9) was noticed at the top of the backfill while retrieving the CR10's data canister on November 4, 1997. The failure went across the intersection and into the east and west headings along the vein. Both 2- and 2.4-m- (6- and 8-ft-) long vertical rock bolts had been placed in

the area. Failure appeared to be above the 2-m (6-ft) rock bolts, but blocked by the 2.4-m (8-ft) rock bolts, the ends of which were just visible at the top of the fill.

This failure was caused by convergence of the vein walls on the backfill. At this time, there had been 2.5 to 7.6 cm (1 to 3 in) of horizontal closure across the vein in the backfill and 7.6 to 15 cm (3 to 6 in) in the gap above the instrumented backfill.

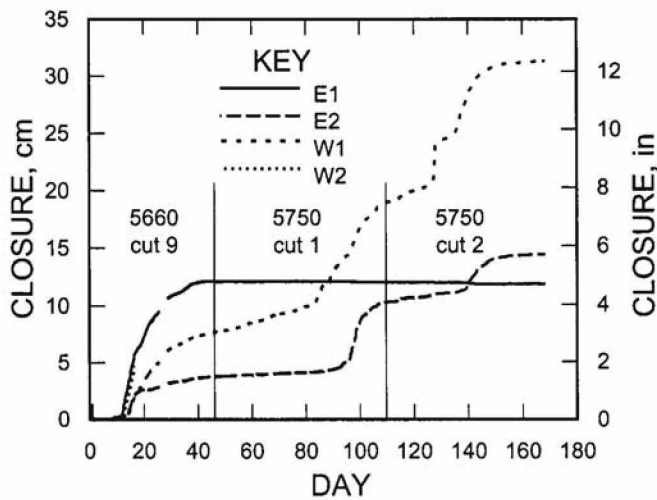
Figure 10.—Backfill closure as a function of time.

Fracturing of the backfill caused upward buckling that gradually reduced the gap between the backfills over time. Buckling continued until the initial 1-m (3.5-ft) vertical gap was reduced to less than 0.3 m (1 ft) before the backfill from cut 7 collapsed onto the instrumented cut 8 backfill. Table 1 is a summary of original stope widths, and table 2 shows closure readings for the three mining cuts. Figure 10 shows backfill closure as a function of time for three mining cuts. Total closure includes

some rapid closure as the cut was mined past the instruments and more gradual time-dependent closure resulting from all previous mining in the area.

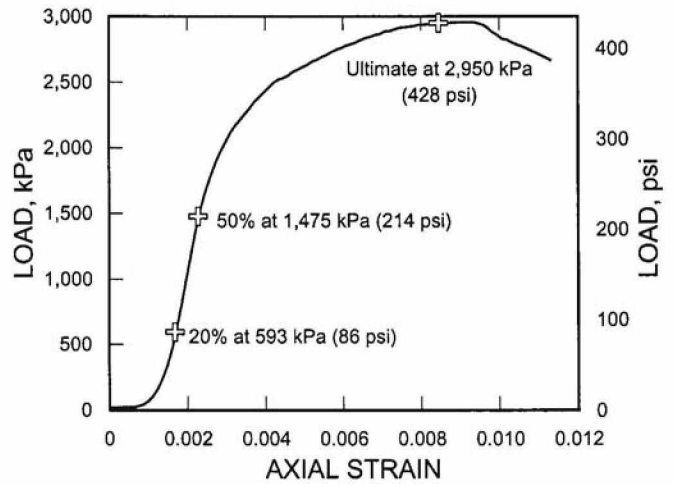
Figure 11.—Compressive test of cemented sandfill, stress/strain curve.

Movement of the platen head of the compression test machine was also recorded to determine an apparent modulus for the 7- and 28-day compressive tests. Figure 11 is an example of the stress-strain curve for the tests. The modulus for the samples is calculated between the 20% and 50% strength values because this is the straight line portion of the curve and most representative of the true response of the backfill. The equation used is —

$$\begin{aligned} \text{20-50 modulus} &= (50\% \text{ strength} - 20\% \text{ strength}) \\ &\div (50\% \text{ strain} - 20\% \text{ strain}). \end{aligned}$$

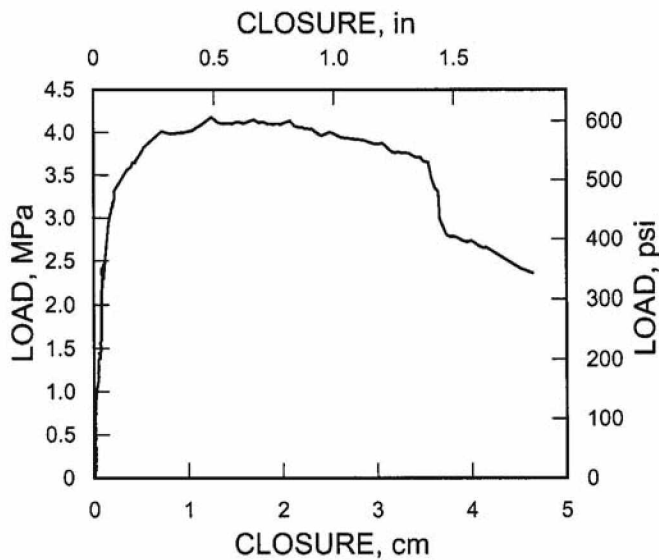
Figure 12.—Backfill closure versus backfill pressure, West 2.

Model 3500 earth pressure cells from Geokon, Inc., were placed in the cemented backfill to monitor pressure as the walls closed. The backfill pressure increased rapidly as wall closure commenced (figure 12). The readings peaked with mining of cut 9, after which backfill pressure dropped as each subsequent cut was completed. Peak pressures ranged from a low of 793 kPa (115 psi) in the intersection to 4178 kPa (606 psi) at West 2; the average across the vein was 2757 kPa (400 psi) at 15 days. The data collected in the mine were within the range of the data collected in the laboratory (7-day unconfined compressive strength of 2082 kPa [302 psi] and 28-day unconfined compressive of 3254 kPa [472 psi]).

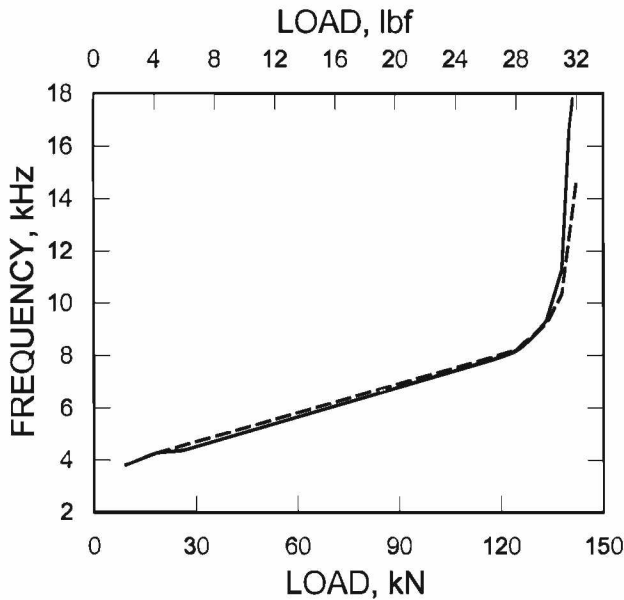
Figure 13.—Calibration curve showing relationship between frequency and load on instrumented rock bolts.

These tests showed that the hole drilled for the vibrating wire did not affect the yield strength of the bolt, but that it did reduce ultimate strength from 240 to 215 kN (54,000 to 48,450 lb). The slope of gauge response was linear between 8.9 and 124 kN (2000 and 28,000 lb) at 27 N/Hz (6 lb/Hz). Gauge response was then rapidly reduced to 2 N/Hz (0.45 lb/Hz). At 142 kN (32,000 lb), the gauges failed before the yield point of the rock bolts was reached. Figure 13 shows calibration load versus gauge response frequency for the bolts tested to failure. These tests showed that the vibrating-wire gauges installed in the end of the bolts were inadequate for this application and any future tests should use a gauge with a higher load range. The data were reanalyzed using this calibration curve.

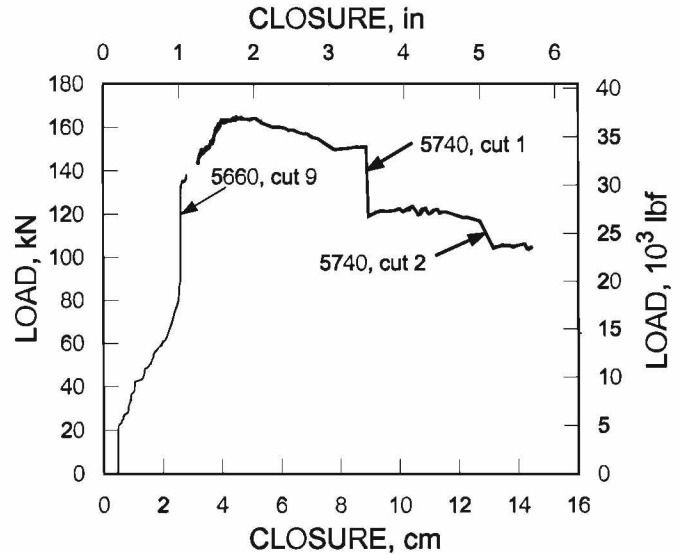
Figure 14.—Backfill closure versus rock bolt load, East 2.

Data from the rock bolt load cells indicated that the vertical rock bolts were under loads from 41 to 179 kN (9300 to 40,300 lb) after cut 9 was mined except in the muck bay, where loads ranged from 2.9 to 19.1 kN (660 to 4300 lb). Loads on the vertical rock bolts along the vein dropped as cuts were subsequently mined. This drop was probably a result of the continued breaking up of the backfill as the walls closed. Figure 14 shows the relationship of rock bolt load to backfill closure at East 2. The data indicate rock bolt load leveling off and

decreasing as closure continued following each mining cut. This drop was probably caused by backfill failure around the rock bolt bearing plates as the walls converged. Inspection of the bottom of the backfill revealed bags of broken backfill in the chain link fencing between the rock bolt plates. Visual observation of the top of the 2.4-m- (8-ft-) long vertical rock bolts also confirmed that the 15- by 15-cm (6- by 6-in) bearing plates resisted backfill deformation and transferred load to the rock bolt.

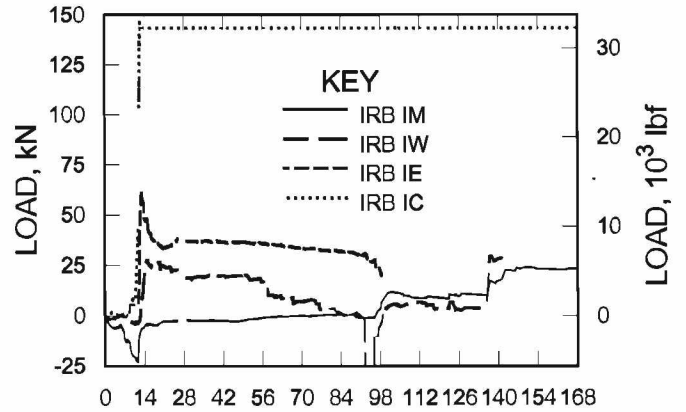
Figure 19.—Data from instrumented bolts in truss.

Data from both the load cells and instrumented bolts indicate that a major redistribution of load was taking place in the intersection during this 18-hr period. Table 4 is a summary of the readings over the 18-hr period for the rock bolt load cells and the instrumented rock bolts. The truss legs along the vein functioned as expected, but the legs extending into the muck bay and slot failed to hold load and were ineffective.
