*RI 9671*

# **Self-Contained Self-Rescuer Long Term Field Evaluation Combined Eighth and Ninth Phase Results**

DEPARTMENT OF HEALTH AND HUMAN SERVICES  
Centers for Disease Control and Prevention  
National Institute for Occupational Safety and Health

October 2006

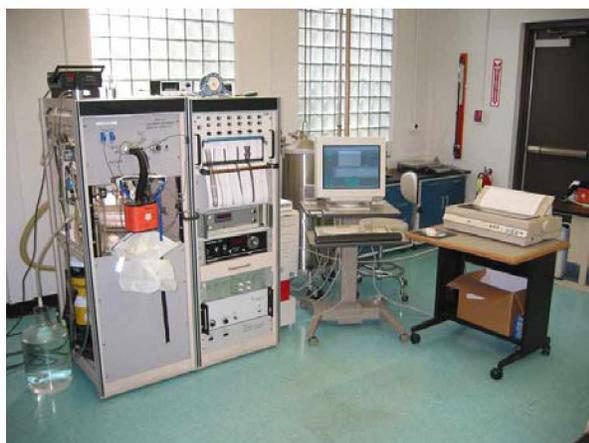
Figure 1. Breathing and Metabolic Simulator

Over 400 SCSRs were tested in the eighth and ninth phases of the study conducted December 2000 – April 2004. Ninety percent of the apparatus were tested on a BMS (Figure 1) and 10% were tested using human subjects on a treadmill (Figure 2). MSHA provides human test subjects from its Mine Emergency Unit for treadmill testing.

The BMS test consists of the average metabolic work rate exhibited by the 50<sup>th</sup>-percentile miner weighing 87 kg while performing Man-test 4 for one hour, as described in 42 CFR, Part 84. Although the average work rate is the same, LTFE testing is not equivalent to certification testing. Certification testing imposes high and

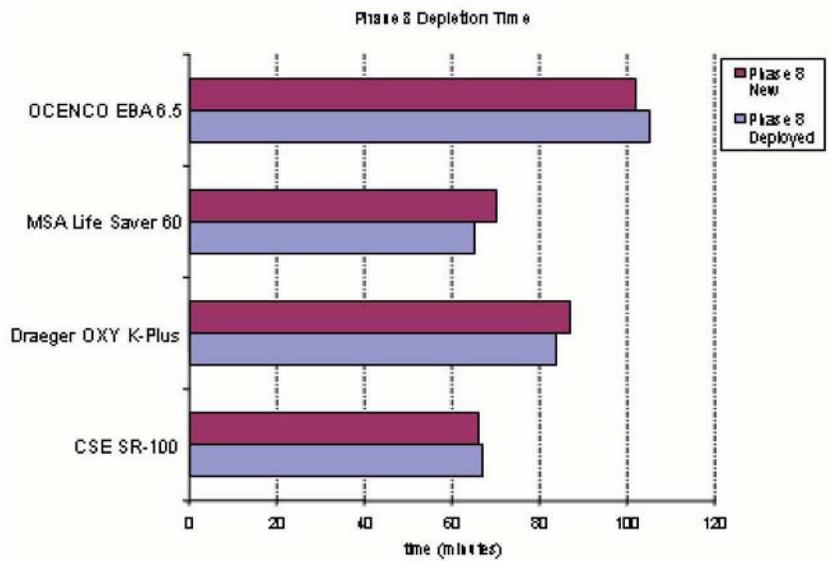
Figure 8a. Depletion Time for All Models Tested–Phase 8

The depletion times for the deployed and new units are shown in Figures 8a and 8b for Phases 8 and 9 respectively.

Time to depletion, as shown on Figures 8a and 8b was comparable for new and deployed units. It should be noted that the sample size in both phases was small, 24 units in Phase 8 and 20 units in Phase 9.

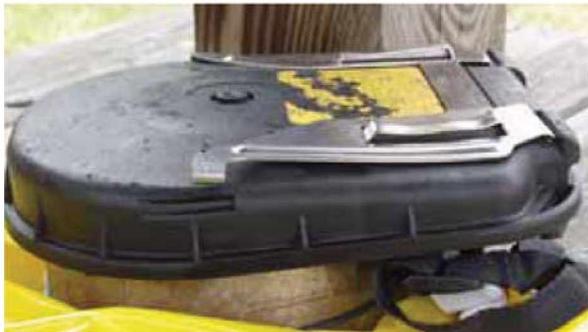
<b>Table 6a. Lab Inspection Results for Draeger OXY K-Plus–Phase 8</b>	
SN	Failure
ARJA 0391	Belt-clip plate dented
ARJA 0393	Belt-clip plate dented

SN	Failure
ARLN 0034	Belt plate dented

**Figure 9.** Dented Draeger OXY K-Plus Belt-Clip

The Draeger OXY K-Plus exhibited a similar problem in that impact in the area of its metal belt-clip can crack or shatter an internal component, permitting in-leaking of the ambient air. While this damage is subtle, it is detectable, because the metal belt-clip is permanently deformed from any such impact. Specific inspection for this damage has been added to the OXY K-Plus's overall inspection criteria within the user's instructions.

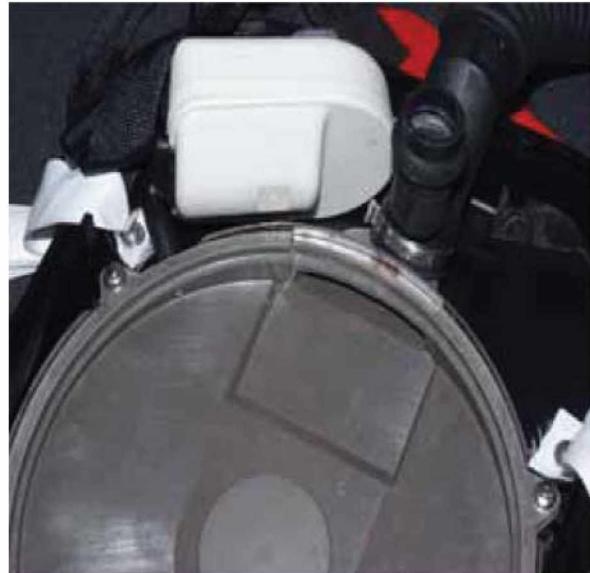
leakage when evaluated and were later found to have internal damage, causing a breach of the breathing circuits. Hypoxia (low levels of O<sub>2</sub>) can occur when ambient air (79% of which is nitrogen) is drawn into the breathing circuit and only the oxygen is removed (by the user). These two units were among three that had dents in their metal belt-clip plates. Draeger alerted inspectors to look for such dents, and has added that to its list of inspection criteria. If the metal belt-clip plate is dented, the large, hard-plastic plenum directly inside the case can be cracked or shattered, resulting in ambient air leakage into the breathing circuit (see Figures 9 and 10). Not only can this result in low O<sub>2</sub> levels, which may cause the user to lose consciousness, it can also result in toxic gases entering the breathing circuit. Draeger submitted a design improvement for certification.

**Figure 10.** Internal damage on Draeger OXY K-Plus

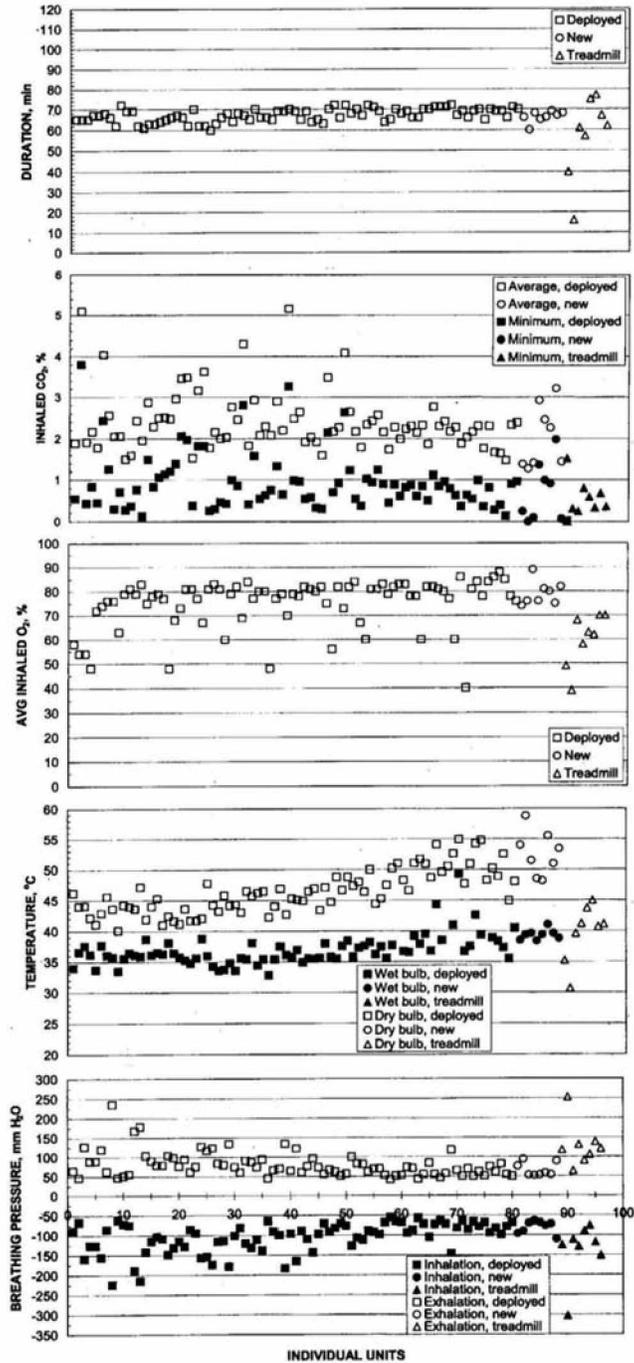
Figure A2-1. CSE SR-100 Test Results Phase 8

The minute-average values of the monitored stressors were averaged over the entire test duration, and are presented graphically for each apparatus by stressor in Appendix 2 (Figures A2-1 through A2-9). The values for new and deployed units tested on the BMS can be compared. To some extent, these values may also be compared with those for deployed units tested on human subjects on a treadmill; however, human subjects may differ from each other and from the BMS in terms of CO<sub>2</sub> production rate, ventilation rate, and respiratory frequency. These parameters affect apparatus duration as well as all of the monitored variables. Treadmill tests cannot be considered equivalent to the BMS tests, even though the O<sub>2</sub> consumption rate is the same.

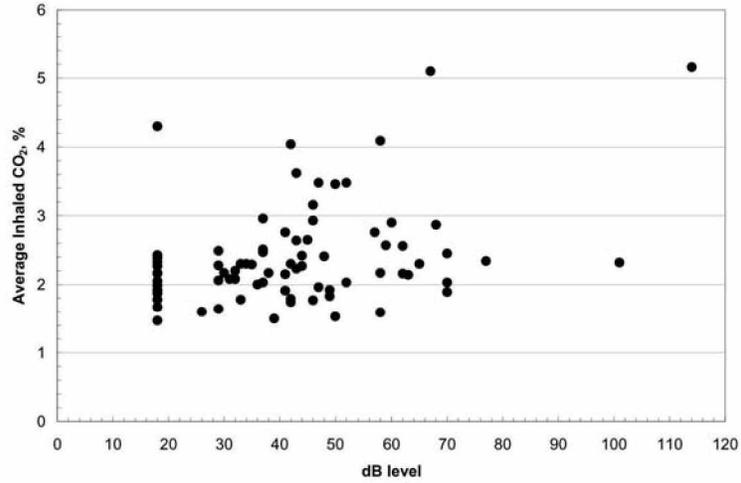
Figure A3-1a. CSE SR-100 Decibel Level versus CO<sub>2</sub> Level Phase 8

CSE developed a test to identify apparatus that have sustained internal damage, based on a correlation between loose particles in the chemical bed and CO<sub>2</sub> breakthrough during the last rest interval of a 1-hour Man Test #4. This was established by testing SR-100s on the CSE breathing simulator performing NIOSH variable-work rate certification tests. The Acoustic Solids Movement Detector (ASMD) analyzes the noise induced in the unit by shaking it in a controlled manner. The noise produced by the SCSR when shaken is used as an indicator of shock and vibration damage incurred by the chemical bed within the SCSR. In the field, this assessment is made using a hand-held instrument provided by CSE. A laboratory version of the ASMD test involves rotating the SR-100 in an anechoic chamber to measure the noise levels in decibels (dB). Various frequency ranges are weighted differently and result in a composite dB rating for each apparatus. A unit with a composite rating of higher than 60 dB fails the test. NIOSH performs the laboratory version of the ASMD test as part of the LTFE inspection. Excessive noise as evaluated by either of the test instruments is an indication of chemical-bed damage that may adversely affect the performance of the SCSR. SCSRs failing the ASMD test must be removed from service. The ASMD test and average inhaled CO<sub>2</sub> levels on CSE units on a BMS performing a constant work rate test are presented in Figures A3-1a and A3-1b.
