Sanitary Engineering

in "Operation

TULIP"

By HARVEY F. LUDWIG, M.S.

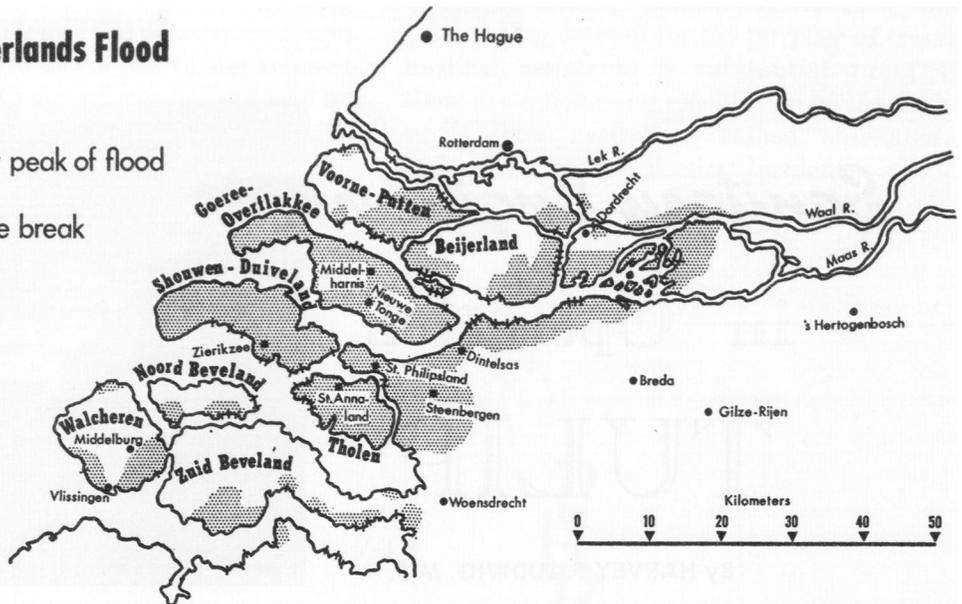
Area of the Netherlands Flood

February 1953

inundated at peak of flood
-

reported dike break

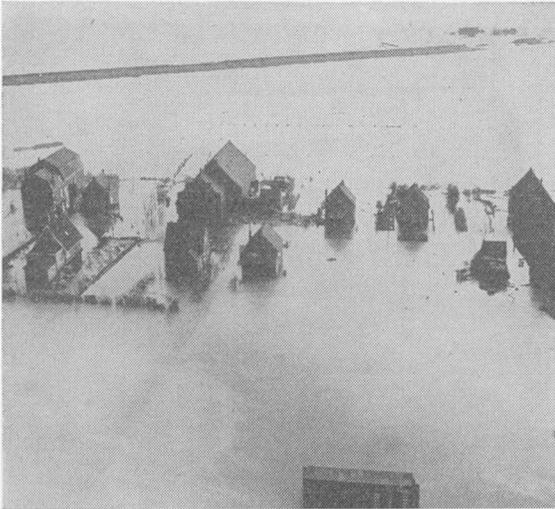
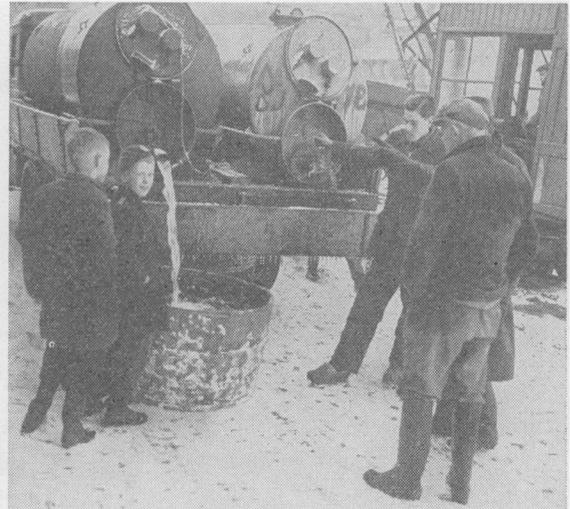
Left: At Nieuwetonge on Overflakkee Island 2 weeks after the area was first flooded, the water has partially receded. Right: A water tank brings drinking water to the people on Schouwen Island.

The emergency situations on the islands were met by two methods: by hauling water from the mainland by boat and by use of the mobile purification units. For boat hauling, the Dutch employed primarily water tankers normally engaged in supplying shipping in the Rhine River, but also a number of other tankers which had to be cleaned for water use. Tanker capacity became increasingly available as the emergency continued, and the need for the water purification units decreased accordingly.
