Analysis of Bench Crest Performance at the Yellowstone Mine: A Case Study

A case study is presented that relates statistical descriptions of joint sets to the distribution of local wedge failures along the crest of a catch bench at the Yellowstone Talc Mine. The fracture sets and bench width were mapped by teams of geological engineering students from Montana Tech under the direction of Dr. Mary MacLaughlin. The students analyzed the fracture data, conducted physical property tests, and used a beta version of a NIOSH program “Bwedge” to predict the distribution of surviving bench widths. In the course of this analysis the students developed evidence of software performance issues that, unfortunately, frustrated their analysis. These have now been addressed and a full analysis completed. The analysis confirms the validity of the student mapping program and provides insight into the effects of blasting and excavation practices on the bench. It also provides a tool for exploring the pattern of bench crest failure that would result from variations in both bench geometry and blasting practices.

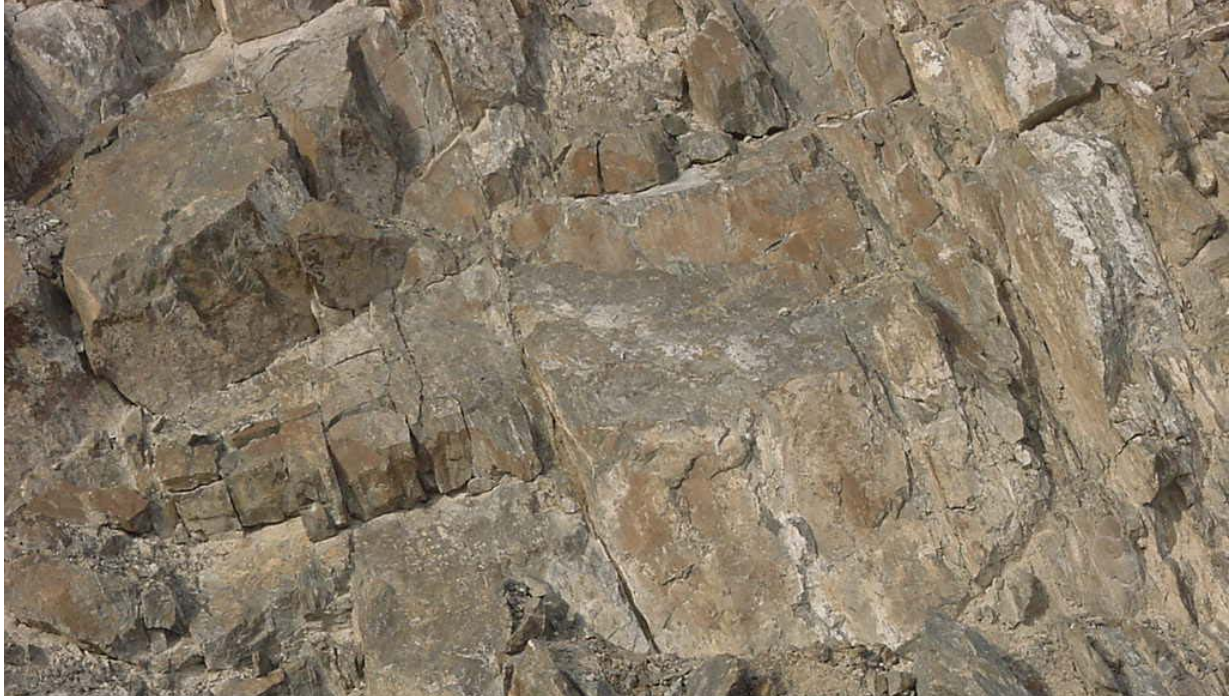
Figure 1: Fractured rock on a bench face.

The study focused on a 90 m (300 ft) section of a single bench within the north wall of the south pit in hydrothermally-altered dolomite of Precambrian age. This rock is overlain by Tertiary age Huckleberry ridge tuff. Severe fracturing of the dolomite appears to form at least four major sets (figure 1). Fractures are likely related, at least in part, to movement along a major fault that runs through the pit, striking N-NW with near vertical dip. This fault lies adjacent to the west end of the study scan line. The rock mass was classified as “Fair” for the RMR and “Very Poor” for the “Q” system (Appendix A).

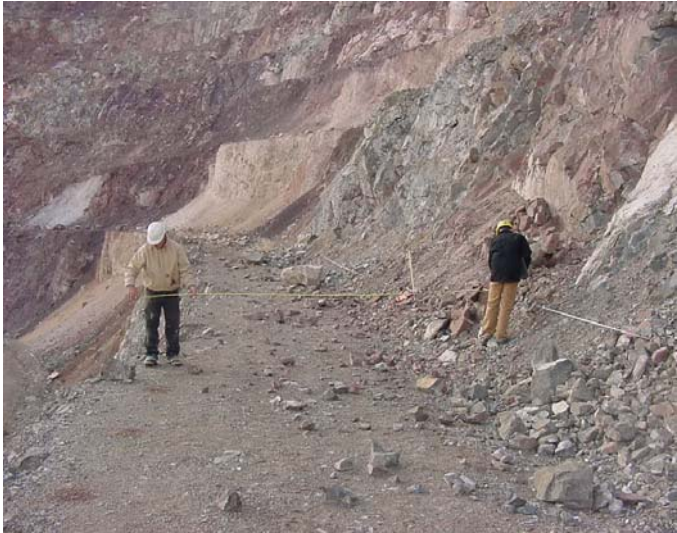
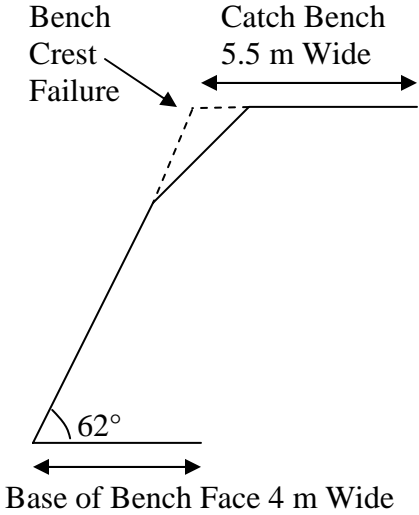
Figure 2: Students measuring the bench width and idealized cross section.

The overall slope angle of the north wall was measured by Brunton compass at roughly 40° . Benches are 7.6 m (25 ft) high with an estimated intact bench width of 5.5 m (18 ft) and bench face dip of 62° . However, the students found that the bench crest was intact at only a handful of locations along the study bench section (figure 2). Widths measured along the study bench are plotted in figure 3. Narrower sections of bench were caused primarily by wedge failures of various sizes along the bench crest (figure 4). Wedges were formed by, and have slid upon, pre-existing fracture planes.

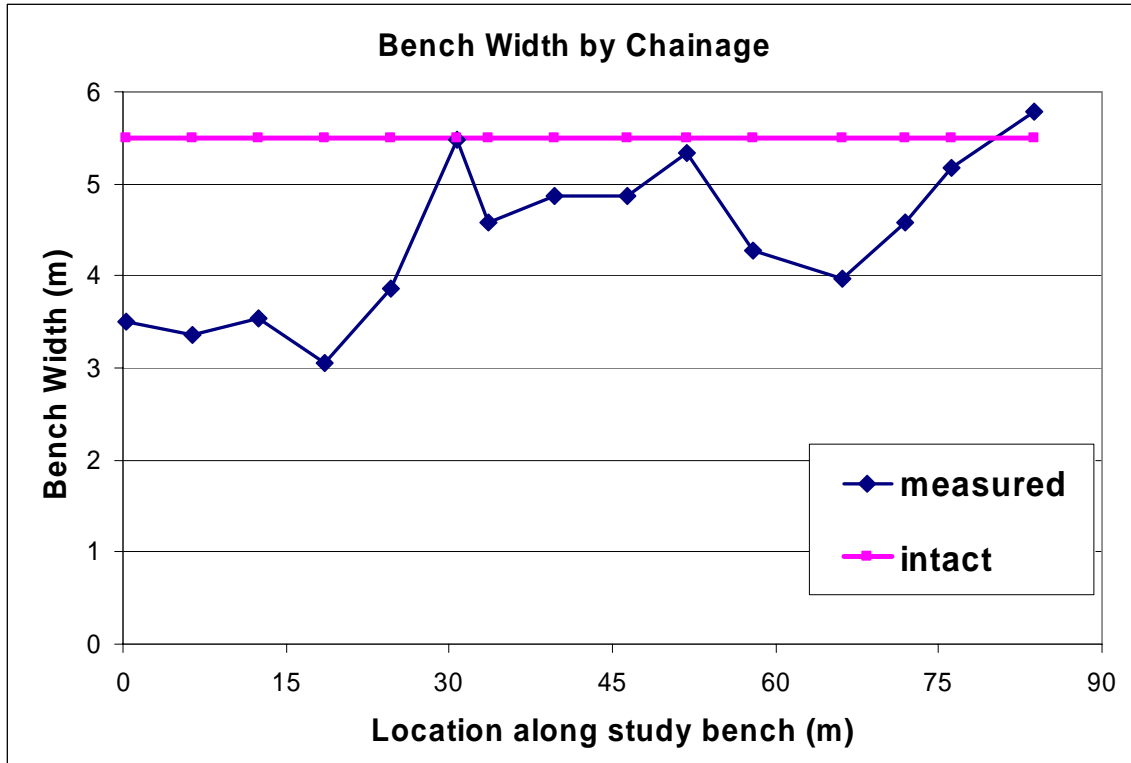
Figure 3: A plot of measured bench widths by distance along the mapped section of the study bench.

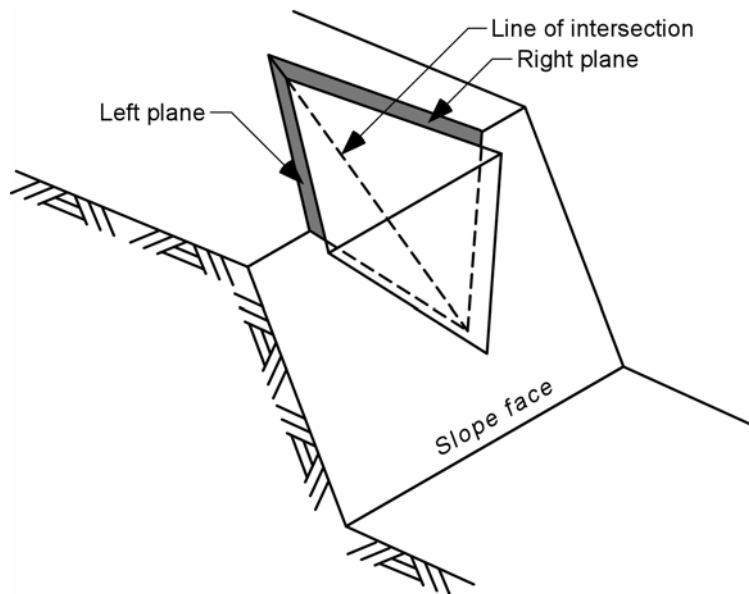
Figure 4: Idealized wedge geometry showing left and right fracture planes.

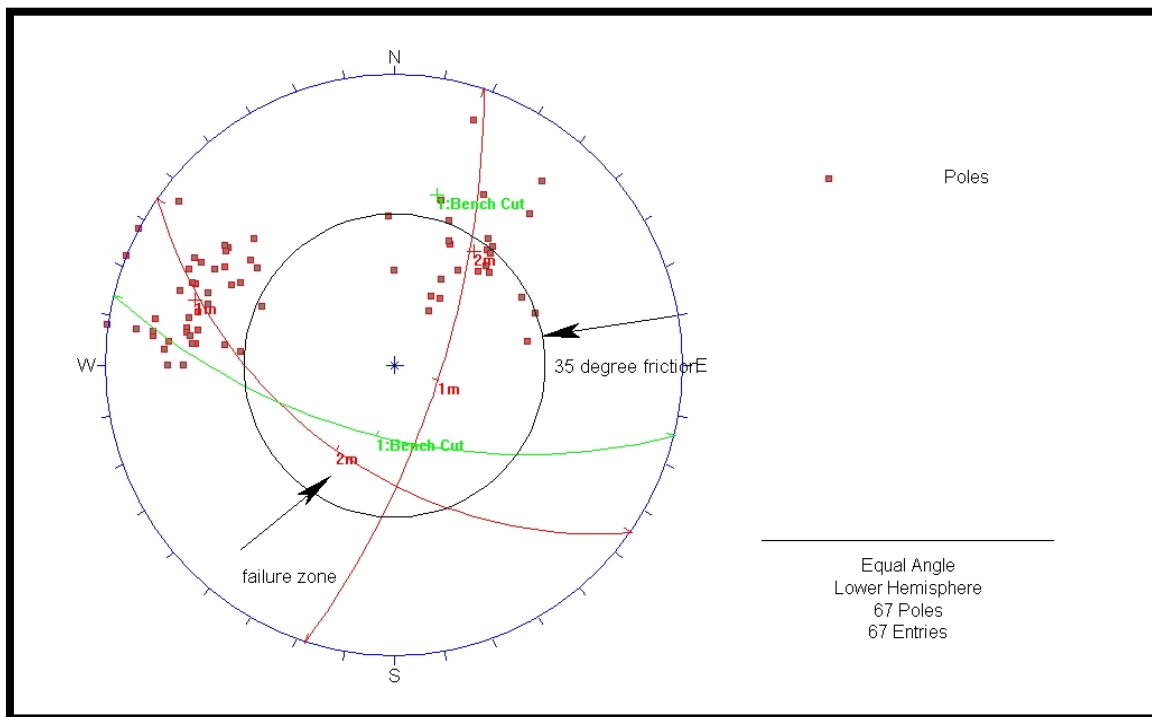
Figure 5: Stereonet plot of joint poles, joint set average orientations and pit slope.

A first cut analysis of wedge stability was developed as shown in figure 5. Bench slope, average fracture-set orientations and the wedge formed by “average” fractures were plotted to show that the wedge formed by set “average” fractures daylight in the bench face. The plunge of the fracture set intersection beneath this wedge was found to be steeper than a 35° friction angle circle, a typical joint friction angle. Thus, failure of such a wedge is likely. Plane failure on the joint set is also possible but its apparent dip in the bench cross section is flatter than the plunge of the wedge fracture plane intersection. Thus, wedge failure will be preferred where both are possible. This tendency is evident in the predominance of wedge failures observed in the field.

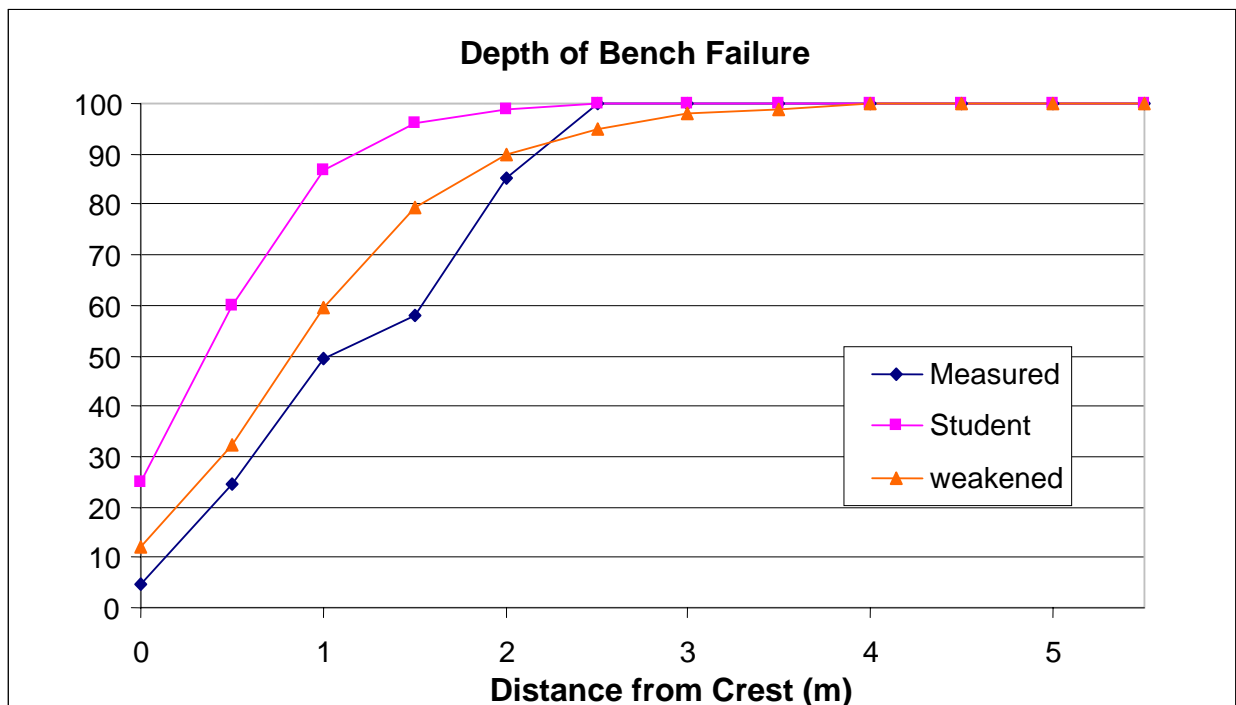
Figure 6. Estimated probability of stability at various depths into the bench crest based on (1) measurements, (2) a model using the student set of fracture parameters and (3) a set of weakened parameters.

An attempt was made to explore the effects of blasting on the bench model by weakening fracture strength. The friction angle was decreased from in situ to saw-cut values and the stabilizing influence of fracture waviness removed. Bwedge runs using these weaker values more closely fit observations for the outer bench, but also underestimate retention deeper into the bench – which is also more sheltered from blasting. This result suggests that the student set of parameters may well describe the fracturing in situ, prior to the influence of blasting. To the extent that this proves to be the case, the overall slope angle could be steepened, while preserving both bench face angle and effective bench width, through more careful blasting. If all blasting effects were removed, and a 90% probability of maintaining a minimum bench width was desired, benches could be narrowed by a full meter. The overall slope angle could be steepened by about 5°, to roughly 45°.

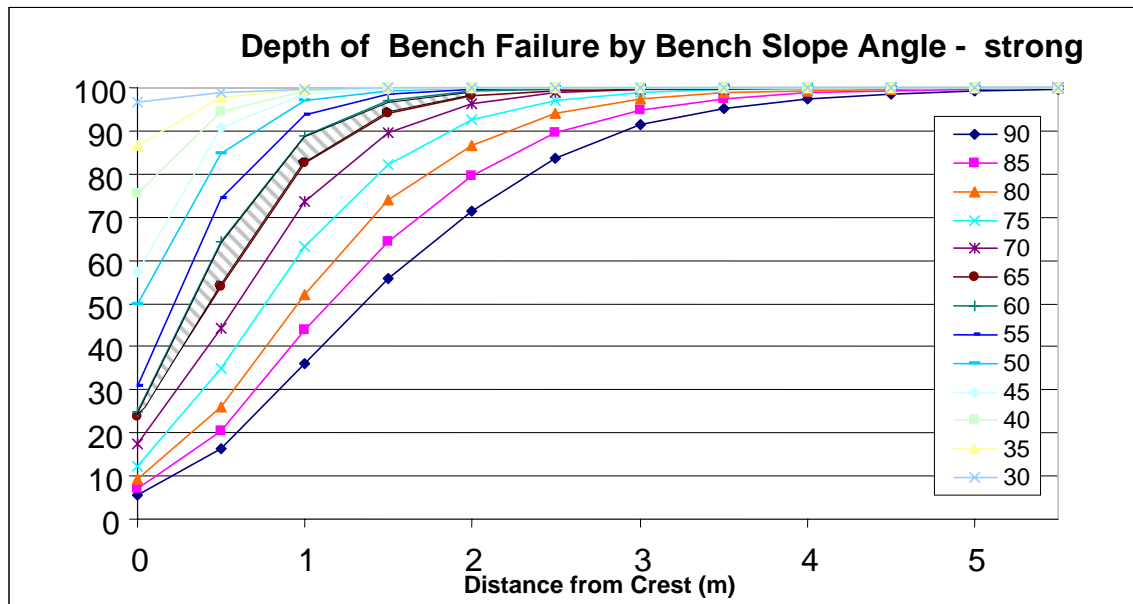
Figure 7. Probability of stability estimated at various depths into the bench for various bench face angles. Curves for steepened slopes are, in sequence, below and to the right of the shaded interval which indicates the actual bench face angle. Curves were computed with Bwedge using the “strong” set of fracture properties.

Bwedge can also be used to explore how variations in bench face angle, bench height and initial bench width can influence the effective, usable width of resulting catch benches and the overall slope angle. For example, the depth of crest failure can be estimated for various bench face angles. Figure 7 is such a plot, developed with strong (intact) rock properties. As such, it is most relevant to considering steepening of the bench and the resulting extension of wedge failures deeper into the bench. Figure 8 is a similar plot for weakened (blast-impacted) properties relevant closer to the bench face.

Given a desired surviving bench width, figures 7 and 8 can be used to estimate the additional bench width that should be developed to allow for local crest failures. That is, the design should consist of a “sacrificial” width that will likely fail, at least locally, and a deeper “protected” width that should have a high probability of survival as a functioning catch bench. Obviously, steepening the bench face increases the sacrificial width while cutting this angle back reduces it. However, it is clear from these figures that it is not possible to completely eliminate crest failure, only manage how much must be dealt with.

For example, we can examine the current design for strong properties (figure 7) and a threshold probability of 90%. Recall that this chart is most relevant when failure extends into rock that is not weakened by blasting. For instance, when careful blasting practices are used or steepening of the bench face pushes failure deeper into the bench. With the current design, the sacrificial width is a little more than a meter. If the bench face were steepened to a vertical dip, the unreliable portion of bench width would increase to more than 3 m. The bench width would have to be increased by a similar amount to maintain the necessary catch bench width.

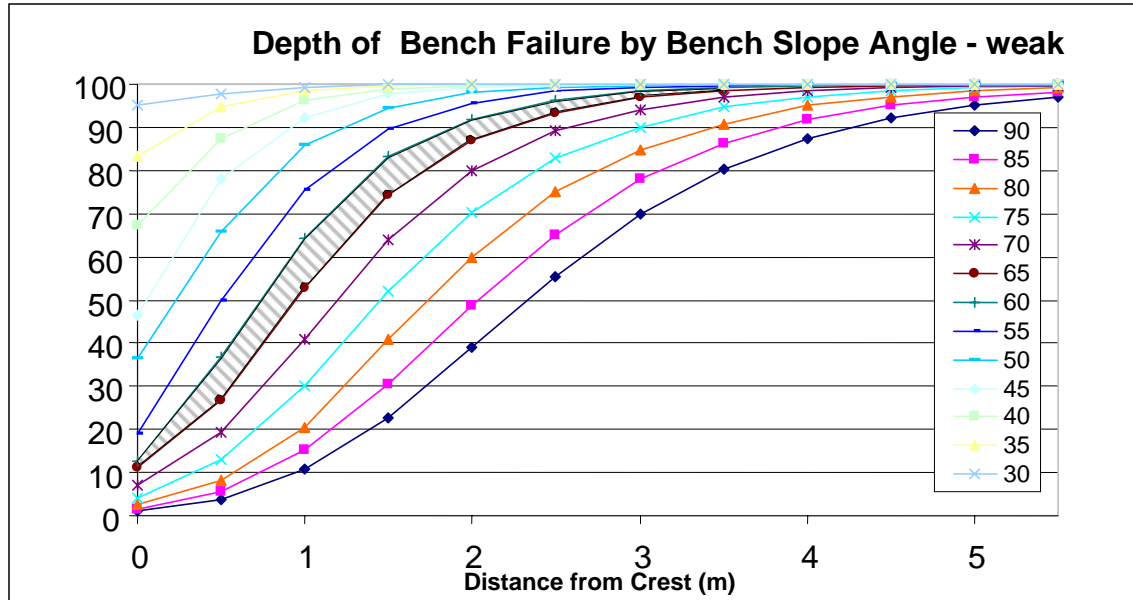
Figure 8. Plot of figure 7 recalculated for “weak” set of fracture properties.

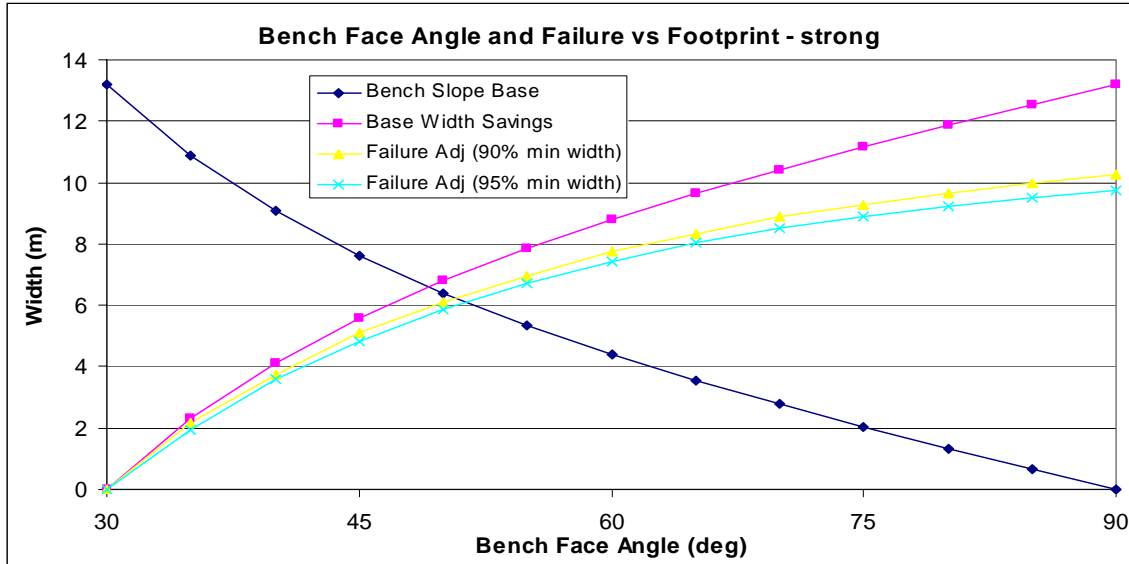
Figure 9: Bench slope footprint plotted as a function of bench face angle. The savings in footprint width are plotted for steepening of the bench face from an initial angle of 30°. These savings are then adjusted for a sacrificial segment of bench width containing crest failures with 90% and 95% probabilities. Sacrificial segment width was calculated with Bwedge using the “strong” set of fracture properties.

Bench footprints can be calculated for a variety of face angles (and other parameters) and the results used to obtain an optimal overall slope angle. This tradeoff is illustrated for this case in figures 9 and 10. The absence of an inflection point in these curves shows that a vertical bench face is optimal, at least for the wedge bench crest failure mechanism.

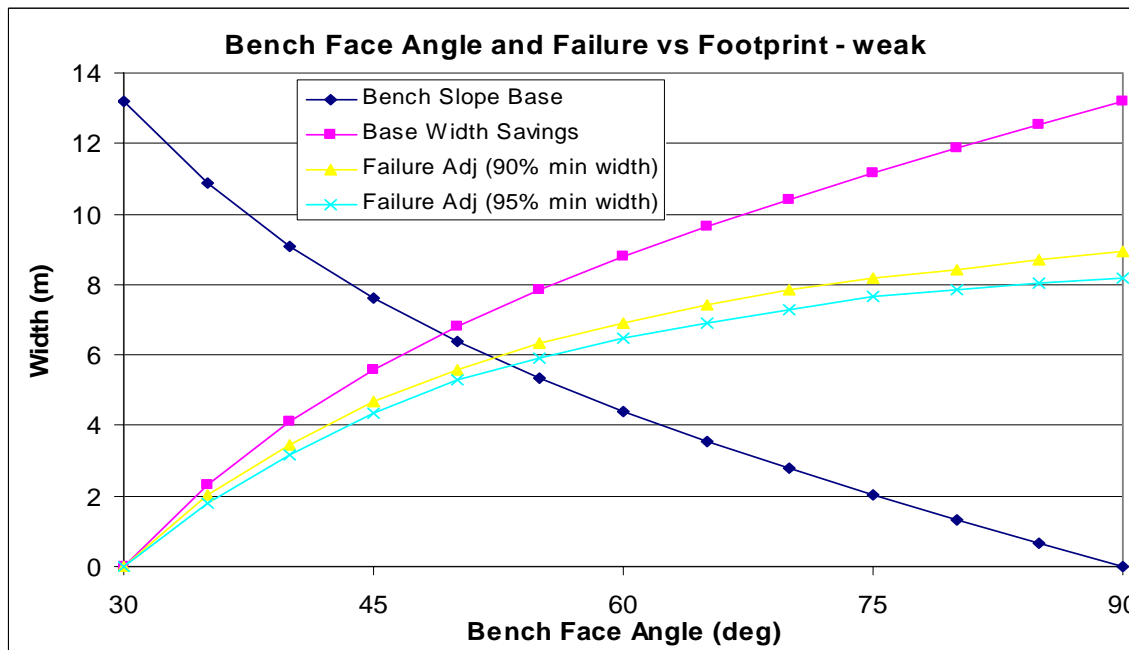
Figure 10: Plot of figure 9 recalculated for the “weak” set of fracture properties.

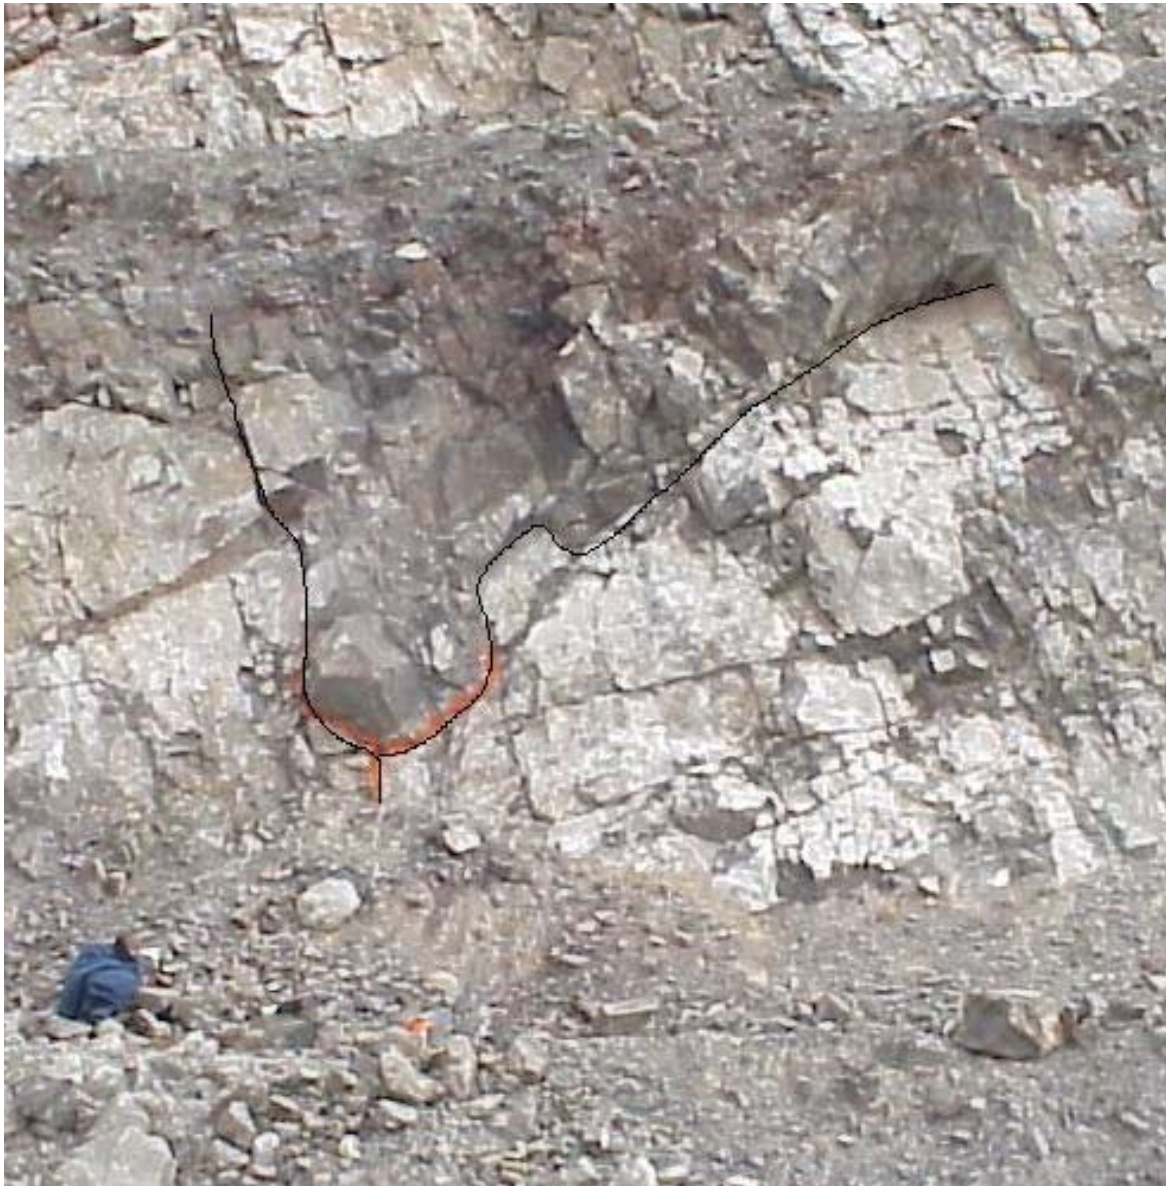
Wedge 1:

- Joint striking 132° , dips 53° , 6.1m (20 ft) long, cemented caliche infill up to 13 mm ($\frac{1}{2}$ inch) thick - broken in places and intact in others, waviness 26 cm (14 inches) amplitude over a 3 m (10 ft) wavelength.
- Foliation fracture striking 15° , dips 72° , 3.7 m (12 ft) long, infill broken, planar.
- Apex of partially failed wedge daylight 4.3 m (14 ft) from crest (photo below). (Note: 4.3 m (14 ft) depth of apex is longer than the foliation fracture, because of rubble on top of the wedge. The actual fracture length was likely longer than 3.7 m (12 ft) before blasting.)

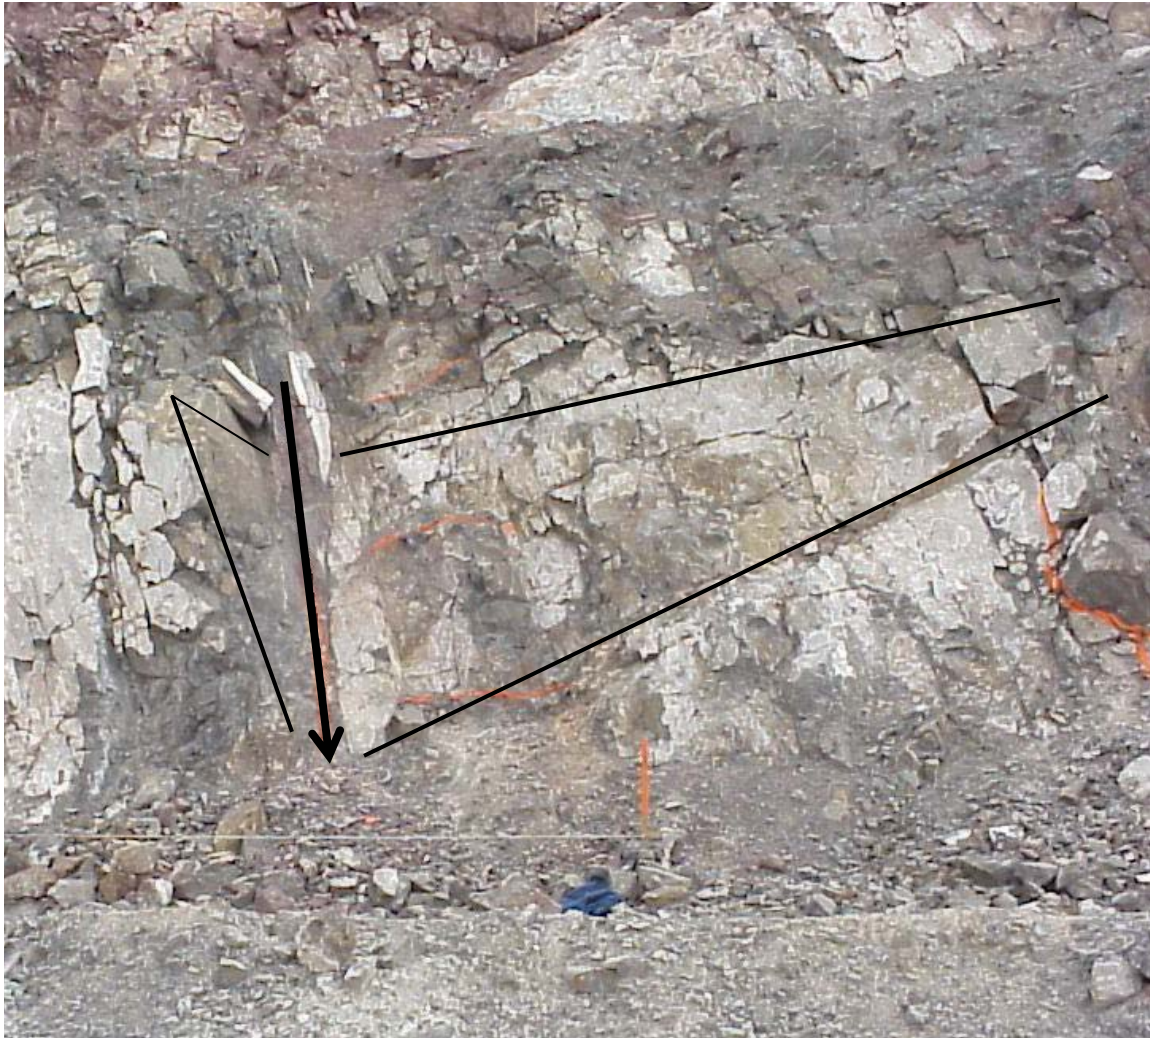
Wedge 2:

- Joint striking 113° , dips 51° , 6.1 m (20 ft) long, cemented caliche infill with steps, waviness 2 cm ($\frac{3}{4}$ inch) amplitude over a 15 cm (6 inch) wavelength.
- Foliation fracture striking 20° , dips 70° , 6.1 m (20 ft) long, open fracture with caliche infill.
- Failed wedge apex daylight 6.1 m (20 ft) from crest (photo below). Arrow traces apex of steeply dipping wedge and lines illustrate sliding planes. Bench crest is near the top of the picture.
