# Characteristics of Mining-Induced Seismicity Associated with Roof Falls and Roof Caving Events

**ABSTRACT:** The National Institute for Occupational Safety and Health (NIOSH) evaluated microseismic activity from three field sites to compare and contrast the characteristics of microseismic emissions from very different geologic, stress, and mining environments. Recently, NIOSH has embarked on a research program to evaluate the use of microseismic monitoring information to identify roof fall failure processes and to assess its potential to warn of unstable roof conditions. Large roof instabilities, such as roof falls and certain roof caving events, have proven difficult to anticipate representing an increased risk to miners working in these inherently hazardous areas. When local failure processes are better understood, appropriate control measures can be engineered to mitigate these hazards. This study used microseismic emissions to help identify three local rock failure processes. It was also shown that analysis of microseismic emissions can aid in assessing the degree of instability associated with these local rock failure processes.

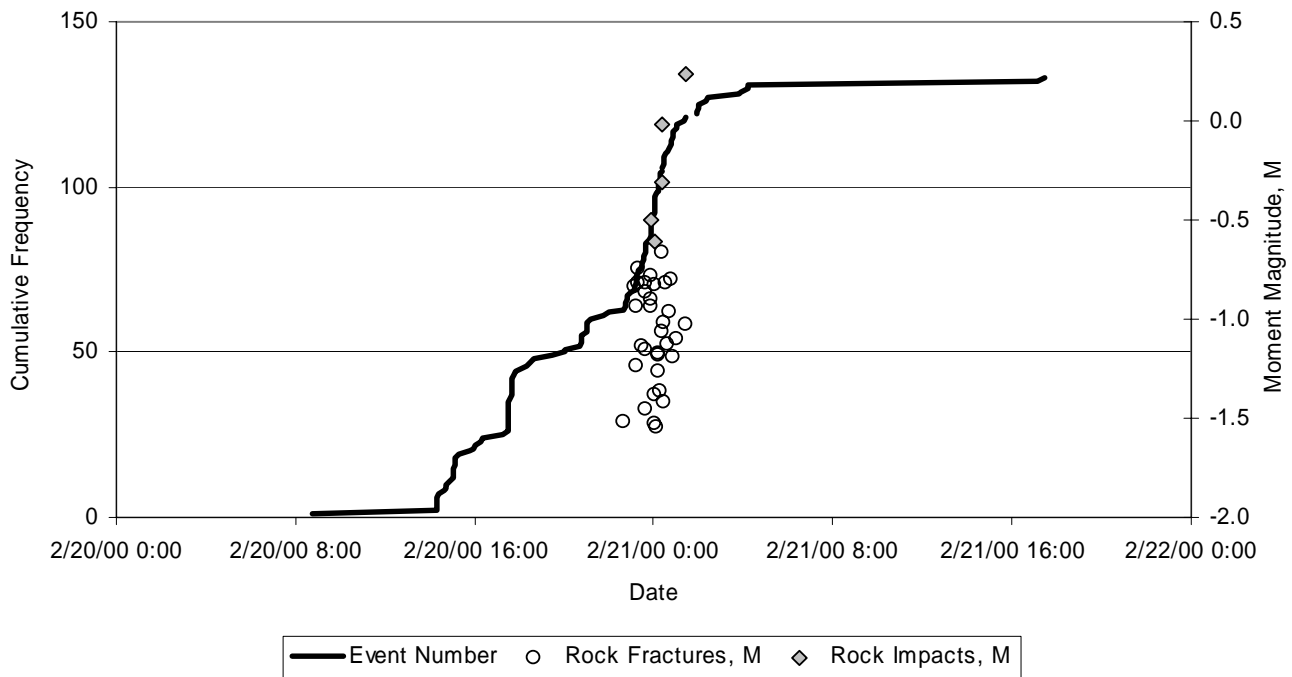
Fig. 1. A plot of the cumulative frequency of the 136 rock fracture events and five rock impact events associated with the February 21, 2000, roof fall at the Springfield Pike Quarry. Moment magnitudes were also calculated and displayed for 32 of the 136 rock fracture and for all five rock impact events.

Five rock impact events and 136 rock fracture events were recorded at this site (Figure 1). Almost all of the rock fracture events occurred over a

The moment magnitude ( $M$ ) of 32 rock fracture and five rock impact events with the lowest location error measurements are shown in Figure 1. The moment magnitude of the rock fracture events ranged from -1.5 to -0.7, averaging -1.1. The

moment magnitude of the rock impact events ranged from -0.6 to 0.2, averaging -0.2. The last rock impact event at 1:24 a.m. on Feb. 21 was the largest ( $M = 0.2$ ) and most likely represented the biggest mass of falling rock. The magnitude of the event was probably lessened when debris buildup from the previous impacts partially absorbed the energy transfer [3].

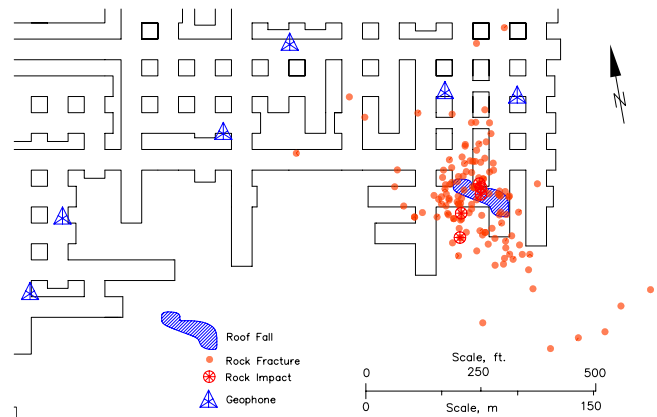
Fig. 2. Location of the 136 rock fracture events, five rock impact events, five geophones, and the February 21, 2000, roof fall at the Springfield Pike Quarry.

14-hour period from 2:17 p.m. February 20 until 4:15 a.m. February 21. The five rock impact events occurred over a 94-minute period and ended with a final major event at 1:24 a.m. on February 21. The locations of the geophones, rock fractures, rock impacts, and roof falls are shown in Figure 2.

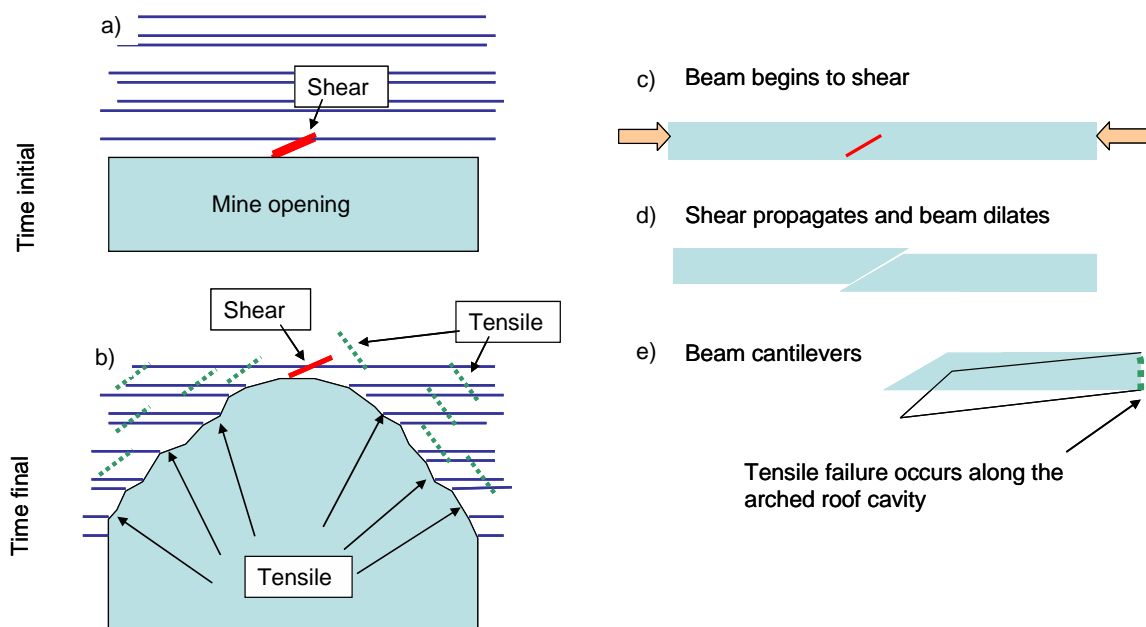
Fig. 3. Generalized sequence in which individual roof beams fail and develop into large roof falls under elevated horizontal stress conditions.

The rock failure process in bedded formations with excessive levels of horizontal stress is initiated when the stiffest and thinnest beds in the roof strata begin to buckle from the horizontal loading [1]. When these layers buckle (Figure 3a), shear and tensile rupture between layers and low-angle shears through the intact rock layers can occur (Figure 3b). Eventually the beam begins to cantilever, initiating a tensile failure along the fixed contact area at the edge of the roof fall (Figure 3c). From this point forward, reductions in super- and sub-adjacent layers lower confinement, resulting in additional low-angle shear failures. One-by-one the individual roof beams are strained to failure, shedding their load to adjacent layers which are also strained to failure. The rock failure process is progressive in nature and reduces when the shape of the roof cavity assumes the more stable arch shape. The roof cavity shape is defined by the sub-vertical tensile failures (Figure 3d). Rock failure can be reinitiated at the axial ends of these roof fall cavities

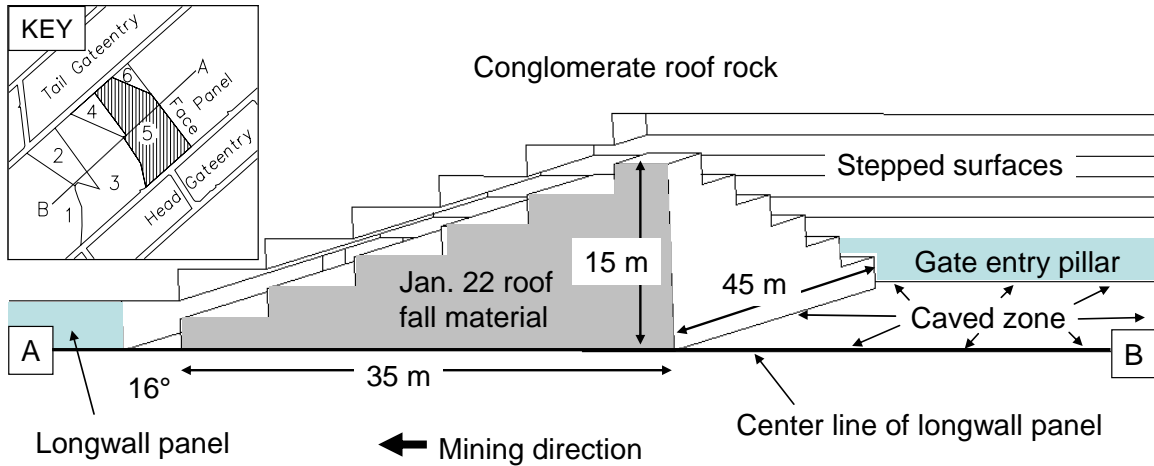
Fig. 4. Generalized sketch of the Jan. 22 roof fall (Fall No. 5), longwall panel No.1, Moonee Mine.

panel roof fall event [9]. This roof fall produced a fallen material geometry similar to half a cone with stepped surfaces (Figure 4). The top of the roof fall failure surface arched approximately  $16^\circ$  over the panel from the longwall face and the two gate entries, reaching a maximum thickness of 15 m in the center of the panel, 35 m from the longwall face (Figure 4). The top of the roof fall cavity was made up of both horizontal and vertical planes that formed a step-like surface. The horizontal planes were most likely associated with local bedding structures within the conglomerate, while the vertical planes were associated with the local jointing, spaced a few meters apart [10]. Above the fallen material, the conglomerate strata continued to bridge across the panel, leaving a 2- to 3-m high air gap. The back side of the fall, facing the previous caved rocks, was approximately parallel to the longwall face but arched toward the longwall face [10]. Edwards [8] and Mills and Jeffrey [10] have indicated that the general pattern described above was typical of longwall panel No.1's roof fall.

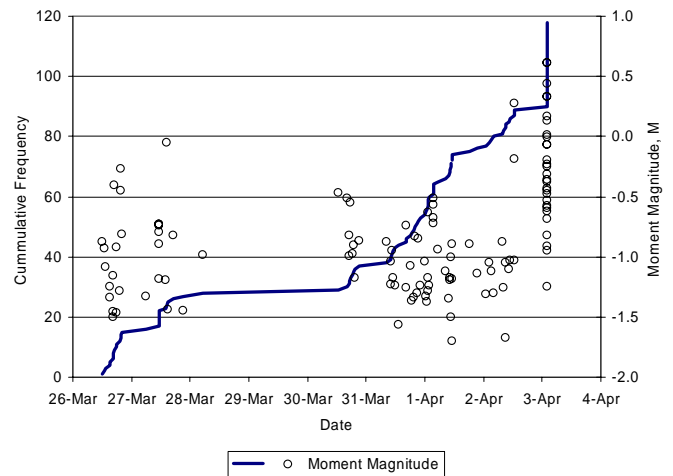
Fig. 5. A plot of the cumulative frequency of the 118 rock fracture events associated with the period between Roof Fall No. 20 and 21 at the Moonee Colliery. Moment magnitudes were also calculated and displayed for all 118 rock fracture events.

example, there were 118 rock fracture events (Figure 5) in the eight-day period that occurred after roof fall No. 20 and prior to roof fall No. 21. Approximately 70% of these seismic events occurred during the last three days of advance. In this case, there was only a weak correlation between advance rate and seismicity. It seems reasonable to ascribe this seismicity to the stepped fracture surface developing in the overlying conglomerate that would soon outline the fallen material for roof fall No. 21 (Figure 6).

cluster of rock fracture events occurred along a northwest-southeast trending dyke 150 m from the longwall face. These events may be associated with fracturing surrounding this stiff intact dyke. The moment magnitude of 118 rock fracture events, shown in Figure 5, ranged from -1.7 to 0.6 and averaged -0.9. Three rock fracture events with moment magnitudes between 0.3 and 0.6 occurred approximately three minutes prior to roof fall No. 21.

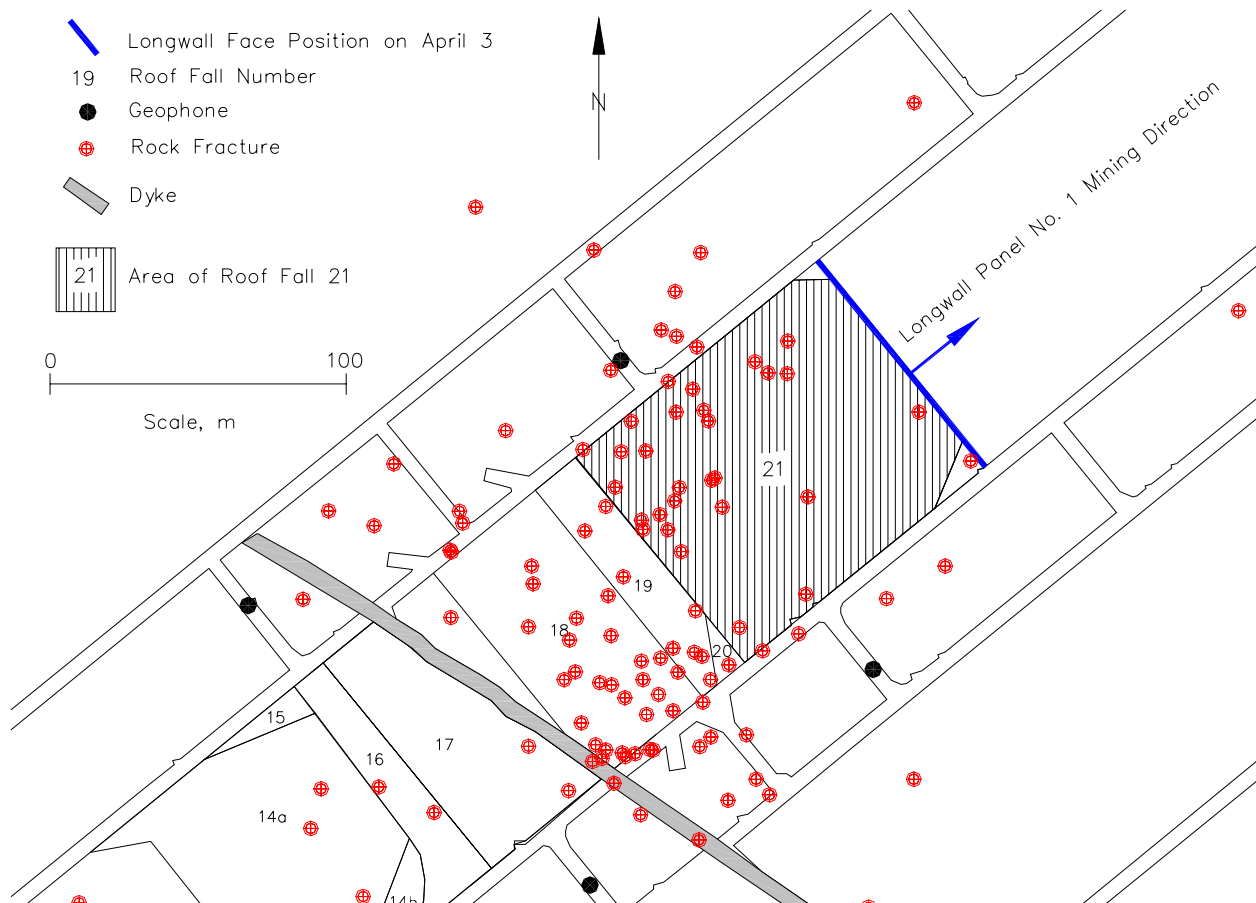
Fig. 6. Location of the 118 rock fracture events, geophones, roof falls, longwall face, and dyke at the Moonee Colliery.

By April 3, the hanging roof extended 97 m encompassing a  $9,830 \text{ m}^2$  area (Figure 6). The average rock fracture event occurred approximately 16 m above the extraction horizon. Also, a small

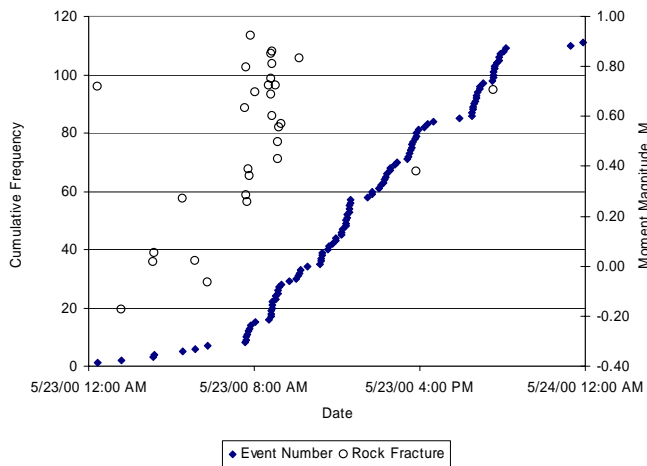
Fig. 7. A plot of the cumulative frequency of the 111 rock fracture events associated with longwall mining on May 23, 2000, at the Willow Creek Mine. Moment magnitudes were also calculated and displayed for 30 of the 111 rock fracture events.

The moment magnitudes of 30 selected rock fracture events are also shown in Figure 7. This subset of the May 23 events was selected because of their low location value residuals. The moment magnitudes of the rock fracture events ranged from -0.2 to 0.9 with an average of 0.5.

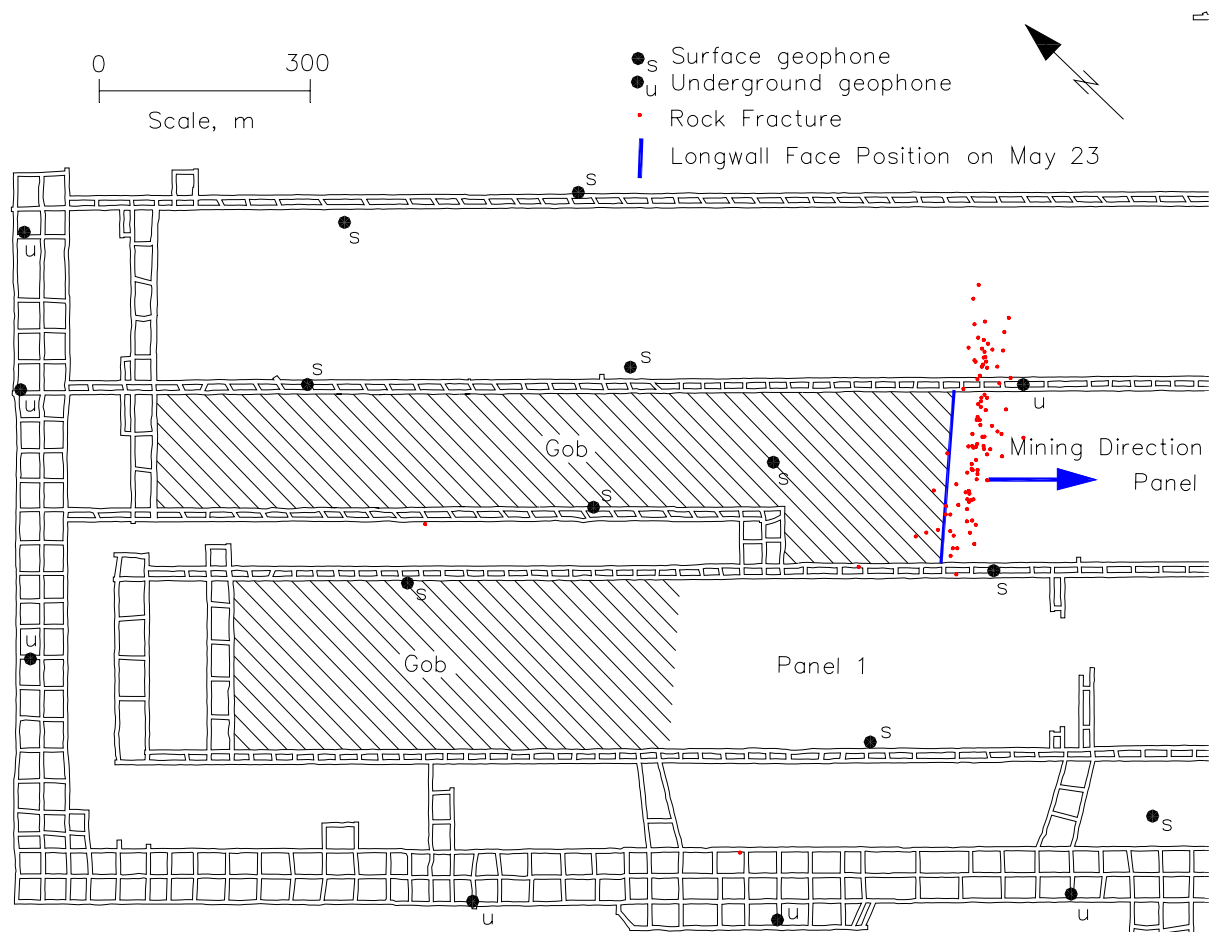
Figure 8. - Location of 111 rock fracture events, geophones, longwall caving zone (gob), and longwall face at the Willow Creek Mine.

The location of 111 rock fracturing events from May 23, 2000, cluster along the longwall face area (Figure 8). There is a noticeable concentration near the headgate entries. Additionally, the events occur both above and below the mining horizon. In examining the data for the entire longwall panel, Heasley et al. [13] found that the events generally occurred in advance of the longwall face, distributed both above and below the mining horizon.

This is most likely an issue of event detection sensitivity. A minimum of eight stations with high-quality arrivals were required to satisfy the criterion for locating events plotted in Figure 8. Average source to receiver distance was 1.1 km. Thus, smaller events which did not satisfy this condition were not detected. Numerical modeling studies by Gale et al. [14] support the notion that events representing incremental fracture in the frontal abutment zone should be larger than events in the gob zone. In the two-dimensional models, fracturing behind the longwall shield was generally not associated with microseismic activity because of low stress drop conditions, a corresponding lack of shear fracturing, and poor transmission of elastic energy through the broken rock mass.
