# Case Studies of Cable Bolts Using Instrumented King Wires

## ABSTRACT

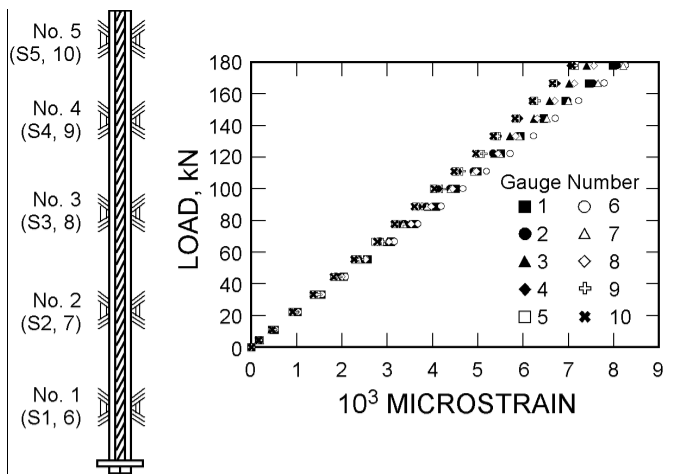
Figure 1.—Calibrated curve for instrumented king wire cable bolt.

The instrumented king wire cable bolt has 12.5-mm-long strain gauges embedded in the king wire at positions defined by the mine operator. Presently, 10 gauges can be installed along a resin-grouted bolt up to 5 m long or a cement-grouted bolt up to 7 m long. These constraints are largely due to current manufacturing processes and not to limits on the system. The gauges can either be set in pairs to detect shear load in the same plane or the flat stock can be set at 90° angles to detect loads in three directions. The cables are capable of sustaining an ultimate load of 251 kN and can produce reliable readings to 179 kN, as shown by the calibration curve in figure 1.

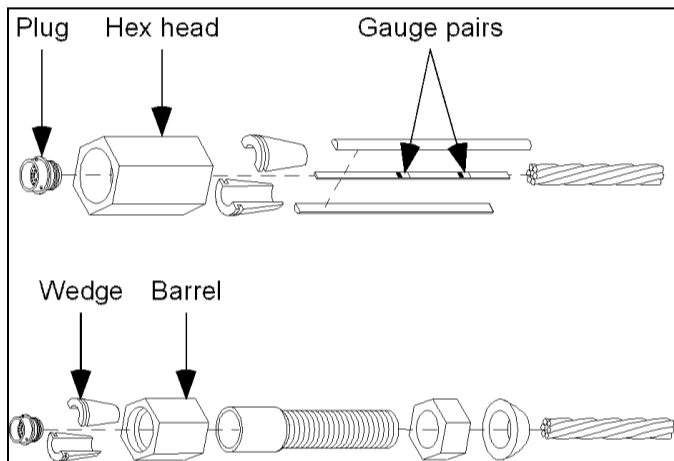
Figure 2.—Instrumented cable bolt assembly with and without pretension head.

To create an instrumented king wire cable bolt, strain gauges are first installed on both sides of an 8- by 2.4-mm metal strip at various user-specified positions on the bolt (figure 2). The individual strain gauges are connected to an instrument plug by 30-awg wire. This apparatus is then placed in a steel mold and injected the total specified length of the bolt with a two-part epoxy. This new king wire measures 8.3 mm in diameter.

The original cable is uncoiled strand by strand, the original center wire is replaced by the new epoxy-filled king wire, and the outer six strands are rewound around it, resulting in an instrumented cable bolt. The gauge wires protruding from the center are then inserted into a 12-pin connector. This connector is recessed into a 4.4-cm hex head attached to the cable by means of a barrel-and-wedge assembly (figure 2).

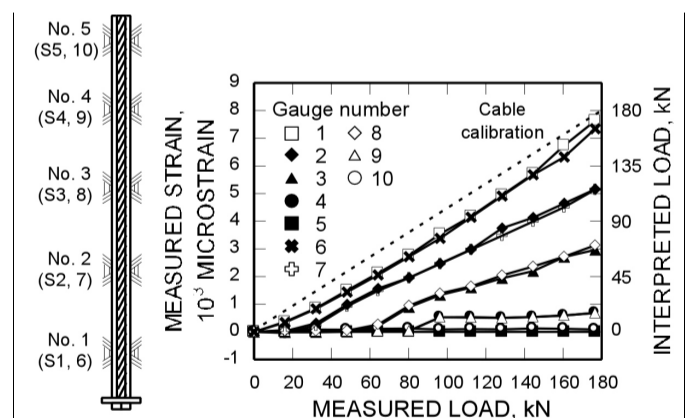
Figure 3.—Calculated load and strain on grouted cable bolt with instrumented king wire.

Laboratory tests were conducted on instrumented king wire cable bolts embedded in concrete blocks to obtain calibration curves for converting microstrain to load in kilonewtons. Pull tests were also conducted to determine the load-carrying characteristics of the bolts. The strain gauges were mounted 0.15, 0.35, 0.61, 0.91 and 1.22 m from the head of the bolt (figure 1). The cables were loaded to 179 kN using hydraulic pull test equipment. A strain-to-load curve is shown in figure 3 and is typical of what Goris et al. (1994) observed in pull tests with conventional cable bolts.

These tests aid in explaining how load on cable bolts is transferred from the cable to the grout and then into the rock mass. A “shelling” effect is shown whereby the grout-cable interface breaks down and the gauge becomes unbonded as load is increased and is taken fully by the cable. Figure 3 shows results of the pull tests as a load profile along the cable length. The curve shows that a 128-kN (~12.8-tonne) pull load on the collar of the cable resulted in measured strain loads of 123 kN along gauges 1 and 6 at a distance of 0.15 m from the collar. Researchers interpreted this measurement (5 kN) as the amount of load the cable was not sensing 0.15 m from the collar. At 1.22 m from the collar, the cable did not sense any load, which indicates critical bond length. Other researchers (e.g., Goris et al. 1994). have reported critical bond length to be approximately 1 m for standard cable. This load capability enables an operator to measure failure in real time as debonding of the grout-cable interface is initiated. In addition, the difference between cable load and applied load indicates grout quality, which can be a better field test of the quality of cable bolt installations than field pull tests.

- Bolt 4 shows a load shelling profile similar to that shown in the laboratory (see figure 3). The greatest load was recorded 3.1 m above the back by gauges 3 and 8. The ungrouted length (2.8 m) shows a low load primarily because load was distributed over a large distance, as discussed previously. It must be noted that loads were lower on the gauges on either side of the bolt at 3.1 m, implying that a crack was close by.

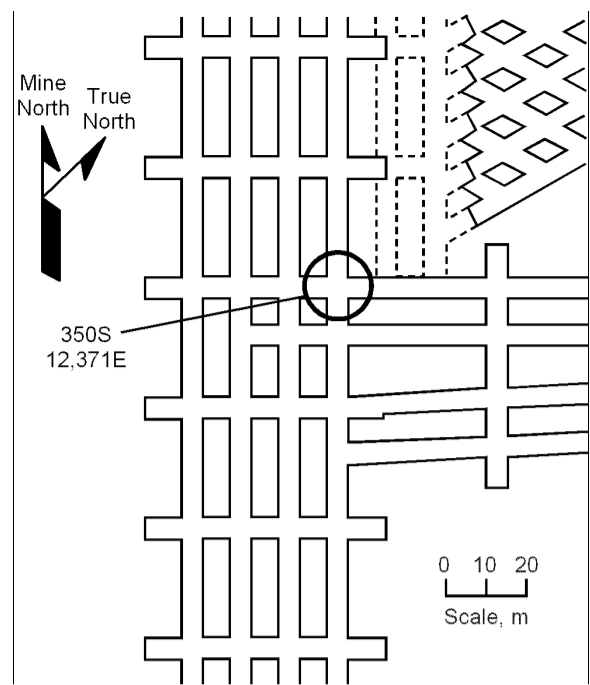
Figure 4.—Instrument locations in trona mine.

Cable bolts were installed in the roof of FMC Granger’s trona mine, a room-and-pillar operation in Wyoming, to measure roof loads in the intersection of 350S and 12371E (figures 4 and 5). This location was chosen because of drill access ahead of the mining cycle and because loads would be induced in the cable bolts as ore was extracted toward the intersection. Mine personnel were interested in determining the potential for instability in the back and the extent of any unwedged blocks.

Loads on the cable bolts were measured from April 29 through July 11, 1999. Mining activities influencing the intersection were progressing from northeast of the site to the south (figure 4). On June 9, mining reached a point one pillar width from the intersection (8 m). Figure 7 shows all load profiles measured by the 4.27-m-long bolts (bolts 1, 2, 4, and 5) and the 3.66-m-long bolts (bolts 6, 8, 9, and 11). Approximately the last 1.5 m of the bolt was bonded with resin grout. What follows is the authors' interpretation of loads on

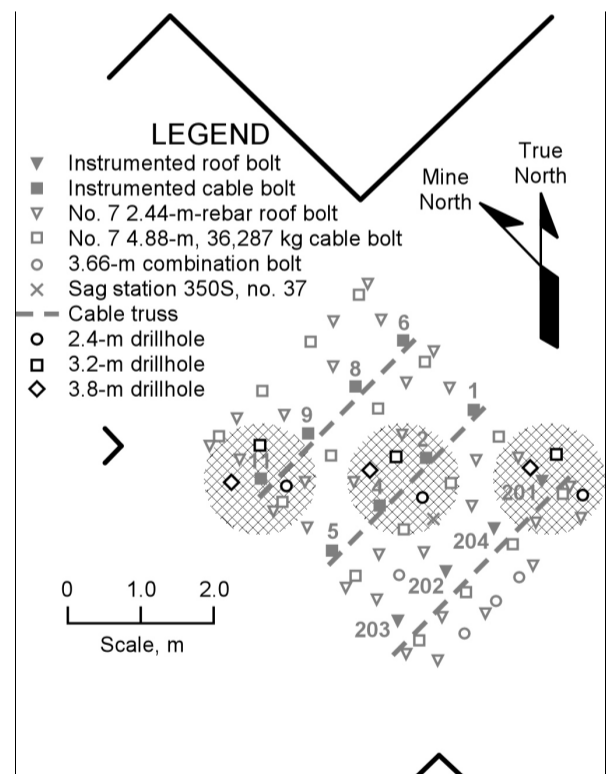
Figure 5.—Bolt and sagmeter locations.

three locations in the intersection (figure 5), and holes were drilled to depths of 2.4, 3.2 and 3.8 m. These sagmeter depths were chosen to correspond with the bolt gauge profiles (figure 6), allowing correlations to be made between deformation recorded by the strain gauges to deformation recorded by the sagmeter stations. This is important because slip expected to occur between the cable-grout-rock interface can be compared to actual rock deformation.

Three sagmeter stations were installed at three different depths (2.4, 3.2, and 3.8 m) at the intersection of 350S and 12,371E (figure 5). Figure 8 shows that sagmeters at the three stations generated similar curves with displacements ranging from 0.5 to 2.0 cm. In general, the most centrally located station had the greatest displacements at all three depths. Generally, the north-northwest and south-southwest

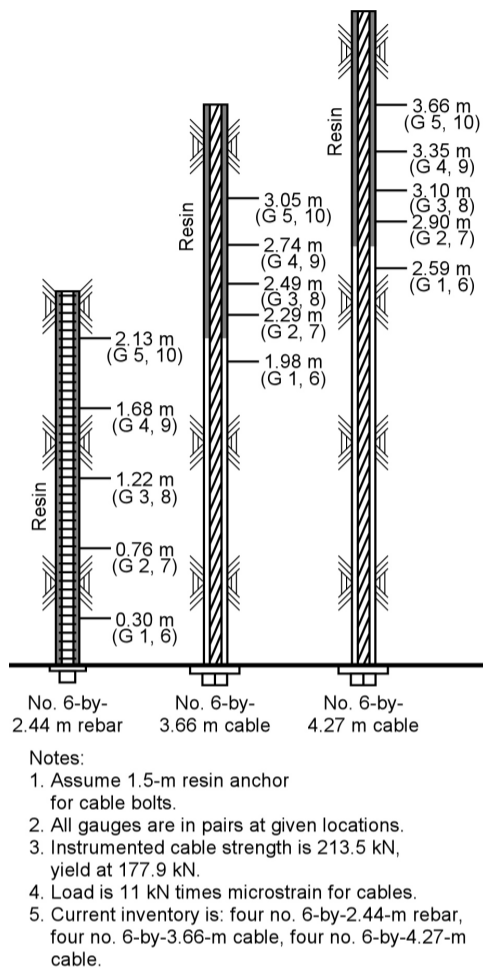
Figure 6.—Positions of strain gauges on bolts (note two at each position).

in the rock mass. Figure 6 shows the position of the strain gauges with respect to the collar. The longest cable bolts were installed at the center of the intersection because these bolts would receive the greatest loads, while shorter cable bolts were installed north of the intersection closer to the pillar front. Resin-grouted rebar bolts were placed in the south part of the intersection to measure loads where the density of rebar bolts was highest. Sagmeter stations were set at

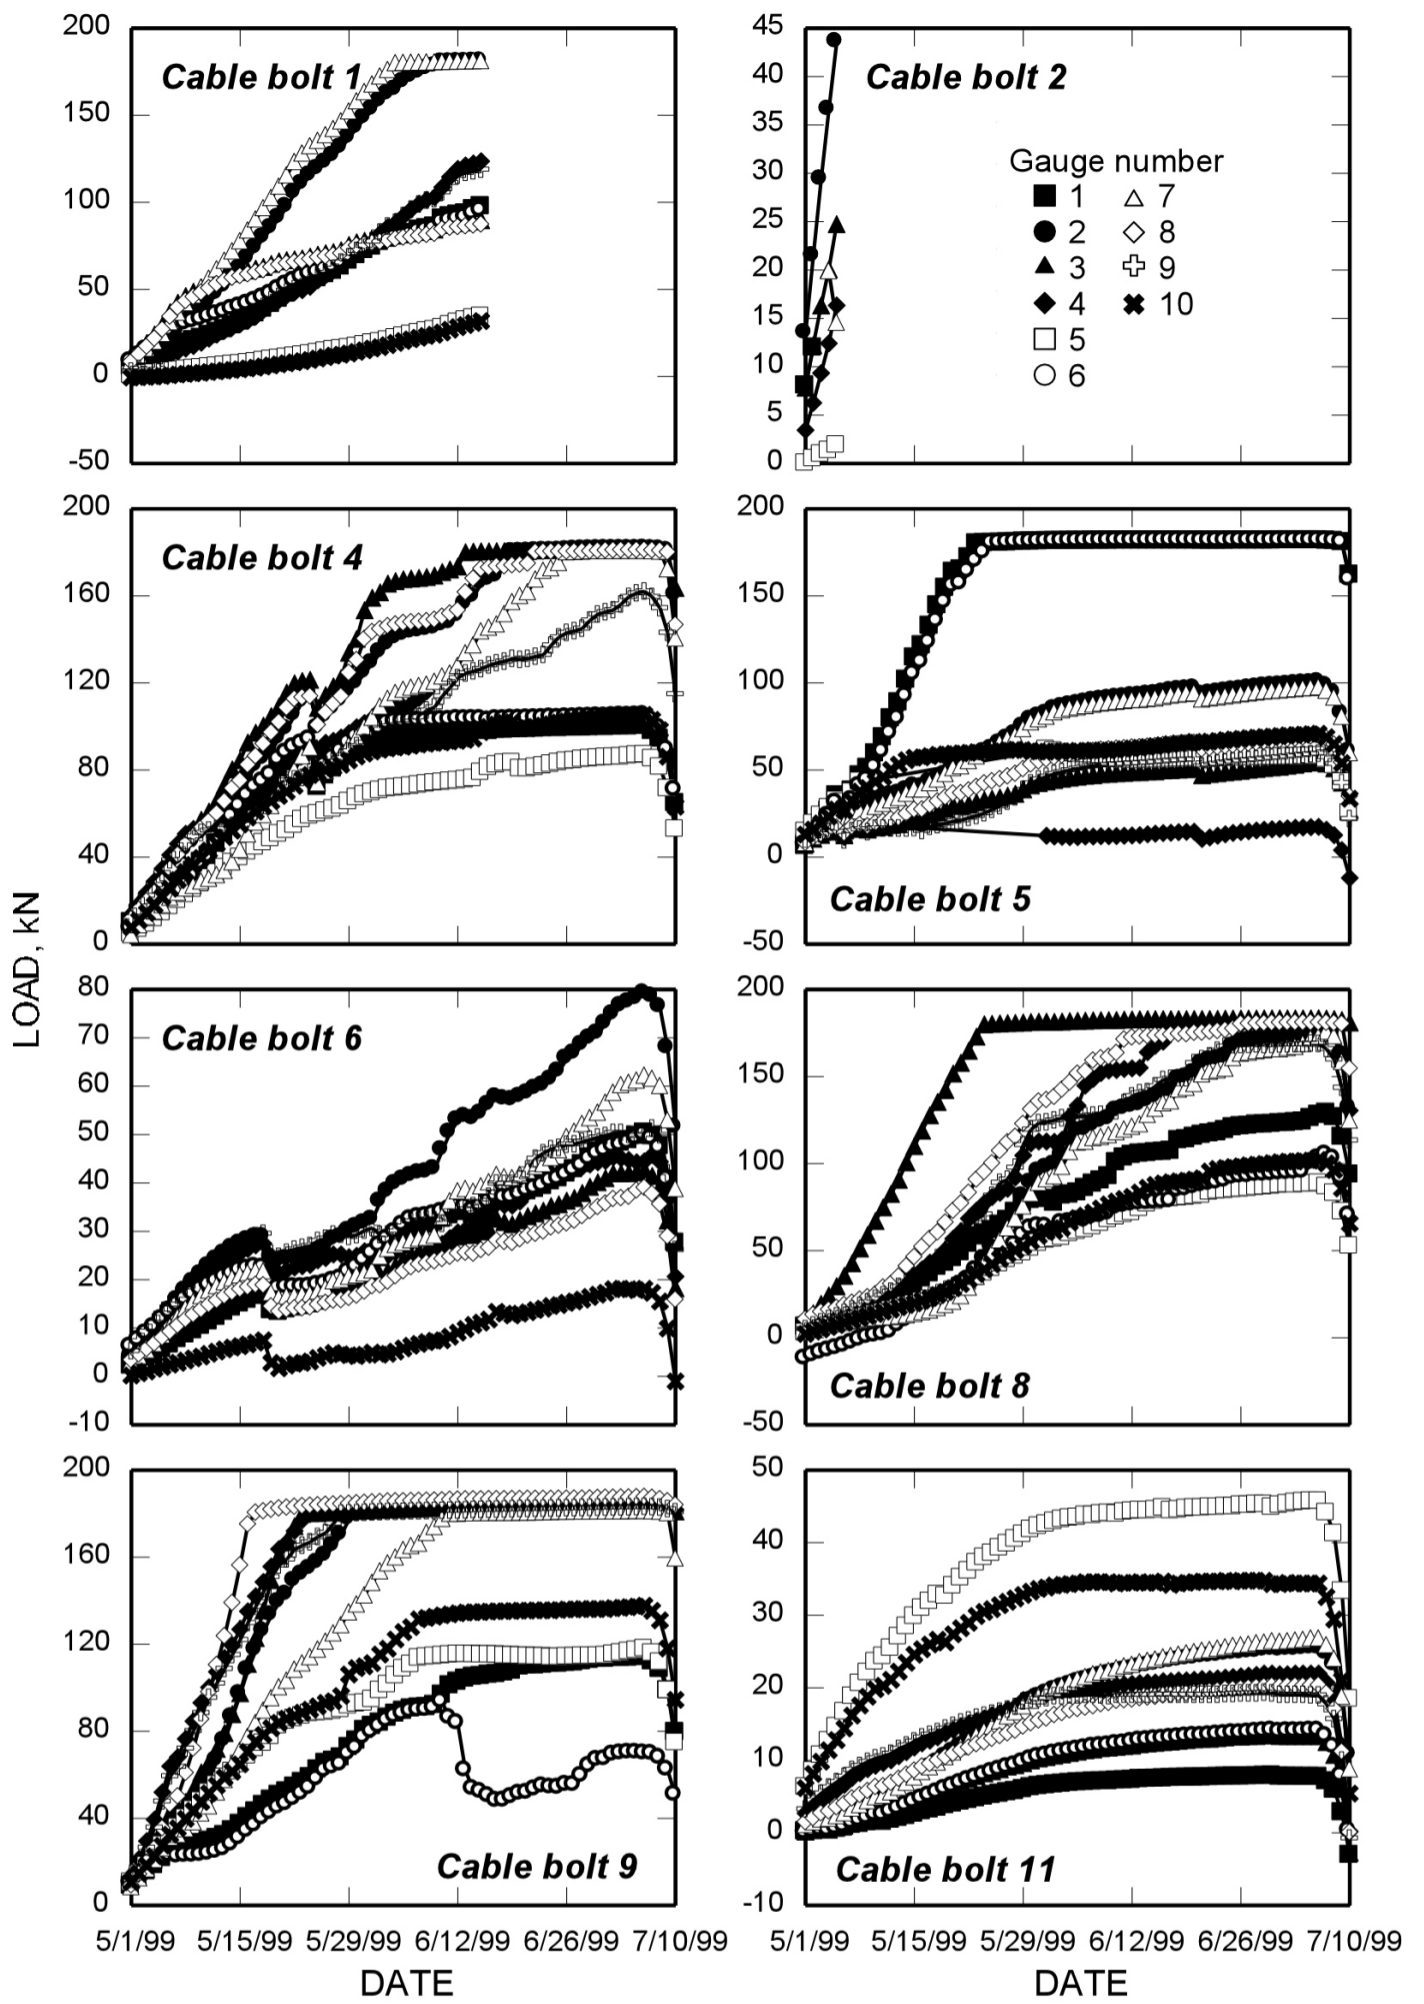
Figure 7.—Load profile versus time on 4.27-m-long bolts (1, 2, 4, and 5) and 3.66-m-long bolts (6, 8, 9, and 11).

- Gauges 2 and 7 on bolt 1 were indicating loads up to the yield limit of the steel. These loads were higher than the axial dead weight loads on the ungrouted section of the bolt and loads on the grouted gauges, indicating that some delamination was occurring close to the gauge. The higher readings were most likely a result of the fact that concentrated load is measured over the gauge length by a strain gauge, whereas an ungrouted gauge measures the sum of all delamination cracks over the length of the ungrouted section, which was 2.8 m. The result is an average load much lower than that of a bonded cable over a given distance.

- Bolt 5 shows the classic load shelling profile. The highest load was recorded in the ungrouted section within 2.8 m of the back. The next highest load was at the bonded gauge 2.9 m from the back. Readings again indicate that delamination was largely controlled by cracks within 3 m of the back.

- Loads on bolt 6 were uniform, with an average of 40 kN, excepting for gauges 2 and 10, which were located 2.3 m above the back. This implies that delamination may have been occurring at this location. Note that this bolt was close to the pillar boundary and therefore the depth of cracking would be less.

- Gauge sets 2 and 7 (2.3 m deep), 3 and 8 (2.5 m deep), and 4 and 9 (2.7 m deep) on bolts 8 and 9 showed a load profile approaching, and in most cases reaching, the yield strength of the bolt. This reading indicates that delamination was occurring throughout the horizon or that rock mass loading was higher. These two bolts were placed in the north-center section of the site, which experienced high loads such

as those on bolt 4, which had also been placed in the center of the intersection. The deepest gauges (5 and 10) at 3.1 m in the back recorded low values, indicating that the bond at depths between 2.7 and 3.1 m was sufficient to absorb most of the load.

- Bolt 11 was located at a pillar boundary and therefore was receiving more support from the mine rock, resulting in less delamination. Therefore, loads were lower. Representative load curves for the 3.1-m-deep gauge resulted in the greatest amount of load. The second set of gauges, at 2.3 m deep, showed the next highest load, and the first set of gauges, at 2.59 m deep, had the lowest loads. Delamination was, however, occurring, albeit at low loads, approximately 3 m above the back.

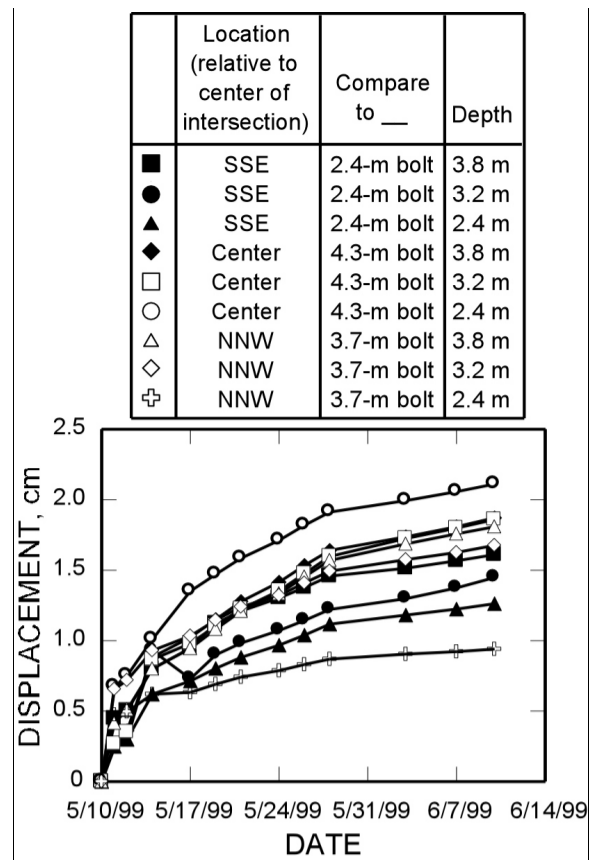
Figure 8.—Displacement of back over time.

sagmeter stations, which were near the boundary pillars, showed the least amount of deformation. Delamination was observed throughout all horizons with the largest amount of movement between 2.4 and 3.8 m of the back. This roof movement corresponded with data collected from the strain gauges, showing that delamination was generally 3 m above the back. Sagmeter readings from the 3.2-m-deep hole at the center of the intersection would be comparable to readings from a 4.3-m-long cable bolt with 1.5 m of resin embedment. This would mean 2.8 m of unbonded cable length.

Hook's law as applied to a cable with a steel modulus (E) equaling  $2.3 \times 10^{11}$  N/m<sup>2</sup> and a cable area of 0.00011 m<sup>2</sup> would yield an elongation of 2 cm over 2.8 m. The calculated force would be approximately about 180 kN. This force correlates with data from the cable bolt for the unbonded section of bolt 5, gauges 1 and 6 (figure 7), and bolt 4, gauges 2 and 7. Based on this information, it is likely that the resin bond was destroyed as a result of loading.

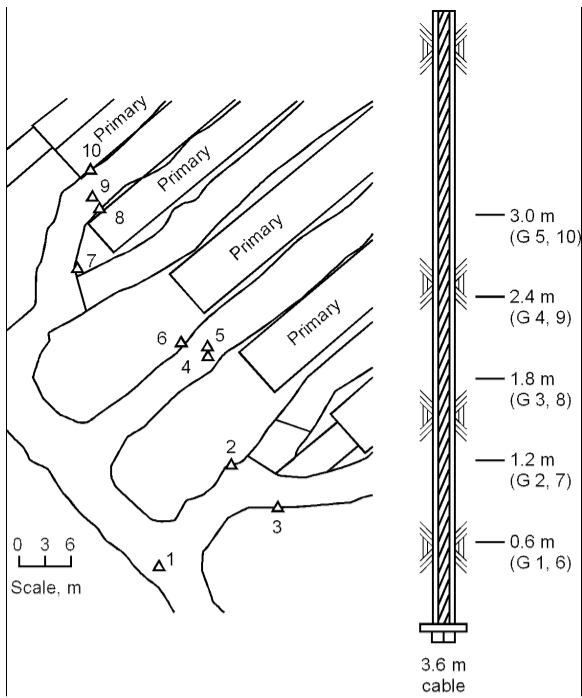
Figure 9.—Plan view of 4950 stope showing locations and depths of strain gauges.

Ten 3.6-m-long instrumented cable bolts were installed at the Getchell Mine, which is a transverse, open-stopping operation in Nevada. Gauges were spaced 0.6 m apart at five positions on the cable bolt. A tensionable head was placed on the bolt (figure 9), and the bolts were grouted with a cement-based grout into the back and ribs at the locations shown in figure 9. The bolts were then tensioned 10 kN on the cables and bearing plates. The instruments were placed after the primary cuts had been backfilled and the secondary drifts to the ore were about to be mined. This enabled analysis of the effects of secondary and tertiary mining effects.

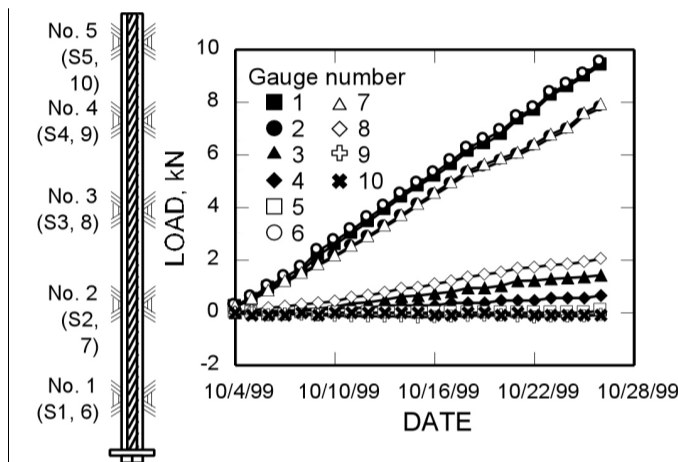
Figure 10.—Load on bolt 4 at Getchell Mine.

Preliminary data indicate that bolt 4 in the stope is showing a load higher than 10 kN (figure 10) while

the rest of the bolts are not showing any significant loading (under 1 kN). Loading on bolt 4 suggests that a crack is most likely developing between gauges 1 and 6 (0.6 m deep) and gauges 2 and 7 (1.2 m deep). A borescope survey was conducted as part of this study and located a crack 0.9 m above the back. Based on a 1.2- by 1.2-m bolting pattern and a depth of 0.9 m (specific gravity = 2.6), a dead load of 38 kN is likely. Measurements and interpretations of the strain data were reinforced by subsequent visual observations intended to provide a higher level of safety for the operator. This area of the mine was reinforced.

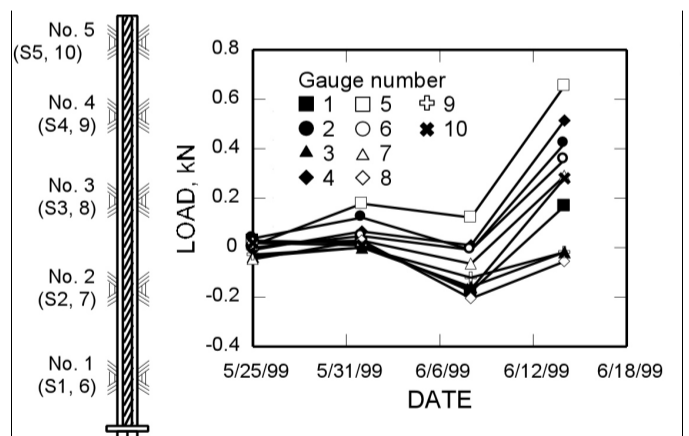
Figure 11.—Load on bolt 14 at K-2 Mine.

The cable bolt was placed into the mine back directly above the sublevel open stope. Preliminary data show low loads on all gauges along the bolt (figure 11). The cable is approaching yield at gauge 5 (3 m deep), and delamination appears to be occurring close to 3 m above the back. The immediate back exhibits minor loading (gauge 1 at 0.6 m deep). The area where the cable bolt is installed is inaccessible since the open stope has yet to be backfilled. There is no concern for personnel because the stope below is nonentry.
