# DESIGN CONSIDERATIONS FOR THE NEXT GENERATION OF LONGWALL SHIELDS

**Thomas M. Barczak**  
National Institute for Occupational  
Safety and Health  
Pittsburgh Research Laboratory

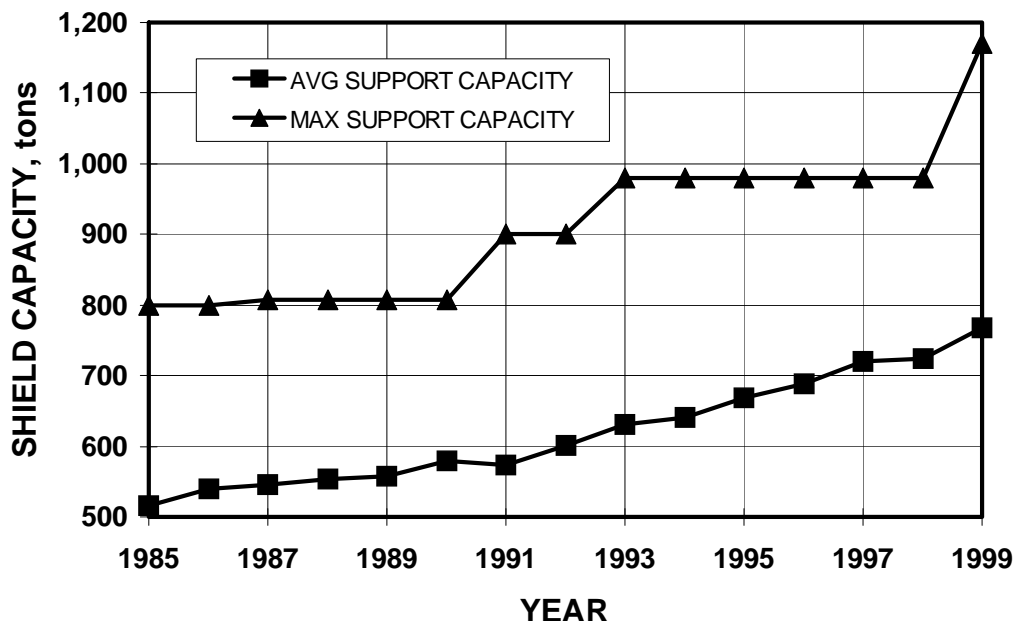
Figure 1 Trend showing increase in support capacity

**Capacity** – Support capacity has continued to increase throughout the history of longwall mining. This trend for the past 15 years is shown in figure 1 (Coal Age, 1999). Average support capacities in the United States have increased by nearly 50 pct since 1985 to an average support capacity at yield of 768 tons for the 62 operating longwalls in the U.S. in 1999. Twelve installations (19 pct) of the current longwalls employ shields with capacities greater than 900 tons, and 19 installations (50 pct) have capacities between 700 and 900 tons. The current distribution of shield capacities is shown in figure 2. The highest capacity shield used in the United States is 1,170 tons (Coal Age, 1999). As shown in figure 1, maximum shield capacities have evolved from 800-ton shields which were common from 1985 to 1990 to the current 1,200-ton shields 1999.

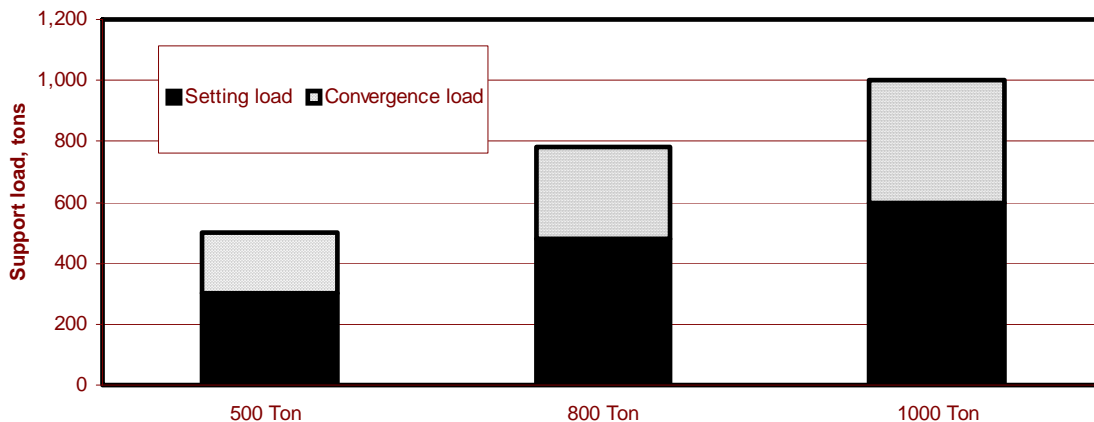
**Figure 3 Setting load and load developed due to roof movement for shields of various capacity**

The increase in capacity has significantly impacted shield design and ground control capability. In order to provide the increased support capacity, larger diameter leg cylinders had to be utilized. One consequence of the larger diameter leg cylinders has been a proportional increase in shield stiffness. The increase in shield stiffness means that the load developed in the support structure will occur at less displacement or face convergence. While the increased stiffness may provide superior control of the immediate roof, main roof weighting that causes irresistible (in terms of the shield capacity) convergence on the longwall face will result in greater shield loading with the stiffer shield design. As a result, it is not uncommon for the high capacity shields to be fully loaded to yield capacity just as often as lower capacity designs that they replaced. An example is illustrated in figure 3 where a 500, 800, and 1,000-ton shield are all fully loaded when 0.5 inches of convergence occurs.

***Setting Forces*** – Setting forces have increased in proportion to the increase in yield capacity because the size (diameter) of the leg cylinders has increased to accommodate the higher yield capacities, while the hydraulic setting pressures have remained constant in the 4,000 to 4,200 psi range. This design practice coupled with the increased stiffness of the higher capacity supports means that the higher capacity shields are fully loaded as often as their lower capacity predecessors (figure 3).

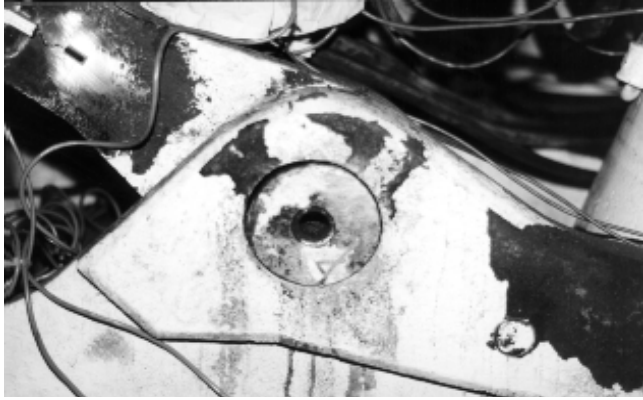
**Figure 6 Reduction in lemniscate pin contact area for worn joint**

Link pins and clevises are a prime example of historically poor design practices in shield supports which continue even today. Deformation and/or excessive wear in the pin clevises are undoubtedly the primary cause of premature shield retirement and/or structural rebuild. There are clear indications that these areas are subjected to stress beyond the yield strength of the steel. This poor design is caused partly by manufacturers not giving sufficient credence to the load conditions which cause high loading in the caving shield - lemniscate assembly, namely loss of frictional contact at the roof and floor interface and standing the support on the toe of the base. With the possible exception of shields designed for low seam heights, there is adequate space available to increase the bearing area of these clevises and pin diameters to reduce the stress and substantially improve the life expectancy of these components. The joint design problem also needs to recognize the importance of pin tolerance. First, the pin contacts only a portion of the clevis. Typically, arcs of 45 to 60° are used in the design analysis. Obviously, the 45° arc assumption will lead to more conservative designs. Conservative assumptions should be made to allow for reduced areas as wear occurs (figure 6). Corrosion effects are also often ignored or not sufficiently accounted for in the design of pins, despite the fact that corrosion is a leading cause of premature pin failures or abnormal wear. Corrosion causes pits to occur in both the pins and the clevises (figure 7) which can reduce the bearing area by 25 to 50 pct and cause a proportional increase in stress.

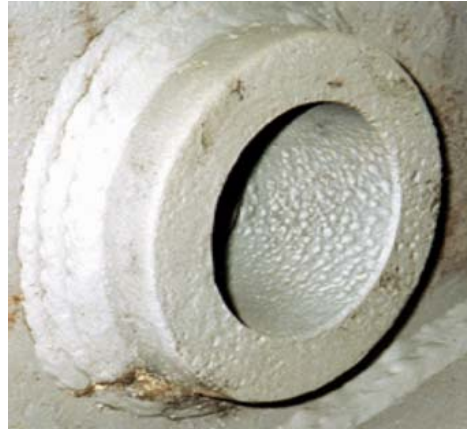
**Figure 7 Corrosion of a lemniscate link clevis**

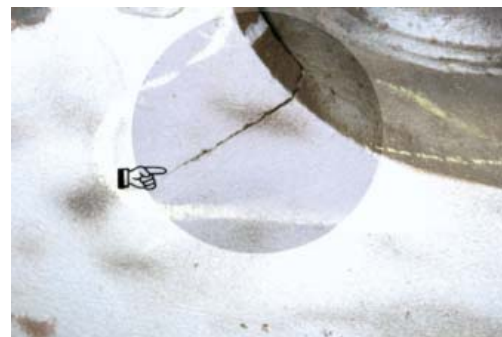
**Figure 9 Failure of base rib side plate where fabrication process left large flaws**

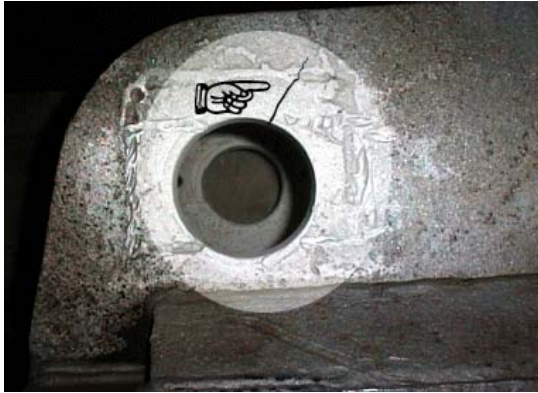
**Figure 10. Failure in base lemniscate link clevis**

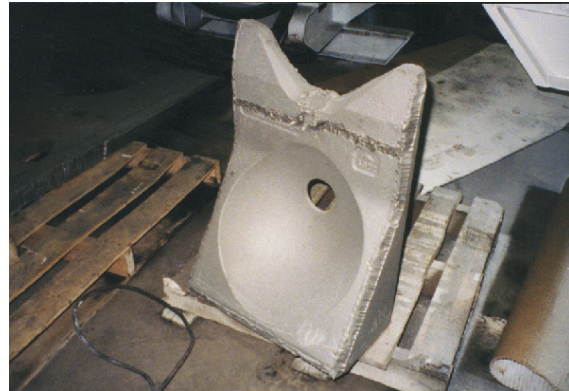
**Fig. 14** “Zipper-shaped” leg cylinder casting to avoid stress concentration caused by orientation of casting to principal stress field

The rectangular geometry of the socket casting and its placement between the side rib plates of the base structure position it at right angles to the principal tensile stress caused by the bending of the base structure. This orientation creates a stress intensity factor which helps to promote fatigue-induced fracturing of the weldment. Some shields are now being designed with more of an elliptical or zipper-shaped casting (figure 14) so that the front and/or rear edge is not perpendicular to the principal tensile stress, thereby resulting in a reduction of the stress intensity factor.

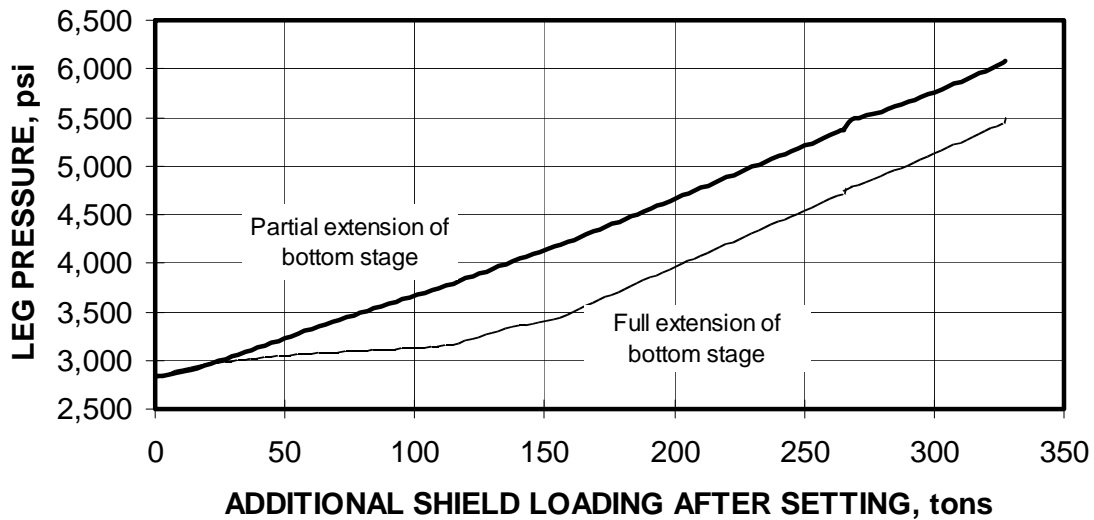
**Figure 16. Difference in hydraulic pressure measurements when bottom is fully or partially extended**

Observations of the relative positions of the cylinder staging can be used to identify cylinder problems and the cause of hydraulic leakages. One indication of internal leakages is when the bottom stage is consistently fully extended. The bottom stage should be fully extended only on operating cycles which establish a new maximum operating height. Hence, on the majority of operating cycles, the bottom stage should not be at full extension. Full extension of the bottom stage can be determined by analysis of the leg pressure data following the setting operation. When the bottom stage is fully extended, there will be a period of nearly zero increase in leg pressure until the top stage is sufficiently pressurized to offset the stress developed in the cylinder casing by the setting pressure in the bottom stage (figure 16) (AISC, 1980).

This information can also be used to track the percentage of time that the shield is set with reduced setting pressure due to full extension of the bottom stage. When this occurs, load development following the setting load should be monitored and analyzed to see if the reduced setting load results in higher levels of loading following the setting action.
