# Damage Delineation in Structures Using Laser Vibrometry And Remote Excitation

Peter Swanson<sup>1</sup> and John Rettkowski<sup>2</sup>

National Institute for Occupational Safety and Health  
Spokane Research Laboratory  
315 E. Montgomery Ave.  
Spokane, WA 99207  
USA

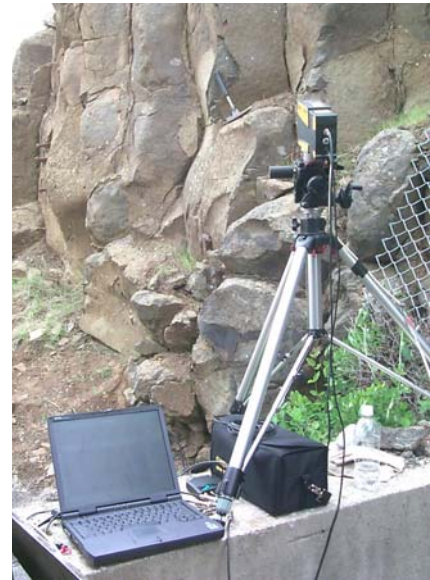
Figure 1.—Portable laser vibrometer, dynamic signal analyzer, battery pack, and data collection computer.

Vibration response was measured with a portable, battery-powered, laser Doppler vibrometer (Figure 1). The vibrometer (LDV) is an optical interferometer that measures relative motion between the LDV and target via a Doppler shift carried by the scattered return signal. The unit outputs analog and digital measures of ground velocity over a frequency range of 0 to 22 kHz with a resolution of 0.05 mm/s. Unlike automated scanning vibrometers, the portable LDV does not have a speckle tracking feature to help compensate for the poor reflective qualities of rough surfaces. Speckle tracking helps maintain high signal-to-noise ratios to reduce momentary signal dropouts [6]. To minimize the time required to collect suitable time periods of dropout-free data, each target site was given a small area of retro-reflective treatment.

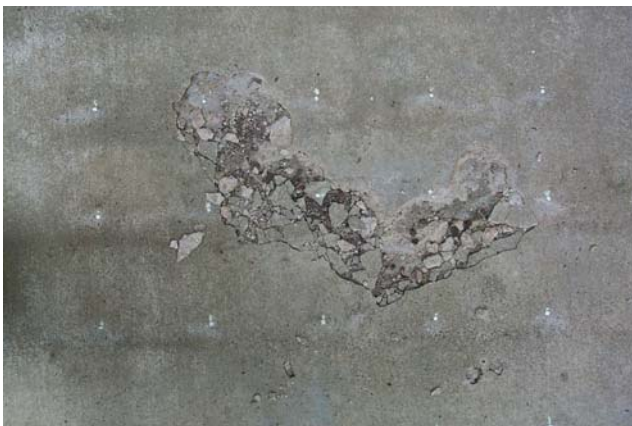
(a)

Figure 2.—(a) Concrete damage that has penetrated through to the slab's surface, exposing more-competent material (field of view is 90 cm across). (b) Near-surface damage and aggregate characteristics exposed at edge of slab (penny for scale)

had become completely detached from the bulk of the slab (Figure 2a) and exposed a deeper, more-competent, rough concrete surface. The thickness of the detached layer in the exposed area was up to one to two aggregate particle diameters. Figure 2b shows a closeup of similar damage on the edge of the slab outside the measurement array.

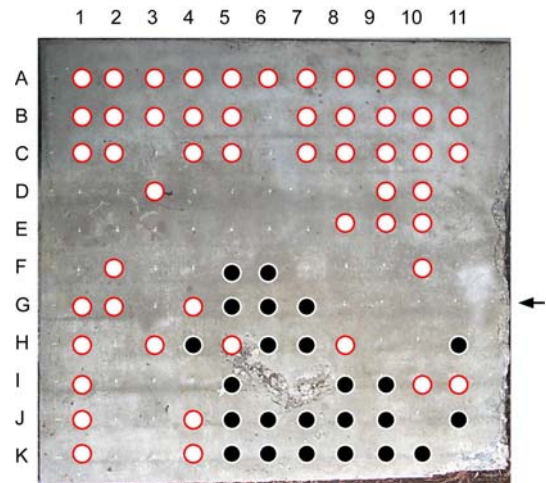
Figure 4—Manual sounding results. Competent (S) sites (white symbols), damaged/loose (L) sites (black symbols), intermediate (H) response (no symbols)

A conventional qualitative sounding test was first used to assess the spatial variation in apparent slab competence. A 1.5-m-square measurement grid was laid out with target points spaced every 0.15 m. Grid points are indicated in Figure 4 as alpha-numeric row-column pairs (e.g., F6). Each target position was repeatedly tapped with a wooden rod or other suitable object. The acoustic response was separated into three categories—S, L, and H. The S category corresponded to what was perceived as being unquestionably solid and competent. L referred to a marked low-frequency response, and H was intermediate where the response was perceived to contain relatively high frequencies in comparison to L. An H designation encompassed a surprisingly wide range in acoustic response. Such an evaluation is very qualitative and is biased by an individual’s tendency to use the most recent sounding measurements as a reference point instead of an absolute reference. S (solid) and L (loose) targets are marked in Figure 4 with white and black circles, respectively, and H (intermediate) targets are not marked.

The lowest frequency audible response (L) was observed in the vicinity of visual slab damage. However, in places where the surface layer of concrete was totally removed by the damage to expose a deeper, more-competent surface, the sounding response was more intermediate. The area of slab exhibiting predominately solid (S) response (rows A-C) was under the protective roof overhang of an adjacent building.

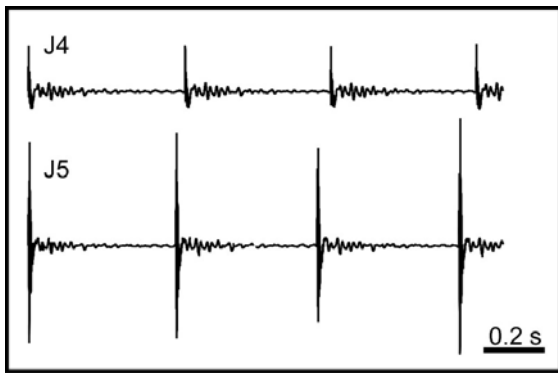
Figure 5—LDV vibration signals from hammer impacts on competent (S) and damaged (L) targets J4 and J5.

Examples of transient vibrations recorded by the LDV as a result of four sequential hammer impacts at source site A (Figure 3) are shown in Figure 5. J4 and J5 target locations were denoted as competent and damaged sites, respectively, in the manual sounding tests. The raw velocity response consists of an initial high-amplitude, high-frequency phase with abrupt first arrival followed by a decaying low-frequency phase. The effect of damage is manifested as an enhancement of the transient high-frequency response.

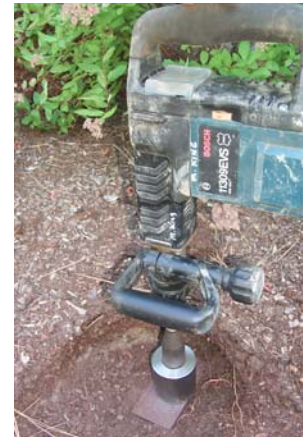
Figure 10—Demolition hammer vibration source

A 1.4-kg hammer with an integrated load cell was used as the first impact source. A 0- to 2-kHz force signal is typically generated by the hammer when equipped with a hard plastic tip. The second vibration source was a standard industrial-grade demolition hammer (5 kg) equipped with a 7.5-cm diameter flat steel bit. It was used to strike a 2.5-cm-thick steel plate at the bottom of a 25-cm hole dug into the loose soil at a distance of 4 m from the edge of the slab.

The demolition hammer source (Figure 10) was applied at source position B (Figure 3) for a duration of 5 s for each LDV target position. Raw velocity spectra from the J4 and J5 target positions are shown in Figure 11. The 43-Hz percussion frequency is clearly seen in the dominant 43.6-Hz spectral peak along with its associated harmonics. Notable elevation in velocity response over the frequency range of 200 to 2000 Hz was observed at J5 and other damaged target sites in comparison to competent targets such as J4.
