ERGONOMIC INTERVENTIONS AT UNIMIN

W. Porter, NIOSH, Pittsburgh, PA
A. Mayton, NIOSH, Pittsburgh, PA
A. O'Brien, Unimin Corp., Winchester, VA

Abstract

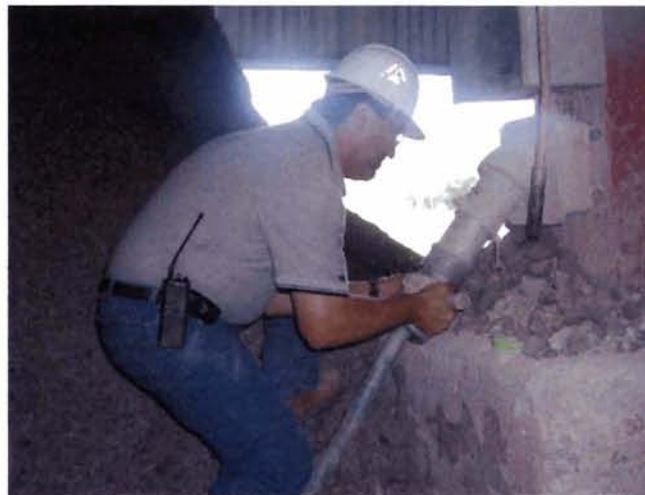
Figure 1. Mine worker demonstrates power connection.

During discussions with the employees, Gleason mine management became aware of difficulties in connecting and disconnecting the shredder

power cable (Figure 1). Issues of concern included the following:

- 1) The aluminum sleeve became bent, which made it difficult to connect and disconnect from the receptacle.
- 2) Hardened and built up clay on the connectors made it difficult to insert into the receptacle.
- 3) Dust on the aluminum sleeve made it more difficult to connect.
- 4) Awkward postures (rounded back, arm position with respect to the body, and standing on uneven ground) occurred when connecting and disconnecting the cable to the power source.

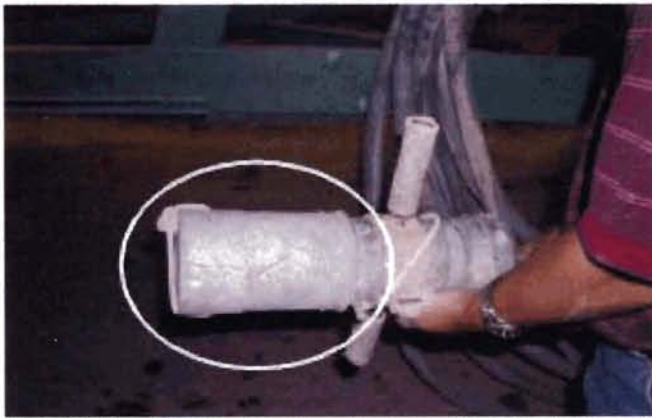
Figure 2. The rubber “boot” to protect the male cable connector from dirt, dust, and damage.

- 1) A rubber boot (Figure 2) for the aluminum sleeve was installed on the male end to prevent the sleeve from bending and to keep it clean. The rubber boot was made from a protective cover for a dust collector cartridge that the mine normally stocks.
- 2) An electric grinder was used to file burrs on the inside of the connectors to make insertion of the plug easier.
- 3) A spray lubricant, commonly known as “Super Slick,” was applied to the contacts and sleeve of the connector to reduce friction when inserting the connector into the receptacle.

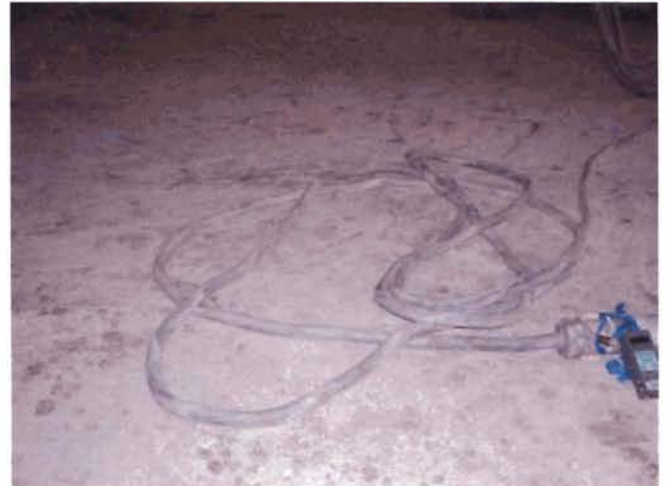
Figure 3a. Shredder cable haphazardly over-lapped.

Afterwards, the mine management team considered a low-cost and simple solution to the cable handling issue offered by an off-shift shredder operator who was listening to the conversation between the NIOSH researchers and a fellow operator. This involved a procedural change to cable handling that constituted a method of looping the cable in 10 foot lengths (as seen in Figure 3b), so that only a 10 foot length of cable is handled at a time instead of a haphazardly over-lapping bundle. NIOSH researchers determined that overlapping the cable (as seen in Figure 3a) while unwinding it, increased the force required by approximately one third (mean forces for small drag at 18.5 pound-force with no cable

overlap versus 25.5 pound-force needed when overlapped cable).

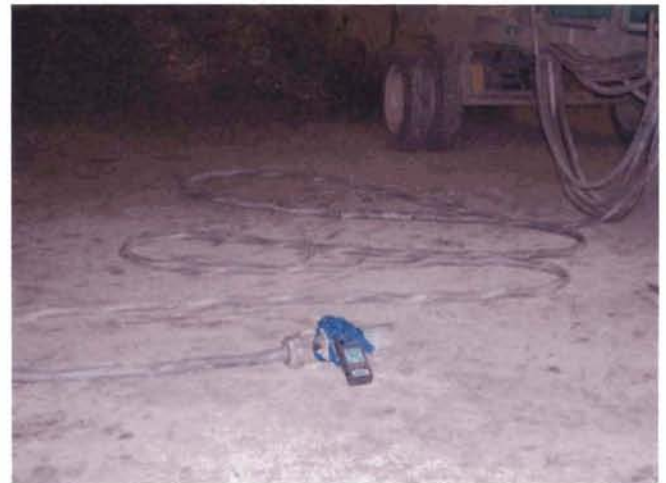
Figure 3b. Shredder cable evenly looped.

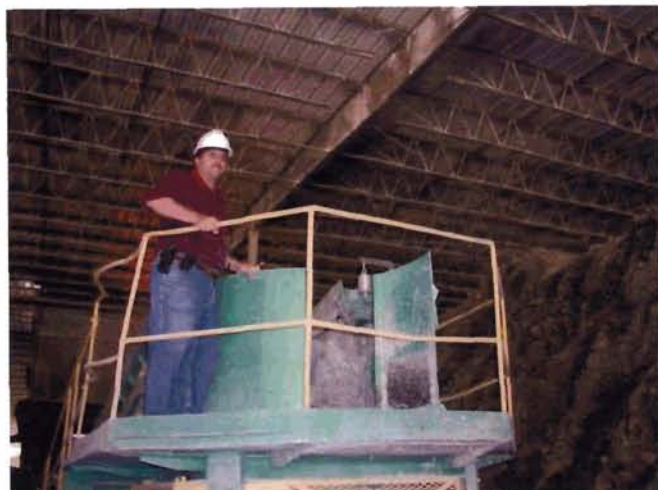
Figure 4a. Shredder tub with door installed.

A team consisting of mine management, maintenance personnel, and shredder operators conducted intensive brainstorming sessions to reach a low-cost effective solution. It resulted in cutting the tub to create a hinged door (Figures 4a and 4b). This intervention demonstrated the following benefits:

- 1) Reduced the risk factors associated with leaning over the side and climbing over the side of the tub. The worker was now able to walk into the tub to perform cleaning or maintenance duties.
- 2) Reduced the injury risk associated with lifting heavy rocks to shoulder height and above to throw them over the top of the tub side. Instead workers are able to use the door of the tub to easily slide out rocks and debris.
- 3) Allowed operators to safely carry maintenance tools into and out of the tub.

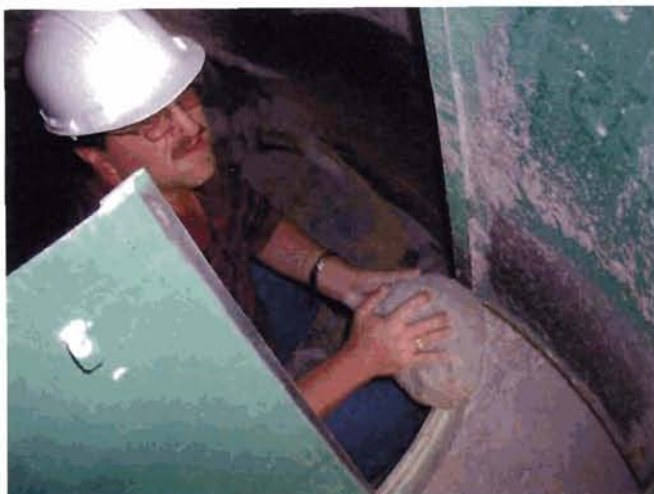
Figure 4b. Worker easily removing large rocks when using door.

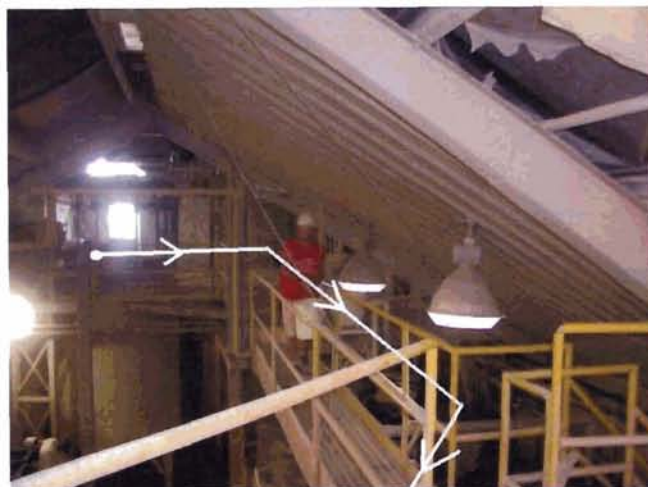
Figure 5a. Pre intervention transportation of the bucket (arrow depicts walking path).

Another task which was improved as a result of the NIOSH-Unimin collaboration was the handling of a clay additive, sodium silicate. The sodium silicate is added in 50 pound increments to the ball clay slurry up to three times a day. Originally the additive was dispensed into a bucket and then carried along a catwalk for about 50 feet (Figure 5a). This catwalk was very narrow and forced workers to carry the bucket one handed in front of or behind their body or to walk sideways.

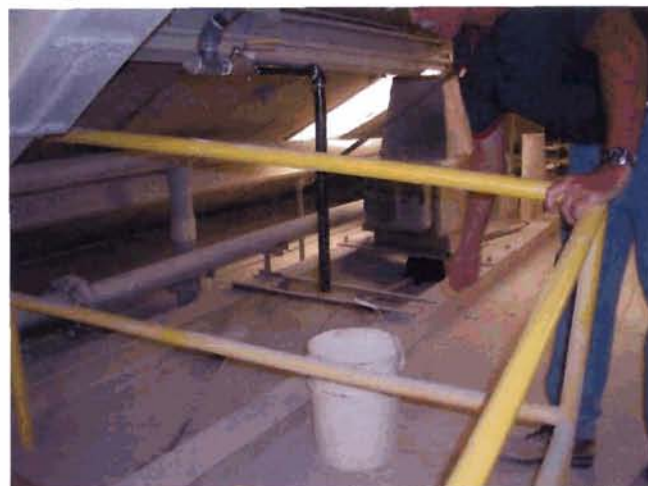
Figure 5b. Post intervention filling of the bucket (occurs at end of path way shown in Figure 5a).

NIOSH researchers recommended extending the piping for the additive over to its destination to eliminate carrying the load. As shown in Figure 5b, it would still be necessary to pour the additive into the slurry by bucket, but workers would no longer carry it 50 feet. The cost of implementing the intervention was approximately \$300. The installation was straightforward since the additive was already piped. They simply added a pump and lengthened the pipe. The employees liked the idea and quickly put it in place.
