# EVALUATION OF MINE SEALS USING GROUND PENETRATING RADAR

*NIOSH, Pittsburgh Research Laboratory*

## **Abstract**

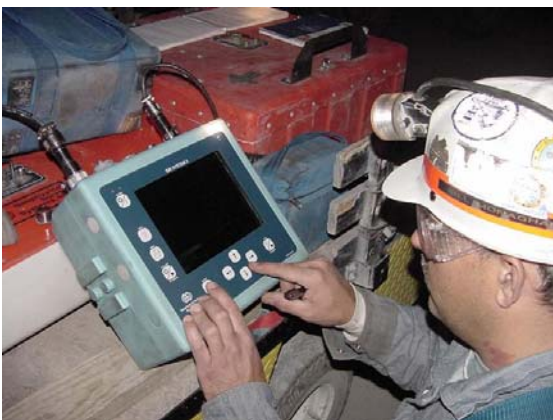
In this study, GPR was used as a non-invasive means of evaluating mine seal construction uniformity. The equipment used was a GSSI SIR<sup>®</sup> System 2 (SIR-2) Model No. DC-2 control unit built by Geophysical Survey Systems, Inc.<sup>2</sup> The SIR-2 is a lightweight, portable, general-purpose radar system and is available as an intrinsically safe unit for use in the underground coal mine environment (figure 1).

**Figure 1:** Engineer using the SIR-2 unit.

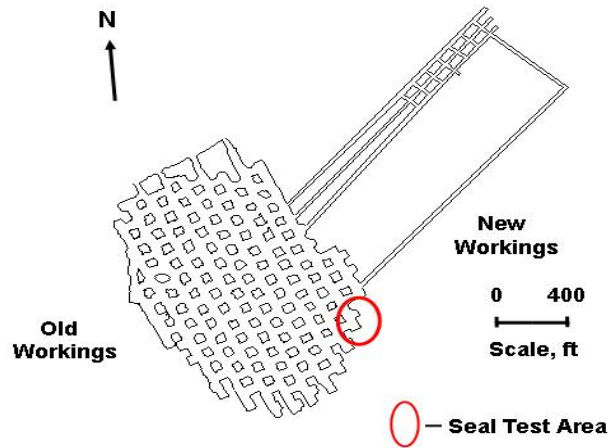
The LLEM was built at an abandoned commercial limestone quarry where underground entries 49-ft wide by 33-ft high (old workings) were developed when surface mining ceased in the late 1960's. Later, under the auspices of the U.S. Bureau of Mines, 7,545 ft of new underground development was constructed using 19.7-ft wide by 6.6-ft high entries (new workings). The new workings can be configured to simulate modern-day coal mining scenarios; including room-and-pillar and longwall mining layouts (NIOSH 1999, Triebisch, 1990) (figure 3).

**Figure 3.:** Layout of the Lake Lynn Laboratory Mine.

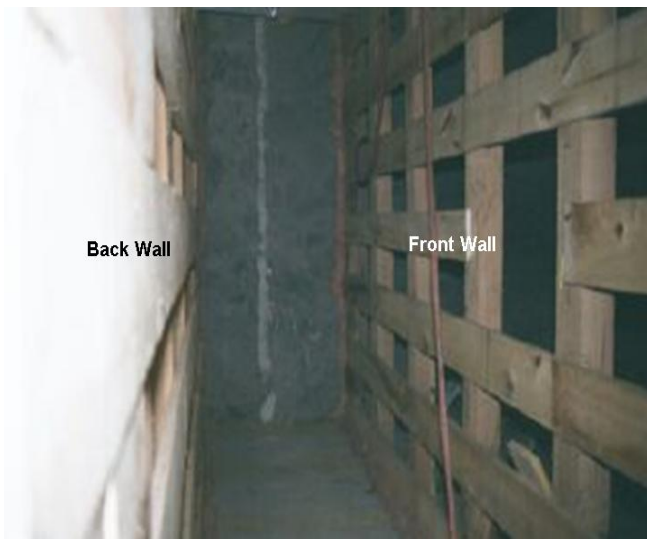
**Figure 4.:** Photo of inside of Mine Seal No. 1 showing the wooden form.

right side. Next, 8-in wide by 1-in thick boards were placed in a horizontal position and were nailed to each post (figure 4). The boards were placed at the bottom of the form and an 8-in horizontal space was left between each row of boards. This procedure was followed on the front and back walls of the form. Fiberglass insulation was then packed into any void space on the mine roof, ribs, and floor areas to minimize slurry leakage around the form. A 48.5-in space was left by design between the front and back walls of the form for the mine seal. Mine brattice cloth was placed on the inside area of the form, was overlapped on the mine roof and rib areas, and was secured with straps to form a tight seal. Eye bolts were then attached to each post through the brattice cloth and were tied together with 1/8-in galvanized steel cable that was extended between the front and back of the form (figure 5).

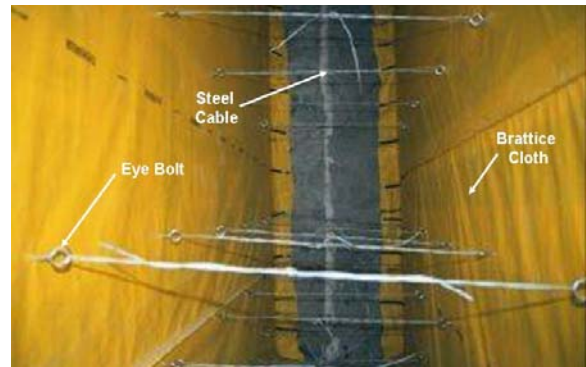
**Figure 5.:** Photo of inside of mine seal No. 1 before foamed cement was added.

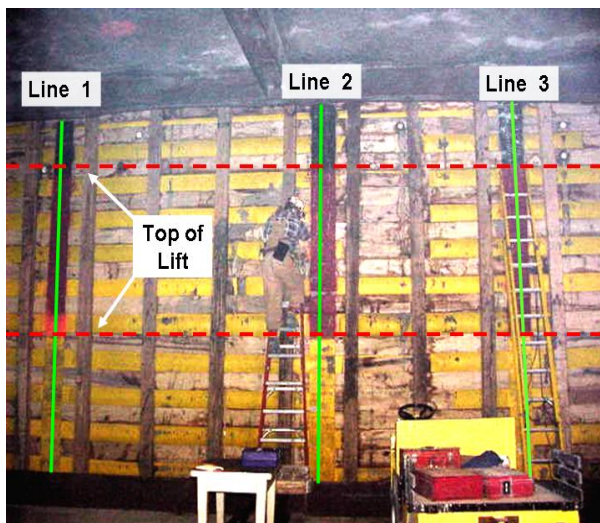
The seal material was cured for 33 days before the GPR evaluation was performed. In order to gain direct access to the face of the seal, three vertical sections were cut into the wooden form and brattice cloth. The three vertical sections were approximately 8-in wide and exposed the seal material from the mine floor to roof. Three vertical GPR survey lines were positioned along these sections shown in figure 6. The vertical sections were located at 4-ft from the left rib (line 1), about 12-ft from the right rib near the middle of the seal (line 2), and 4-ft from the right rib (line 3). Each vertical section was subdivided into one-foot segments for use as reference points during the GPR evaluation.

**Figure 6.:** Photo of mine seal No. 1 and location of GPR survey lines.

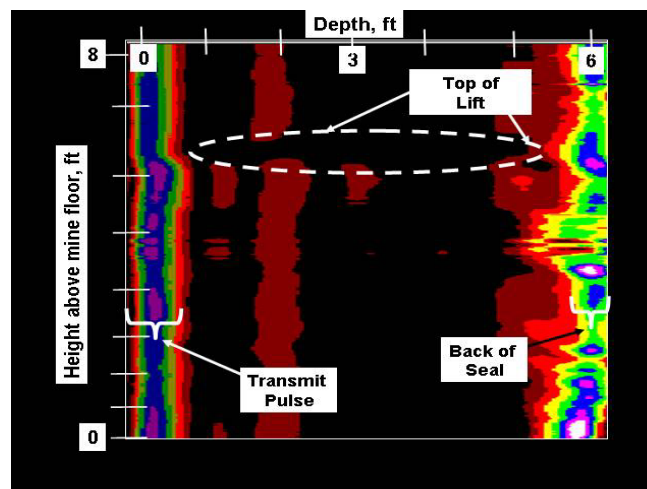
into the record corresponding to the 1-ft marks on the mine seal. In this manner, it was easy to associate any observed anomalies with the specific location on the mine seal. A representative post-processed radar record and the associated interpretations are shown in figure 7. The vertical scale in the figure represents the height above the mine floor and the horizontal scale represents depth into the seal. The reflected pulse energy is shown in terms of a color scale, with hot colors (yellow, white) being the higher level of reflected pulse energy and colder colors (brown, black) the lower levels. Areas in the record shown with similar colors should be interpreted as similar levels of reflected pulse energy. In the radar record, the top of the lift is visible along with the back of the seal. As discussed earlier, the top of a lift represents a boundary in the seal. Figure 8 shows the positions of all observed anomalies from the GPR surveys of the mine seal. As shown in figure 8, a total of 12 anomalies were observed in surveys where the 500-MHz antenna was used and four anomalies were observed in surveys where the 400-MHz antenna was used. Of the anomalies observed, 11 were located near the top of a lift and were either related to the hard surface that had formed at the top of the lift or areas where the seal components could have been mixed at different ratios. The five remaining anomalies could be related to the construction practice of the mine seal (use of eyebolts and galvanized wire).

**Figure 7.:** Interpreted radar record (Line 2) for Mine Seal No. 1 using a 400-MHz antenna.

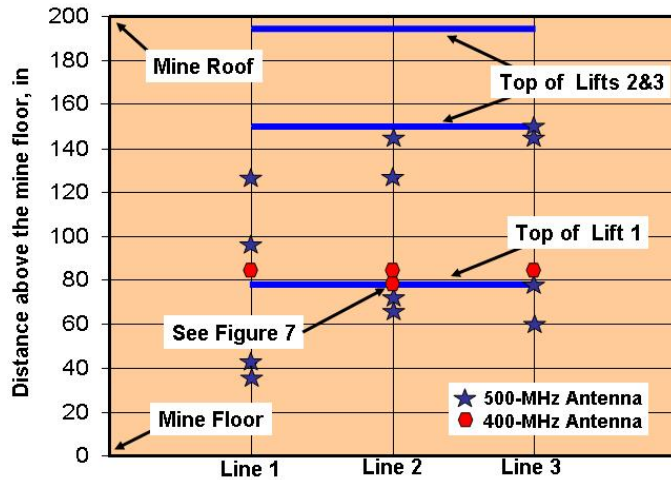
**Figure 8.:** Location of observed anomalies from radar scans of mine seal No. 1.

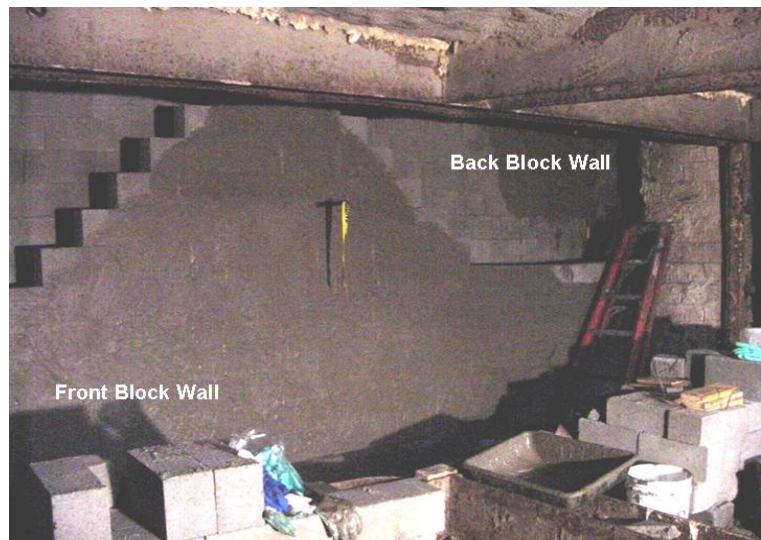
Mine seal No. 2, a solid block, polyurethane foam, and gravel seal, was erected in the small chamber in the LLEM. The seal was constructed 8-ft high by 20-ft wide and about 2.5-ft thick. The seal was not hitched into the mine roof, rib or floor areas. The seal was built using two parallel walls of solid blocks with a 17.5-in open space between the walls. The walls were constructed with dry-stacked solid blocks (each measuring 6-in by 8-in by 16-in) and was capped by 2-in by 8-in by 16-in blocks and wedges at the mine roof (figure 9).

**Figure 9.:** Photo of solid block walls for Mine Seal No. 2.

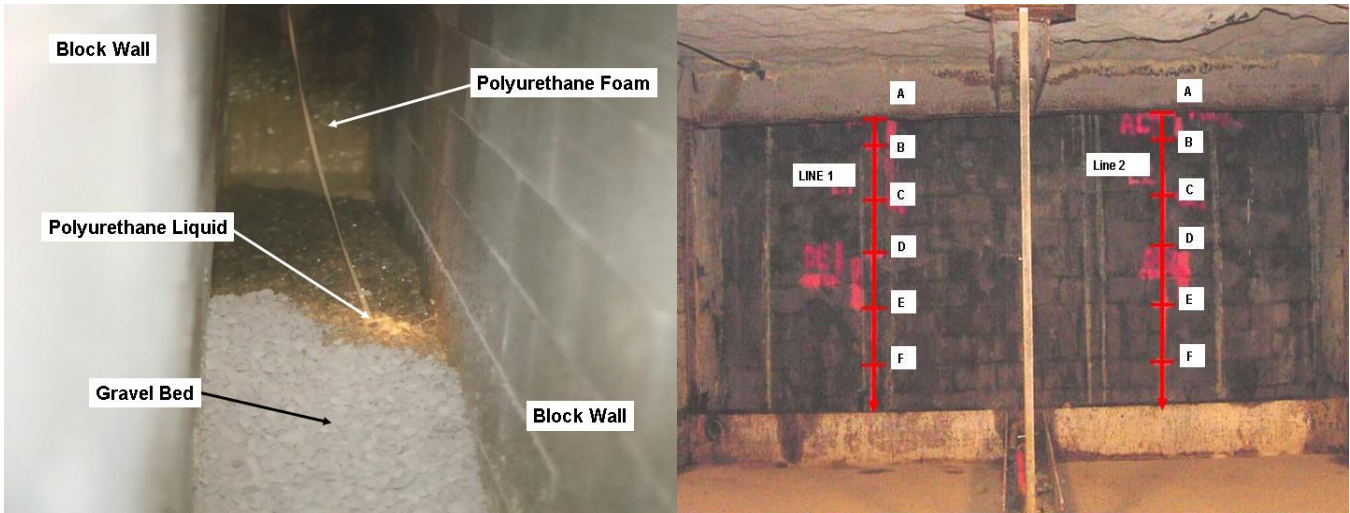
material was poured into the gravel bed and was supposed to infiltrate the gravel bed before it began to foam. By design, as the resin turned to foam, it was supposed to pick-up and disperse gravel in the resulting matrix. For each lift, gravel was placed to a depth of 10- to 12-in. Polyurethane resin was then poured over the gravel bed at a rate of about 2.5 gpm and the resulting foam rose to a height of about 10-in above the level of the gravel bed (figure 10). The core of the seal was constructed in 7 lifts over a 5.5-day period and any remaining open space above the lifts was then closed to the mine roof using injected polyurethane foam. In all, the seal was built using 292 blocks, 10,350 lbs of limestone and 2,000 lbs of polyurethane resin. Once the inner portions of the seal were built, the exposed face of the seal was coated with B-Bond<sup>2</sup> to a maximum thickness of 0.25-in.

The open space between the block walls was filled in a series of lifts using gravel and polyurethane foam. The polyurethane

**Figure 10.:** Photo of inner core of Mine Seal No.2 during addition of polyurethane resin.

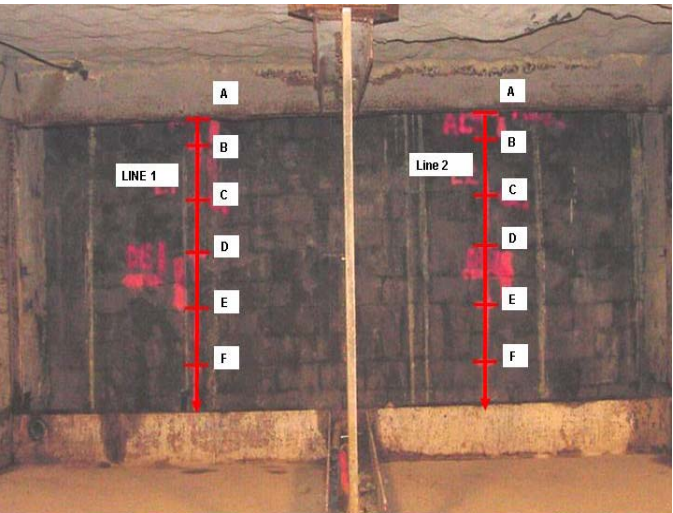
GPR was used to determine if the gravel had been evenly dispersed throughout the mine seal. For the radar survey, two parallel vertical GPR survey lines were drawn on the mine seal face and were positioned about 6 ft from each mine rib (figure 11). Reference points (labeled A-F), spaced about 18-in apart, were then placed on the seal and were added to the radar records for comparative purposes. Each survey was made by placing the antenna against the seal face and then slowly moving downward at a constant velocity. The radar survey of the seal was made using 1,000-MHz antenna because this antenna

**Figure 11.:** Photo of Mine Seal No. 2 showing GPR survey lines.

Figures 12 and 13 show two representative post-processed radar records and their associated interpretations. Reflected pulse energy is shown in terms of a grayscale, with near-white being the highest level of reflected pulse energy and near-black the lowest. Areas in the record shown with similar gray tones should be interpreted as similar levels of reflected pulse energy. The vertical scale shown in the figures corresponds to the reference points (labeled A-F) shown in figure 11.

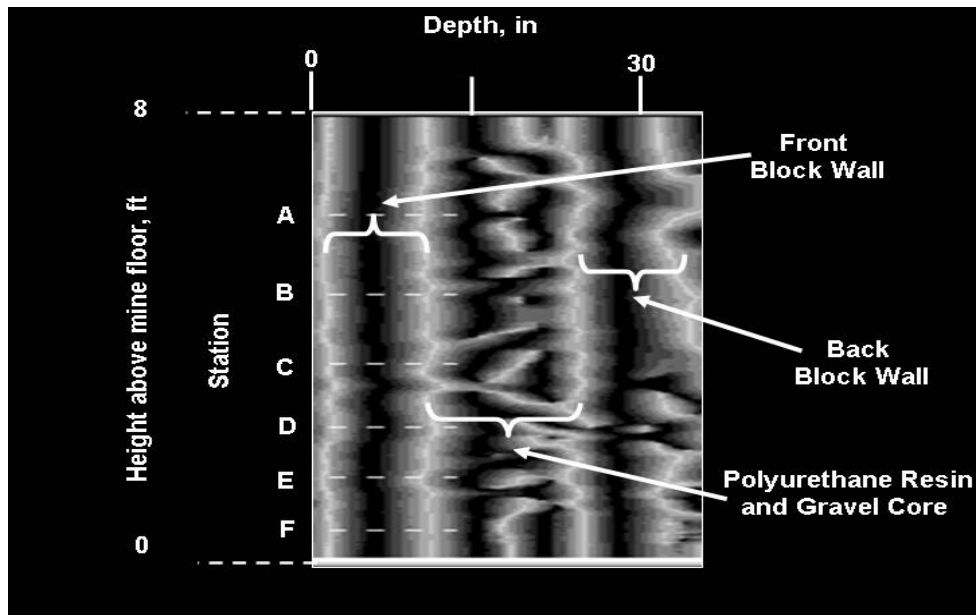
In the radar records (figures 12 and 13), it is possible to see both the front and back block walls. It was hypothesized that the area between the block walls showed varying amounts of reflected pulse energy because of the concentration of gravel in the polyurethane foam was most likely not consistent

**Figure 12.:** Interpreted radar record for Mine Seal No. 2, Line 1.

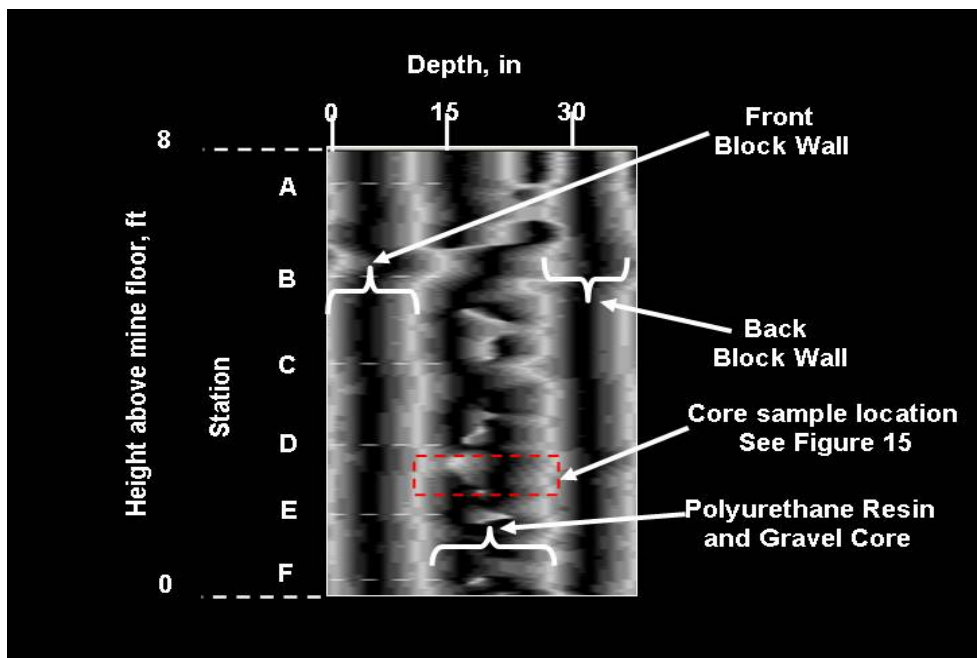
**Figure 13.:** Interpreted radar record for Mine Seal No. 2, Line 2.

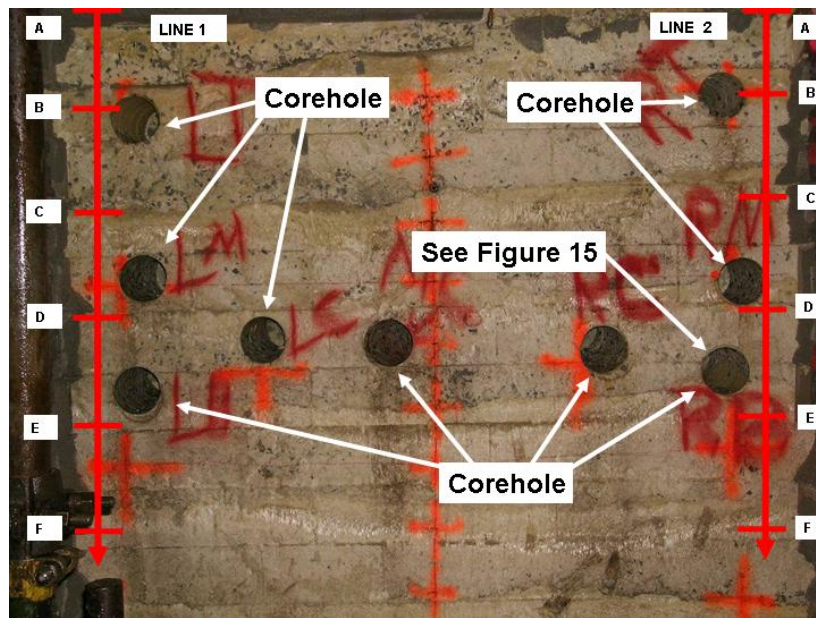
throughout the seal. To confirm this hypothesis, several large coreholes (6- by 18-in) were drilled into the seal after the GPR study was completed (figure 14). For this work, the block face of the seal was removed to facilitate core recovery. Figure 15 shows an example of a recovered core sample. This sample clearly shows a lift boundary and a detailed analysis of this core sample showed that the gravel was not evenly dispersed in the polyurethane foam. This confirms the hypothesis made from the radar records.

**Figure 14.:** Photo of Mine Seal No. 2 showing location of coreholes.

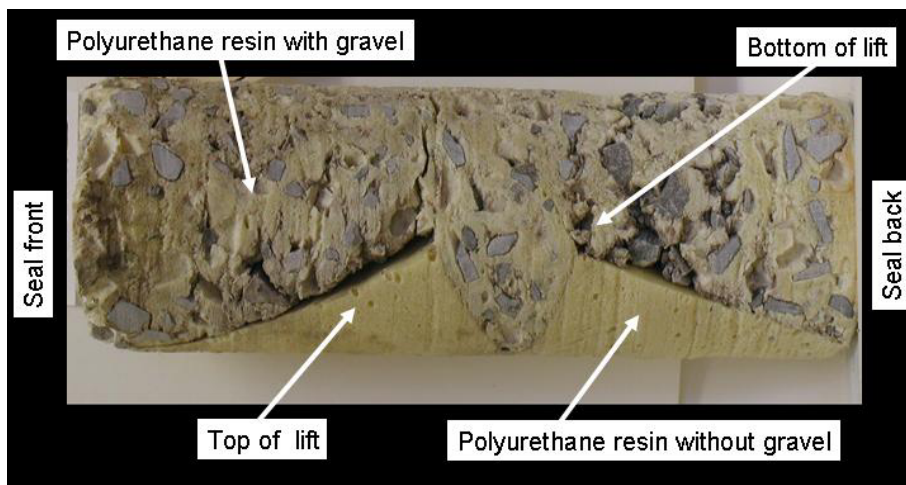
**Figure 15.:** Photo of recovered core sample from Mine Seal No. 2. Refer to figure Nos. 13 and 14.

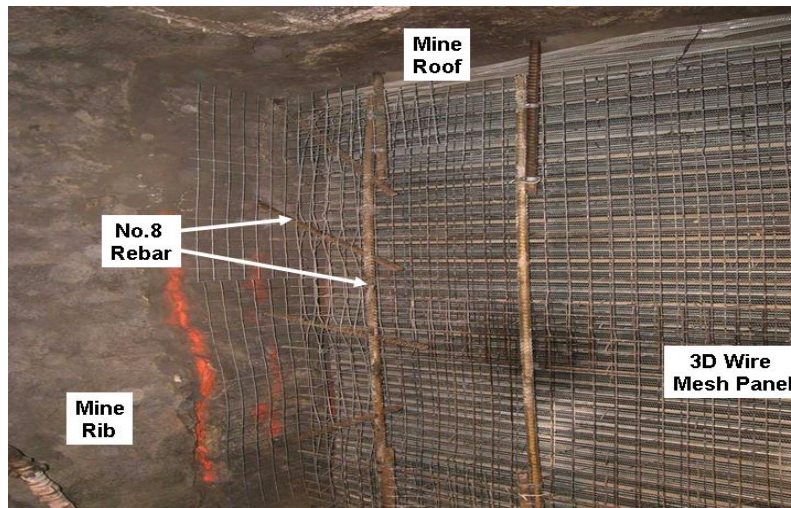
Mine Seal No. 3 was erected in the small chamber in the LLEM. The seal was constructed 8-ft high by 20-ft wide and 11-in thick and was built using Stayfoam<sup>2</sup> panel backing and Insteel 3D<sup>2</sup> wire mesh panels. The panels were anchored to the mine roof rib and floors with No. 8 reinforcing bar (rebar) that was drilled and set into the exposed strata. Across the front of the seal, the segments of rebar that were anchored into the roof and floor strata were affixed with steel strapping to vertical sections of rebar and the wire mesh panels (figure 16). The entire face of the seal was then sprayed with Riregrete<sup>2</sup> gunite to complete the construction.

**Figure 16.:** Photo of Mine Seal No. 3 showing the mesh panels and reinforcing bars.

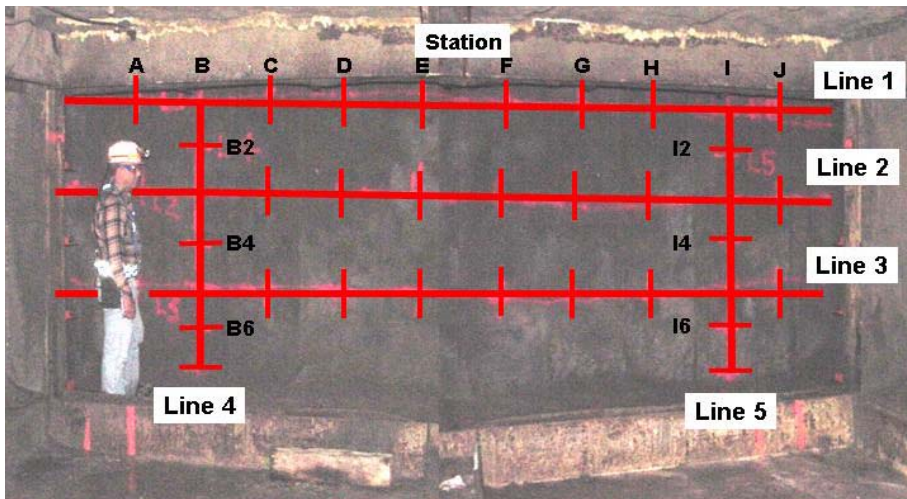
GPR was used to determine if the metal construction components could be resolved. For the radar survey, three perpendicular horizontal lines (lines 1-3) were positioned on the seal with the first line located about 6-in below the mine roof interface and the remaining two lines spaced about 24-in apart. In addition, two vertical lines (lines 4-5) were positioned approximately 4-ft from each mine rib. Reference points, spaced 24-in apart, were added to each survey line and these points were also added to the radar records (figure 17). Each survey was made by placing the antenna against the seal face and then moving along the line at a constant velocity. The radar survey of the seal were made using 1,000-MHz antenna because this antenna could provide the necessary depth of penetration and the desired level of resolution. A total of 22 surveys were made of the mine seal and table 3 shows the setup parameters used for each survey.

**Figure 17.:** Photo showing Mine Seal No. 3 with GPR survey lines.

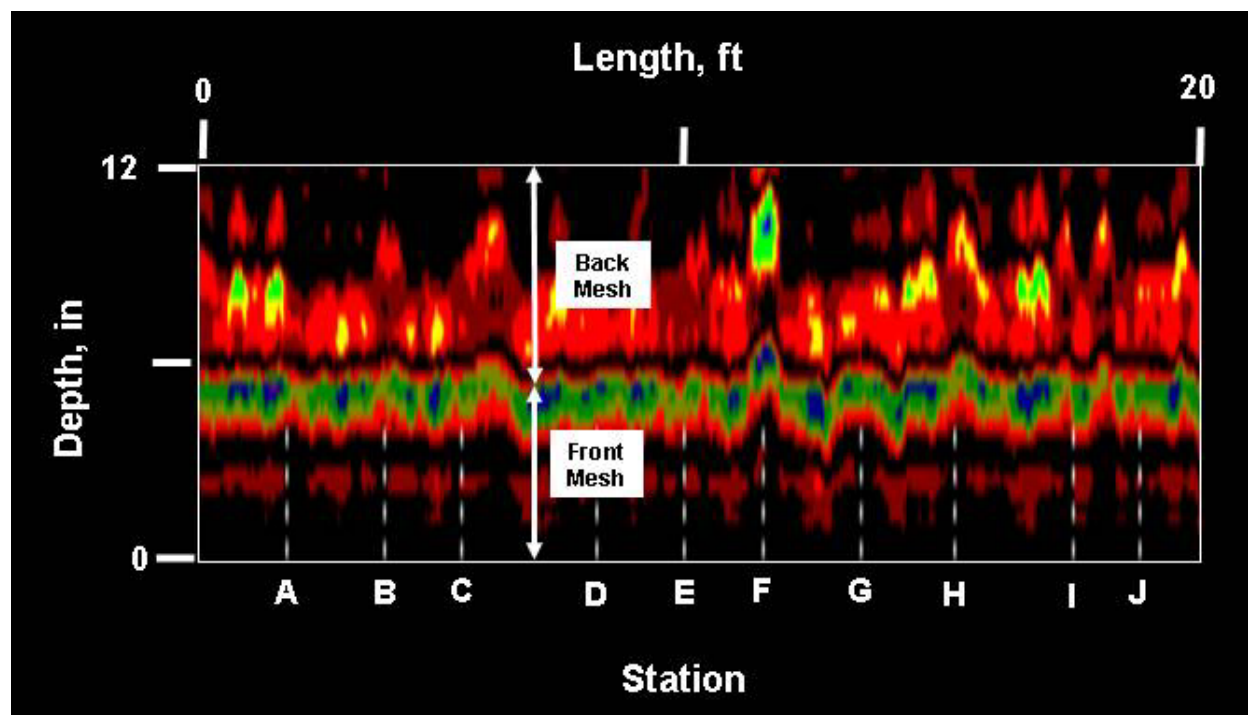
Figures 18 and 19 show representative post-processed radar records of Mine Seal No. 3 and their associated interpretations. The reflected pulse energy is shown in terms of a color scale, with hot colors (yellow and bright green) being the higher level of reflected pulse energy and colder colors (brown and black) the lower levels. Areas in the record shown with similar colors should be interpreted as similar levels of reflected pulse energy. The vertical scale shown in the figure corresponds to the

reference points shown in figure 17. In the radar records, two layers of wire mesh can be seen. The Stayfoam<sup>2</sup> panel however cannot be discerned from the back of the second wire mesh panel most likely because it was attached to the panel. This also explains the higher energy reflections seen in the deeper portions of the radar records (shown as back mesh areas in the records) because the Stayfoam<sup>2</sup> panel had a closely spaced mesh and thus a larger reflective surface.

**Figure 18.:** Interpreted radar record for Mine Seal No. 3, Line 1.

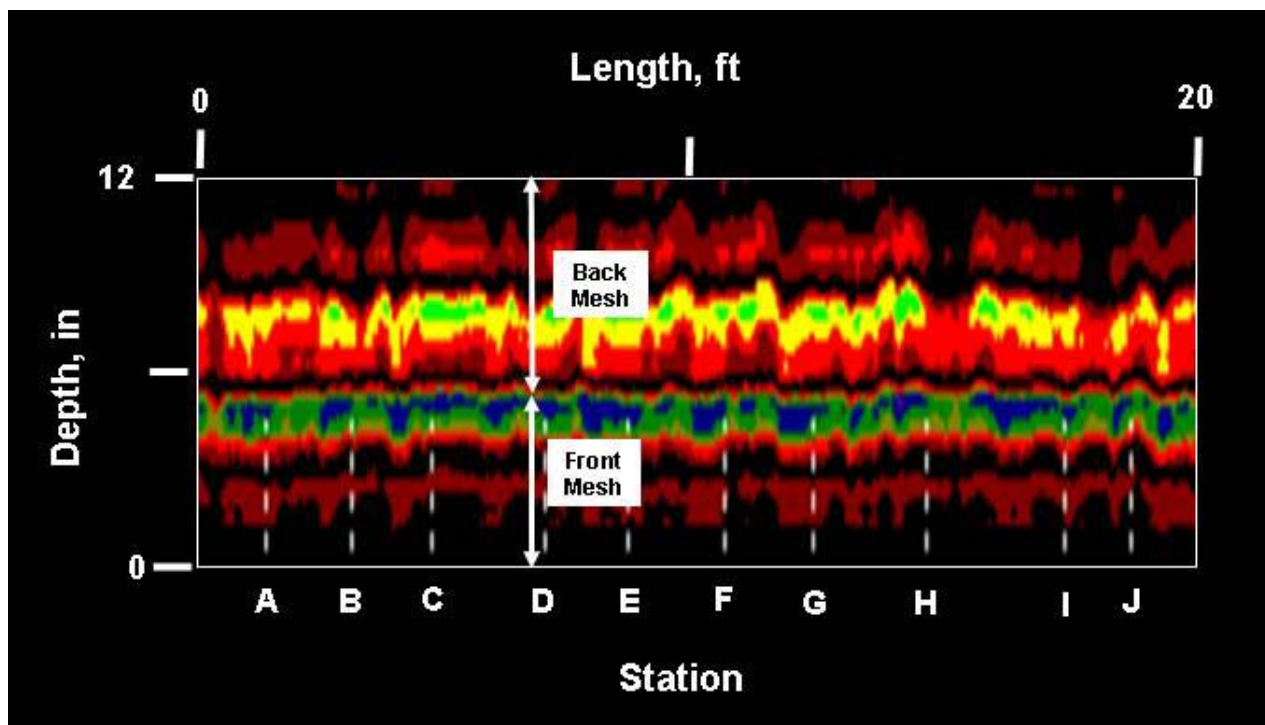
**Figure 19.:** Interpreted radar record for Mine Seal No. 3, Line 3.
