AN EXAMINATION OF THE LOYALHANNA LIMESTONE'S STRUCTURAL FEATURES AND THEIR IMPACT ON MINING AND GROUND CONTROL PRACTICES

Anthony T. Iannacchione, Senior Scientist
Paul R. Coyle, Geologist
National Institute for Occupational Safety and Health
Pittsburgh Research Laboratory
Pittsburgh, Pennsylvania USA

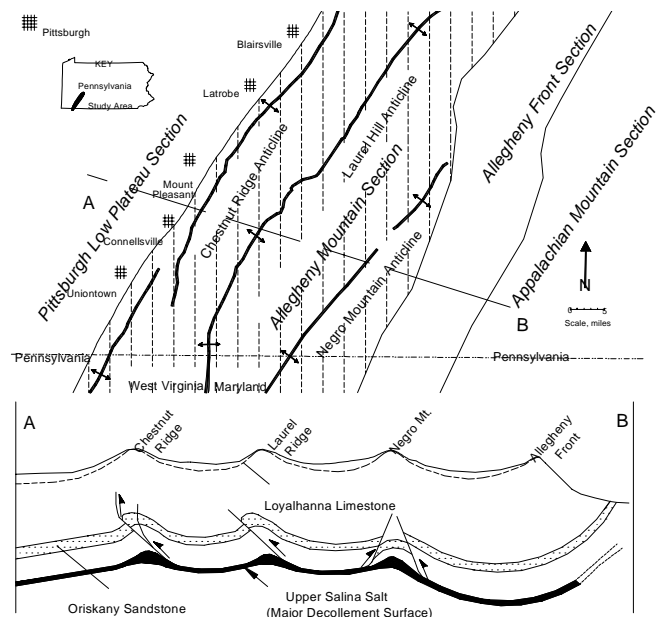
Figure 1. Location of major anticlinal structures and a generalized cross-section through the Allegheny Mountain Section of the Appalachian Plateaus Province.

(figure 1). These outcrops have historically been the sites for commercial aggregate mining, especially those closest to the population centers in and around Pittsburgh, Pennsylvania. Currently nine quarries mine the Loyalhanna through underground and surface operations in Monongalia Co., West Virginia, and Fayette and Westmoreland Counties, Pennsylvania, (table 1) along the linear trace of Chestnut Ridge.

Apparently the Loyalhanna and surrounding strata in the Allegheny Mountain Section have moved some distance along the Salina detachment horizon (figure 1). In addition, the overlying Middle Devonian rocks are intensely faulted. The faults originate within the Salina and quickly rise into a series of branching splay thrust faults under the limbs of the anticline. The complicated nature of the stiffer rock units between the Salina and the Tully Limestone is shown in figure 5 where these units are either stacked in an imbricate fashion by ramping thrust faults (5) or flexurally bent by an overturned fold with imbricate faulting (11). Gwinn explained the stacking at depth as caused by shortening of the detached strata above the Salina Salt. This produced a depressed zone along the anticlinal crest which has helped to create Chestnut Ridge’s broad fold at the surface. Shumaker indicates that the highly deformed Salina has thickened into a salt core under some parts of Chestnut Ridge. The overlying Middle Devonian rocks are overturned in relatively tight folds with large splay faults emanating from the base of the overturned limb.

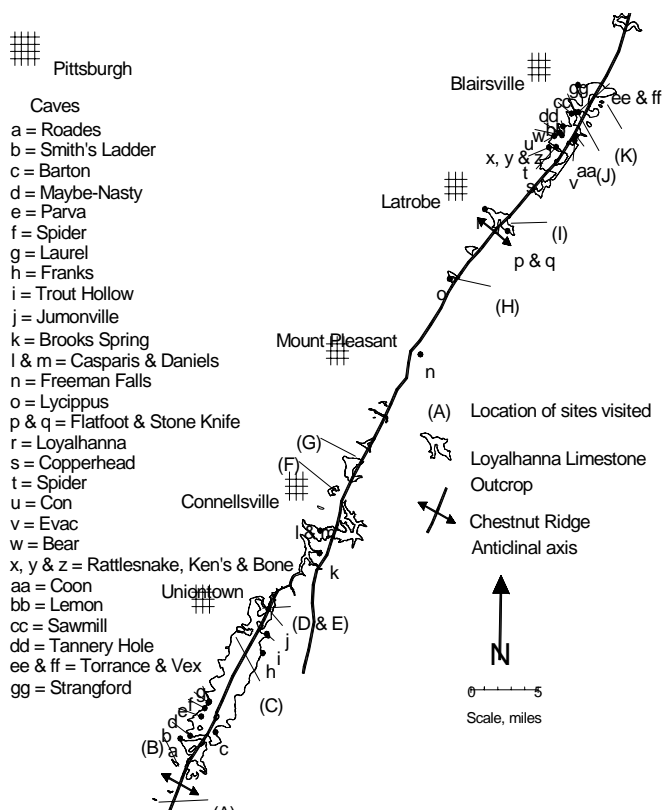
Figure 2. Location of Loyalhanna Limestone outcrop, caves, and sites visited during this study. Capital letters A, B, D, E, F, G, H, I, and J are quarries; C is a highway outcrop; and K is an abandoned coal strip mine.

1. The first fault is exposed along Rt. 40 (Site C, figure 2) where it climbs the western flank of Chestnut Ridge at an altitude of about

The Summit and Griffin Domes have extensive caves developed in the limestone. Caves occur when existing joints open as the confining stresses are relieved by erosion, uncovering the limestone. These unconfined joints are then widened as flowing water dissolves the limestone over extended periods of time. The residual fine-grained material that is left in place can be easily carried away by the small streams of flowing water. Under these conditions, whatever locked-in stresses that once existed are released. Quarries that clearly have low stress conditions (Site D and J, figure 2) are located within the Summit and Griffin Domes.

Despite the low stresses discussed above at two quarries, the level of horizontal stress is, in general, considered to be excessive. Mines with excessive levels of horizontal stresses (Sites F and I, figure 2) are located in saddle structures and are close to either an inferred cross-strike slip fault or a projected lineament that may form the boundary of a large ramp structure. At both of these mines a significant number of joints with low dip angles were observed. Additional research is required to fully understand the important structural factors that either diminish or concentrate stresses in this area.

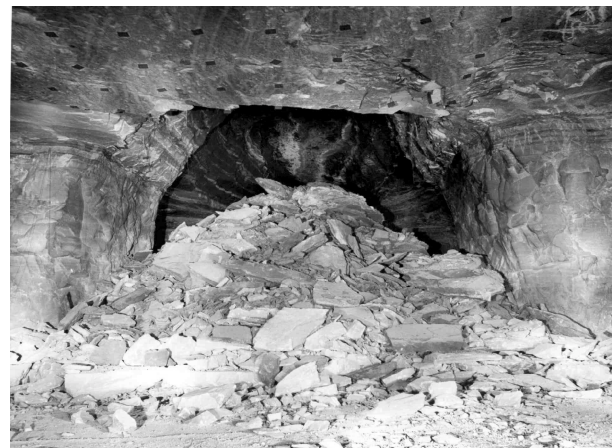
Figure 3. Massive roof fall measuring 45 ft wide by 20 to 30 ft high and extending for approximately 200 hundred feet.

Mines along Chestnut Ridge have experienced roof and rib falls with some falls resulting in injuries to mine workers. One quarry with a workforce of approximately 30-miners experienced 7-injuries from ground falls over a 30-month period from March 1993, until September 1995 (table 2). A second mine had vehicles struck by falling rocks approximately a dozen times during a 12-month period. A third mine reported 9 roof falls to the Mine Safety and Health Administration (MSHA) during an 18-month period from April 1999, until November 2000 (4). Ground falls range in volume from boulder size rocks, falling from the roof or rib, to massive roof falls measuring 45 ft wide by 20 to 30 ft high and extending as far as 500 ft (figure 3). Many of the ground falls were, in part, due to the unique and complex structural environment of the Loyalhanna. The primary reason for initiating this National Institute for Occupational Safety and Health (NIOSH) study is to increase knowledge of the root causes of these hazards and promote the use of timely ground control measures so that miner safety can be improved.

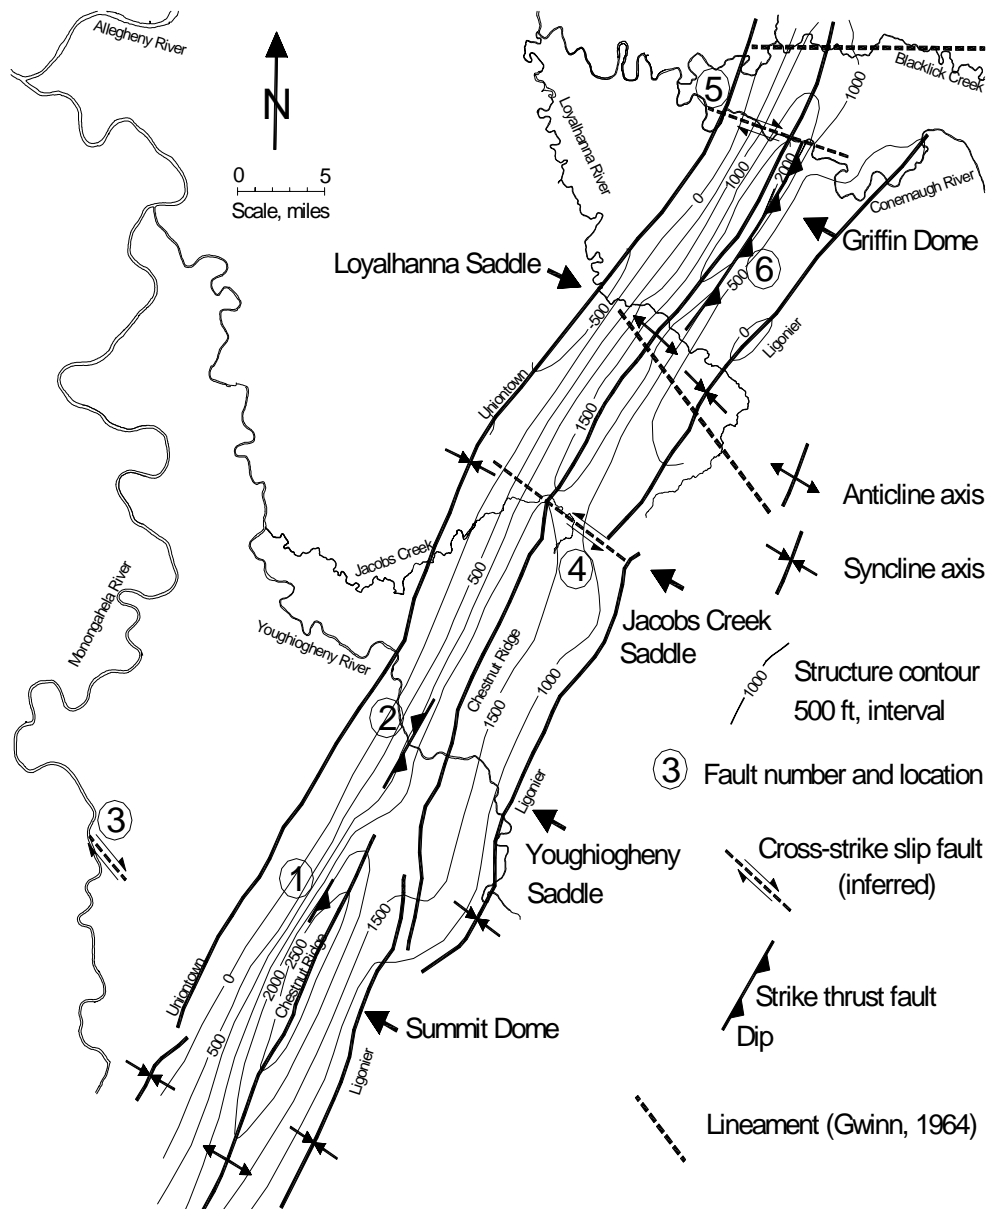
Figure 4. Structure contour map on the top of the Loyalhanna with major fold structures, surface faults, lineaments, and rivers and streams.

areas form enclosed contour elevations called domes. The Summit Dome (figure 4) lies midway between the Cheat River Gorge to the southwest and the Youghiogheny River Gorge to the northeast. The Griffin Dome (figure 4) lies further to the northeast between the Loyalhanna and Blacklick Creeks.

Six major faults have been previously recognized within the study area as shown in figure 4. Three of the faults were reported by Hickok and Moyer (7) and three were reported by Shaffner (8, 9). Two were observed on the western flank of Chestnut Ridge (Fault No. 1 and No. 2), a third along the Monongahela River (Fault No. 3), a fourth and fifth inferred slip faults transecting Chestnut Ridge (Fault No. 4 and No. 5), and a sixth was observed along the eastern flank of Chestnut Ridge (Fault No. 6). These faults can be classified as either strike thrust faults or cross-strike slip faults. The strike thrust faults, in general, have bearings along the strike of the anticlinal structure and dip at a relatively low angle. The cross-strike slip faults (Faults No. 4 and No. 5) were never actually seen by Shaffner although he speculated that they must exist in order to explain the topographic and structural anomalies in this area. The inferred strike of these faults is perpendicular to the anticlinal structure with dips of approximately 90°. These trends are consistent with those expected in response to the formation of the Appalachian Mountain System. A summary of the characteristics of each fault shown on figure 4 follows:

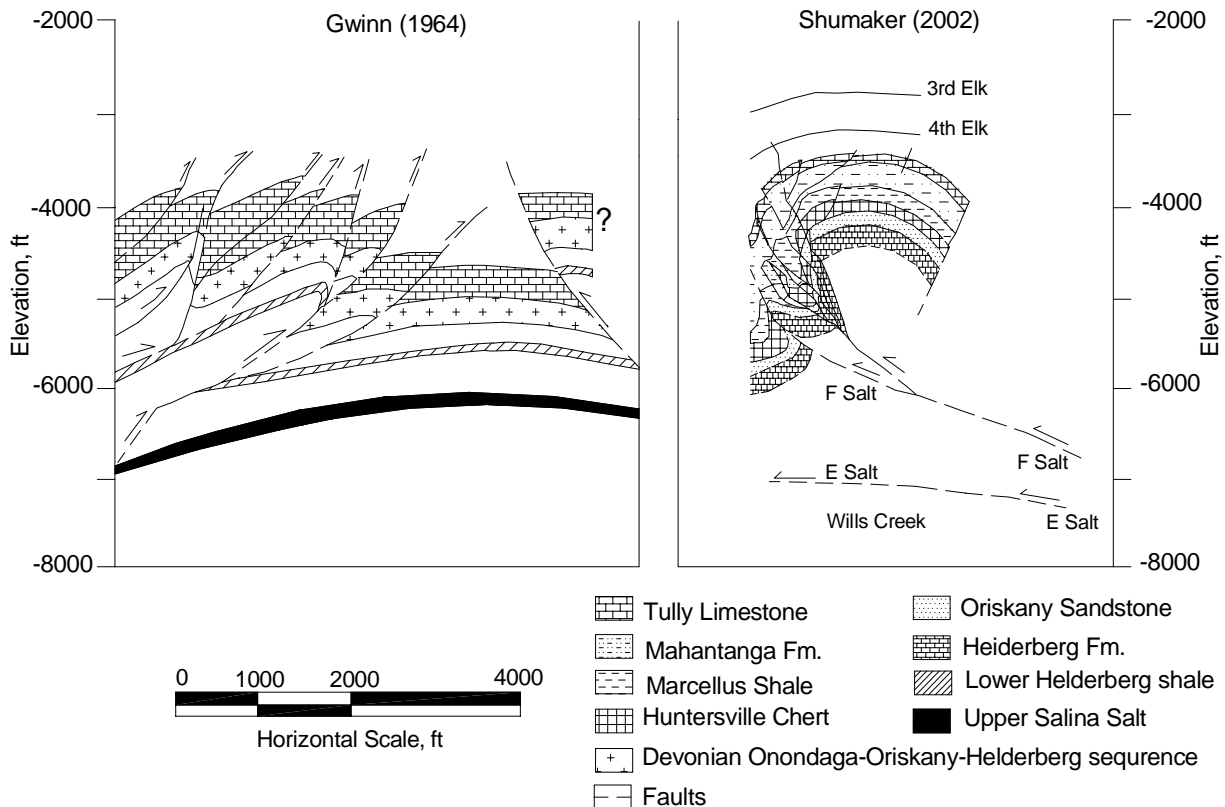
Figure 5. Complex structure under Chestnut Ridge at depths of -2,000 to -8,000 ft below sea level (5, 11).

Both Gwinn and Shumaker state that the strata above the Tully shows far less deformation than the rocks below this unit. Wiltschko and Chappel (12) suggested that most faults were absorbed by the Upper Devonian shales and did not extend above the Tully. While the displacements and frequency of faults are far less at the surface than at depth there is little doubt that many of the Middle Devonian faults have made it to the Loyalhanna. It is important that this connection be made so that the trends established at depth can be

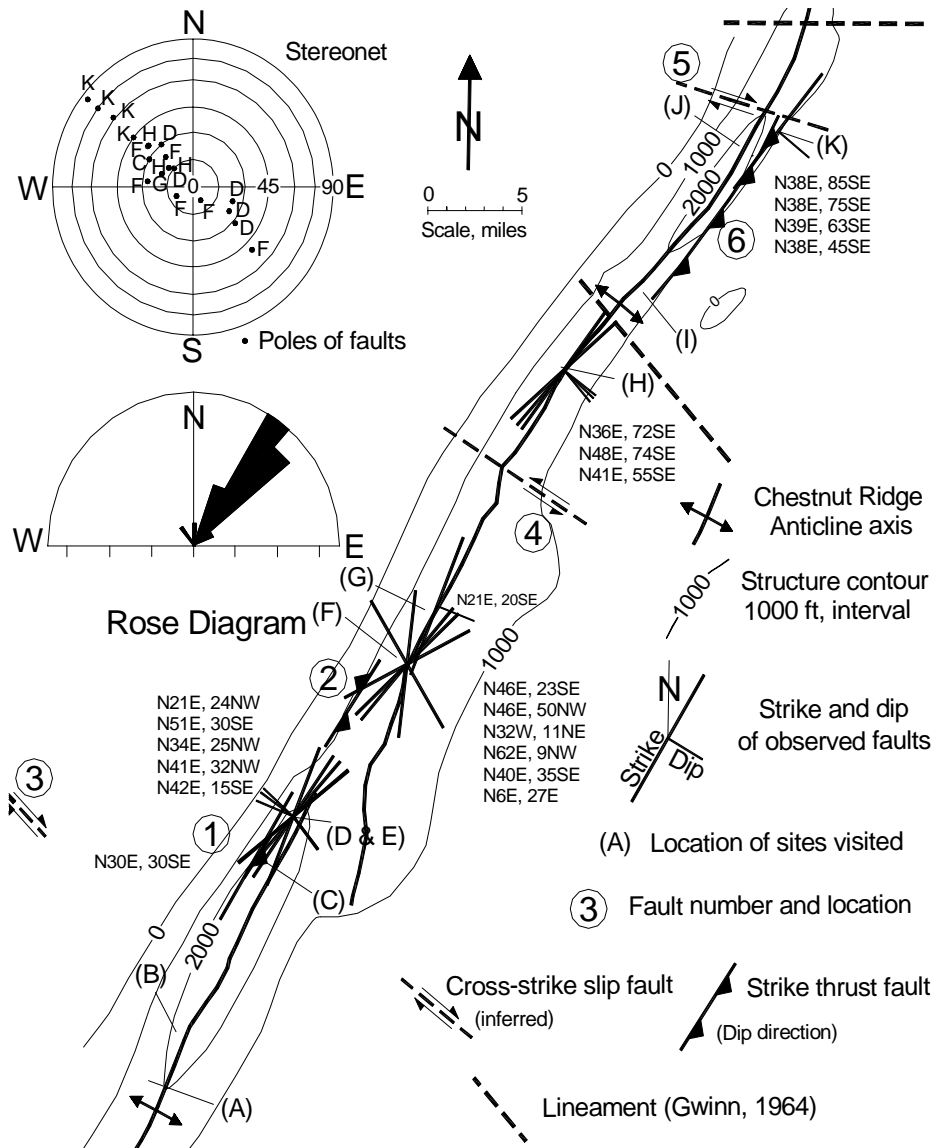
Figure 6. Location and strike and dip of faults observed during this study.

In addition to these known and inferred faults, numerous other faults were observed during visits to several quarries. Figure 6 shows the location, bearing, and dip of these faults in various formats. First, the location, strike, and dip of each fault are displayed in conjunction with the structure contour map on the Loyalhanna. Second, a stereonet projection is provided which locates the poles of the fault planes. Two important facts are revealed in the stereonet: (1) the faults align along a consistent orientation of N 40° E, and (2) the dips of these faults vary widely from approximately 60° to the northwest through 80° to the southeast. The consistent strike is further illustrated with the associated rose diagram. The strike of N 40° E, observed at all quarries with the exception of Site F (figure 6), aligns closely with the general bearing of Chestnut Ridge. While the dips vary widely, some consistencies can be observed. For example, all the faults from sites G, H, and K dip to the southeast, whereas the majority of the faults from site D dip to the northwest. Site F shows both northwest and southeast dipping faults.

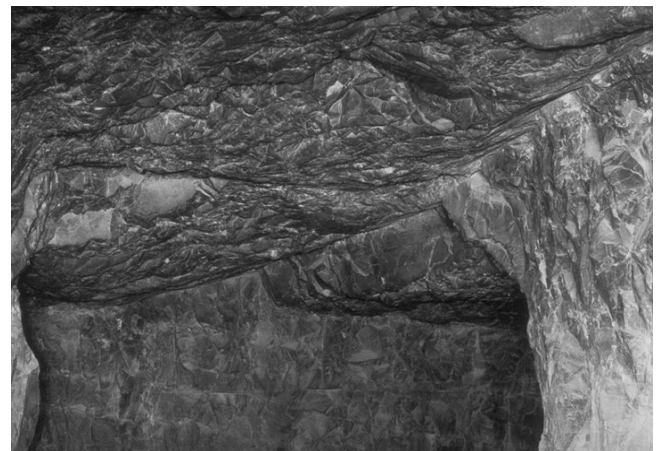
Figure 7. Unstable roof associated with typical low-angle thrust faults.

Most mines should expect to encounter strike faults with dips ranging from 10 to 60° either to the northwest or southeast. These strike faults are more likely to occur on the southeastern side of the Chestnut Ridge Anticline from the Loyalhanna Creek northward and on the northwestern side south of Loyalhanna Creek. It is also likely that Loyalhanna dips will increase significantly on the flank side of these faults. The immediate roof associated with typical low-angle thrust faults can be very unstable and in many locations has failed entirely (figure 7).

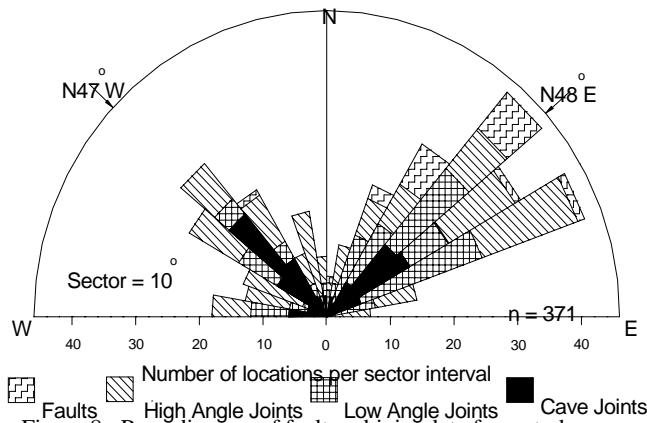
Figure 8. Rose diagram of fault and joint data from study area. 371 measurements were grouped into two clusters. Northwest quadrant data had a mean resultant direction of N 47° W (left arrow). Northeast quadrant data had a mean resultant direction of N 48° E (right arrow).

Jointing was observed throughout the study area and was found to have two distinct trends. A total of 371 joint bearings and dips were measured and plotted on a rose diagram shown in figure 8. These measurements were grouped into two clusters: 1) northwest quadrant data with a mean resultant direction of N 47°W of mostly vertical joints; and 2) northeast quadrant data with a mean resultant direction of N 48° E with varying dips. The N 47° W joint trend strikes across Chestnut Ridge and the N 48° E trend roughly parallel the strike of Chestnut Ridge. These trends are coincident with the orientation of local folding and faulting and are thought to be caused by the same processes.

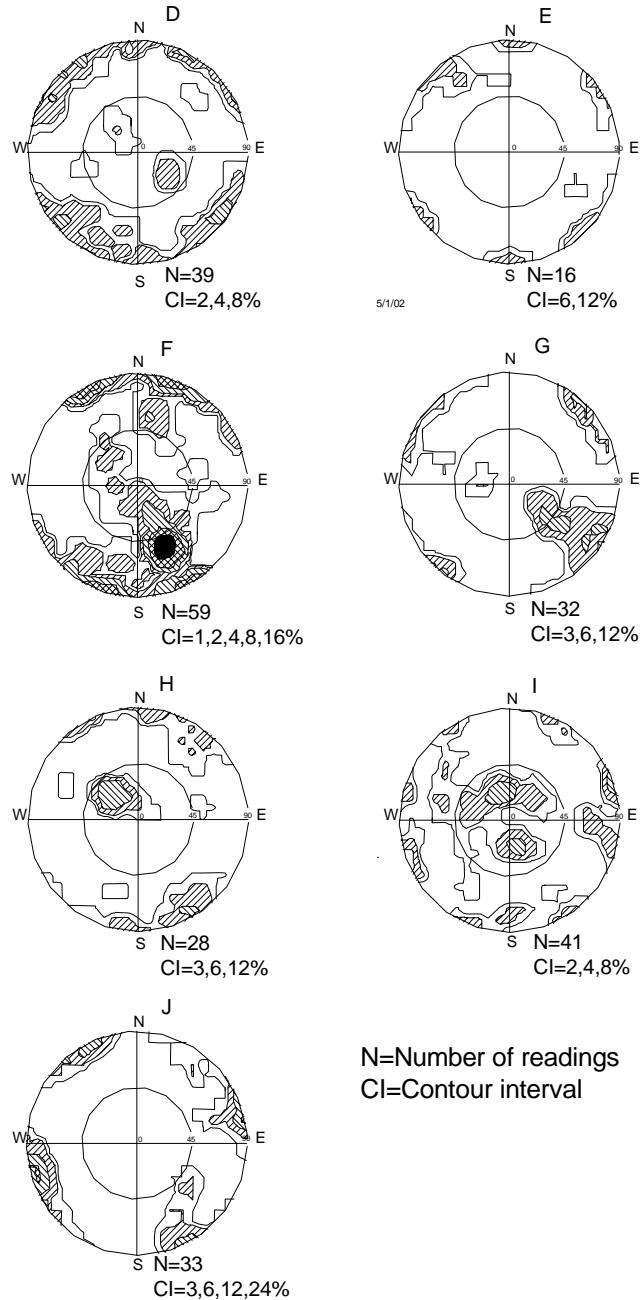
Figure 9. Stereonet projections for seven of the sites visited during this study.

The joint bearings and dips become more significant when the measurements from individual sites within the study area are analyzed (figure 9). For example, at site D (figure 2) most of the joints are vertical with a modest concentration of joints dipping from 10 to 45° to the northwest and lesser concentration of joints dipping from 0 to 45° to the southwest. Site E and J are composed almost exclusively of vertical joints. Sites F and G are dominated by joints dipping from 0 to 90° to the northwest. Site H has a strong concentration of joints

dipping from 0 to 45° to the southeast. Sites F and H have a significant number of joints dipping from 0 to 45° oriented over a wide range of bearings. The spacing of most joint sets ranges from a few feet to tens-of-feet. Displacements along vertical joints were not observed, however, lateral displacements along joints dipping from 0 to 45° were observed at Sites F and I.

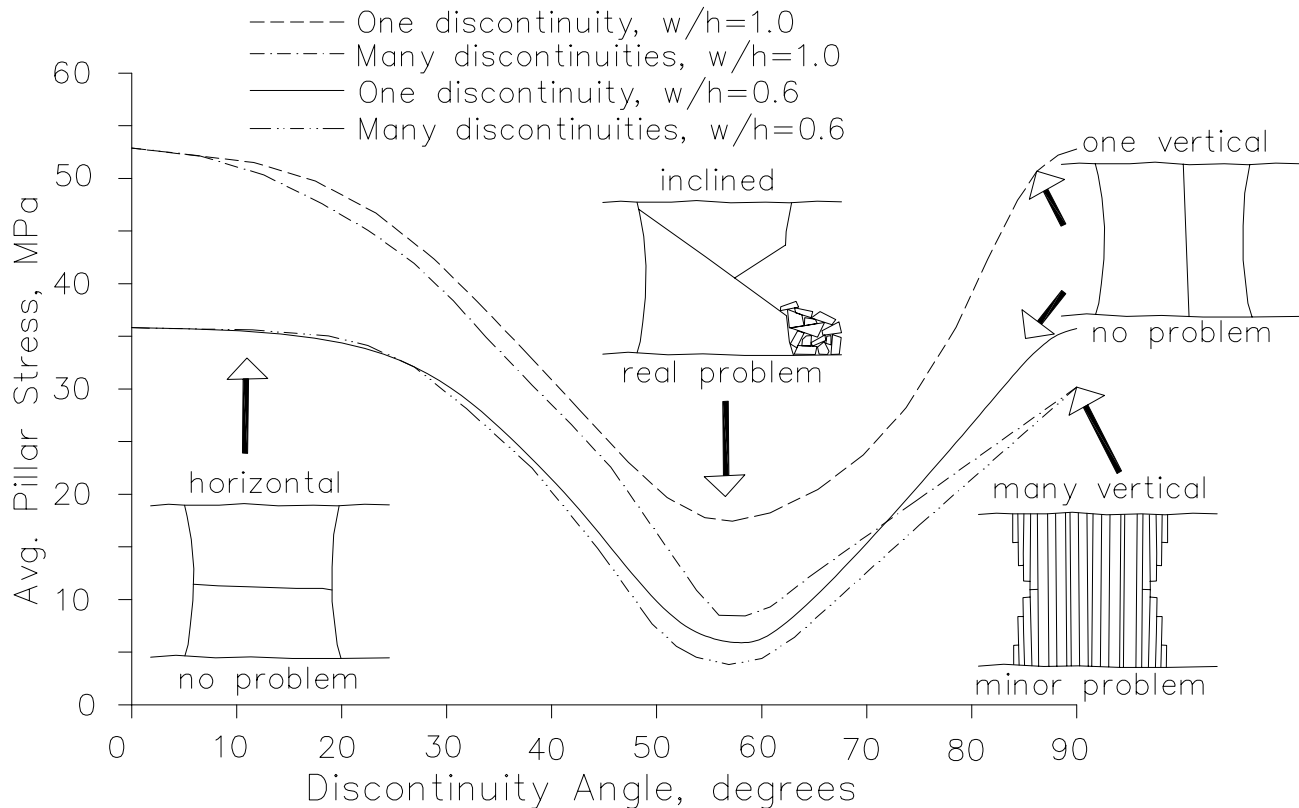
Figure 10. Changes in average vertical peak stress as the dips of discontinuities are varied from 0 to 90° for two different width-to-height ratio pillars.

To illustrate some of these concepts, a model with very closely spaced joints, relatively low joint strength, and variable joint dip was presented by Iannacchione (18). The highest pillar strength occurred with a discontinuity dip of 0° and gradually decreased as discontinuity dip angle increased (figure 10). As the discontinuity dip angle increased above 60°, pillar strength began to increase again, although the original starting strength was never achieved. This result could be expected when near vertical joints are closely spaced, allowing buckling at the edges of the pillar and producing a strain-softening material behavior. Conversely, a near vertical through-going discontinuities with a dip approaching 90° could allow a pillar to regain almost of its strength (figure 10).

pillars took on the appearance of the “real problem” pillars shown in figure 10. Because of the significant percentage of joints within the critical dip range of 30 to 75°, pillar stability is expected to be an important safety issue, especially when pillar width-to-height ratios fall below 1.0 (18, 19). Width-to-height ratios above one are more desirable because there is less chance for the discontinuity to pass entirely through the pillar.
