Field Tests of Cable Bolts Using Instrumented King Wires

Lewis A. Martin

Spokane Research Laboratory, National Institute for Occupational Safety and Health, Spokane, WA

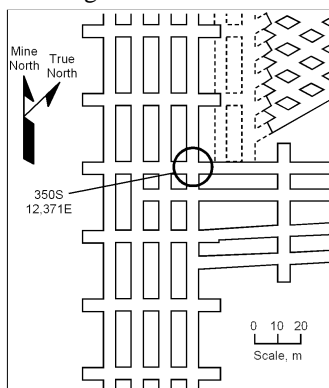
Figure 4.—Instrument locations in trona mine.

Cable bolts were installed in the roof of T.G. Soda Ash’s trona mine, a room-and-pillar operation in Wyoming, to measure roof loads in the intersection of 350S and 12371E (figures 4 and 5). This location was chosen because of drill access ahead of the mining cycle and because loads would be induced in the cable bolts as ore was extracted toward the intersection. Mine personnel were interested in determining the potential for instability in the back and the extent of any unwedged blocks.

Loads on the cable bolts were measured from April 29 through July 11, 1999. Mining activities influencing the intersection were progressing from northeast of the site to the south (figure 4). On June 9, mining reached a point one pillar width from the intersection (8 m). Figure 7 shows all load profiles measured by the 4.27-m-long bolts (bolts 1, 2, 4, and 5) and the 3.66-m-long bolts (bolts 6, 8, 9, and 11). Approximately the last 1.5 m of the bolt was bonded with resin grout.

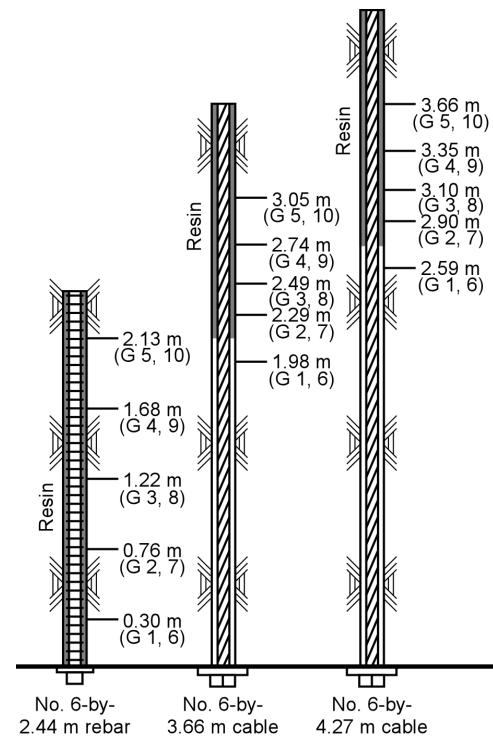
No. 6-by-2.44 m rebar No. 6-by-3.66 m cable No. 6-by-4.27 m cable

- Notes:
1. Assume 1.5-m resin anchor for cable bolts.
 2. All gauges are in pairs at given locations.
 3. Instrumented cable strength is 213.5 kN, yield at 177.9 kN.
 4. Load is 11 kN times microstrain for cables.
 5. Current inventory is: four no. 6-by-2.44-m rebar, four no. 6-by-3.66-m cable, four no. 6-by-4.27-m cable.

Figure 6.—Positions of strain gages on bolts (note two at each position).

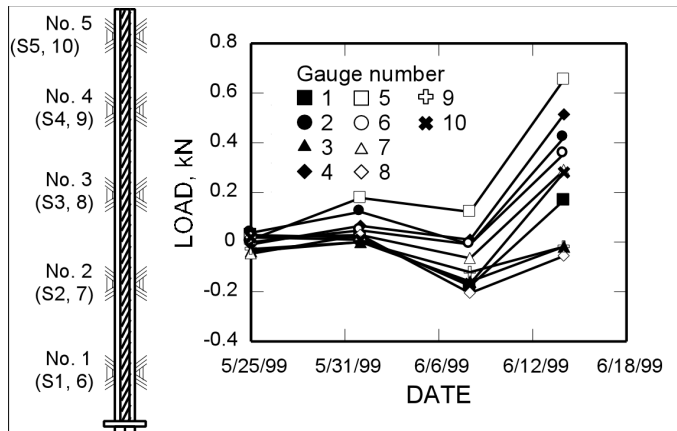
Figure 11.—Load on bolt 14 at K-2 Mine.

The cable bolt was placed into the mine back directly above the sublevel open stope. Preliminary data show low loads on all gages along the bolt (figure 11). The cable is approaching yield at gage 5 (3 m deep), and delamination appears to be occurring close to 3 m above the back. The immediate back exhibits minor loading (gage 1 at 0.6 m deep). The area where the cable bolt is installed is inaccessible since the open stope has yet to be backfilled. There is no concern for personnel because the stope below is nonentry.
