FIELD TEST WITH STRAIN-GAUGED FRICTION BOLTS AT THE GOLD HUNTER MINE, MULLAN, IDAHO, USA

Jeffrey Johnson, Ted Williams, Carl Sunderman, and Stephen Signer
Spokane Research Laboratory, National Institute for Occupational Safety and Health, Spokane, Washington, USA

Douglas Bayer, Hecla Mining Company, Mullan, Idaho, USA

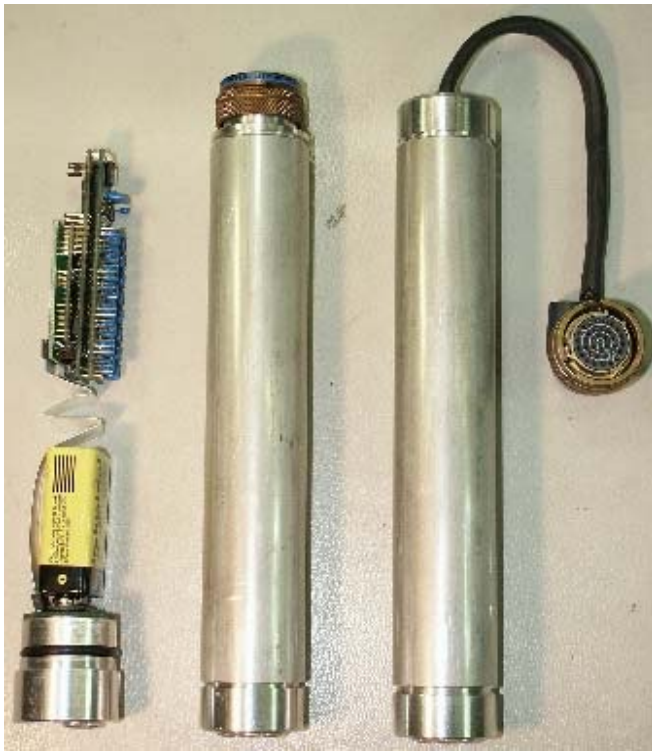
Figure 1.—Miniature data acquisition system (MIDAS)

Friction bolts have been used for 30 years, but little is known about their actual mechanical behavior when installed in mine rock. To learn more about such behavior, researchers at NIOSH's Spokane Research Laboratory (SRL) developed a miniature data acquisition system (MIDAS) (figure 1) that would fit inside the center of an installed 46-mm friction bolt (Sunderman, personal communication, 2001). To fit inside a 39-mm bolt, the first 12 in of the bolt hole must be overdrilled or reamed with a 1-5/8-in bit so that the wall of the friction bolt will not collapse.

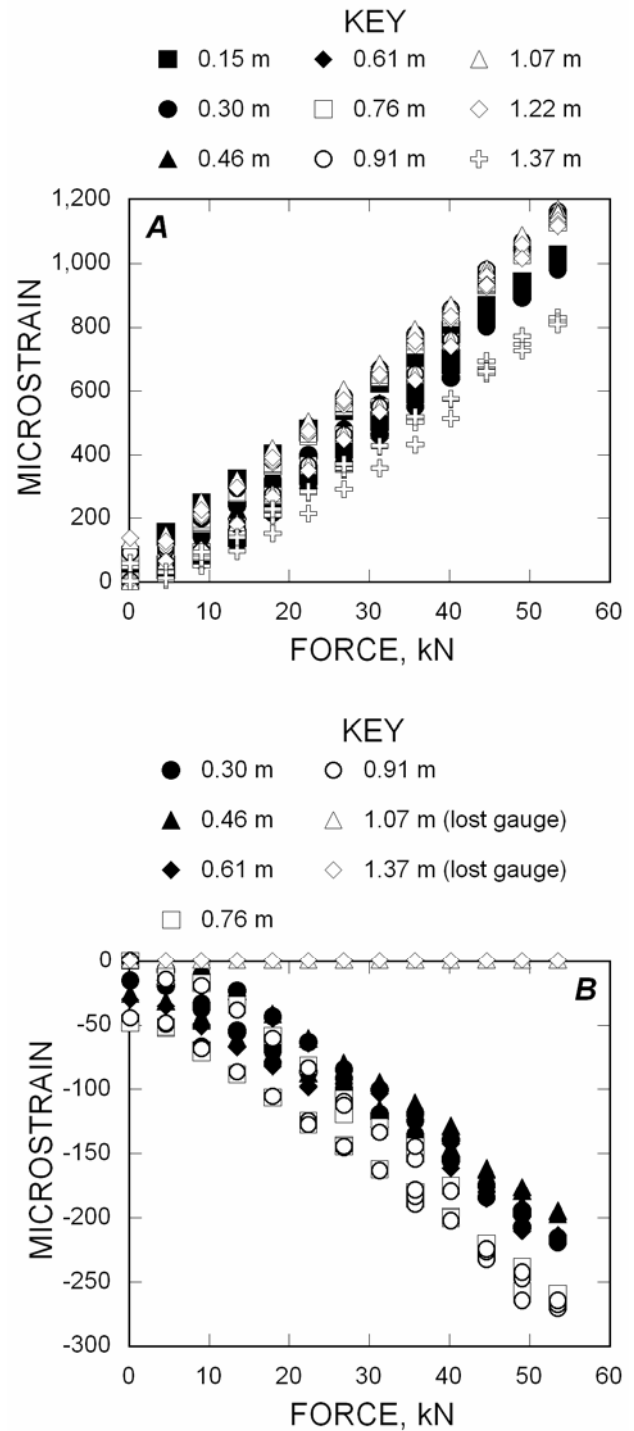
Figure 2.—Uniaxial tension (positive) test on strain-gauged friction bolt. A, Axial strains; B, circumferential or radial strains.

The bolt was then attached to a Tinius-Olsen stiff testing machine. An initial load of 1000 lb was applied to set the bolt, followed by increases in load in 1000-lb increments up to 12,000 lb. A yield load of 16,000 lb and an ultimate load of 20,000 lb was assumed for the bolt. Figure 2A shows axial strains as a function of applied load. All axial strain gauges 12 in from the end of the bolt

show a linear response with an r-squared value of 0.96. Measured elastic modulus was about 10% higher than steel's nominal value of 30 million psi. 2B shows circumferential strains as a function of applied load. The circumferential strains were also linear, with Poisson ratios ranging from 0.20 to 0.25 as computed from pairs of axial and circumferential gauges. Circumferential strains are all negative, indicating that radially the bolt is in compression and getting smaller in diameter. This aspect will be important for explaining the effects of resin in pull-out tests.

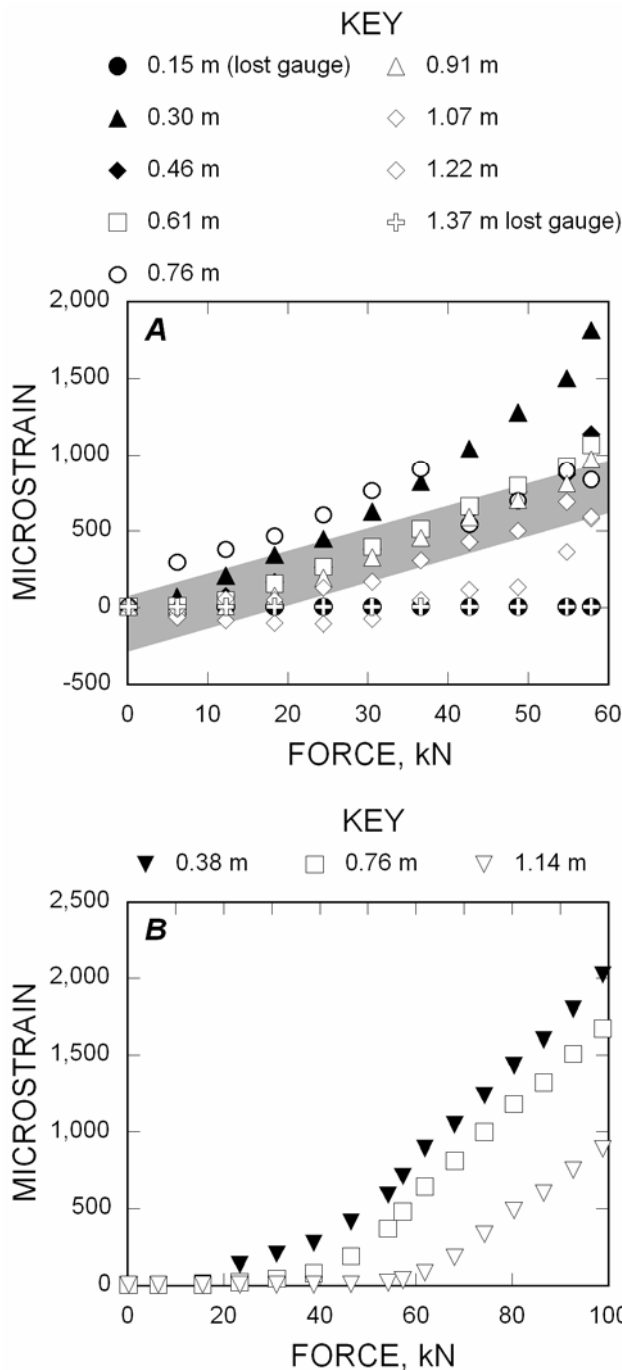
Figure 3.—Pull-out test on strain-gauged friction bolts. A, Without resin showing uniform axial strains along most bolt lengths; B, with resin showing axial strain related to distance from applied load.

The pull-out tests were performed using a large concrete block and installing the bolts with and without resin. The first test (without resin) used the same bolt as used for the uniaxial tension test. A 1-3/8-in hole was drilled into the concrete block, and the bolt was inserted. All the radial gauges showed extremely large strains, and most did not survive insertion. Because of the low survival rate of the circumferential gauges and to keep the costs of the experiment at a minimum, all friction bolts were then constructed with only axial strain gauges. Figure 3A shows axial strain versus pull-out load for a 5-ft-long friction bolt installed without resin. A zone in the center shows most of the axial gauges behaving similarly. The gauges at both ends, the ring, and the tapered end are outside the center zone.

The center zone shows that along most of the length of the friction bolt, an approximately equal amount of strain is developed. This finding is different than that shown during pull tests on grouted bolts, where a decrease in load is seen with distance from applied pull load. Pull-out load is about 6.5 tons, or 1.3 tons/ft, which is a normal value for a pull test on a friction bolt. Calculated stiffness of the bolt using the pulling force and the measured strains is 33.3 million psi, which is about 11% higher than the nominal 30 million psi value.

Figure 3B shows axial microstrain versus pull-out load for a friction bolt installed with resin. Loading behavior is similar to that with grouted bolts, such as reinforcement bars (Serbousek et al. 1987; Signer 1990) and for cable bolts (Martin et al. 2002).

The increased strain in the friction bolt may come from two conditions: bonding of the rock–bolt interface and filling the hollow portion of the bolt at the back end of the drillhole. When the friction bolt is inserted into the resin cartridge, it first pushes the cartridge back into the hole. It then punches holes in the cartridges,

spreading the resin between the bolt and the rock, but also packing a large portion of the resin into the hole and filling the center cavity. When a friction bolt takes axial load in tension, the diameter of the bolt is decreased according to Poisson's ratio, allowing the bolt to come out of the hole more easily. The resin in the back of the hole fills the cavity and the slot that prevents the bolt from getting smaller in diameter, as demonstrated in the laboratory uniaxial tension test. The resin has an effect similar to filling the cavity with cement grout to increase pull-out load.

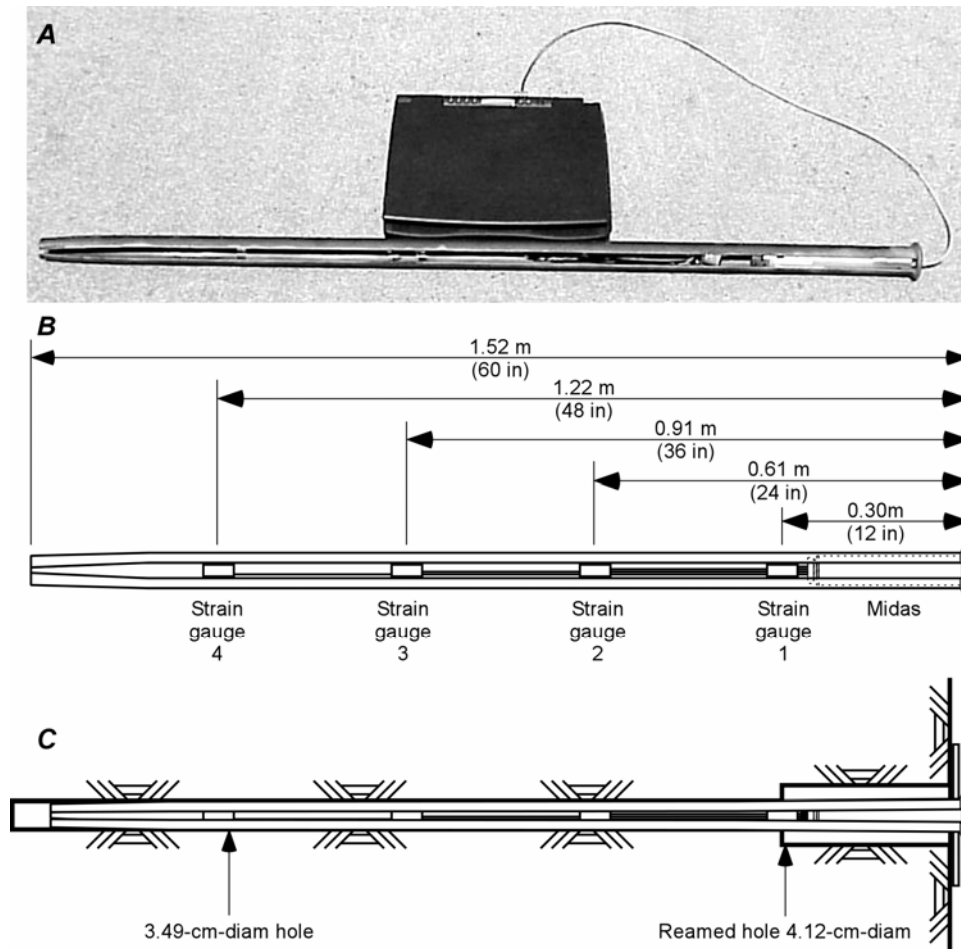
Figure 5.—A, Strain-gauged friction bolt with MIDAS attached to laptop computer; B, Diagram of friction bolt showing location of strain gauges; C, diagram showing installation of 39-mm strain-gauged friction bolt and reamed section of hole.

On October 10, 2002, four strain-gauged friction bolts were installed in the Gold Hunter Mine. The Gold Hunter is accessed from the Lucky Friday Mine, both owned by the Hecla Mining Co. (figure 4). The mining method is underhand mechanized-cut-and fill. The purpose of the field test was to test the MIDAS and measure the strains developed in friction bolts during actual mining. All bolts were 5 ft long; two were 39-mm in diameter, and two were 46 mm in diameter. For these tests, each bolt was equipped with four strain gauges placed 1 ft apart, as shown in figure 5. The strain gauges were numbered sequentially (1, 2, 3, and 4) from the ring end and read using the MIDAS.

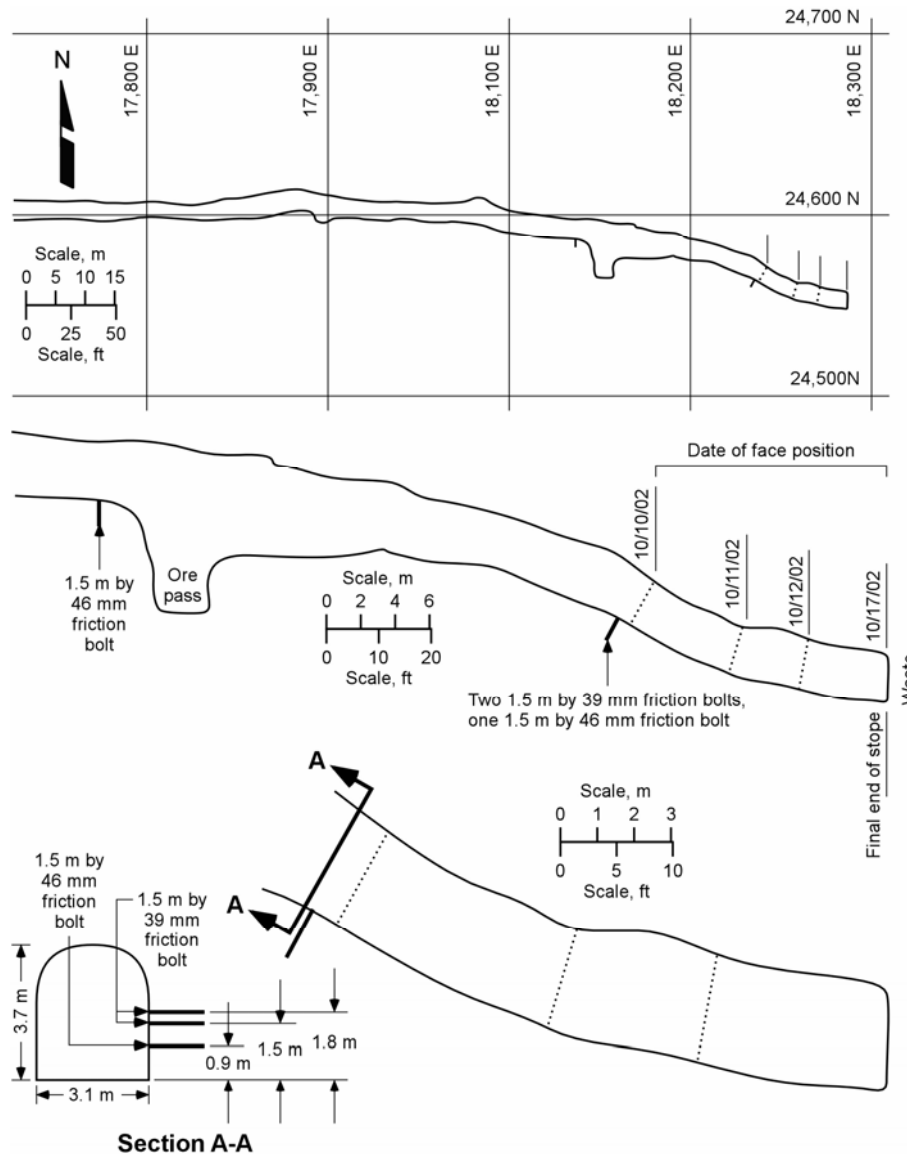
Figure 6.—Plan view of 4520 level. Section A-A shows location of three strain-gauged friction bolts installed 5 ft from stope face on October 10, 2002. Three advances of 20, 13, and 16 ft were made and the date of the new face labeled. A fourth bolt was installed near the ore pass.

Three bolts were installed in a vertical row approximately 5 ft back from the face on the 4520 level of the mine and 3, 5 and 6 ft above the floor (section AA, figure 6). A 39-mm bolt was installed without resin at the 6-ft position and with resin at the 5-ft position. A 46-mm bolt was installed without resin at the 3-ft position. All bolts were installed during the regular mining cycle, and no special training or equipment was needed. However, the size of the MIDAS required that the first foot of the 39-mm bolts had to be reamed with a 1-5/8-in bit to allow the MIDAS to be inserted into the friction bolt. A newer model of MIDAS will fit inside the 39-mm friction bolt without the need to ream the bolthole. All bolts were installed with the friction bolt slot down to allow water to drain from the hole and to keep the gauges as high as possible on the back side of the drill hole. A fourth bolt was installed near an ore pass about 100 ft back from the face. The ore pass was chosen by mine personnel because the area was being loaded and causing the end rings of the friction bolts to yield. No resin was used in the ore pass hole.

Figure 6 shows the advance of the stope (dashed lines) and the date corresponding to the position of the face so they can be compared to the bolt strain data. Each advance was about 15 ft. Data from the strain gauges were collected from October 10 to October 30, 2002, at which time the MIDAS was removed from each bolt, and the stope was backfilled.

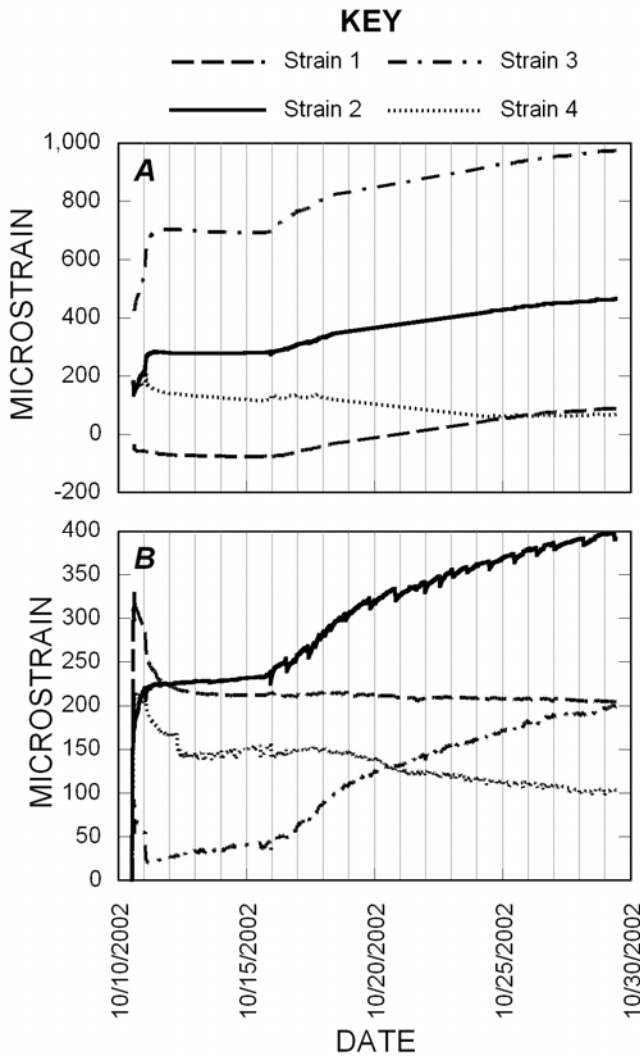
Figure 7.—Axial strain versus time for 39-mm friction bolts installed 5 ft from face. A, With resin; B, without resin.

Figure 7 shows the data plots of axial strains versus time. Since the MIDAS was zeroed out, the first movement in strain resulted from the first advance of the drift, resulting in a new face (October 11 on the figure). A day later, the second advance was made (October 12 on the figure). The third advance was 5 days later, resulting in the final face of the stope on October 17.

Figure 7A shows the strain on the 39-mm friction bolt installed with resin. Strain gauge 3, at 3 ft back from the ring end, shows the greatest amount of initial and final strain. Tensile strain is positive. The initial instantaneous strain shown by gauge 3 is 400 microstrain and resulted from the first face advance. The sharply rising increase to 700 microstrain resulted from an additional 300 microstrain of tensile strain from the second face advance. A 5-day pause in mining resumed with the third and final face advance on October 17, which completed mining of the stope and resulted in another increase of slowly creeping tensile strain of 300 microstrain. Final strain reached 1000 microstrain. The final stress in the bolt at gauge 3 is found by multiplying the strain by the Young's modulus of the steel (30 million psi), resulting in a bolt stress of 30,000 psi that is about one-half the yield strength of the bolt.

Strain gauge 2, 2 ft back from the ring end, showed behavior similar to that of gauge 3, but lower in magnitude, with

microstrains of 150 (initial), 300 (secondary), and 400 (final). Gauge 1, in the reamed out portion of the hole, responded to the initial advance with a slight negative or compressive strain and was flat until the third advance, where it showed a slowly creeping tensile load increase of 100 microstrain. Gauge 4 showed an initial instantaneous tensile response of 200 microstrain that then declined gradually but steadily to 50 microstrain at the end of mining.

Figure 7B shows the 39-mm friction bolt installed without resin. The most prominent feature is the "stick-slip" pattern of the second gauge, which occurred near the time of the third face advance. A slowly creeping stick-slip resulted in a final value of about 400 microstrain. Gauge 3 showed a pattern similar to that of gauge 2 without the stick-slip for the second and third face advances. This gauge went into compressive strain with the first face advance. Gauge 4 showed an initial tensile strain of 200 microstrain that decreased to about 100 microstrain at the end of mining. Gauge 1 showed an initial strain of 325 microstrain that decreased quickly to a value of 200 microstrain for most of the mining.

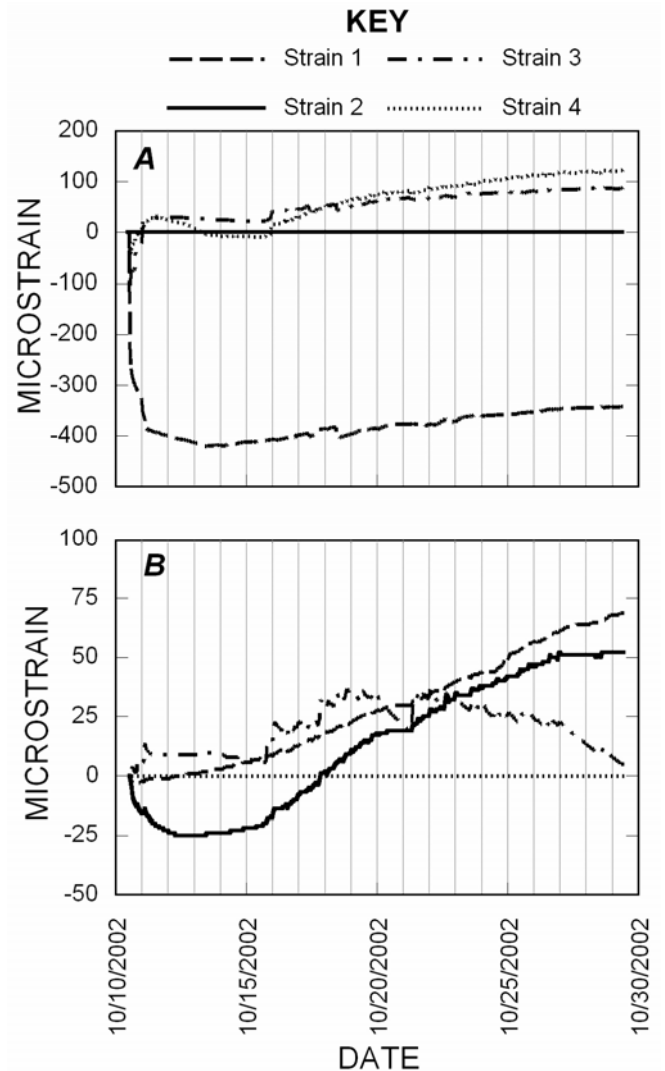
Figure 8.—Axial strain versus time for 46-mm friction bolts installed without resin. A, Bolt installed 5 ft from face and 3 ft above floor; B, bolt installed 100 ft from face and 5 ft above floor.

Figure 8A shows the 46-mm bolt installed without resin. One or two of the lead wires of strain gauge 2 were apparently torn off during installation. Gauges 1, 3, and 4 went into compression (-100 microstrain) during the first face advance. The second face advance caused gauges 3 and 4 to go slightly into tension while gauge 1 continued to increase in compressive strain to -400 microstrain. The reason for this compressive state is thought to be

that the bolt was bending. The third face advance shows all operating gauges undergoing slow tensile creep for an additional 100 microstrain.

The fourth friction bolt was installed in the rib near an ore pass about 100 ft from the initial stope face. Because some of the rings on the friction bolts were coming off in the mine, a bolt was placed there to determine the amount of loading taking place near the ore pass. Figure 8B shows that the initial face advance did not load the bolt significantly. A slight amount of loading (from 50 and 75 microstrain) occurred near the third face advance for gauges 2 and 1 respectively. The ring damage on the friction bolts may have resulted because bolts installed early in the mining cycle of the stope are initially loaded from the face advance and then are loaded by slow creep that ultimately exceeds the strength of the ring weld on the friction bolt.
