Geomechanics of Large Stone Structures: A Case History from the Washington National Cathedral

ABSTRACT: The Washington National Cathedral is one of the largest masonry structures in the USA, and like many of its European Gothic counterparts, it required nearly a century to construct. The design was altered during this period, resulting in greater loadings than were originally anticipated on the soil beneath the foundation. When signs of continuing differential settlement were observed in the early 1990's, the Cathedral approached the US Bureau of Mines (now the National Institute for Occupational Safety and Health (NIOSH)) for assistance in monitoring the movements of the massive towers and walls. An array of dual-axis tiltmeters was installed about 40m above ground level to measure wall and tower inclination, with the data sent over a dedicated phone line to the NIOSH Pittsburgh Research Laboratory for processing. Mechanical gages and string-potentiometers are also being used to measure motion across cracks and joints, and differential pier settlement is being monitored with optical-level surveying. Data have now been collected for almost 7 years, and they show a long-term settle

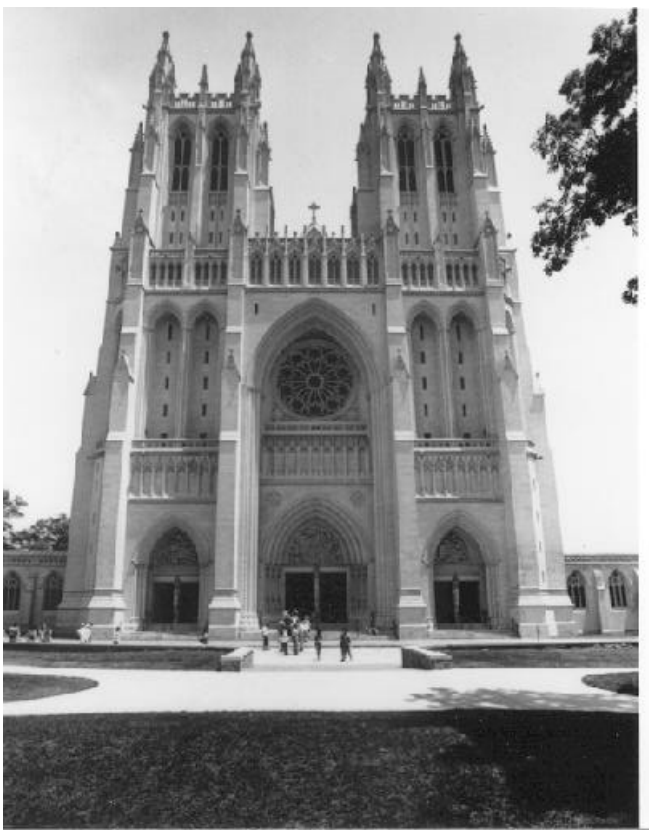
Figure 2. View of the west front and west wings of Washington National Cathedral.

The entire foundation, including that for the projected west front towers, 8 m in depth, was in place by 1924. The structure of the choir was completed in 1930. Work slowed during the depression and WWII, but the three eastern-most bays of the 31-meter tall (floor to vault keystone) nave and both transepts were standing by 1966, by which date the 92 meter high crossing tower was also complete. Before raising the western-most bays of the nave, the relatively diminutive western wings were constructed between 1963 and 1968 on spread footings isolated from the footing for the west front towers. The nave was completed in 1976, but little further work was carried out at the site until 1983 when the 72 m-high west towers (Fig. 2) were raised in an intensive six-year building campaign (Feller 1989).

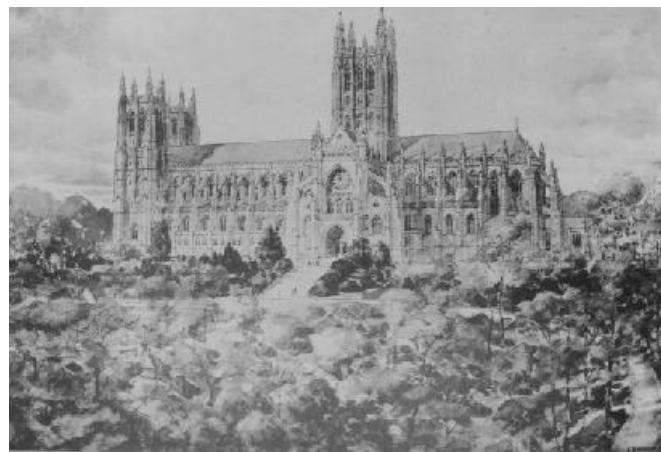
Figure 4. Prospective of the south flank of the Washington National Cathedral, by Donald Robb in 1934, indicating grade below the South transept outer wall.

The differential settlement is largely a consequence of several crucial, early decisions made by the Cathedral architects. The first of these, a determination made around the time of the original design (1907), is linked to the positioning of the Cathedral on the building site. The south transept arm lies at the summit of a long, steep hill extending away from the end wall of the transept (Fig. 4) that was filled to furnish a more-or-less level building site. Secondly, no core samples were taken of the subsoil below the foundations during any stage of construction. Instead, the foundation was designed using information obtained from test pits. The Cathedral is sited on one of the highest elevations in the District of Columbia, and thus it might appear that bedrock would lay close to the surface. However, the test pits showed that the upper 10 m of ground consisted of layers of relatively competent silty sand and clayey sand. It was assumed that these soils continued down to bedrock. In fact, test borings taken by Schnabel Engineering Associates (1994) near the west towers found that the hard shale bedrock is 35 m deep, and that the lower 25 m of soil includes layers of “fat” (fine-particle high-plasticity) and “lean” clays. Laboratory testing indicated that the clay soils display primary and secondary consolidation behavior, and that they are overconsolidated. Figure 5 is an idealized soil section based on those borings, and Table 1 shows representative geotechnical properties.

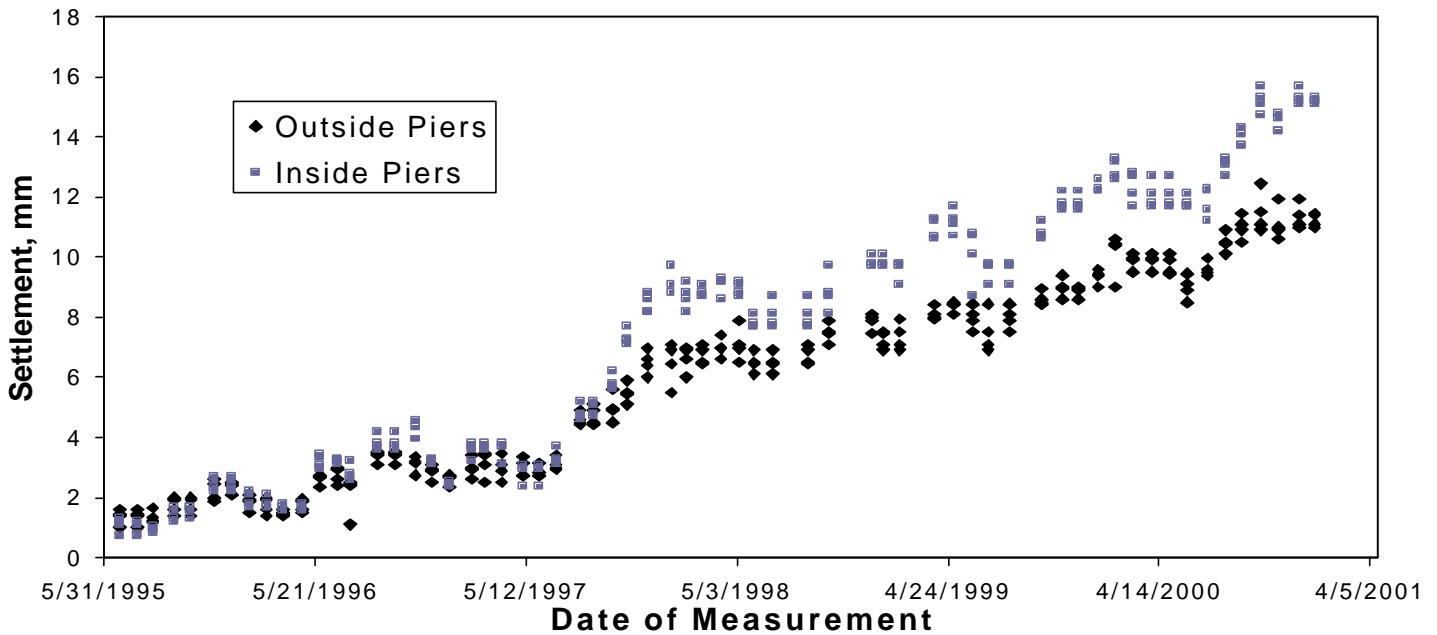
Figure 8. Level elevation measurements from the piers supporting the west towers. The “inside piers” are located closer to the longitudinal centerline of the Cathedral, the “outside piers” are located closer to the wings.

much less pronounced. However, ongoing slow settlement is clearly evident in the data. Regression lines through the measurements on each of the eight supporting piers indicates that the average rate of differential settlement during the last six full years is approximately 1.4 mm/year (Fig. 8). The r-squared for these regressions averaged 0.8. The measured rate is slightly greater than the calculated value of 0.9 mm/year for secondary settlement during this period. While there is no evidence yet that the rate of secondary settlement is diminishing, the current rate is appreciably less than it was during the period of primary settlement (when it averaged about 8 mm/year).

The data also indicate that the eight piers are settling at slightly different rates. The average for the outer four piers ranged from 0.118 to 0.123 mm/year, while the inner four rates range from 0.153 to 0.156 mm/year. It appears that the concrete mat foundation, which is believed to be unreinforced, is bowing slightly in response to the soil pressure.

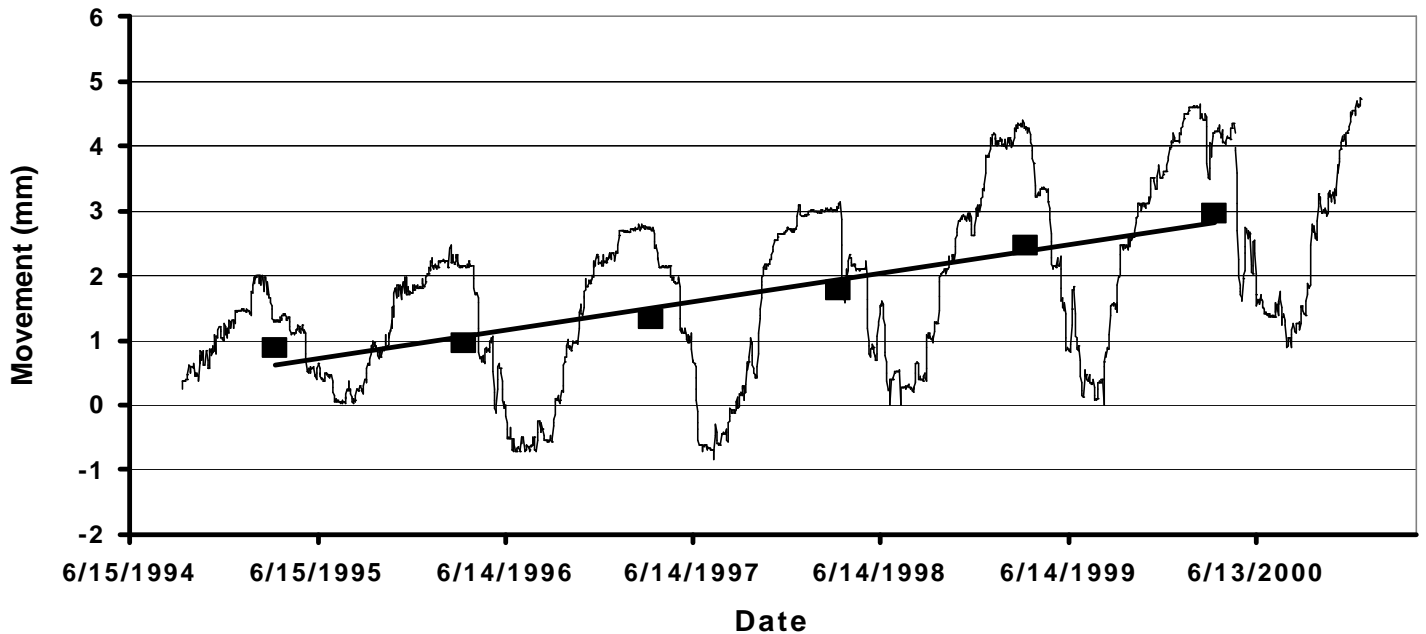
Figure 9. Gap movement (in mm) vs. time measured by a string potentiometer installed over the nave high vault adjacent to the south-west tower. Annual averages and the regression line through them are also shown.

The automatic, effectively-continuous data recording from the string potentiometers has been effective in showing long-term crack opening trends. For example, regression of data from the string potentiometer located over the high vault adjacent to the south-west tower indicates a rate of 0.43 mm/year (r-squared = 0.95 based on yearly averages). The

maximum yearly range, due to seasonal effects, is as much as 4.5 mm/yr (Fig. 9). The less frequent mechanical measurements broadly agree with the string potentiometers.
