# INVESTIGATION OF PILLAR-ROOF CONTACT FAILURE IN NORTHERN APPALACHIAN STONE MINE WORKINGS

**Gabriel S. Esterhuizen**, *Mining Engineer*  
**Anthony T. Iannacchione**, *Senior Scientist*  
National Institute for Occupational Safety and Health  
Pittsburgh Research Laboratory  
Pittsburgh, Pennsylvania USA

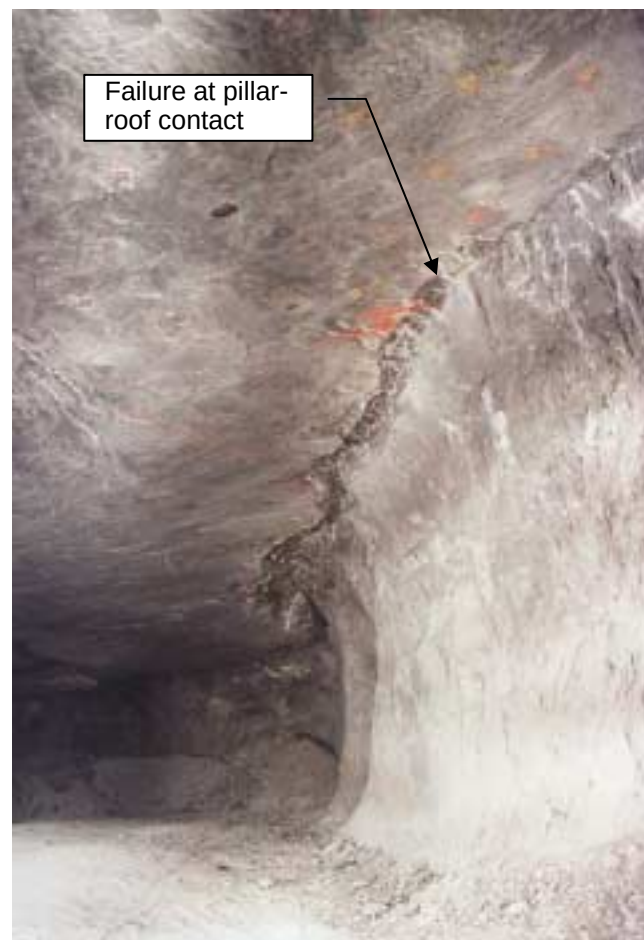
Figure 1. Photograph showing failure at pillar-roof contact after loose rock has been removed and roof has been re-supported.

Pillar-roof contact failure differs from the typical failure mode described above because it is asymmetrical, usually occurring only along one edge of each pillar in an array of pillars. The failure is initially restricted to a small area around the pillar edge, but may propagate to the full collapse of an entire room. Figure 1 illustrates a typical example of pillar-roof contact failure. The failures all appeared to be caused by stress related damage of the intact rock. The mode of failure, whether tensile or compressive, was not always readily observable. In several cases the failed rock had been removed and the roof had been scaled back to a solid face, which precluded direct observation of the failure mechanism. Both cases of pillar-roof contact failure were associated with a dip of greater than 5°.

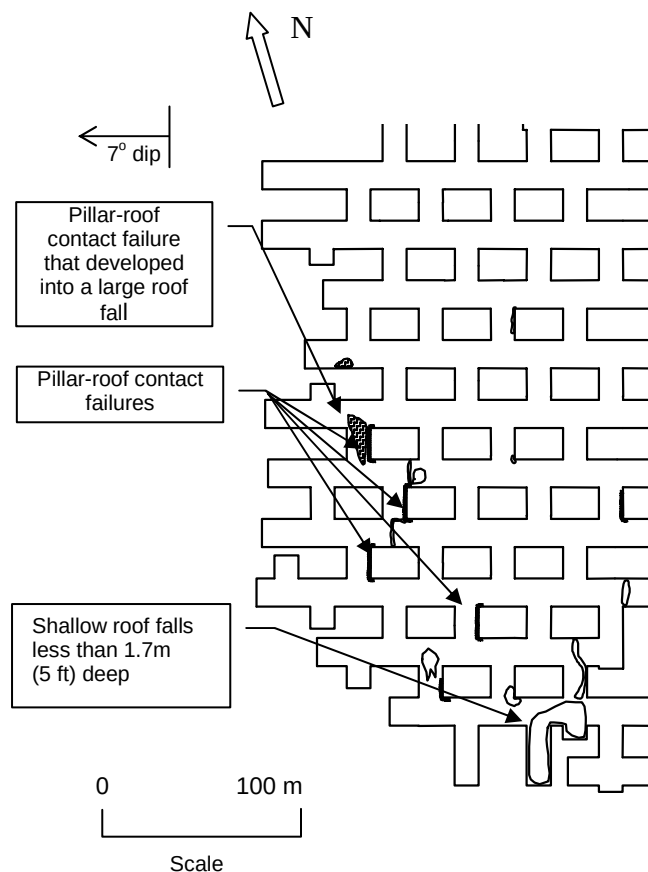
Figure 2. Plan showing layout of pillars and location of pillar-roof contact failures at case study site.

Asymmetrical failures at the pillar-roof contact were observed only in the southwestern part of the mine where the dip is gradually increasing. Figure 2 shows a plan view of a portion of the workings and the locations of pillar-roof contact failures as well as other roof failures. At one of the locations, the pillar-roof contact failure progressed into a massive directional failure. In this area the major horizontal stress appears to be oriented at approximately  $N80^\circ W$ , parallel to the dip of the limestone. The change in orientation is apparent from major roof falls which are oriented along the strike of the workings in this area. Further indirect evidence of the major horizontal stress parallel to the dip is the dip-symmetry of the pillar-roof contact failures.

The case study mine is located in the Loyalhanna Formation which is nearly horizontal in the greater proportion of the workings but increases to  $7^\circ$  in the south-western part of the mine. The Loyalhanna formation in this area is between 17 m (55 ft) and 20 m (65 ft) thick. The limestone is massive, fine to medium grained with cross beds and strong, discontinuous bedding layers in the main body of the formation. The upper 3 m (10 ft) of the formation contains well developed laminations and alternating layers of weaker and stronger limestone, sandstone and shale. The immediate roof rocks are fine to medium grained sandstone but may also contain interbedded shale and limestone bands of the Mauch Chunk Formation. The RQD in the layered upper portion of the limestone formation is typically 85-95% increasing to 100% in the main body. At the base of the pillars in benched areas the floor rocks are a fine to coarse grained Pocono sandstone occasionally with a weak shale contact. RQD values in the floor are in the range of 60% to 90%. The Rock Mass Rating (RMR) (Bieniawski, 1989) of the massive limestone is in the range of 85 to 90 units. The mine exhibits many of the characteristic signs of excessive horizontal stress conditions. Mapping of roof damage has confirmed the presence of sporadic roof shearing and occasional massive directional roof falls. Most of the roof falls are oval in shape with the long axis in the  $N30^\circ W$  direction.

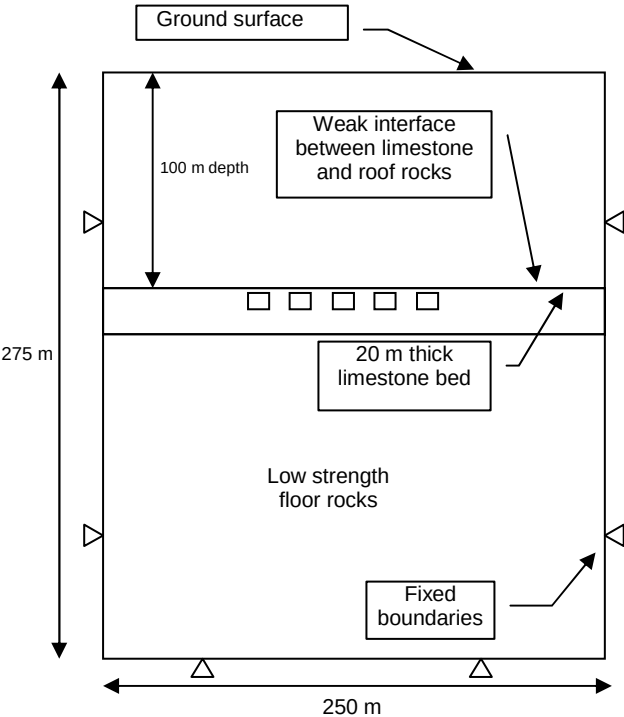
showing the room, pillars and location of the weak interface is presented in figure 3. The material properties were selected to represent typical Loyalhanna limestone and the surrounding weaker rocks. Table 3 lists the material properties used in the basic model setup. The model was loaded in the vertical direction by gravity. The horizontal stresses were initialized to simulate the effects of constant tectonic strain, varying between 0.1 and 0.4 millistrain. The horizontal stress in the stiff limestone was always higher than in the softer surrounding rocks owing to the constant tectonic strain field. In these models the rock was assumed to be linearly elastic, so that shedding of stresses due to rock failure would not occur.

Figure 3. Numerical model layout showing location of rooms and pillars in the limestone formation.

The parametric study was carried out to assess the effect of an increase in the dip on roof stability and the potential for pillar-roof contact failure. A base case two-dimensional FLAC model was set up to simulate the mining of a series of rooms in a 20 m (66 ft) thick limestone bed with a nominal depth of cover of 100 m (330 ft). The contact between the top of the limestone and the overburden was simulated as a weak interface, which is free to slide if the frictional resistance is overcome. The model layout,

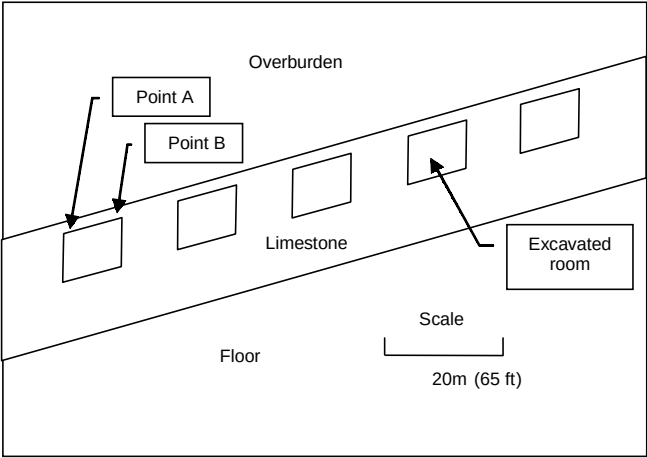
The effect of an increase in the dip of the workings on stresses in the roof was assessed by changing the dip of the limestone in the model to 5, 10 and 15°, see figure 4.

Figure 4. Detail of numerical model showing dipping limestone formation and location of Points A and B for assessment of stresses in the roof beam.

The results of an analysis in which the horizontal stress in the limestone was 25 MPa (3,620 psi) (corresponding to a tectonic strain of 0.36 millistrain) are presented in table 4. These results show that the stress at the down-dip corner of the roof tends to decrease with increasing dip, while the stress at the upper corner increases. The changes in stress are relatively small. This implies that failure will only be caused by an increase in dip if the roof is already highly stressed and is near the point of failure. Under such a scenario, an increase in dip may initiate asymmetrical failure at the pillar roof contact on the up-dip side of a room.

<sup>1</sup>Refer to figure 4 for location of points A and B.

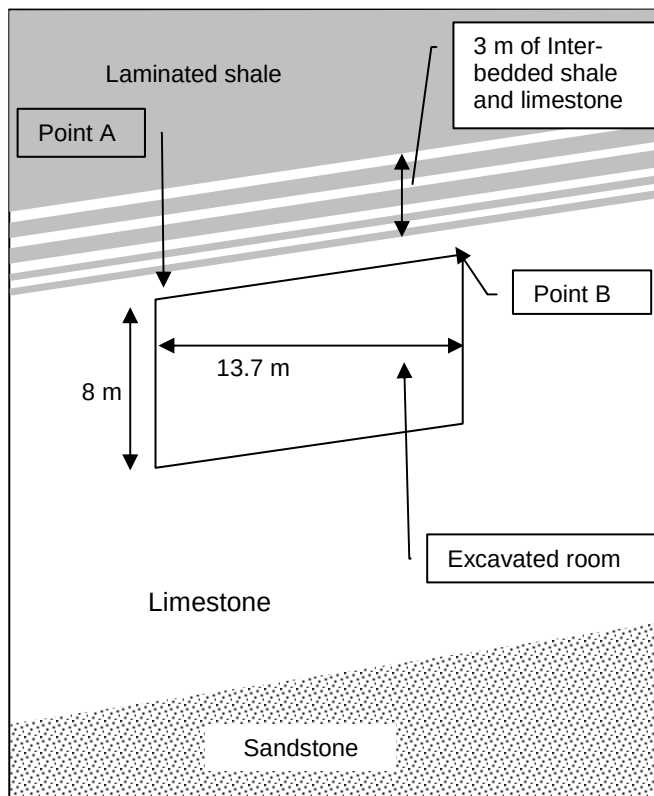
A detailed FLAC model of three rooms and the four adjacent pillars was used to back analyze the observed pillar-roof contact failures. The strain-softening ubiquitous joint constitutive model in FLAC was used to simulate the effect of layering of the rocks. This allows initial rock yield to occur and stresses to be shed as the failure progresses. A portion of the FLAC model is presented in figure 5, which shows the detail of the layering of the limestone and weaker overburden materials. The strength properties of the limestone rocks and the weak and strong roof beds are listed in table 5. The large scale rock strengths of the limestone and surrounding rocks were reduced by 0.58 from the laboratory determined strength values to account for the difference in strength of laboratory size specimens relative to the field scale, after Hoek and Brown (1980). The main body of the limestone was modeled as a massive unit, without any bedding weaknesses. The effect of weak bedding layers within the limestone pillars was evaluated separately.

Figure 5. Detail of the numerical model used to assess the effect of dip on roof stability for the case study site. The locations of point A and B for assessment of roof stability are shown.

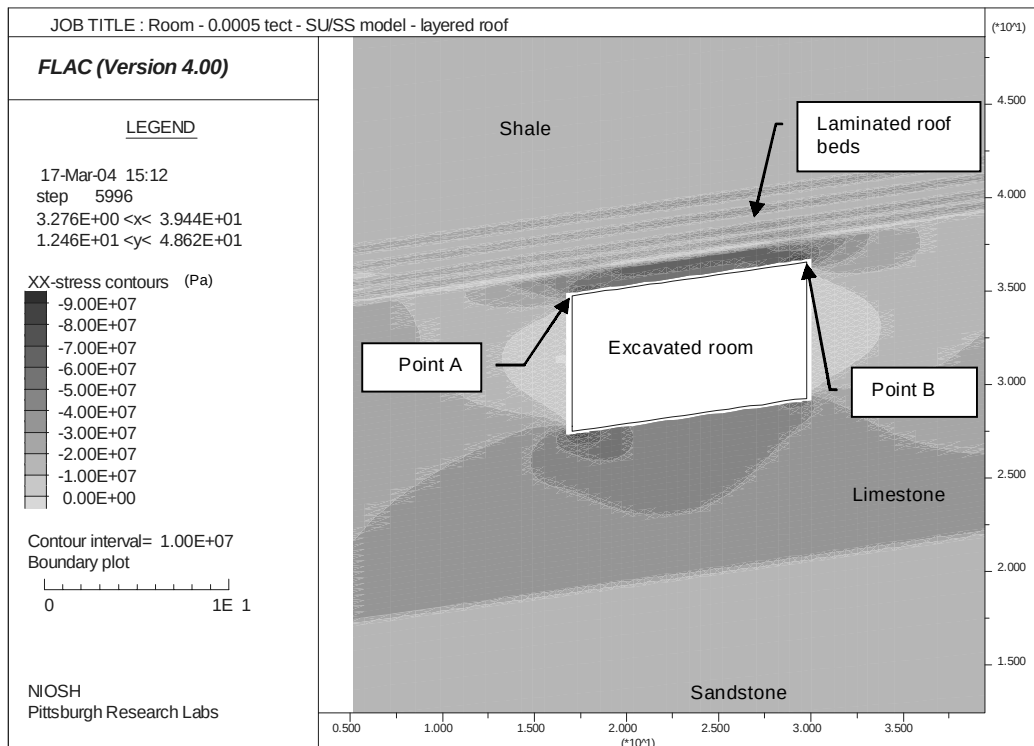
The horizontal stresses in the rock surrounding the room are presented in figure 6 which clearly shows the asymmetrical nature of the stress distribution. The average horizontal stress in the roof beam increased considerably above the tectonic stress in the limestone, being in the range of 50-60 MPa (7,250-8,700 psi) at center span while the tectonic stress was 35 MPa (5,070 psi). The maximum horizontal stress values in the roof beam are found near the corners of the room. The horizontal stresses adjacent to the downdip corner (Point A) and updip corner of the roof (Point B) were 73.5 MPa (10,660 psi) and 88.5 MPa (12,830 psi), respectively.

Figure 6. FLAC plot showing horizontal stress distribution around a room with interbedded roof rocks in massive limestone. Contour intervals are 10 MPa (1,450 psi). The tectonic stress was 0.5 millistrain.

The stress near the updip corner of the room is therefore approximately 20% higher than at the downdip corner. This is consistent with the observations that showed that failure initiated at the up-dip corner of the rooms and confirms that failures at the pillar-roof contact are likely to be the result of asymmetrical stresses owing to the dip of the workings.

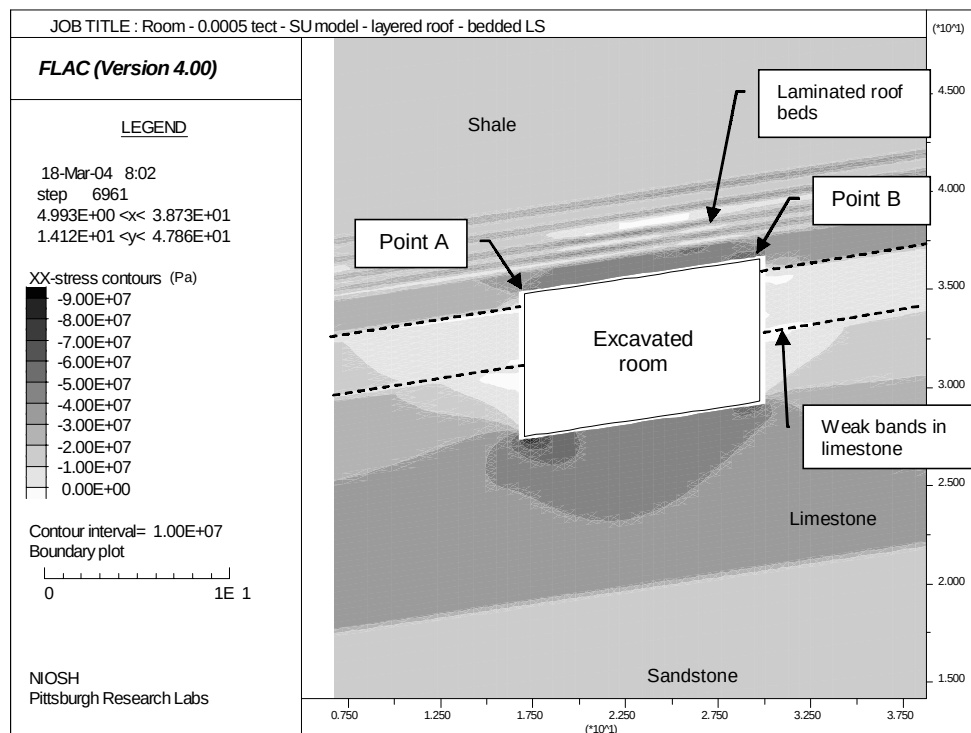
Figure 7. FLAC plot showing horizontal stress distribution around a room with interbedded roof rocks in limestone containing weak bands. Contour intervals are 10 MPa (1,450 psi).

The above analyses demonstrated the importance of layering in the roof and stress relief by sliding along weak beds. The fact that failure at the pillar-roof contact did not occur at all the pillars was thought to be related to a stress relief mechanism, which may be associated with weak bands in the limestone. Consequently, a model was set up to simulate limestone pillars that contain two weak bands near mid-height. Figure 7 shows the horizontal stress distribution in such a pillar, and can be directly compared to figure 6. It can be seen that stress relief along the weak bands in the pillar result in a significant reduction in the stress in the roof. The horizontal stress at Point A reduces from 73.5 MPa (10,660 psi) to 54.3 MPa (7,870 psi), which is a 26% reduction. The horizontal stress at Point B reduces from 95.6 MPa (13,860 psi) to 65.1 MPa (9,440 psi), which is a 32% reduction.

The results demonstrate that the presence of weak bands in the limestone may act as a stress relief mechanism. Limestone containing strong and discontinuous bedding would therefore be more prone to stress related roof failures than a limestone with weak bedding planes.
