Improving the Capability for Real Time Assessment of Roof Conditions Through Intelligent Roof Bolt Drilling Operations

Robert Anderson, Design Engineer
J. H. Fletcher & Company
Huntington, WV

L. J. Prosser, Research Scientist
NIOSH-Pittsburgh Research Laboratory
Pittsburgh, PA

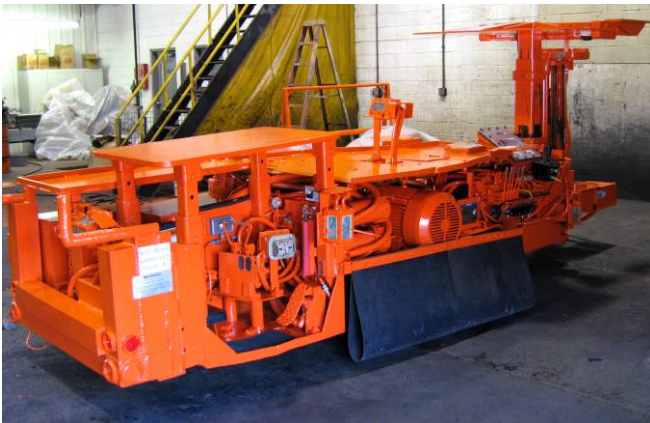
In another joint project with WVU, a test machine was built for use in an underground coal mine. An older single-boom roof bolter was rebuilt with modern components including the latest generation of drill head and drill control unit. The FLETCHER® Information Display was installed in an explosion-proof housing on the machine. Figures 3 and 4 show the coal test machine and the information display.

Figure 3. Roof bolter used for testing in underground coal mine.

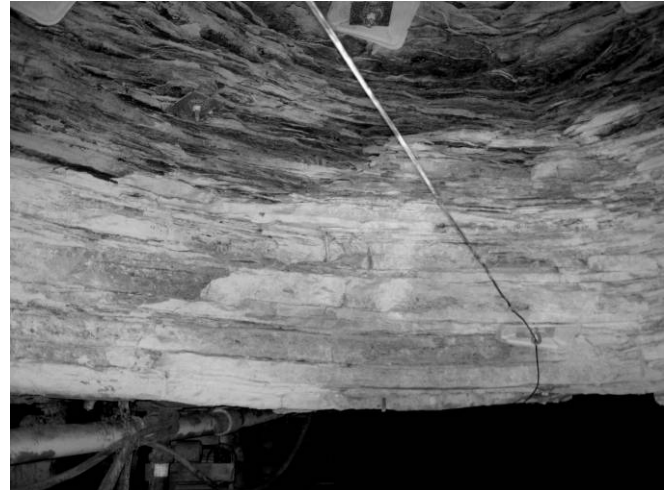
The test machine was moved to another section of the mine where there had previously been roof problems including a large roof fall. Figure 5 shows this area and gives a cross section of the roof strata in this area.

Figure 5. Section of roof adjacent to large roof fall.

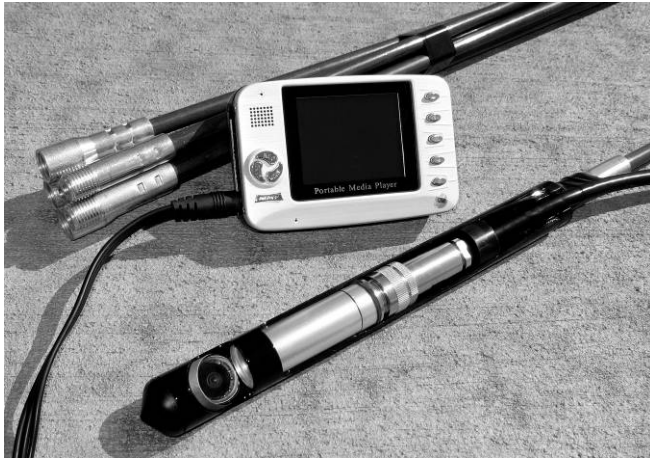
Scoping holes were also analyzed using a small bore scope (less than 1 in diameter) as shown in figure 7. Video files were recorded for each hole. Initially, the bore-scope videos showed few discontinuities in the holes. Only two of the holes had obvious voids (see figure 8). The holes were flushed out with water, assuming that dust from the drilling might be obscuring the voids. The holes were bore-scoped a second time and again there were not clear voids at the locations indicated on the drill data files. A scratch tool was used to feel for soft bands or ledges in the holes.

Figure 7. FLETCHER® Bore Scope.

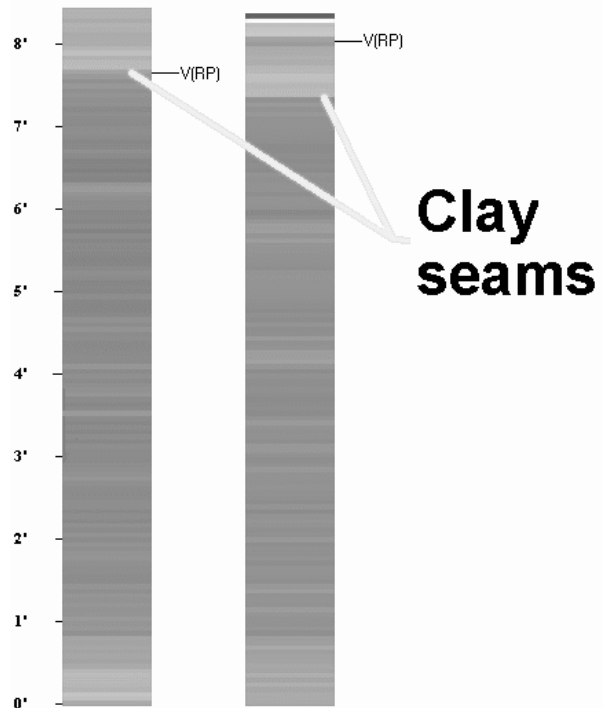
A Pennsylvania limestone mine which has the pendant recorder on a roof bolter offered another opportunity to record drill data files and compare them to bore-scope video. Again, NIOSH was present to observe these tests. Here, four holes were drilled in two different sections of the mine. Three of the holes showed large clay seams near the top of the hole. These were visible in the drill data files as lighter shades of gray. When the software sensitivity was adjusted they were marked as voids. The clay seams were clearly visible in the bore-scope videos. Figures 14 and 15 show the hole graphs and a bore-scope image.

Figure 14. Hole graphs showing clay seams.

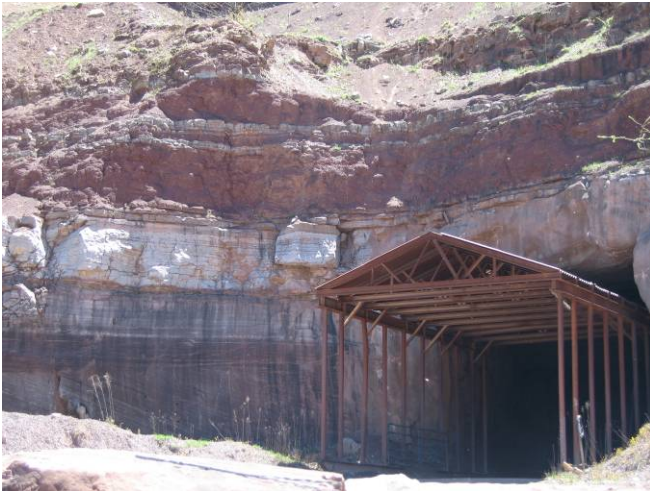
A photo from outside the mine opening shows the red clay above the limestone seam (see figure 16).

Figure 16. Red clay above limestone.
