# MECHANICS OF A LARGE, STRAIN-TYPE ROCK BURST AND DESIGN FOR PREVENTION

Brian G. White, Theodore J. Williams, and Jeffrey K. Whyatt

*Spokane Research Laboratory, National Institute for Occupational Safety and Health, Spokane, WA*

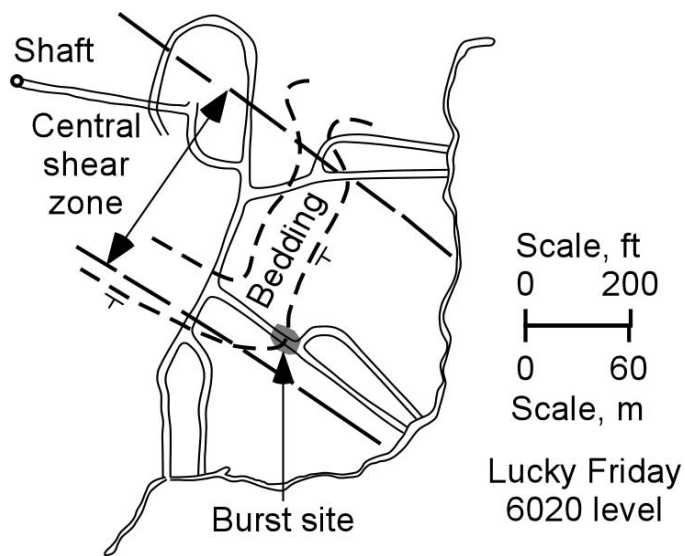
The Lucky Friday ore body is a narrow, steeply dipping galena-quartz vein that has been mined over a vertical extent of 1500 m and to depths of nearly 2000 m. The vein is currently mined from successively developed sublevels, each of which enables development of a number of up- and down-ramps to the vein (fig. 1) [9].

Crosscuts to 06 stopes are driven southeastward from a primary sublevel haulage (fig. 1), which is the best practical location and orientation in the area for avoiding a known major fault. The 06 crosscuts are developed at the same elevation as the highly stressed abutment. Rock bursts affecting 06 crosscuts and ramps have been a recurrent problem, with major

**Figure 1.—Map of typical sublevel showing 06 crosscut, central shear zone, and folded quartzite.**

The 6020 crosscut approximately follows the axial plane of a prominent, nearly overturned anticline that plunges about 30° at this location, resulting in the relatively low bedding dips seen along part of the crosscut (figs. 1 and 2). Steep dips are mapped on the north limb of the fold.

as the “central shear zone,” which is defined by steeply dipping, metamorphic shear foliation and an anastomosing network of minor faults (fig. 1). It is evident that foliation creates important planes of weakness, as the rock often splits into layers parallel to this fabric. Most faults in the central shear zone have little or no gouge, but one fault containing several centimeters of gouge forms the effective northern limit of the damage zone. The strike of the central shear zone structures traverses the crosscut at a slight angle in its most extensively damaged part, but changes to a more northwesterly direction toward the west, where damage diminishes.

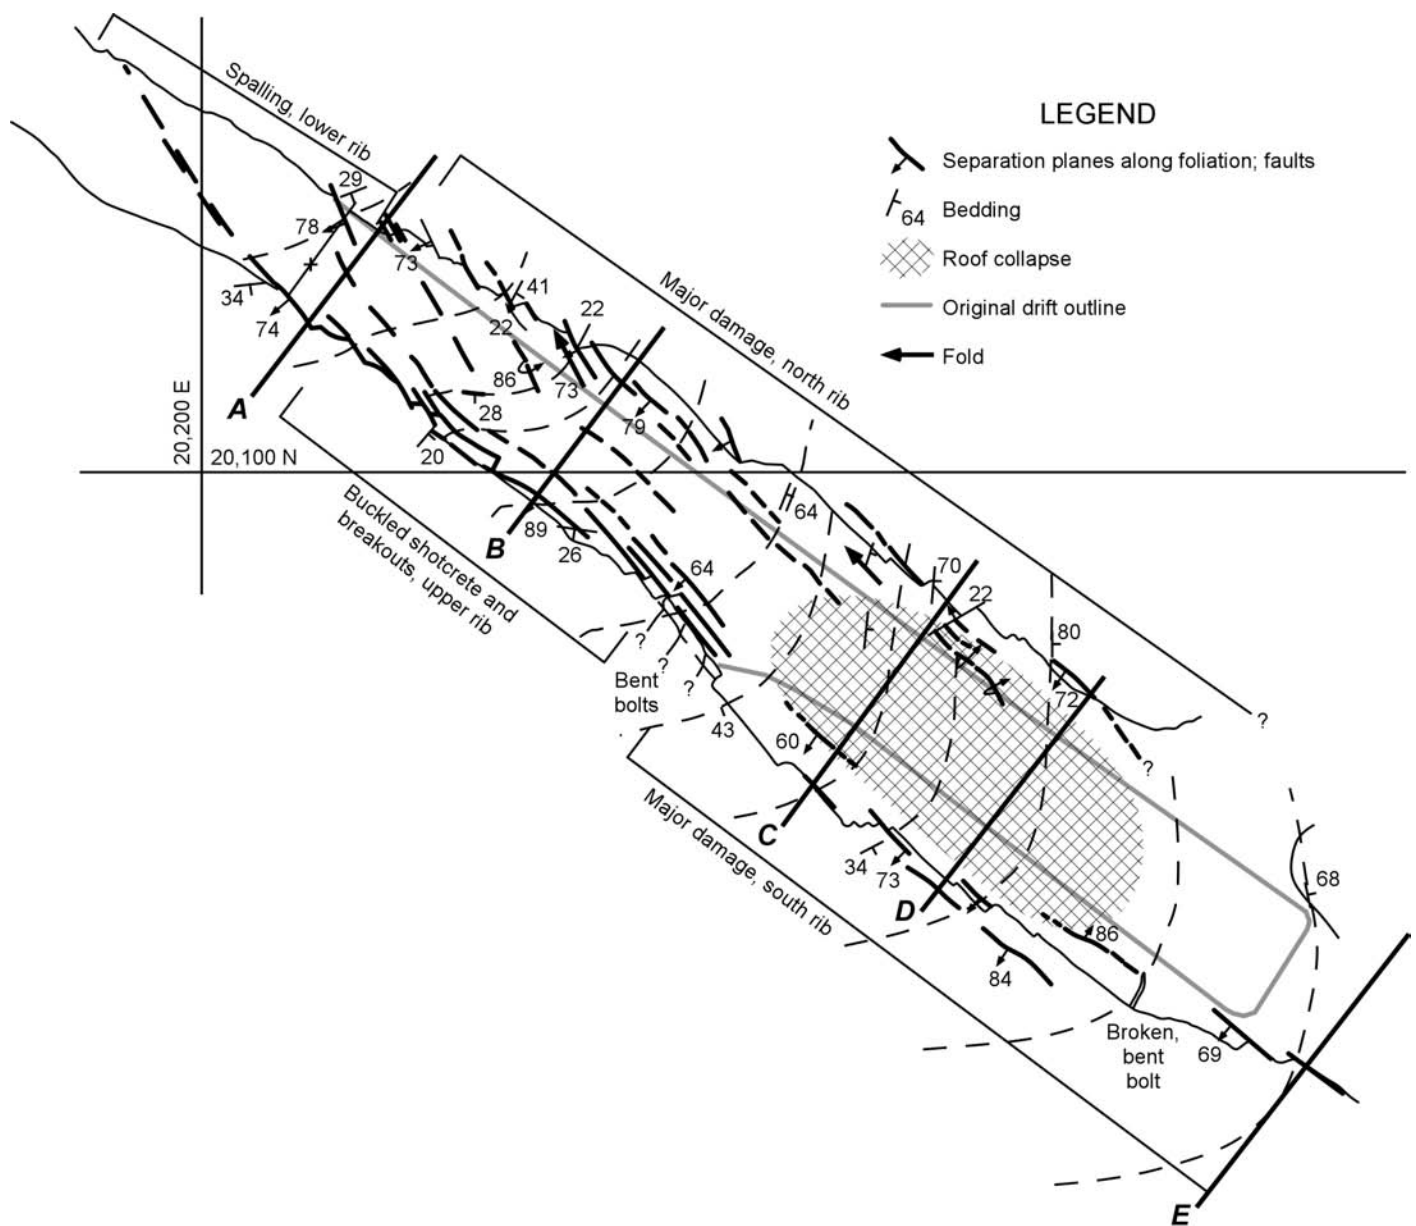
The rock burst expelled approximately 320 tons of broken rock from both ribs, approximately doubling the width of the access (fig. 2). Additional rock came down from the back. After the displaced rock had been removed and new ground support installed, an extensive cavity was exposed on each side of the crosscut. A series of cross sections along the crosscut (figs. 3A through 3E) shows that the damage along opposite sides, both major and minor, is diagonally opposed and centered at different elevations on the respective sides.

Figure 2.—Map of burst site.

the northwest-trending central shear zone (fig. 2). These structures split the rock into 5- to 20-cm-thick layers. The layers were conspicuous at the edges of the burst cavities, where they formed extensive planar surfaces that also tended to form the deeper limits of the cavities (figs. 2 and 3), but were poorly developed across the central part of the back. This contrasts with separations along bedding plane laminations, which, while prominent in the back, were not present at all in the ribs. In each case, the direction of splitting was at a low angle to the respective surfaces and close enough to the predicted orientations of mining-induced fractures that splitting along inherent planes of weakness due to high stress was likely.

Strata at the burst site are massive sericitic quartzite beds (fig. 2) that sometimes split into thin layers along bedding laminations, evidently because of high stress along bedding and the absence of confining pressure.

The second indicator of movement is provided by bent Split-Set bolts that remained relatively intact in a surviving part of the original south rib (fig. 2). Inspection of the interiors of the bolts showed that the collars had moved

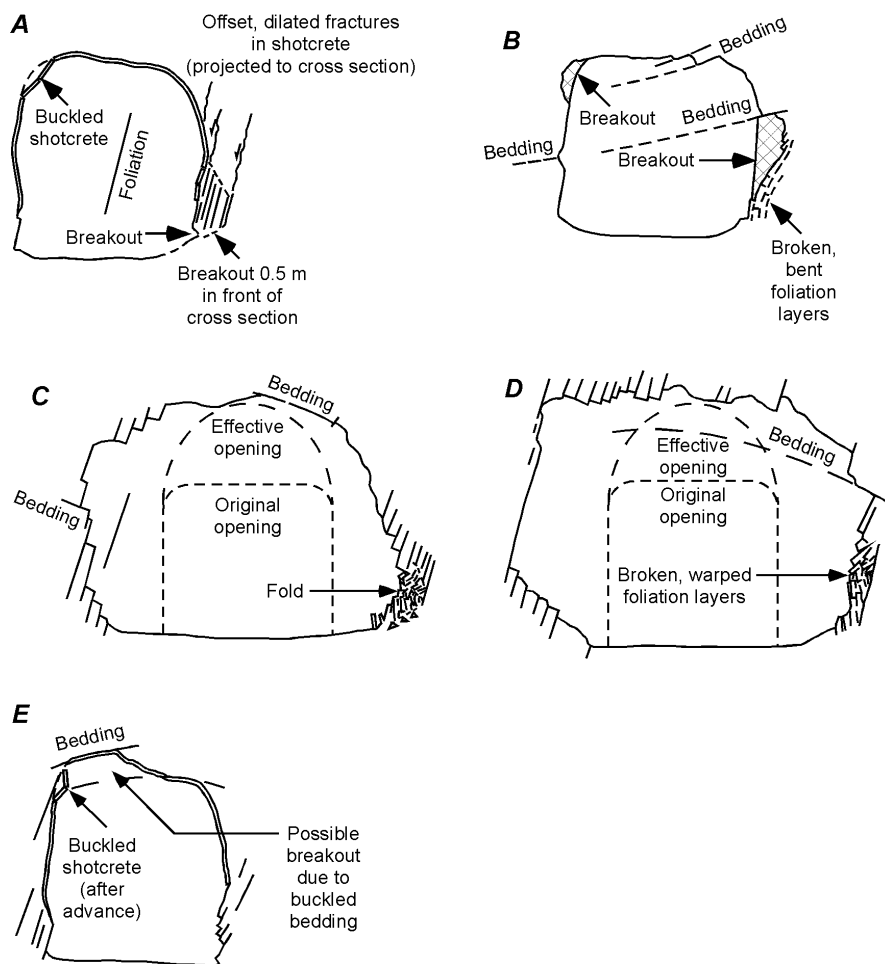
Figure 3.—Cross sections across burst site. Locations are shown in Figure 2.

The directions and relative magnitudes of ground movements involved in the burst were identified by a burst-created fold preserved deep in one of the burst cavities and by bent Split-Set bolts. The fold is defined by intensely broken foliation layers that wrap discontinuously about an axis (fig. 3B, 3C, and 3D). The fold plunges northwest, with its plunge locally measured at  $22^\circ$  as viewed along the side of the fold where the broken layers dip approximately vertically. The amount of shortening represented by the fold can be roughly estimated from the amount of curvature and locally is at least 0.1 to 0.2 m, which identifies significant vertical convergence.

The fold developed above a planar substrate formed by a basal foliation separation plane or minor fault (fig. 3C and 3D). However, the fold appears to die out in the direction of plunge, as planar layers ultimately cover the layers involved in the fold (fig. 3A). This gives the fold a conical shape. These geometries require that slippage took place on a series of basal shear planes, with movements converging toward the center of the fold from one side or the other, or both. The displacement must die out along strike over a distance of 5 to 15 m from the original rib (as estimated from plan view). Since the fold axis plunges at a low angle to the northwest, compressive shortening along a line raking steeply southeast is indicated.

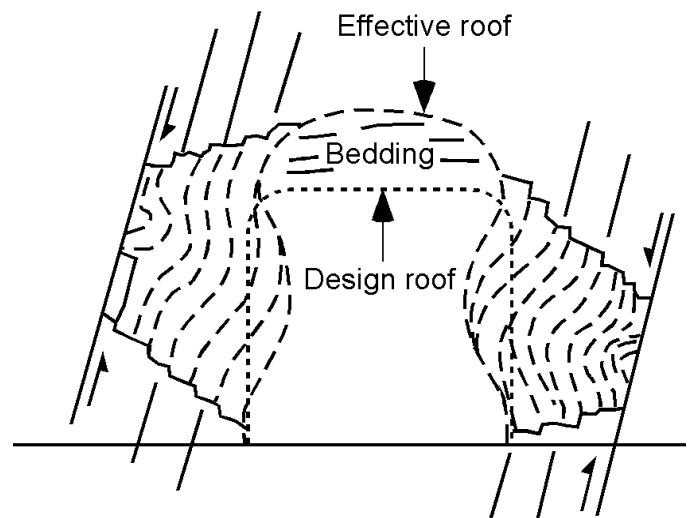
be unrecognizable as a fold. Only compressive shortening in the plane of the shears, accompanied by slippage along a basal shear plane, can account for the fold (fig. 4). If crushing were instantaneous, which is implicit, bulking of broken rock would have briefly created confining pressure within the interior of the broken mass, enabling the fold to develop without being ejected. Damage to both ribs was accompanied by displacement toward the central part of each cavity and is reasonably explained by buckling and breakage of the rock layers. Damage to diagonally opposed parts of the opening, frequently seen with large rock bursts in crosscuts, also argues for the burst resulting from compressive stress.

On the side of the crosscut where layers dip toward the opening, the innermost layers would have become the most tightly folded (fig. 4). However, since the strike of the layers was also oblique to the crosscut, the outermost layers would have assumed the position of the innermost layers at some distance into the

Figure 4.—Schematic of buckled, broken rock layers responsible for damage.

section. Consequently, the fold would be conical and plunge into the section, just as is seen at the burst site. Thus, the geometries predicted to be produced strictly by buckling are identical to those actually seen and provide additional support for the interpretation that the breakouts and the fold resulted from buckling caused by compression along a line raking steeply southwest.
