USE OF GROUND PENETRATING RADAR AND SCHMIDT HAMMER TESTS TO DETERMINE THE STRUCTURAL INTEGRITY OF A MINE SEAL

*National Institute for Occupational Safety and Health
Pittsburgh Research Laboratory
Pittsburgh, Pennsylvania*

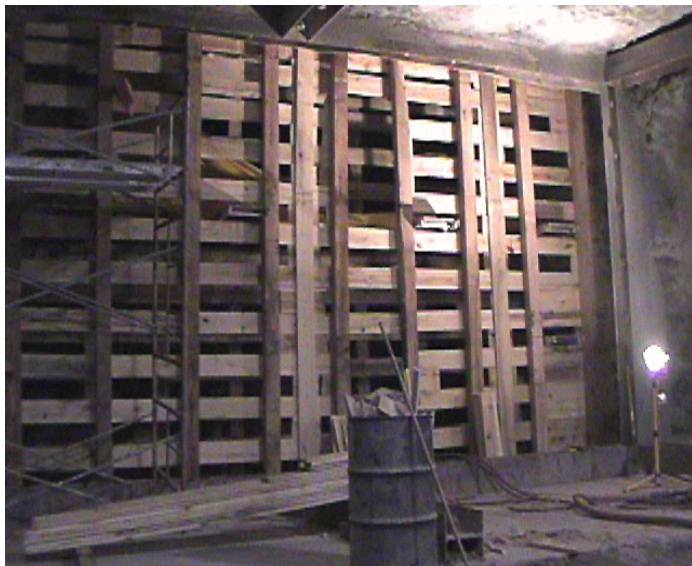
Figure 2. Mine seal form under construction showing posts and cross members.

Mine brattice cloth was placed on the inside area of the form and was overlapped on the mine roof and rib areas and was secured with straps to form a tight seal. Eye bolts were then attached to each post through the brattice cloth and were tied together with 1/8-in galvanized steel cable that was extended between the front and back of the form. The eye bolts were spaced approximately 32 in apart on each post and were used throughout the vertical extent of the form. The eye bolts and cable served to tie the front and back walls of the form together and assisted in keeping the walls parallel and straight.

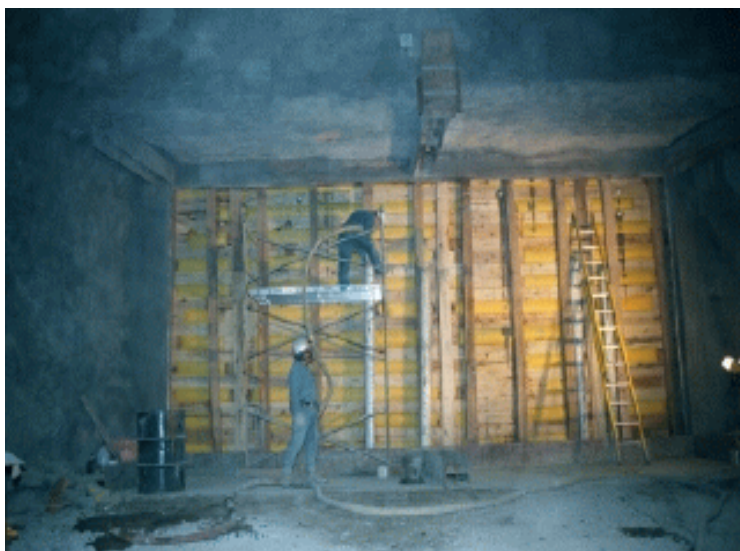
Figure 3. View of mine seal at a late stage in construction.

concentrate, approximately 436 gallons of water and 989 bags of Quikrete cement.¹ The water and foam concentrate was mixed together and was added to the cement at a rate of 8.5 gpm. The resulting slurry was then pumped into the form. The first lift was poured to a height of 72.5 in above the mine floor and was left to set overnight. The next day, before the second lift was poured, it was observed that a hard surface had formed at the top of the lift. The second lift was poured to a height of 77.5 in (or 150 in above the mine floor) using the same mixing procedure and was also allowed to set overnight. As had been observed the previous day, it was noticed that a hard surface had formed at the top of the second lift. The third lift was constructed using the same procedure as the first two lifts to fill the remaining 43.2 in space to the mine roof. The overall dimensions of the resulting mine seal were 30 ft wide by 16.1 ft tall by 4 ft thick (figure 2).

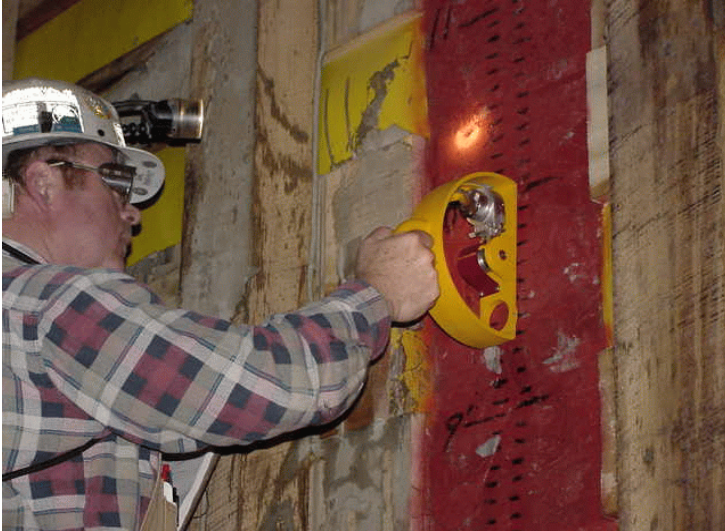
Figure 4. Miner performing Schmidt Hammer test on Section 3 of the mine seal.

Schmidt Hammer tests were performed on the seal using a pendulum-type unit as shown in figure 3. Tests were made in triplicate at each location over the vertical extent of each section of the seal. The resulting values were then averaged for each location and this average value was used to calculate the compressive strength for any given height. The results of the Schmidt Hammer tests expressed as compressive strength are shown in Figures 4 to 6. It is assumed that the values of compressive strength only represent the conditions of the mine seal to a depth of about 1 ft. As can be observed in each figure, there appears to be an overall gradual decrease in compressive strength progressing higher through the vertical

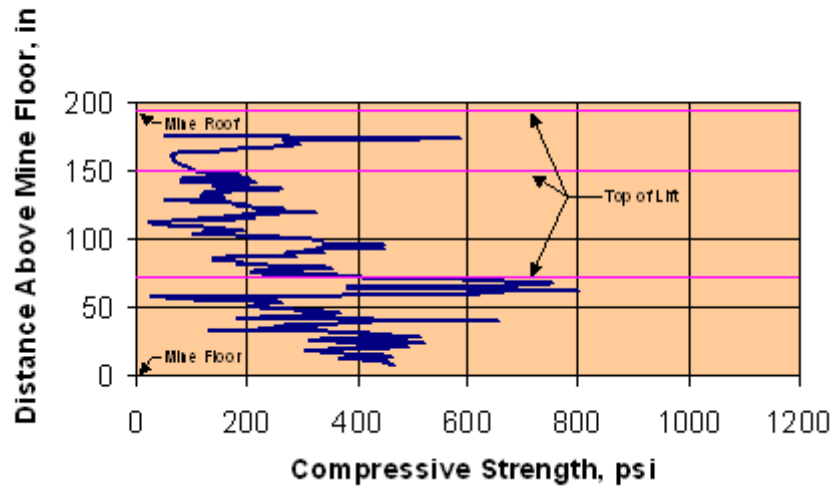
Figure 6. Plot of calculated compressive strength from Schmidt Hammer test data versus distance above the mine floor for Section 2.

extent of the mine seal. Although the exact reason for the change in compressive strength is unknown, it is speculated that the following factor could be responsible. Bubbles in the foamed water in the lower portions of the seal may have been compressed or squeezed-out during construction. This process would then create a seal with more dense material near the lower portions and progressively less dense material moving upward towards the top of the seal.

Examining each lift, there is a marked increase in compressive strength near the top of lift 1 across all sections. This increase is also observed near the top of lift 2 in Section 1 (although not as dramatic) and similarly in Section 3. During the construction process for

each lift, all components of the seal material were mixed and blended in a pipeline, rather than in a bulk mixing tank. As the seal was being poured towards the top of the lift, it is speculated that the liquid components of the mix may not have been added at the exactly the same concentration (perhaps lower) as was used earlier in the pour. If this occurred, then the resulting material, when cured, would have a higher compressive strength at the upper area of a lift.

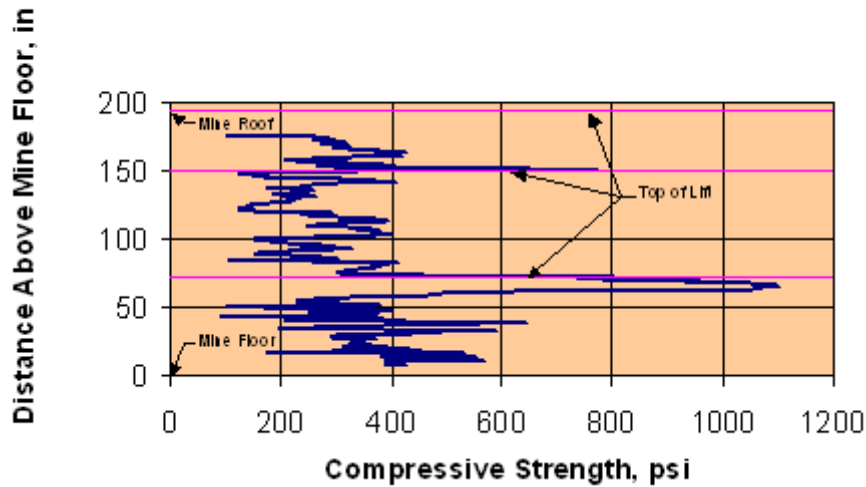
Figure 7. Plot of calculated compressive strength from Schmidt Hammer test data versus distance above the mine floor for Section 3.

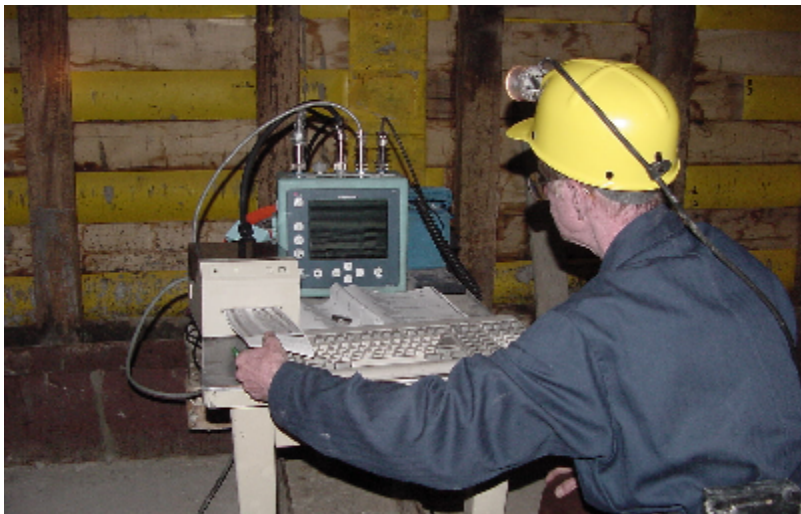
Figure 8. Engineer monitoring SIR-2 unit during GPR scan of mine seal.

A total of 25 scans were made of the mine seal. Each scan was made by placing the antenna against the seal face and then moving downward at a constant velocity (figure 8). Reference points were placed into the record corresponding to the 1 ft marks on the mine seal. In this manner, it was easy to associate any observed anomalies with the specific location on the mine seal. The scan data were analyzed using GSSI's Radar Data Analyzer for Windows NT (RADAN) software.¹ This package allows the user to operate in the Windows environment with application-specific modules. An example of an interpreted radar record showing an anomaly is displayed in figure 9. Figure 10 shows the positions of all observed anomalies from the GPR scans of the mine seal. As shown in figure 10, a total of 12 anomalies were observed in scans where the 500 MHz antenna was used and 4 anomalies were observed in scans where the 400 MHz antenna was used.

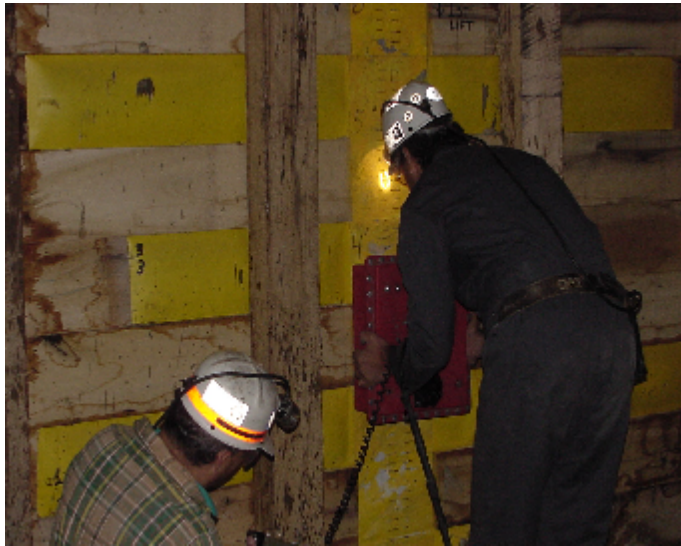
Figure 9. Researchers performing GPR scan of mine seal.

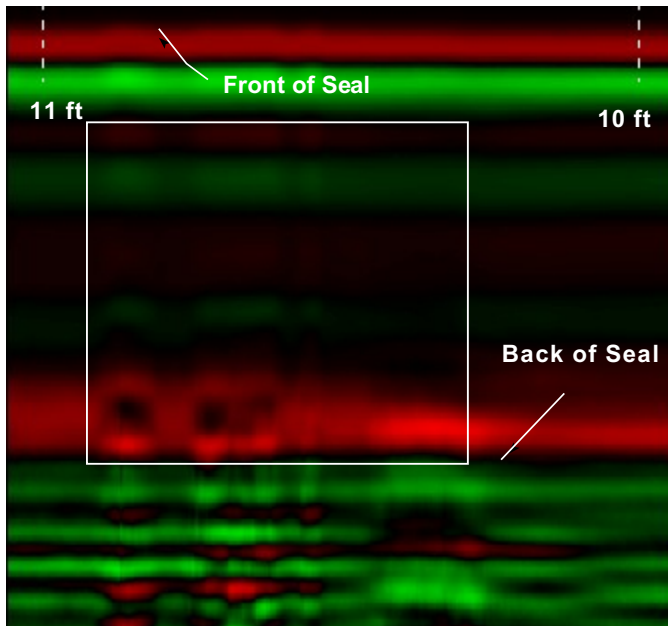
Figure 10. Interpreted radar plot from GPR scan of Section 2 from a height of 10 to 11 ft above the mine floor. Note the anomaly is shown in the box.

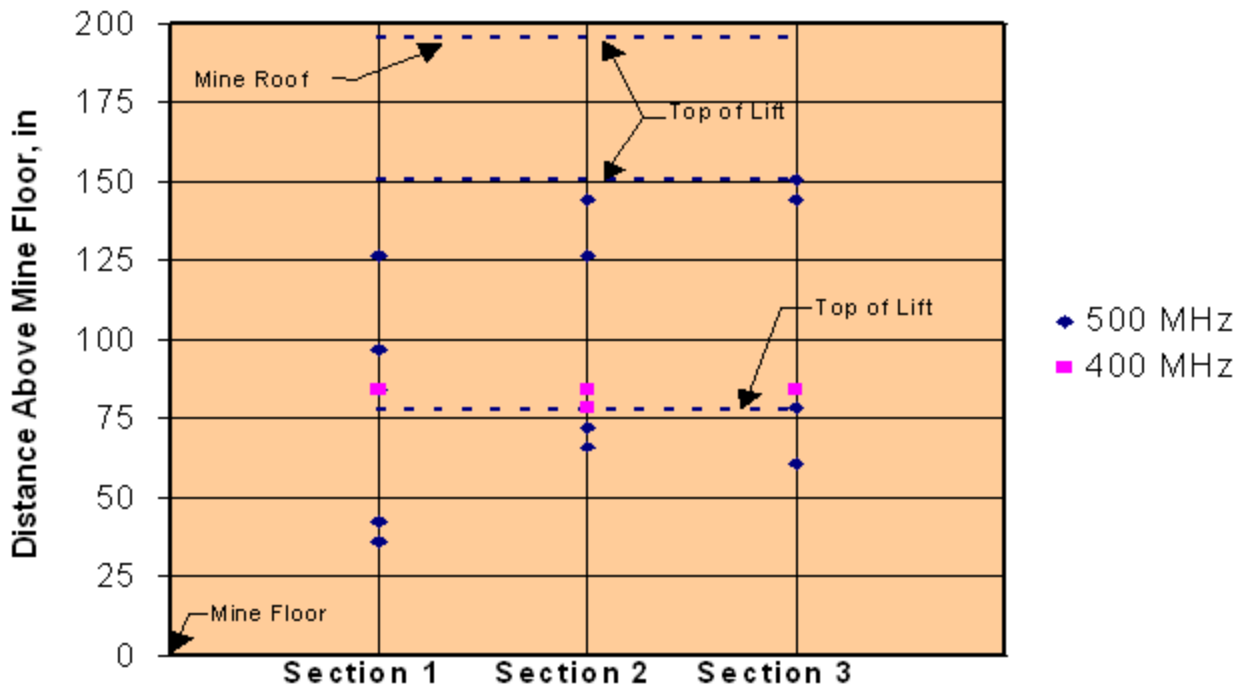
Figure 11. Plot of observed anomalies from GPR scans versus distance above the mine floor.

From table 3, it can be observed that 11 of the 16 anomalies were located about 12 in from the top of a lift. The top of a lift represents a boundary in the seal. This was apparent from observations made during mine seal construction that showed a hard surface had formed overnight on the top of the first and second lifts. Furthermore, the 11 anomalies are also located at or near the areas of increased compressive strength as calculated from the Schmidt Hammer test results.

Of the remaining five anomalies, four were located at the position of an eyebolt and galvanized wire connection that was used to secure the front and back of the seal form (refer to the discussion on mine seal construction earlier in this paper). Also, examinations of the compressive strength data showed that the position of each of the five remaining anomalies were located near areas where the compressive strength values of the seal material were changing from either a local high or low value.

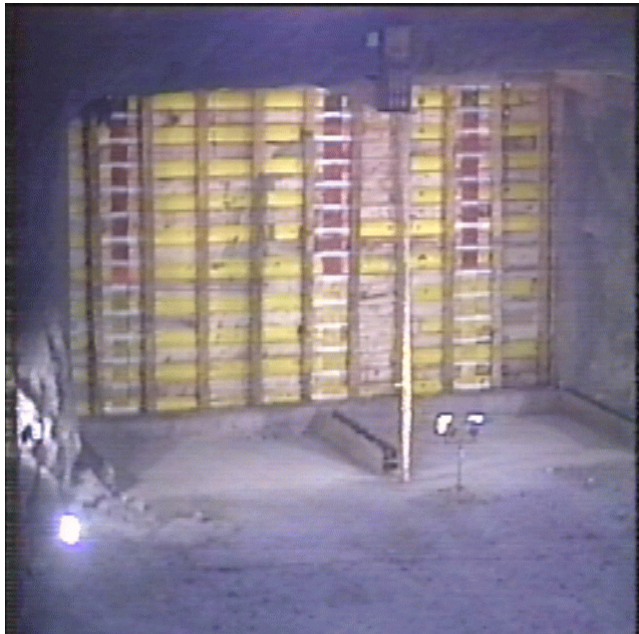
Figure 11. Mine seal just prior to explosion test.

the confined methane-air explosion pressure reached 8 psi. A total of 120 ft³ of methane gas was used in the test. Figures 11 to 14 is a sequence of photos showing the progression of the explosion test. NIOSH research on similarly constructed seals in the small chamber suggested that this seal would fail below the 20 psi threshold. As expected, failure occurred in the center area of the seal since this area was not confined by the mine roof ribs and floor. The sequencing of seal failure did not appear to correlate to the variations in compressive strength observed in the data or to any of the anomalies observed in the GPR scans.

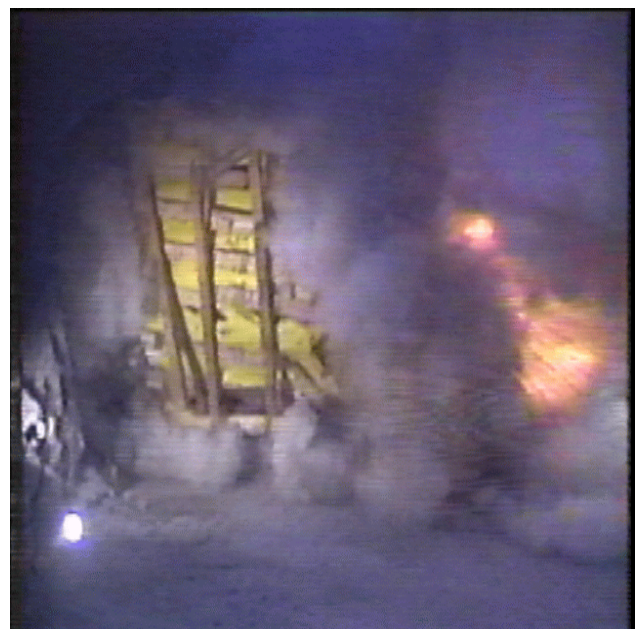
Figure 14. Complete failure of seal.

The sequencing of mine seal failure during explosion testing did not appear to correlate to the compressive strength trends observed from the Schmidt Hammer test data or to any of the anomalies observed in the GPR scans.
