# Roof Stability Issues in Underground Limestone Mines in the United States

**Gabriel S. Esterhuizen**, Senior Research Engineer  
**Dennis R. Dolinar**, Lead Research Engineer  
**John L. Ellenberger**, Lead Research Scientist  
**Leonard J. Prosser**, Research Scientist  
**Anthony T. Iannacchione**, Principal Research Engineer  
NIOSH-Pittsburgh Research Laboratory  
Pittsburgh, PA, USA

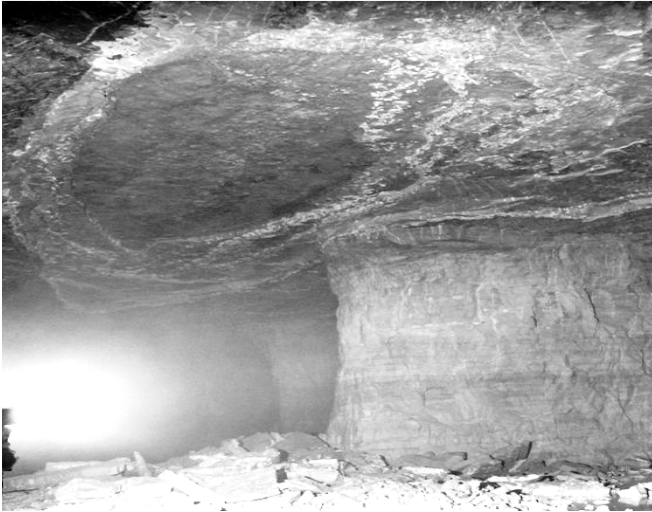
Figure 1. Typical oval shaped roof fall associated with horizontal stress in the roof.

The horizontal stress can cause beams within the roof to buckle and fail in shear (Iannacchione et al., 2003). Failure can initiate as guttering in one corner of an excavation, called "cutter roof" in coal mines, and propagate to a large-scale roof fall (Esterhuizen and Iannacchione, 2004). Falls related to horizontal stress typically line up in the direction perpendicular to the regional maximum

horizontal stress and are oval shaped when seen in plan view, see figure 1. Careful observation of the roof falls and other signs of excessive stress can assist in identifying the orientation of the maximum horizontal stress (Mark and Mucho, 1994).

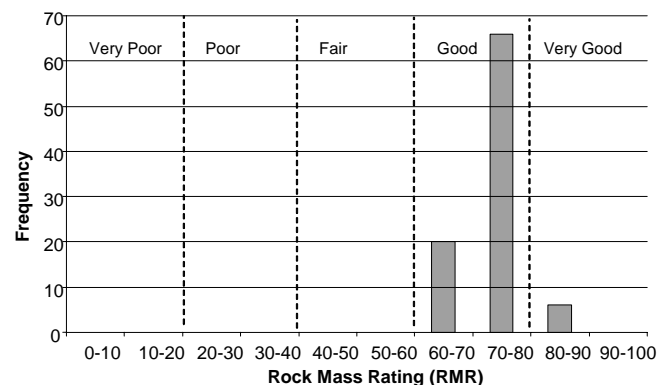
Figure 2. Distribution of Rock Mass Rating (RMR) values in underground limestone mines.

In all cases the data collection for rock mass rating was carried out approximately 2 m (6 ft) from the floor of the mining horizon. The rating results therefore do not describe the detail of the rock layer in the immediate roof, but rather represent the typical rock mass conditions at the site. The rock mass rating is presented in terms of the RMR, which classifies the rock mass on a scale of 0 to 100, with higher numbers indicating stronger rock masses. The RMR values were found to fall in a narrow range, and the ratings for the immediate roof are not expected to be significantly different from the remainder of the formation. Figure 2 shows the distribution of RMR values obtained. It can be seen that the values range between 60 and 90, which lays within the “Good” to “Very Good” quality categories.

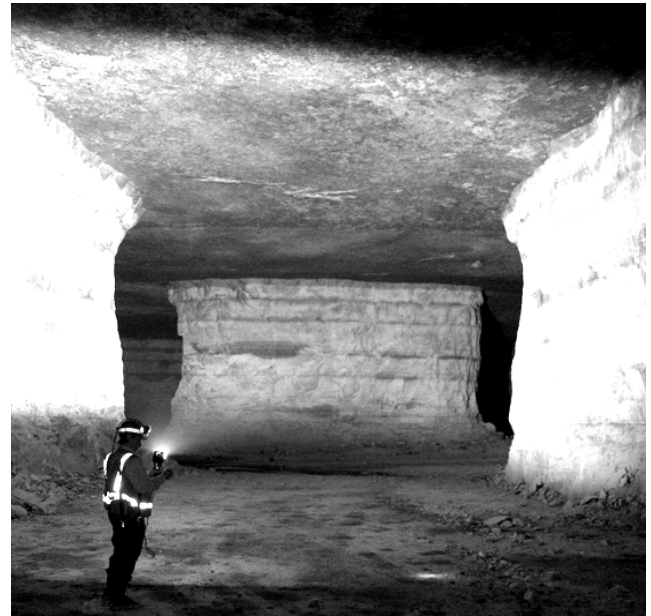
Figure 3. Naturally stable 13 m (44 ft) wide roof spans in a limestone mine in the Central Plains region.

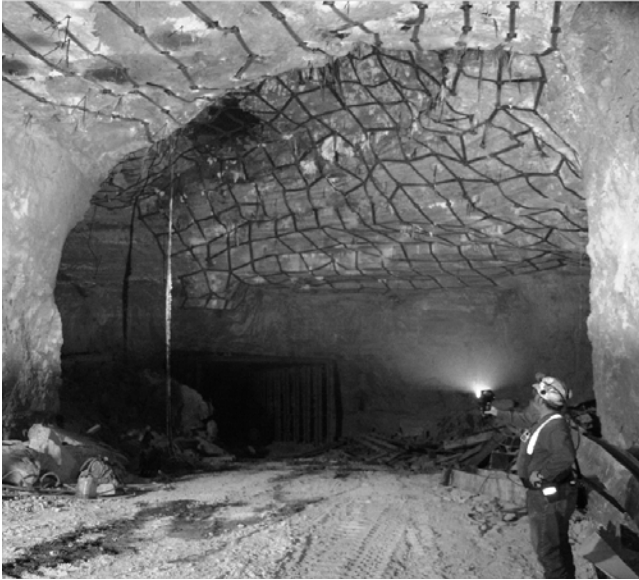
Figure 4. Repair of a large roof fall in which horizontal stress is thought to have contributed to the failure.

Although the large roof falls only make up a small percentage of the total roof exposure, their potential impact on safety and mine operations can be very significant. Most cases of large roof falls required barricading-off or abandonment of the affected entry. When large roof falls occur in critical excavation areas, the repair can be very costly. Figure 4 shows a case where extensive support was required to rehabilitate a large roof fall.
