NIOSH COMPUTER PROGRAMS FOR
BENCH CREST FAILURE ANALYSIS IN FRACTURED ROCK

SYNOPSIS

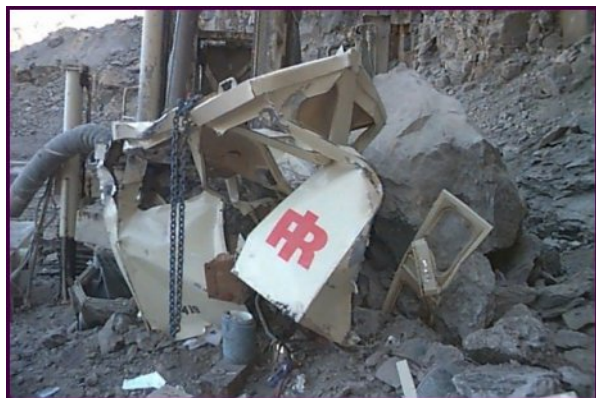
The importance of bench integrity is well illustrated by two of these accidents. One occurred on the evening of October 5, 1998, early in the night shift. A large piece of rock fell 6 m from the highwall to a safety bench, split, then fell an additional 17 m onto the cab of a drill, destroying the cab (Figure 4). The rock measured about 2 m long, 2 m wide, and 1.2 m thick.

Figure 4: Cab crushed during slope failure (MSHA fatalgram, www.msha.gov).
